## **RCRA Inspection Report**

Adornus Manufacturing USA, LLC EPA ID# SCD000648493  
1551 Highway 9 Bypass West  
Lancaster, South Carolina 29720

February 26, 2021

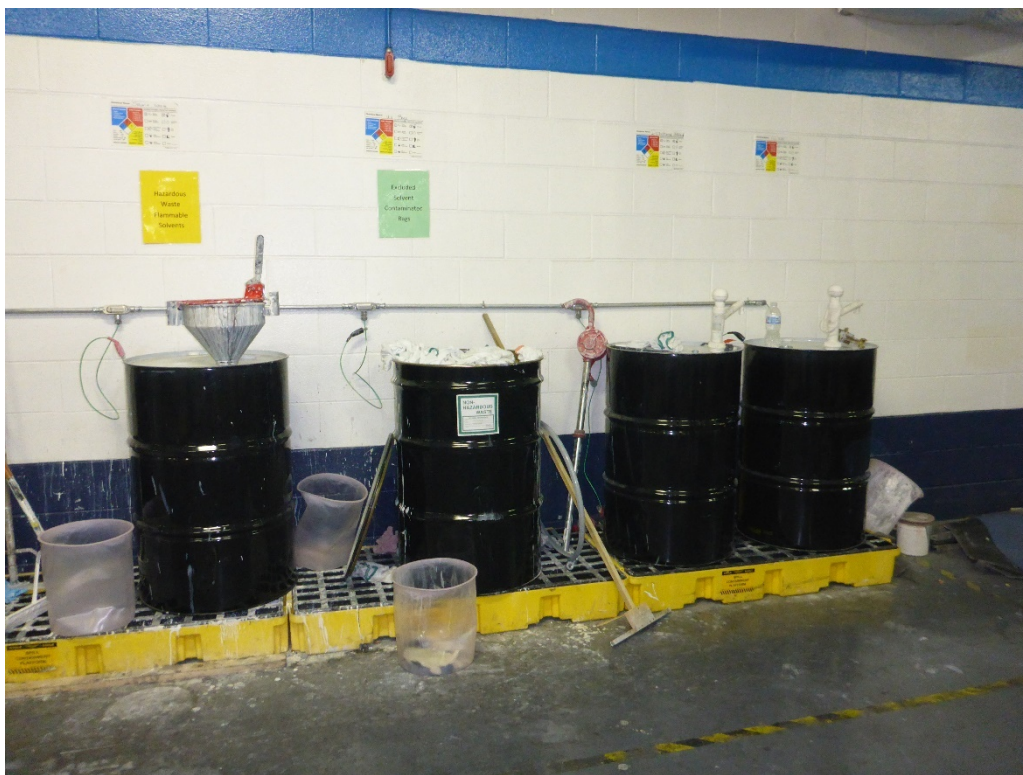
**Paint Mixing Room Area:** The facility tour began just outside of the paint mixing room, where the inspectors observed five 55-gallon drums sitting on portable secondary containment pallets along the wall (Photos 1 and 2). The first drum was identified as nonhazardous UV water based paint, the second was identified as hazardous waste flammable solvents, the third was identified as excluded solvent contaminated disposable wipes, the fourth was identified as denatured alcohol product, and the fifth was identified as acetone product. Although the sign on the wall behind the second 55-gallon drum indicated that this drum contained hazardous waste flammable solvents, no hazardous waste label was visible on the drum. The drum was equipped with a funnel, which was open when the inspectors arrived in this area. The inspectors also observed a flammable liquid DOT hazard placard on the drum. The drum of excluded solvent contaminated disposable wipes was labeled as nonhazardous waste excluded solvent contaminated wipes. This drum was completely open and was not equipped with a lid.

**Photo 2:** Four of five 55-gallon drums staged on portable secondary containment pallets in the UV Paint Coating Area along the wall just outside of the Paint Mixing Room. The drum on the left was identified for accumulating hazardous waste flammable solvents; second drum from the left was identified for accumulating excluded solvent contaminated disposable wipes; the second drum from the right was identified as denatured alcohol; and the drum on the right was identified as acetone.

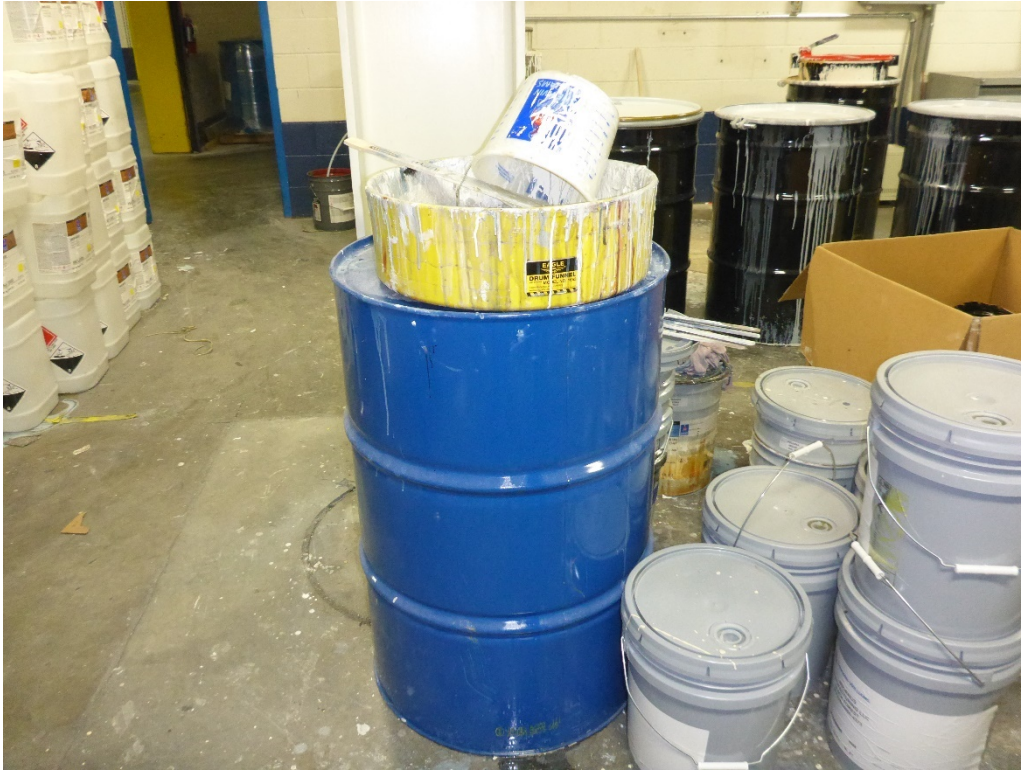
**Photo 3:** One 55-gallon drum observed near a post in the Reclaim Room. According to facility personnel, this drum, which is equipped with an open funnel, is used to accumulate waste UV paints that are brought into this room. Personnel stated that the standard operating procedure is to pour the contents of waste UV paint buckets into the designated 55-gallon accumulation drum located on portable secondary containment pallet in the UV Paint Coating Area along the wall just outside of the Paint Mixing Room shown in Photo #1. However, personnel working in this room maintain the accumulation drum shown in this photograph as a courtesy when employees mistakenly bring the 5-gallon containers of UV paint waste to this room.

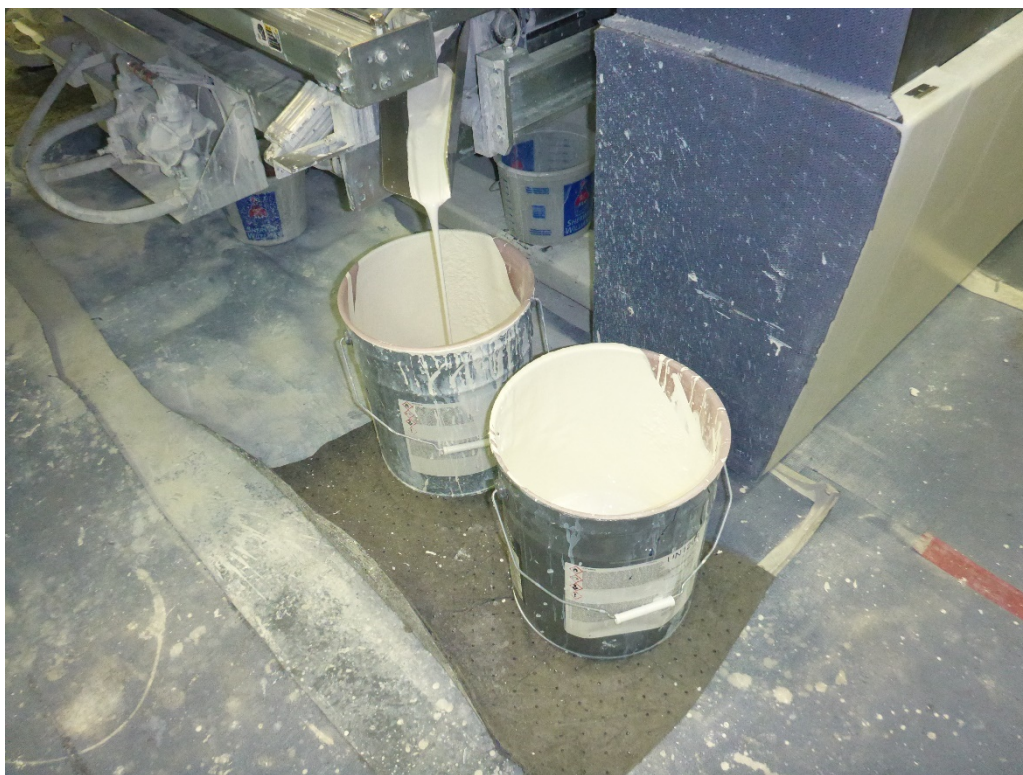
**Photo 13:** Two 5-gallon buckets staged at the first solvent paint spray line SAA. These buckets are used to accumulate D001 / F003 / F005 hazardous waste flammable liquid (toluene / acetone) that is generated as excess paint and overspray in this solvent paint spray line unit. Neither bucket is labeled with the words “hazardous waste.” Neither bucket is closed, but only one has waste being added into the container.

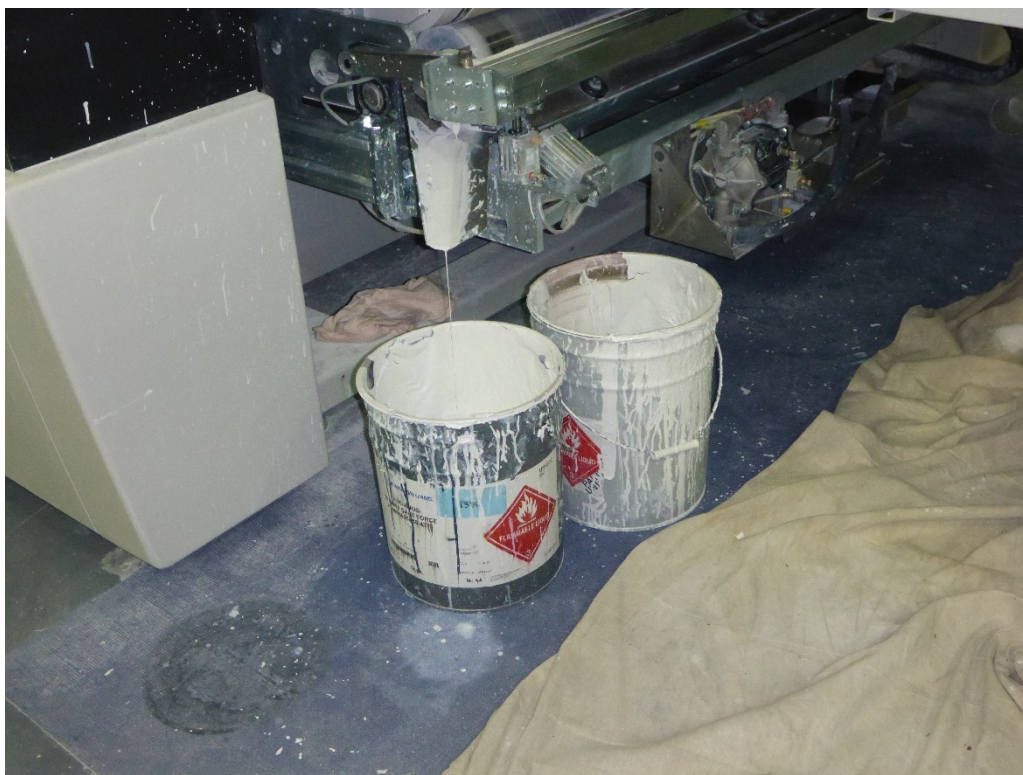
**Photo 18:** Two 5-gallon buckets staged at the second solvent paint spray line SAA. These buckets are used to accumulate D001 / F003 / F005 hazardous waste flammable liquid (toluene / acetone) that is generated as excess paint and overspray in this solvent paint spray line. Neither bucket is labeled with the words “hazardous waste.” Neither bucket is closed, but only one has waste being added into the container.

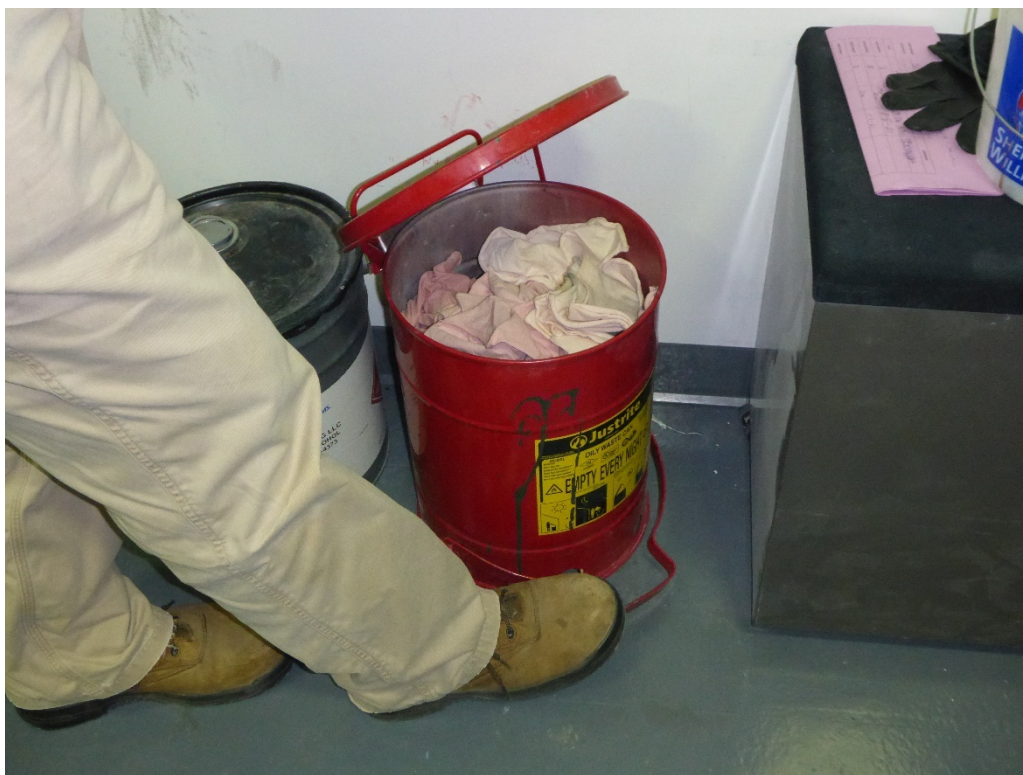
The inspectors observed one 5-gallon flip-top flammable can next to the paint / stain mixing station (Photo 21). The can is used to accumulate excluded solvent contaminated disposable wipes, but it was labeled “oily waste, empty every night.” The can was not labeled as excluded solvent contaminated wipes.

**Photo 21:** One 5-gallon step-open flammable can for accumulating excluded solvent contaminated disposable wipes at the laquer spray line. The container is labeled as “oily waste” and “empty every night.” It is not labeled as excluded solvent contaminated wipes.

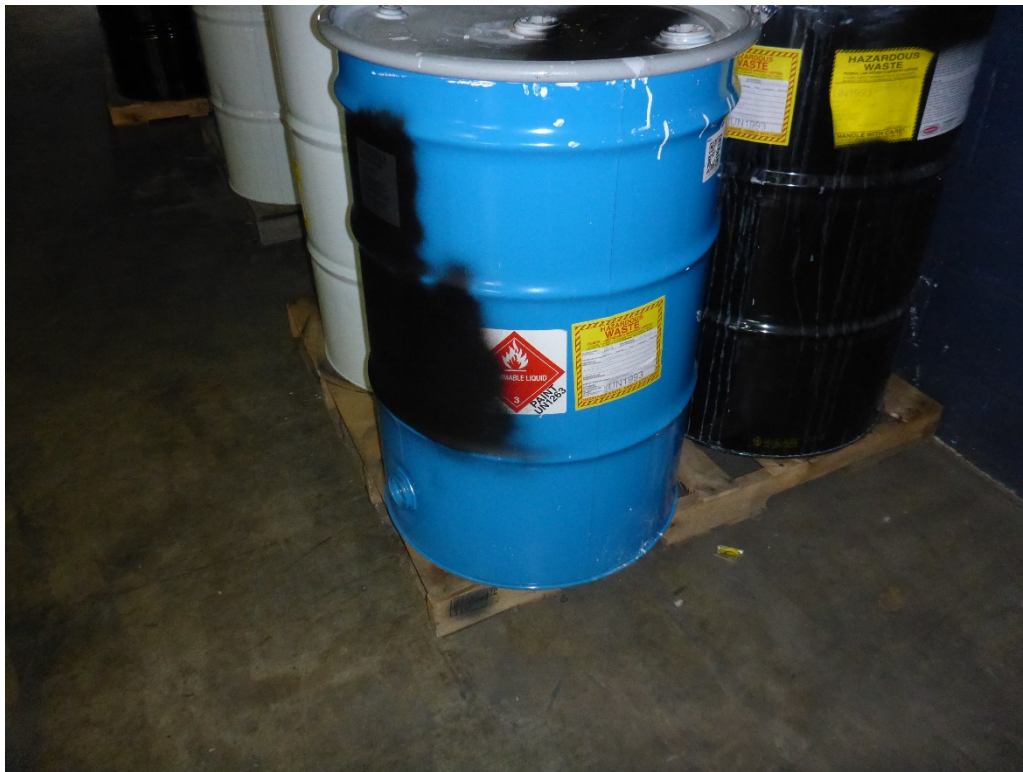
**Photo 23:** Partially covered flammable liquid DOT hazard placard on one drum in the hazardous waste CAA.

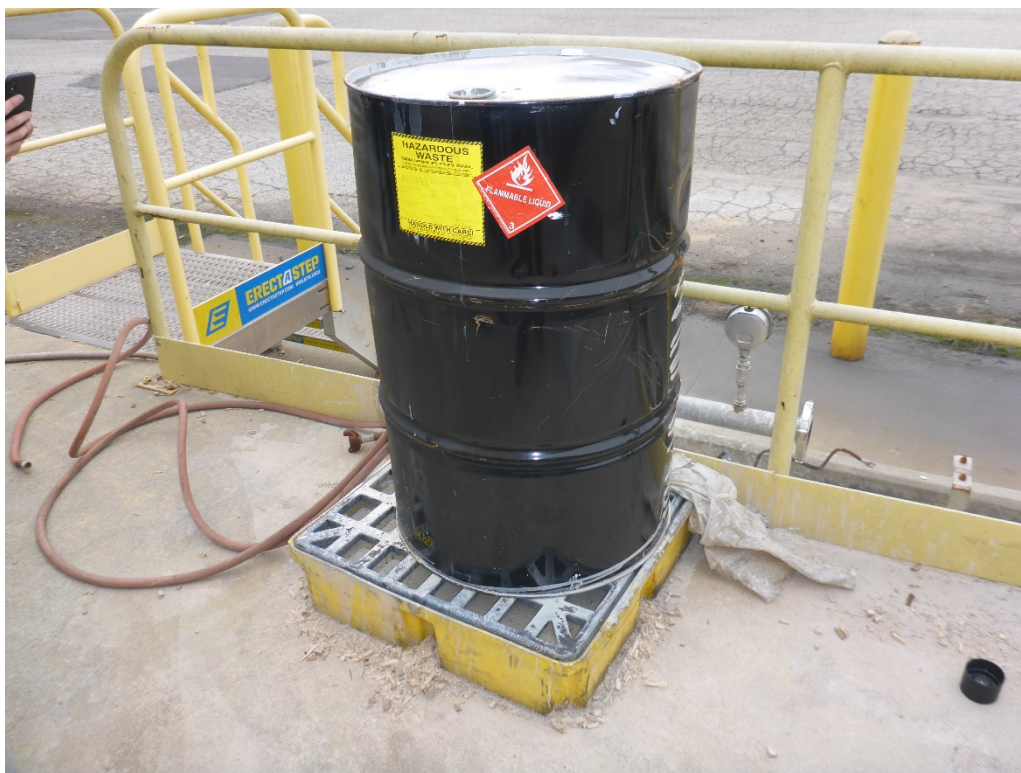
**Photo 26:** One drum of hazardous waste observed on a secondary containment pallet on the loading dock outside of the hazardous waste CAA. The drum was labeled D001 / F003 / F005 hazardous waste flammable liquid (acetone / toluene) and identified with a flammable liquid DOT hazard placard. The drum was dated 10/07/2020, and the secondary containment unit was full of liquid. Mr. Lucas explained that the drum was hit with a forklift during loading activities, which caused it to leak. Because the leaking drum could not be loaded onto the truck for transport off-site, it was moved out to this portable secondary containment unit
