## **RCRA Inspection Report**

| Sentury Reagents, Inc. | EPA ID#: SCD982085136 |

November 16, 2021

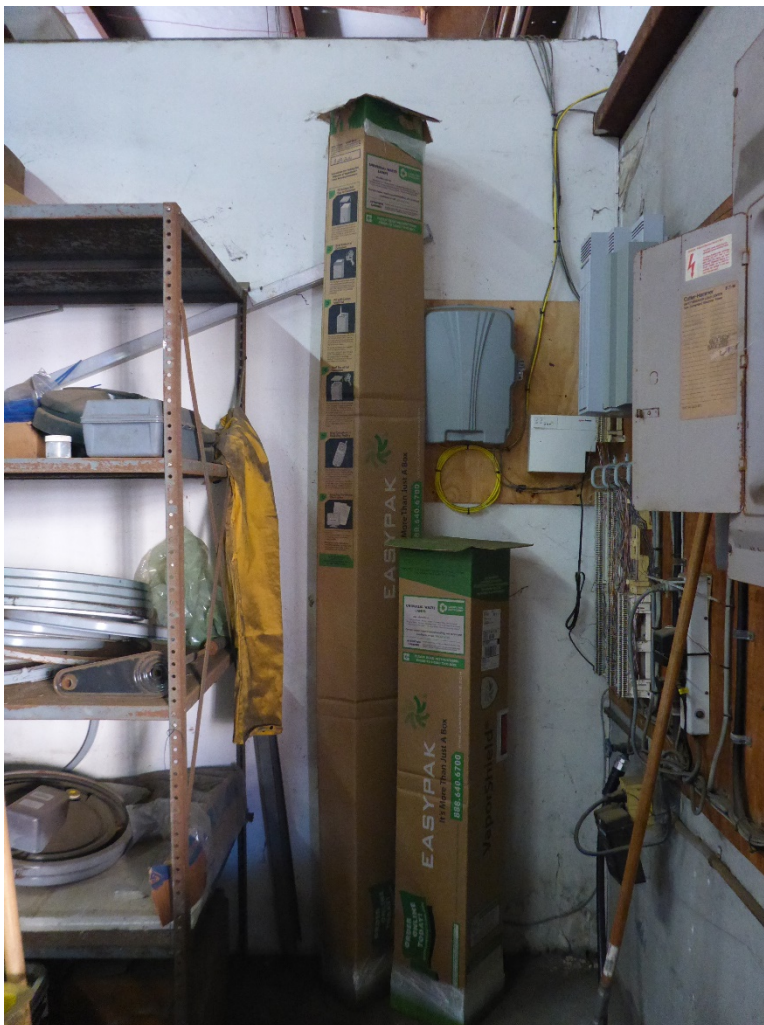
Sentury Reagents also manages universal waste lamps in the warehouse. The inspectors observed one box of 4-foot used fluorescent lamps and one box of 8-foot used fluorescent lamps in this area (Photo 1). Both boxes were closed and labeled as universal hazardous waste lamps. The box of 4-foot lamps was marked with an accumulation start date of 04/22/2021 and the box of 8-foot lamps was marked with an accumulation start date of 03/29/2021.

**Photo 1:** One box of 4-ft used fluorescent lamps and one box of 8-ft used fluorescent lamps in the Warehouse. Both boxes were closed and labeled as universal hazardous waste lamps. The 4-ft box was marked with an accumulation start date of 04/22/2021 and the 8-ft box was marked with an accumulation start date of 03/29/2021.

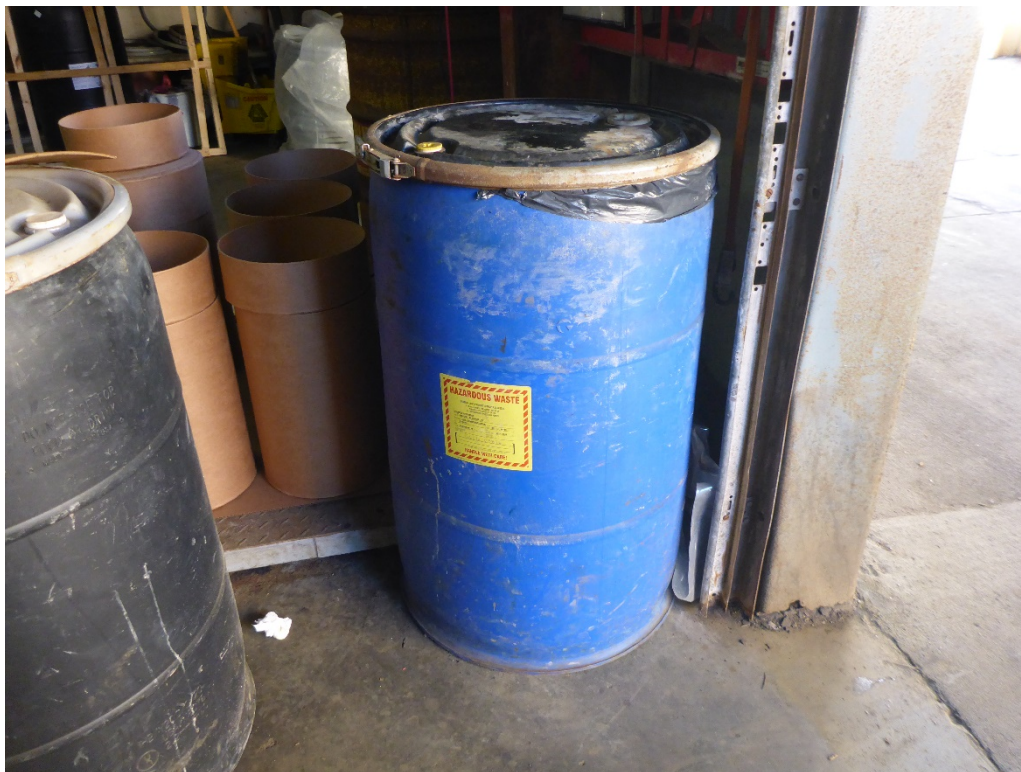
Sentury Reagents also manages one SAA in the warehouse for managing empty raw material bags, used PPE and contaminated trash as hazardous waste solids (Photo 2). The inspectors observed one 55-gallon drum in this SAA, which is identified as SA4 Weighing Area on the weekly inspection log. The drum was located near the exit leading to the Main Plant. The drum was labeled D007 / D008 hazardous waste solid, but it was not marked with an indication of the hazards of its contents.

**Pursuant to 25 S.C. Code Ann. Regs. 61-79.262.15(a)(5) [40 C.F.R. § 262.15(a)(5)(ii)], which is a condition of the SAA Permit Exemption, a generator is required to mark or label its containers with an indication of the hazards of the contents.**

**Photo 2:** SAA One 55-gallon drum in the Warehouse SAA for managing empty raw material bags, used PPE and contaminated trash as hazardous waste solids. The drum was closed and labeled D007 / D008 hazardous waste solids, but it was not marked with an indication of the hazards of its contents.

On the day following the inspection, Mr. Ellis sent an email to the inspectors which included a photograph to show that the hazardous waste label has been modified to indicate that the contents of this container are toxic.

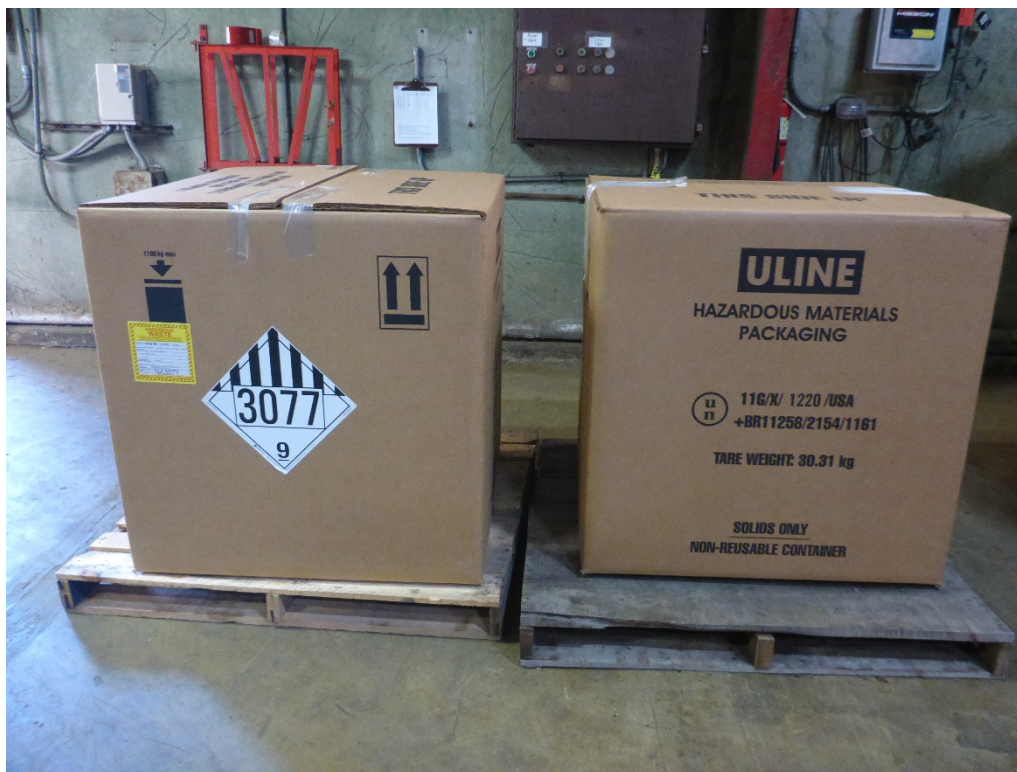
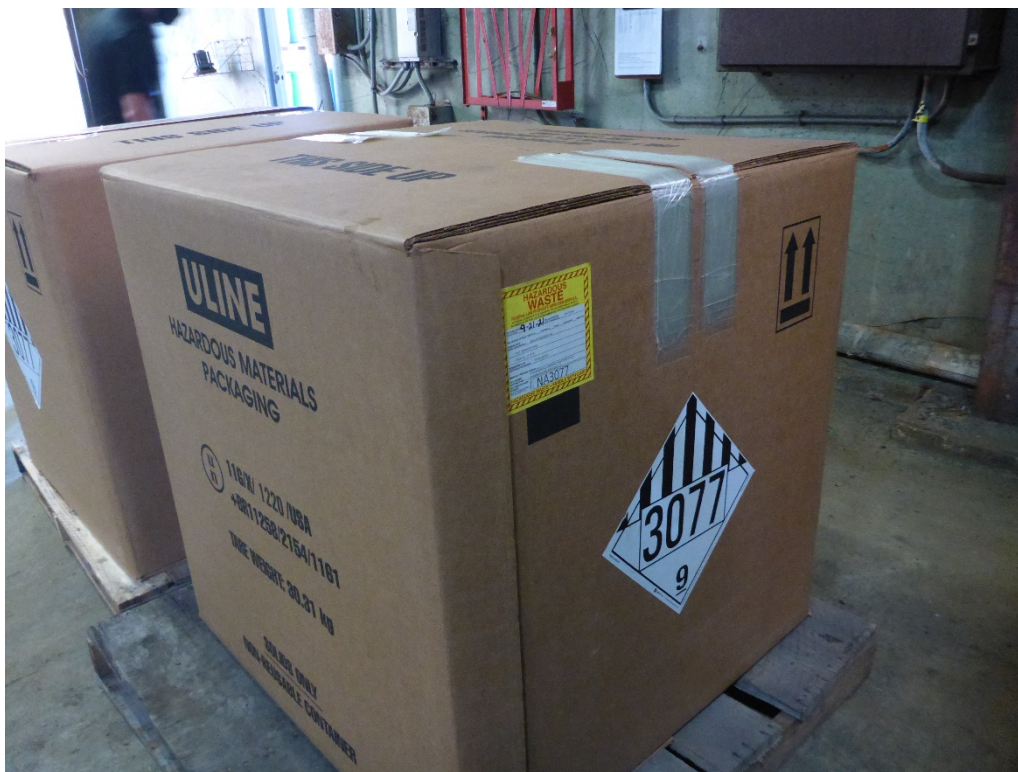
The inspectors observed two cubic yard boxes on wooden pallets in the designated CAA (Photos 3 and 4). Mr. Ellis stated that the boxes contain used gloves, respirator cartridges and other PPE, empty product bags and other contaminated trash. Each box was labeled D007 / D008 hazardous waste solid and identified with a DOT class 9 hazard placard. One box was dated 11/16/2021 and the other was dated 09/21/2021.

**Pursuant to 25 S.C. Code Ann. Regs. 61-79.262.16(b)(6)(i)(B) [40 C.F.R. § 262.16(b)(6)(i)(B)], which is a condition of the SQG Permit Exemption, a generator is required to mark or label its containers with an indication of the hazards of the contents.**

**Photo 3:** Two cubic yard boxes of used gloves, respirator cartridges and other PPE, empty product bags and contaminated trash in the CAA. Each box was labeled D007 / D008 hazardous waste solid and identified with a DOT class 9 hazard placard. One box was dated 11/16/2021 and the other was dated 09/21/2021.

**Photo 4:** Two cubic yard boxes of used gloves, respirator cartridges and other PPE, empty product bags and contaminated trash in the CAA. Each box was labeled D007 / D008 hazardous waste solid and identified with a DOT class 9 hazard placard. One box was dated 11/16/2021 and the other was dated 09/21/2021.

On the day following the inspection, Mr. Ellis sent an email to the inspectors which included a photograph to show that the hazardous waste labels had been modified to indicate that the contents of these containers are toxic.

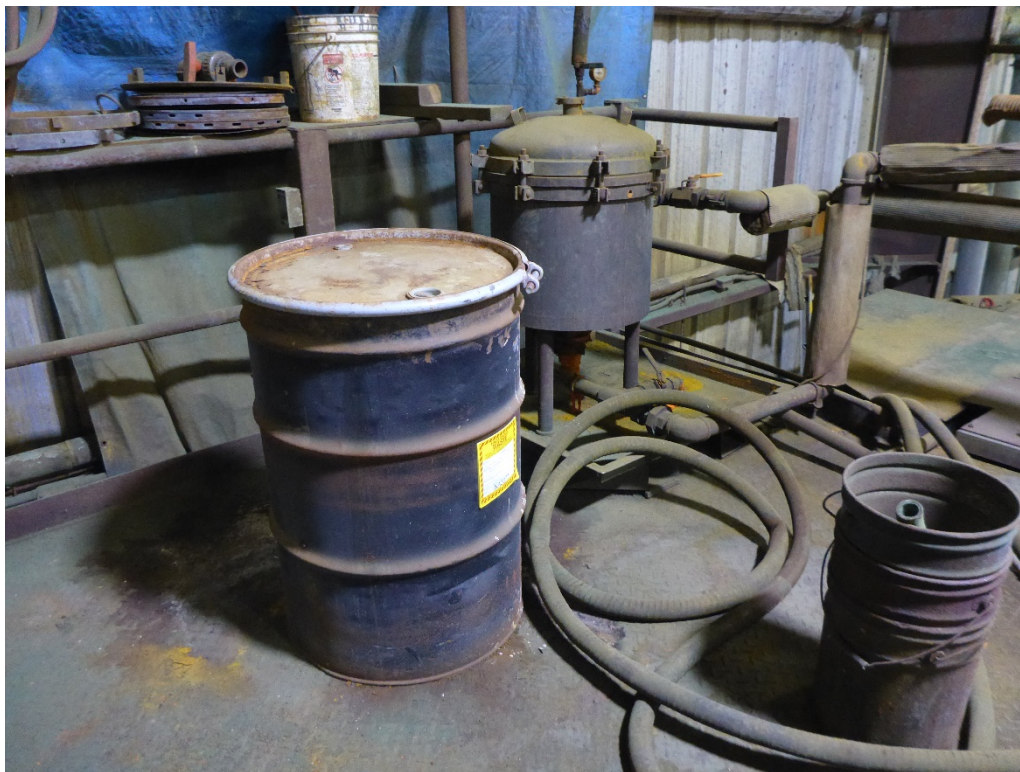
Sentury Reagents manages one SAA in the Main Plant for managing hazardous waste filter cloths that are generated in the production process (Photo 5). The inspectors observed one 55-gallon drum in this SAA, which is identified as SA1 Amm Mix Platform on the weekly inspection log. The drum was located on the Mix Platform. The drum was closed and labeled D007 hazardous waste solids, but it was not marked with an indication of the hazards of its contents.

**Pursuant to 25 S.C. Code Ann. Regs. 61-79.262.15(a)(5)(ii) [40 C.F.R. § 262.15(a)(5)(ii)], which is a condition of the SAA Permit Exemption, a generator is required to mark or label its containers with an indication of the hazards of the contents.**

**Photo 5:** One 55-gallon drum in the Main Plant SAA for managing hazardous waste filter cloths that are generated in the production process. The drum was closed and labeled D007 hazardous waste solids, but it was not marked with an indication of the hazards of its contents.

On the day following the inspection, Mr. Ellis sent an email to the inspectors which included a photograph to show that the hazardous waste label has been modified to indicate that the contents of this container are toxic.

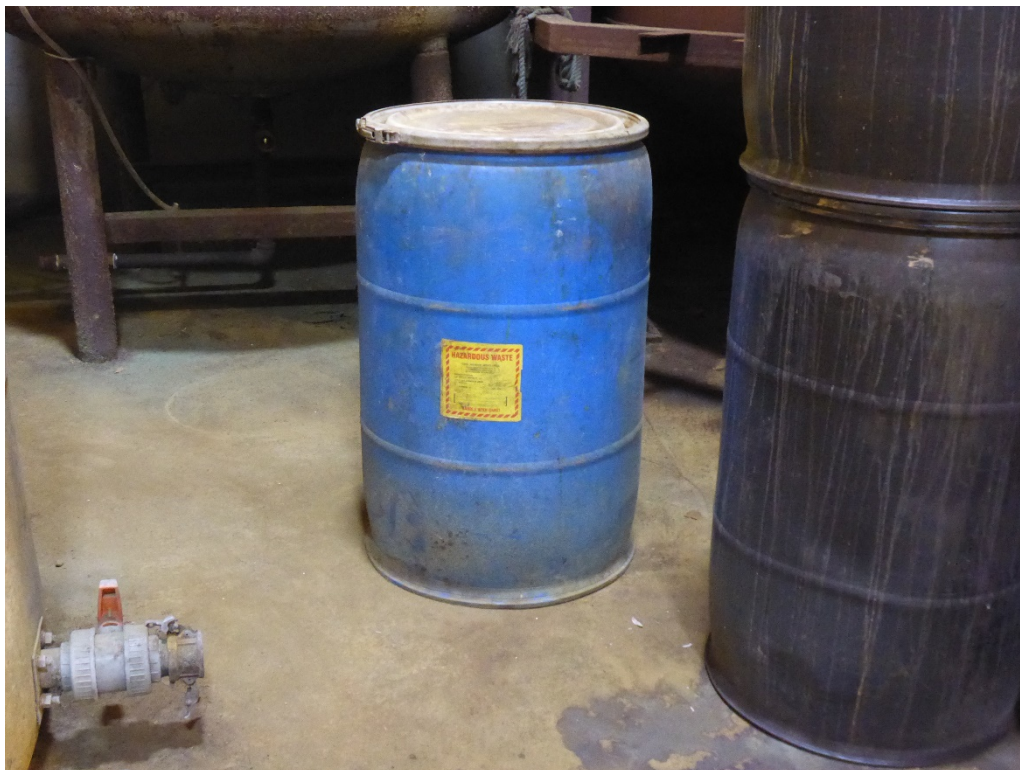
Sentury Reagents manages one SAA on the floor in the Potassium Room for managing used PPE, gloves and trash that are generated in the production process (Photo 6). The inspectors observed one 55-gallon drum in this SAA, which is identified as SA3 Kroom / 300 Room Floor on the weekly inspection log. The drum was closed and labeled D007 / D008 hazardous waste solids, but it was not marked with an indication of the hazards of its contents.

**Pursuant to 25 S.C. Code Ann. Regs. 61-79.262.15(a)(5)(ii) [40 C.F.R. § 262.15(a)(5)(ii)], which is a condition of the SAA Permit Exemption, a generator is required to mark or label its containers with an indication of the hazards of the contents.**

**Photo 6:** One 55-gallon drum on the floor in the Potassium Room SAA for managing hazardous waste used PPE, gloves and trash. The drum was closed and labeled D007 / D008 hazardous waste solids, but it was not marked with an indication of the hazards of its contents.

On the day following the inspection, Mr. Ellis sent an email to the inspectors which included a photograph to show that the hazardous waste label has been modified to indicate that the contents of this container are toxic.

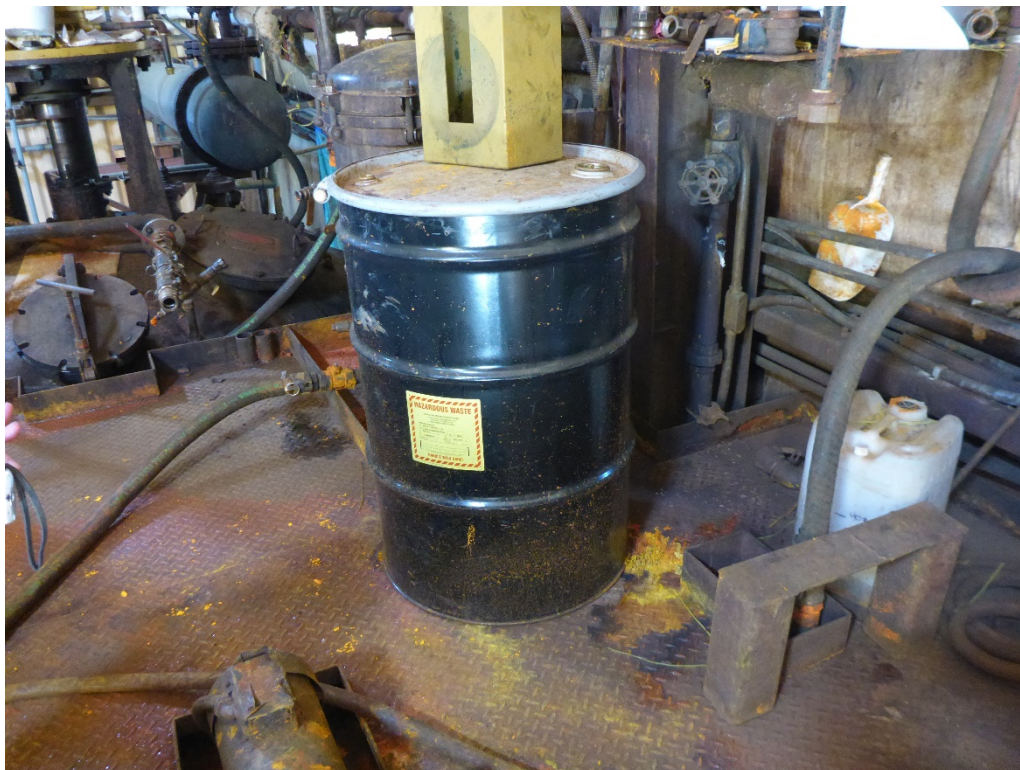
Sentury Reagents manages one SAA on the Potassium Mix Platform for managing hazardous waste filter cloths that are generated in the production process (Photo 7). The inspectors observed one 55-gallon drum in this SAA, which is identified as SA2 Potassium Mix Platform on the weekly inspection log. The drum was closed and labeled D007 / D008 hazardous waste solids, but it was not marked with an indication of the hazards of its contents.

**Pursuant to 25 S.C. Code Ann. Regs. 61-79.262.15(a)(5)(ii) [40 C.F.R. § 262.15(a)(5)(ii)], which is a condition of the SAA Permit Exemption, a generator is required to mark or label its containers with an indication of the hazards of the contents.**

**Photo 7:** One 55-gallon drum in the Potassium Room platform SAA for managing hazardous waste filter cloths that are generated in the production process. The drum was closed and labeled D007 / D009 hazardous waste solids, but it was not marked with an indication of the hazards of its contents.

On the day following the inspection, Mr. Ellis sent an email to the inspectors which included a photograph to show that the hazardous waste label has been modified to indicate that the contents of this container are toxic.

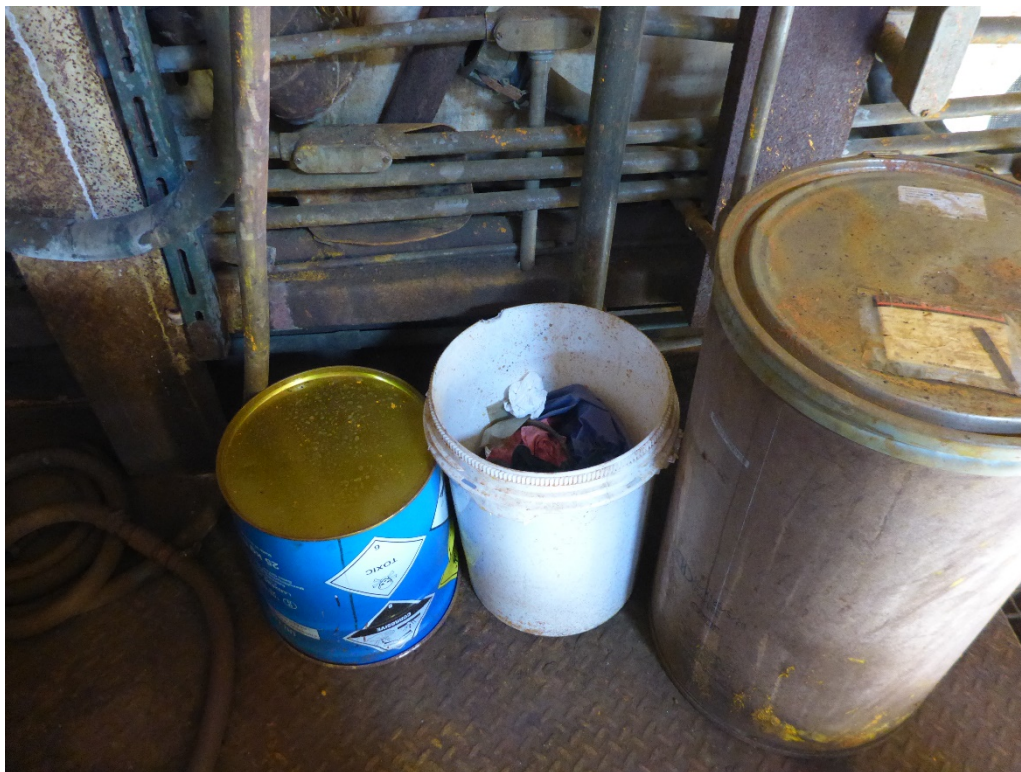
Although Century Reagents had not identified another SAA on the Potassium Mix Platform, the inspectors observed a 5-gallon bucket, which was being used to accumulate hazardous waste used PPE, gloves and trash (Photo 8). Mr. Ellis explained that the contents of this bucket are emptied into one of the cubic yard boxes in the CAA. The bucket was not equipped with a lid, it was not labeled as hazardous waste, and it was not marked with an indication of the hazards of its contents.

**Pursuant to 25 S.C. Code Ann. Regs. 61-79.262.15(a)(4) [40 C.F.R. § 262.15(a)(4)], which is a condition of the SAA Permit Exemption, a generator is required to keep containers of hazardous waste closed at all times during accumulation, except when adding, removing, or consolidating waste; or when temporary venting of a container is necessary for the proper operation of equipment, or to prevent dangerous situations, such as build-up of extreme pressure.**

**Pursuant to 25 S.C. Code Ann. Regs. 61-79.262.15(a)(5) [40 C.F.R. § 262.15(a)(5)], which is a condition of the SAA Permit Exemption, a generator is required to mark or label its containers (i) with the words “hazardous waste,” and (ii) with an indication of the hazards of the contents.**

**Photo 8:** One 5-gallon bucket on the platform in the Potassium Room for accumulating hazardous waste used PPE, gloves and trash. The drum bucket was not closed or labeled, and this area was not identified as a SAA.

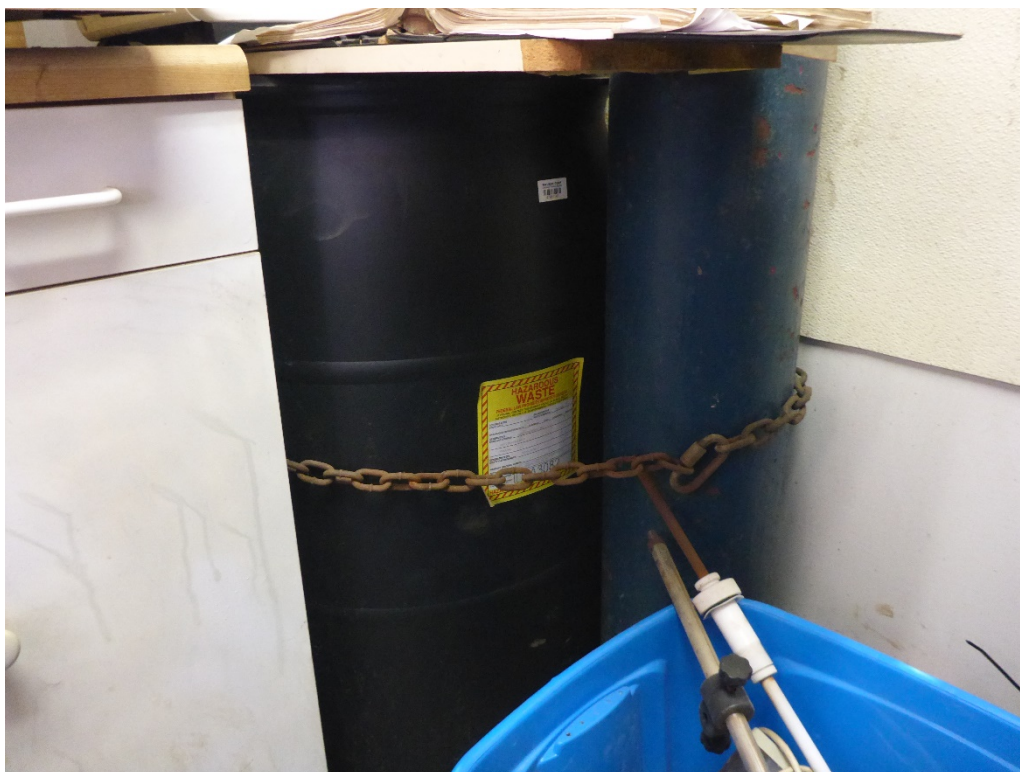
Laboratory SAA: Sentury Reagents manages one SAA for managing hazardous waste lead chromate liquid that is generated by the Atomic Analyzer (AA) in the laboratory. The inspectors observed two containers in this SAA, one 55-gallon drum (Photo 9) and one 5-gallon carboy (Photo 10). Hazardous waste lead chromate liquid generated in the AA machine drains into the 5-gallon carboy through a tube, which was threaded through the container lid. Mr. Ellis explained that liquid is poured from the carboy into the 55-gallon drum at the end of each day.

The 5-gallon carboy was located on the floor next to the AA machine and the 55-gallon drum was located in the corner of the room on the other side of the AA machine. Both containers were labeled hazardous waste, but neither was marked with an indication of the hazards of its contents.

**Pursuant to 25 S.C. Code Ann. Regs. 61-79.262.15(a)(5)(ii) [40 C.F.R. § 262.15(a)(5)(ii)], which is a condition of the SAA Permit Exemption, a generator is required to mark or label its containers with an indication of the hazards of the contents.**

**Photo 9:** One 55-gallon drum in the Laboratory SAA for managing hazardous waste lead chromate liquid that is generated by the Atomic Analyzer. The drum was closed and labeled hazardous waste liquid, but it was not marked with an indication of the hazards of its contents.

On the day following the inspection, Mr. Ellis sent an email to the inspectors which included photographs to show that the hazardous waste labels have been modified to indicate that the contents of these containers are toxic.

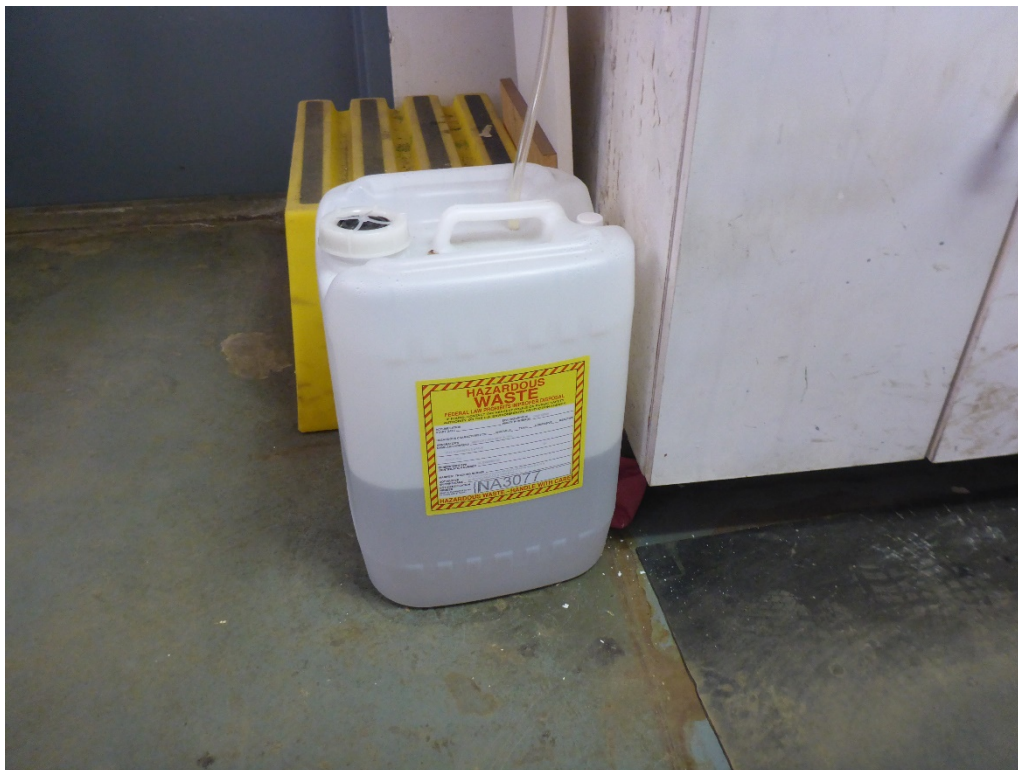
**Photo 10:** One 5-gallon carboy in the Laboratory SAA for managing hazardous waste lead chromate liquid that is generated by the Atomic Analyzer. The container was closed and labeled hazardous waste liquid, but it was not marked with an indication of the hazards of its contents.
