## **RCRA Inspection Report**

GM Nameplate, Inc. EPA ID# NCD003156510  
North Carolina Division  
300 Acme Drive  
Monroe, North Carolina 28112

January 7, 2021

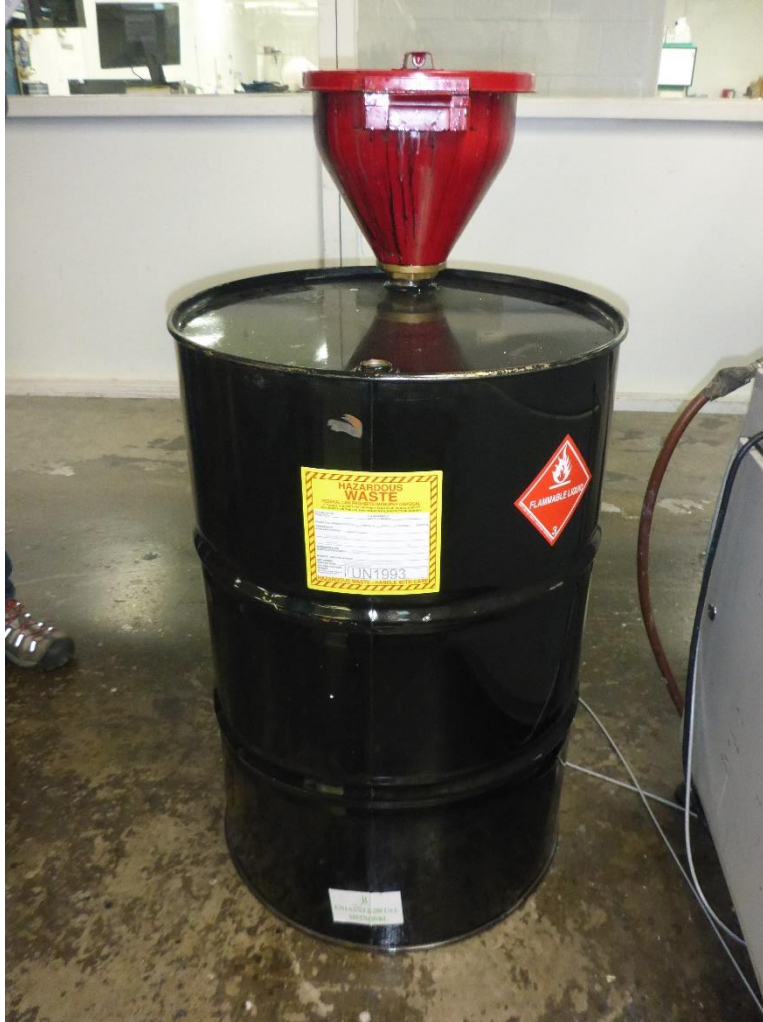
The inspectors also noted that the 55-gallon drum in the Screen Print Area One SAA was labeled D001 / D035 / F005 hazardous waste flammable liquid (MEK<sup>1</sup>), which is different from the F005 / F003 / D001 hazardous waste ink sludge with UV component label on the one-gallon container in the R & D Laboratory. Mr. Harper explained that the hazardous waste label on the one-gallon container was only intended to indicate that the container should be used to accumulate hazardous waste, but that the waste description on the label was not intended to describe the waste in the container. It was unclear if the R & D Laboratory generates D001 / D035 / F005 hazardous waste flammable liquid (MEK), F005 / F003 / D001 hazardous waste ink sludge with UV component, or both. Furthermore, Ms. Pruitt observed that, according to product labels observed on the one-gallon containers of ingredients used in the ink mixing process, some of these ingredients contain lead. GMN did not provide any records of analytical testing to verify that the D001 / D035 / F005 hazardous waste flammable liquid (MEK), or the F005 / F003 / D001 hazardous waste ink sludge with UV component do not exceed the regulatory threshold for the toxicity characteristic of any heavy metals found in the ink ingredients, including the threshold for D008 hazardous waste containing lead.

Screen Print Area One: GMN manages a SAA inside the Screen Print Area One, and the inspectors observed one 55-gallon drum in this SAA (Photo 2). The drum was labeled D001 / D035 / F005 hazardous waste flammable liquid (MEK), and it was identified with a flammable liquid hazard placard. The small bung on the lid of the drum was open.

**Photo 2:** One 55-gallon container for accumulating hazardous waste generated in the Screen Print Area One. The container is labeled as D001 / D035 / F005 hazardous waste flammable liquid (MEK), and identified with a flammable liquid hazard placard.

**Pursuant to 15A NCAC 13A .0107(a) [40 C.F.R. § 262.15(a)(4)], which is a condition of the SAA Permit Exemption, a generator is required to keep containers of hazardous waste closed at all times during accumulation, except when adding, removing, or consolidating waste; or when temporary venting of a container is necessary for the proper operation of equipment, or to prevent dangerous situations, such as build-up of extreme pressure.**

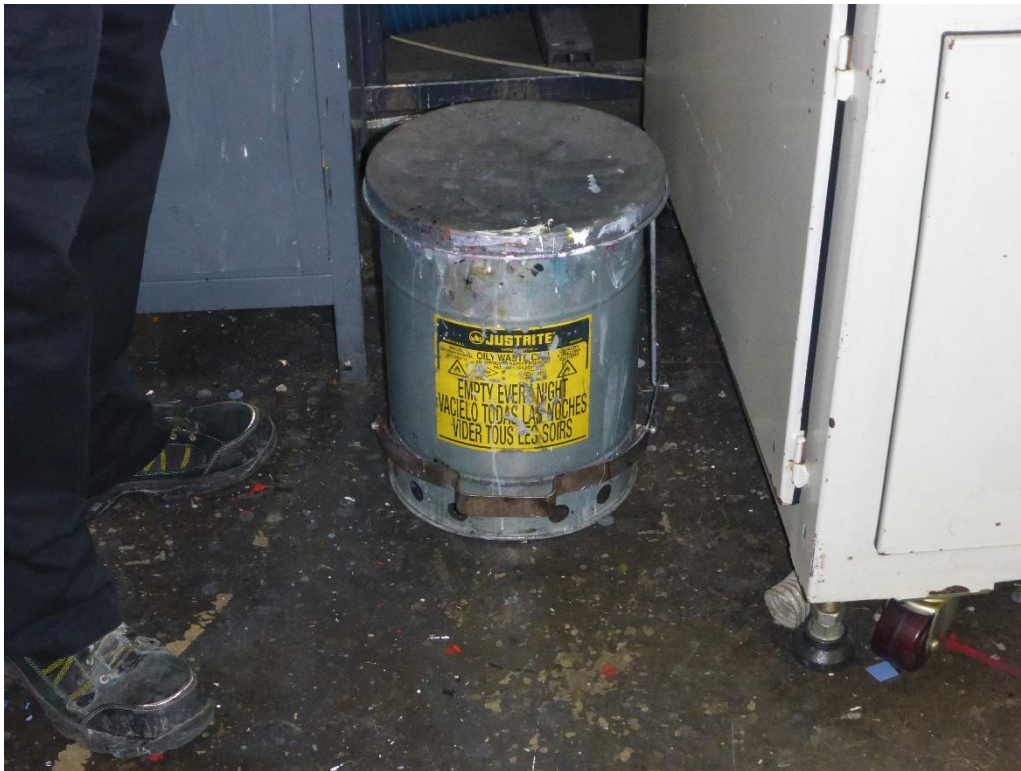
containers (Photos 3 – 5). The inspectors observed the words “contaminated shop towels,” and “keep closed” on these containers, but none of the containers were labeled “excluded solvent contaminated wipes.”

**Photo 3:** One flip-top 5-gallon container for accumulating solvent contaminated wipes in the Screen Print Area One. The container, which was located next to one of the screen print stations, was not labeled “excluded solvent contaminated wipes.”

**Pursuant to 15A NCAC 13A .0106 [40 C.F.R. § 261.4(a)(26)(i)], which is a condition of the Solvent-Contaminated Reusable Wipes Exclusion, solvent-contaminated wipes when accumulated, stored, and transported, must be contained in non-leaking, closed containers that are labeled “Excluded Solvent-Contaminated Wipes.”**

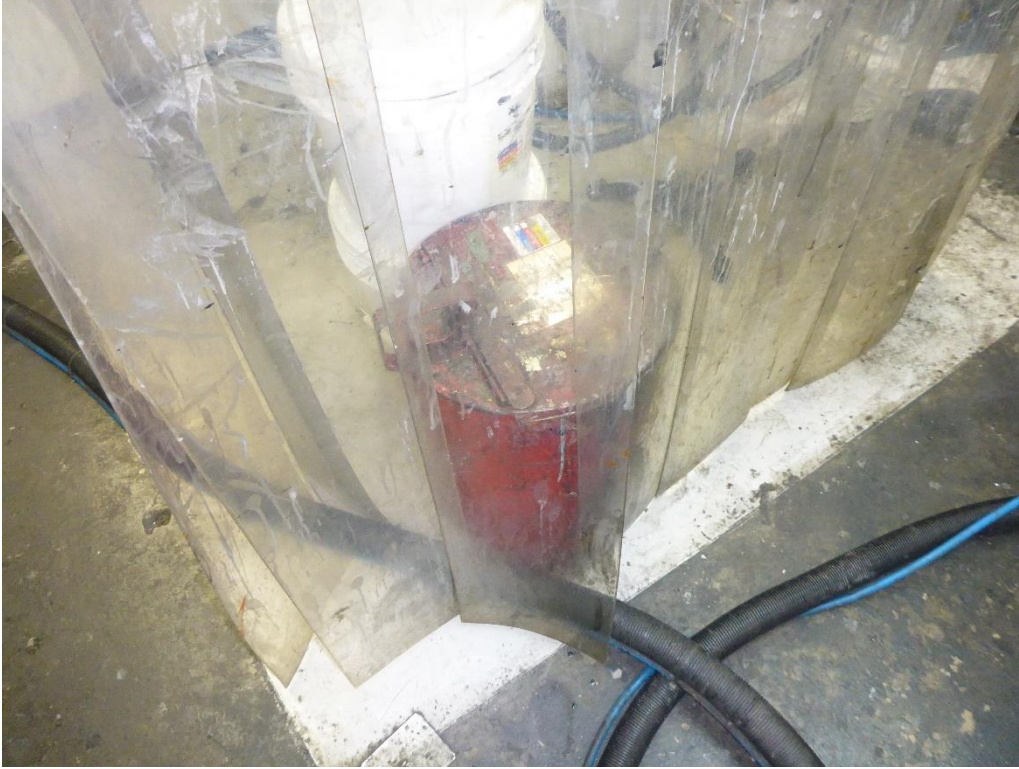
**Photo 4:** One flip-top 5-gallon container for accumulating solvent contaminated wipes in the Screen Print Area One. The container, which was located next to one of the roll coat stations, was not labeled “excluded solvent contaminated wipes.”

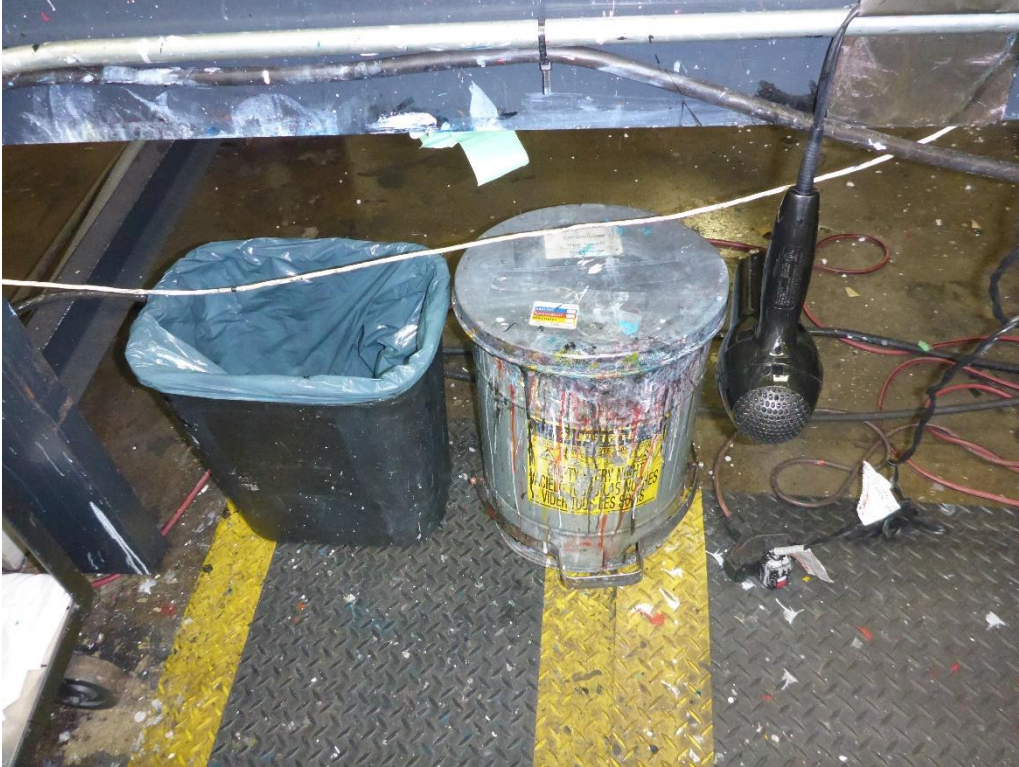
**Photo 5:** One flip-top 5-gallon container for accumulating solvent contaminated wipes in the Screen Print Area One. The container, which was located next to one of the screen print stations, was not labeled “excluded solvent contaminated wipes.”

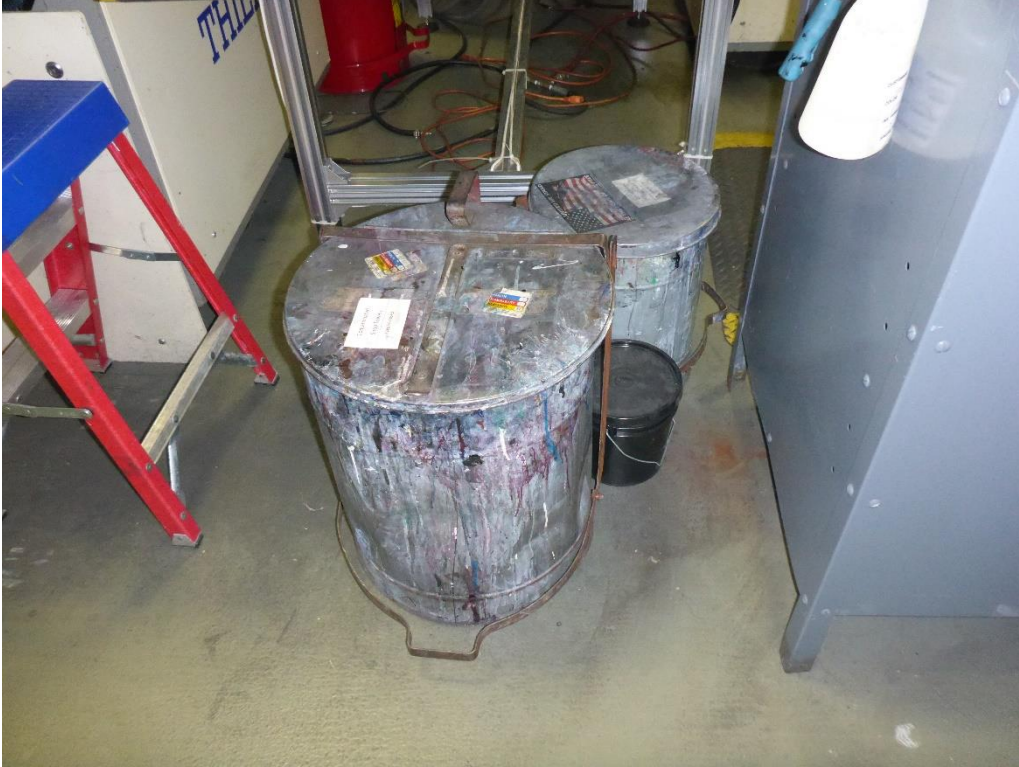
The inspectors observed approximately five step-open flammable cans for accumulating solvent contaminated wipes (Photo 7). None of the containers were labeled “excluded solvent contaminated wipes.”

**Photo 7:** Flip-top containers for accumulating solvent contaminated wipes in the Screen Print Area Two. The containers were not labeled “excluded solvent contaminated wipes.”

**Pursuant to 15A NCAC 13A .0106 [40 C.F.R. § 261.4(a)(26)(i)], which is a condition of the Solvent-Contaminated Reusable Wipes Exclusion, solvent-contaminated wipes when accumulated, stored, and transported, must be contained in non-leaking, closed containers that are labeled “Excluded Solvent-Contaminated Wipes.”**

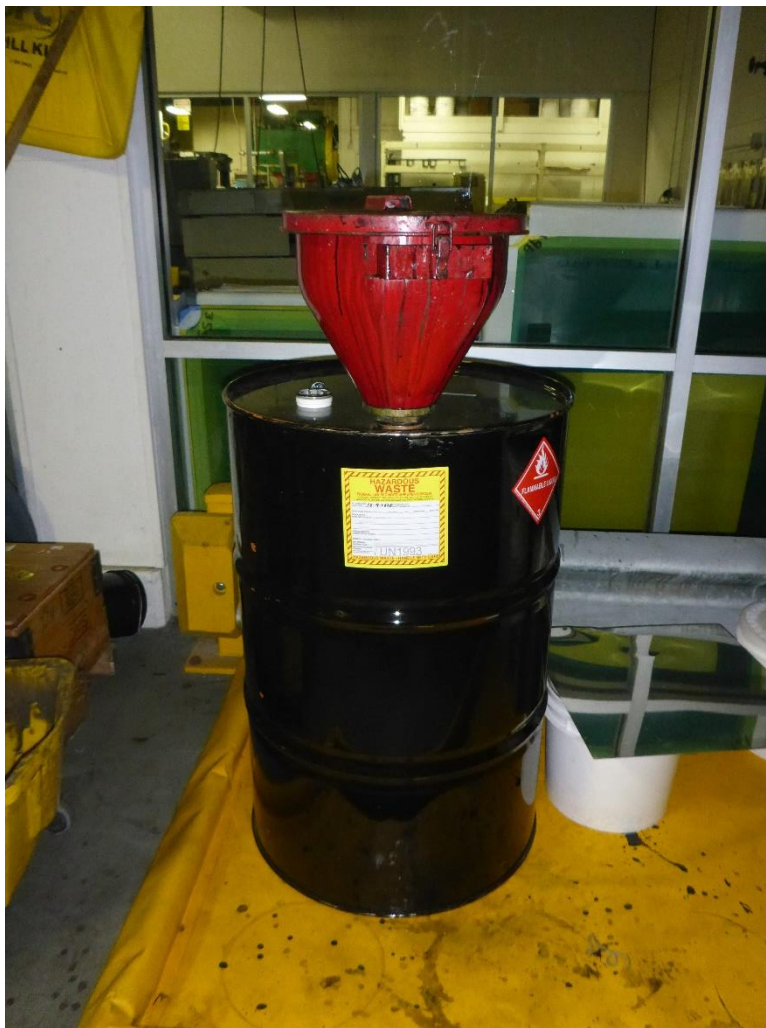
Roll Coat Area Two: At the time of the inspection, no operations were active in the Roll Coat Area Two. Mr. Casey explained that this area is not used as frequently as Roll Coat Area One. GMN manages one SAA inside the Roll Coat Area Two, and the inspectors observed one 55-gallon drum in this SAA (Photo 8). The drum was labeled D001 / D035 / F005 hazardous waste flammable liquid (MEK), and it was identified with a flammable liquid hazard placard. The drum was dated 12/09/2020. The small bung on the lid of the drum was open.

**Photo 8:** One 55-gallon container for accumulating hazardous waste generated in the Roll Coat Area Two. The container is labeled as D001 / D035 / F005 hazardous waste flammable liquid (MEK), and identified with a flammable liquid hazard placard. The small bung on the lid of the drum was open.

**Pursuant to 15A NCAC 13A .0107(a) [40 C.F.R. § 262.15(a)(4)], which is a condition of the SAA Permit Exemption, a generator is required to keep containers of hazardous waste closed at all times during accumulation, except when adding, removing, or consolidating waste; or when temporary venting of a container is necessary for the proper operation of equipment, or to prevent dangerous situations, such as build-up of extreme pressure.**

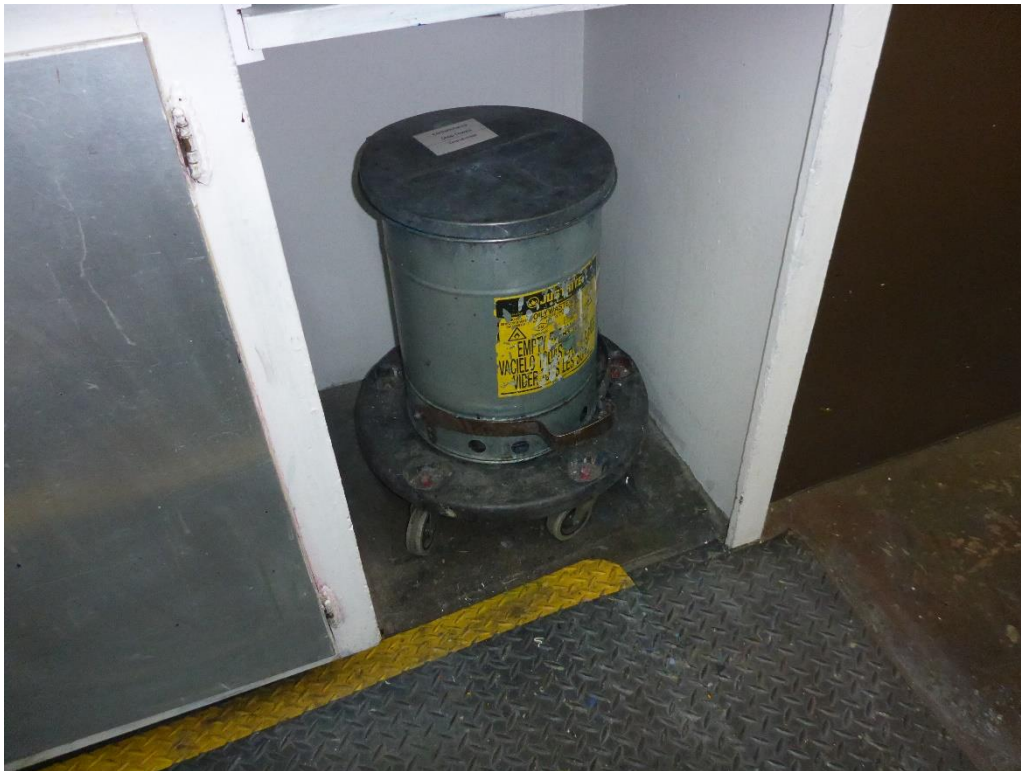
Waste inks and coatings are typically not generated in the Ink Lab, but the area does generate solvent contaminated wipes from clean-up activities. The inspectors observed two flammable cans for accumulating solvent contaminated wipes (Photo 10). These containers were not labeled “excluded solvent contaminated wipes.”

**Photo 10:** One 5-gallon flip-top container for accumulating solvent contaminated wipes in the Ink Lab. The container was not labeled “excluded solvent contaminated wipes.”

**Pursuant to 15A NCAC 13A .0106 [40 C.F.R. § 261.4(a)(26)(i)], which is a condition of the Solvent-Contaminated Reusable Wipes Exclusion, solvent-contaminated wipes when accumulated, stored, and transported, must be contained in non-leaking, closed containers that are labeled “Excluded Solvent-Contaminated Wipes.”**

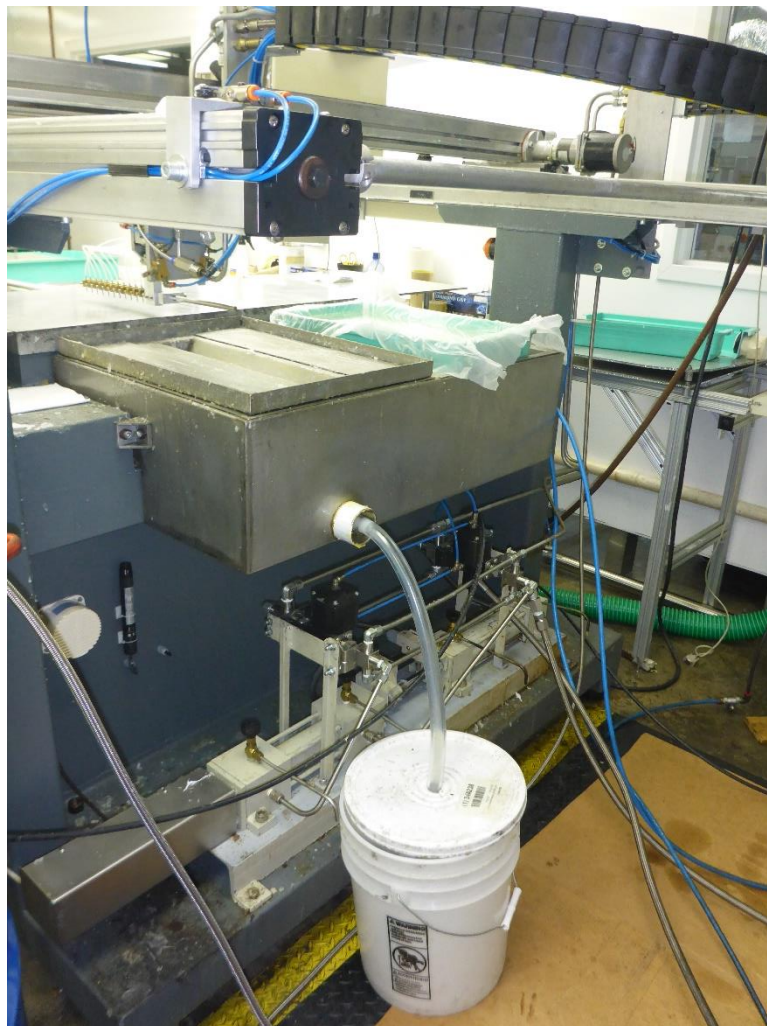
Doming Area: GMN manages a SAA for managing D009 hazardous waste solid (mercury) generated in the Doming Area. GMN uses a two-part urethane product which contains mercury to create a clear dome on customer labels. When mixed, the two liquid components react within approximately eight minutes to form a clear, solid urethane. It is therefore necessary to purge the mixing lines with cleaner whenever the system is shut down for more than a couple minutes. Employees purge the urethane components from the lines into a shallow, lined tray, where the components react to form a block of D009 hazardous waste solid (mercury) (Photo 11). This block and the tray liner are both removed from the tray and placed into a 55-gallon hazardous waste accumulation drum (Photo 12).

The inspectors observed that accumulation tray containing purged urethane components was left open to the atmosphere, and it was not labeled as hazardous waste or marked with an indication of the hazards of its contents. The 55-gallon drum of solidified purged urethane components was labeled D009 hazardous waste solid (mercury), and it was identified with a DOT class 9 hazard placard. Although the drum was covered with a lid, it did not have a ring to secure that lid.

**Photo 11:** Process unit in the Doming Area. When the system needs to be shut down, the two-part urethane is purged from the lines into a shallow tray lined with plastic. This tray is shown on the right side of the metal box in this photo. After the purged urethane reacts and forms a block of D009 hazardous waste solid, the block and liner are removed from the tray and placed into a 55-gallon hazardous waste accumulation drum.

When the system is prepared for restarting, cleaner is purged from the lines into the drain shown on the left side of the metal box. Purged liquid flows from the drain into the 5-gallon bucket on the floor. The contents of the bucket are transferred into a 55-gallon non-hazardous waste accumulation drum.

**Pursuant to 15A NCAC 13A .0107(a) [40 C.F.R. § 262.15(a)(4)], which is a condition of the SAA Permit Exemption, a generator is required to keep containers of hazardous waste closed at all times during accumulation, except when adding, removing, or consolidating waste; or when temporary venting of a container is necessary for the proper operation of equipment, or to prevent dangerous situations, such as build-up of extreme pressure.**

**Pursuant to 15A NCAC 13A .0107(a) [40 C.F.R. § 262.15(a)(5)], which is a condition of the SAA Permit Exemption, a generator is required to mark or label its containers with the words “Hazardous Waste” and with an indication of the hazards of the contents.**

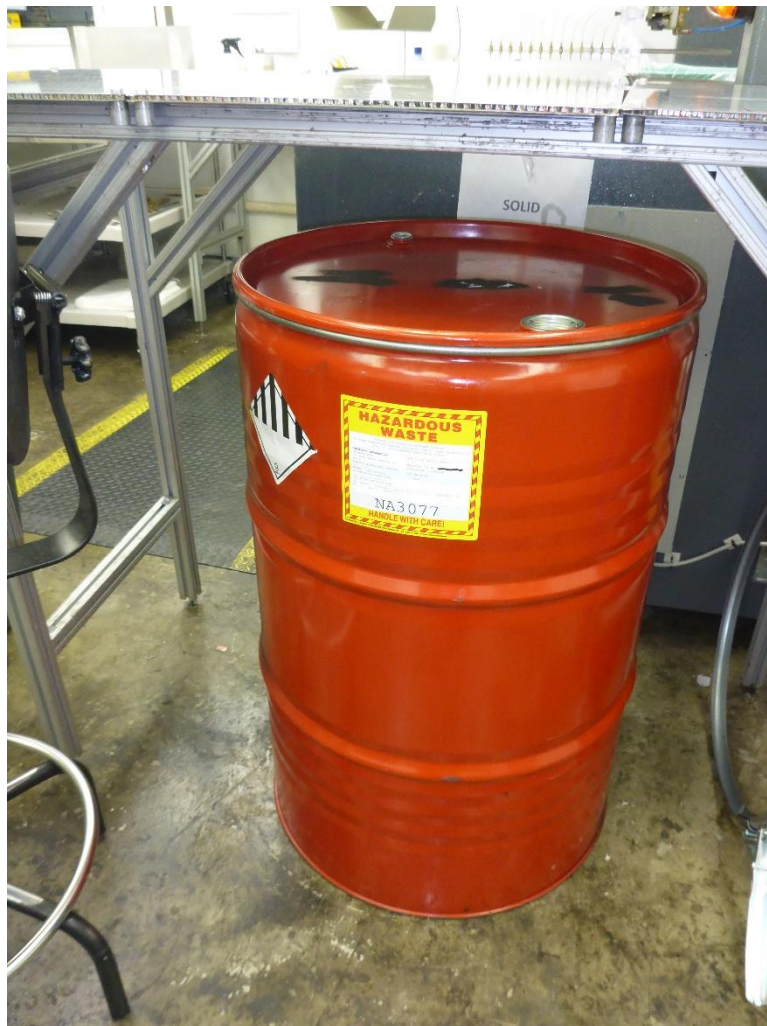
**Photo 12:** One 55-gallon container for accumulating D009 hazardous waste solid in the Doming Area. The container is labeled as D009 hazardous waste solid (mercury) and identified with a DOT class 9 hazard placard.

The tray and the drum are both containers within the SAA. Although GMN may manage more than one container in the same SAA, please note that the SAA Permit Exemption limits the total volume of waste accumulated in this area at any given time to be no more than 55 gallons. Pursuant to 15A NCAC 13A .0107 [40 C.F.R. § 262.15(a)(6)], a generator who accumulates hazardous waste in excess of 55 gallons must, with respect to that amount of excess waste, comply with 15A NCAC 13A .0107 [40 C.F.R. § 262.17(a)] or remove the excess waste from the SAA within three consecutive calendar days.

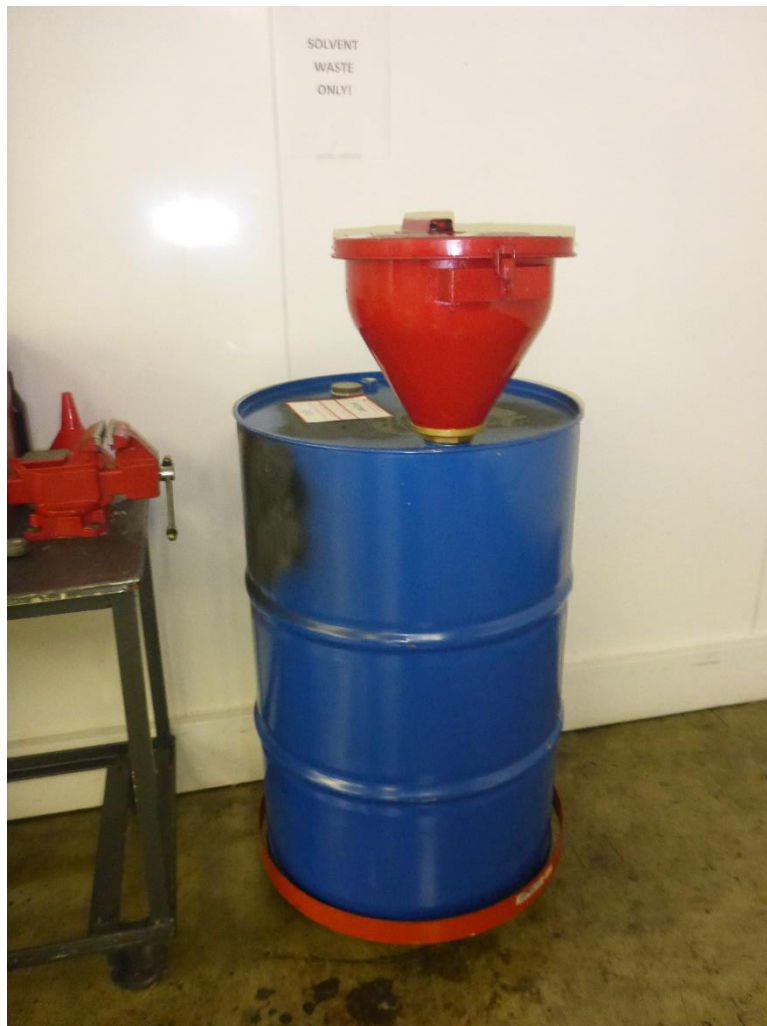
As employees prepare to restart the system, they fill the mixing lines again with the urethane components. This process purges cleaner from the lines and employees accumulate the purged liquid in a 5-gallon bucket. The contents of the 5-gallon bucket are transferred into a 55-gallon drum (Photo 13). The inspectors observed the 5-gallon bucket next to the process unit, and the 55-gallon drum along the wall inside this room. The bucket was open, and it was not labeled. The drum was equipped with a latched funnel; it was labeled nonhazardous waste with profile

According to the waste profile for F137581, GMN has used generator knowledge to determine that the material generated when purging lines during system restart is non-hazardous. Although urethane components containing mercury may also be discharged into this 5-gallon bucket at the end of the purging process, the facility did not provide records to support a determination that this material does not exceed the regulatory threshold for D009 hazardous waste containing mercury.

**Photo 13:** One 55-gallon container for accumulating purged liquid from restarting the doming process unit. The container is marked with waste profile number FC137581, labeled as non-hazardous waste, and identified with a flammable liquid hazard placard.

**Pursuant to 15A NCAC 13A .0107(a) [40 C.F.R. § 262.11], a person who generates a solid waste, as defined in 15A NCAC 13A .0106 [40 C.F.R. § 261.2], must use the steps articulated in 15A NCAC 13A .0107(a) [40 C.F.R. § 262.11(a) – (e)] to make an accurate determination as to whether that waste is a hazardous waste in order to ensure wastes are properly managed according to applicable RCRA regulations.**

**Pursuant to 15A NCAC 13A .0107(a) [40 C.F.R. § 262.11(f)], an LQG must maintain records supporting its hazardous waste determinations. These records must comprise the generator’s knowledge of the waste and support the generator’s determination, as described at paragraphs (c) and (d) of this section.**

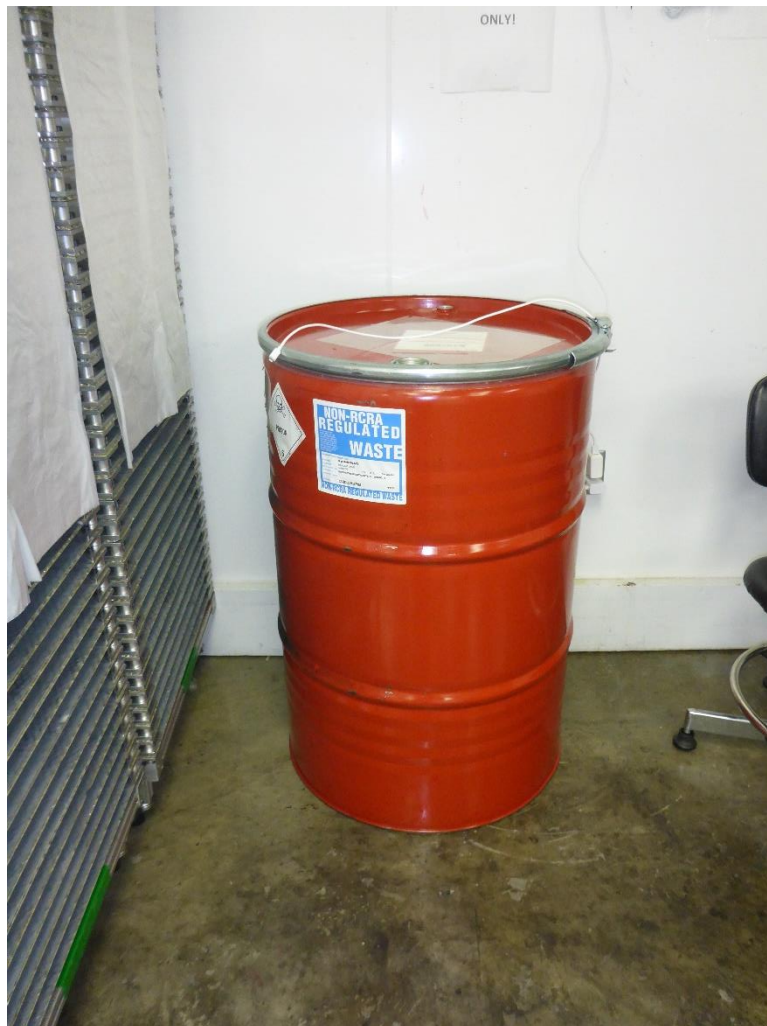
The inspectors also observed one 55-gallon drum labeled non-RCRA Isophorone diisocyanate along the wall in the Doming Area (Photo 14). The drum was identified with a poison hazard placard, and the waste profile number B107658. Neither Mr. Harper nor Mr. Casey was familiar with this waste or how it was generated.

**Photo 14:** 55-gallon container labeled non-RCRA Isophorone diisocyanate in the Doming Area. The container was identified with a poison hazard placard and the waste profile number B107658.

**Pursuant to 15A NCAC 13A .0107(a) [40 C.F.R. § 262.11], a person who generates a solid waste, as defined in 15A NCAC 13A .0106 [40 C.F.R. § 261.2], must use the steps articulated in 15A NCAC 13A .0107(a) [40 C.F.R. § 262.11(a) – (e)] to make an accurate determination as to whether that waste is a hazardous waste in order to ensure wastes are properly managed according to applicable RCRA regulations.**

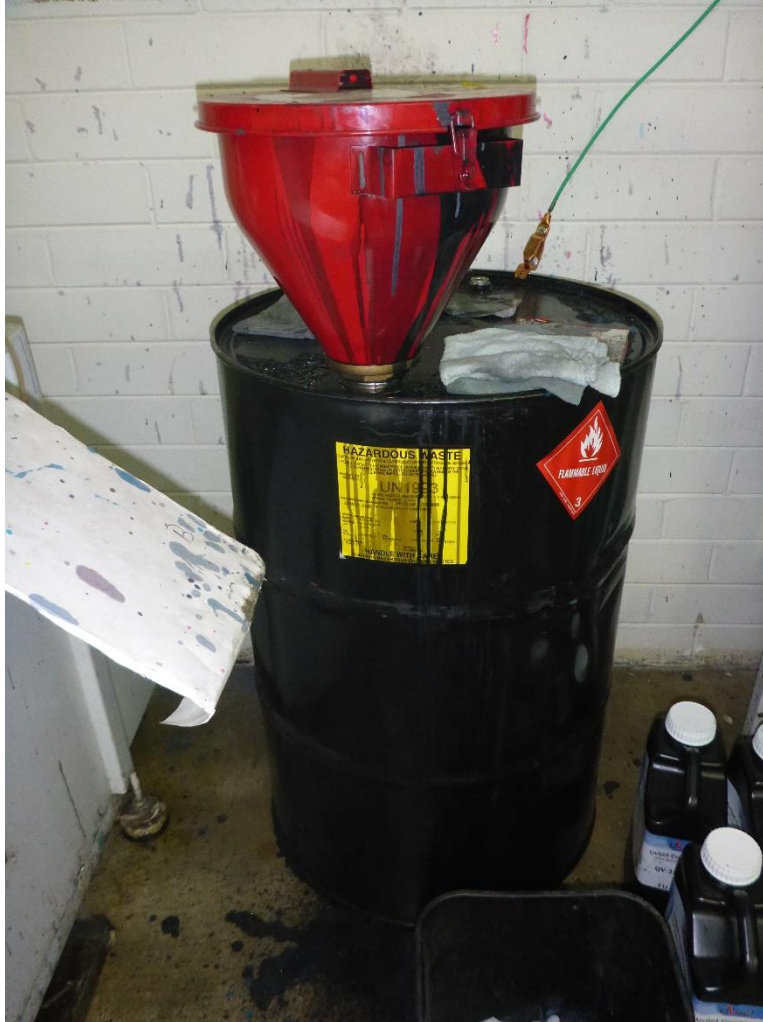
Lithographic Area: GMN manages a SAA in the Lithographic Area for managing hazardous waste excess ink with UV component and hazardous waste ink with UV component that is generated by cleaning the lithographic equipment with solvents. The inspectors observed one 55-gallon drum (Photo 15) and one two-gallon container in this SAA. The drum was located in the far corner of the room, and it was equipped with a latched funnel lid. Although ink waste drips and spills covering the hazardous waste label made it difficult to read, the drum appeared to be labeled D001 / F003 / F005 hazardous waste ink waste with UV component. The drum was also identified with a flammable liquid hazard placard. The two-gallon container was observed beneath a table near the workstation. The container was not labeled, but the employee working in this area confirmed that the contents of this container are poured into the 55-gallon drum.

**Photo 15:** One 55-gallon container for accumulating hazardous waste in the lithographic area. The drum was identified with a flammable liquid hazard placard. Ink waste drips and spills obscured part of the hazardous waste label, but the container appeared to be labeled as D001 / F003 / F005 hazardous waste ink sludge with UV component (mineral spirits).

**Pursuant to 15A NCAC 13A .0107(a) [40 C.F.R. § 262.15(a)(5)], which is a condition of the SAA Permit Exemption, a generator is required to mark or label its containers with the words “Hazardous Waste” and with an indication of the hazards of the contents.**

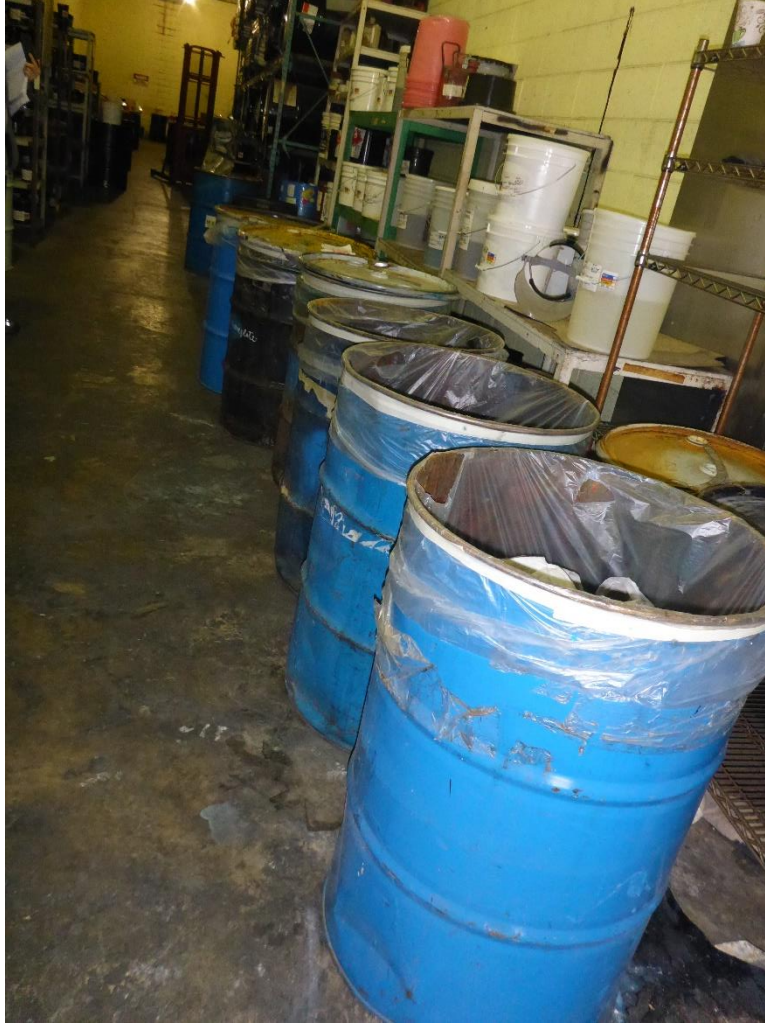
**Photo 16:** A row of six 55-gallon drums containing solvent contaminated rags in the Ink Shed. Five of the drums were labeled excluded solvent contaminated wipes, but the sixth drum was not labeled. Three of the drums did not have a lid, and the rings on two of the remaining three drums were not secured.

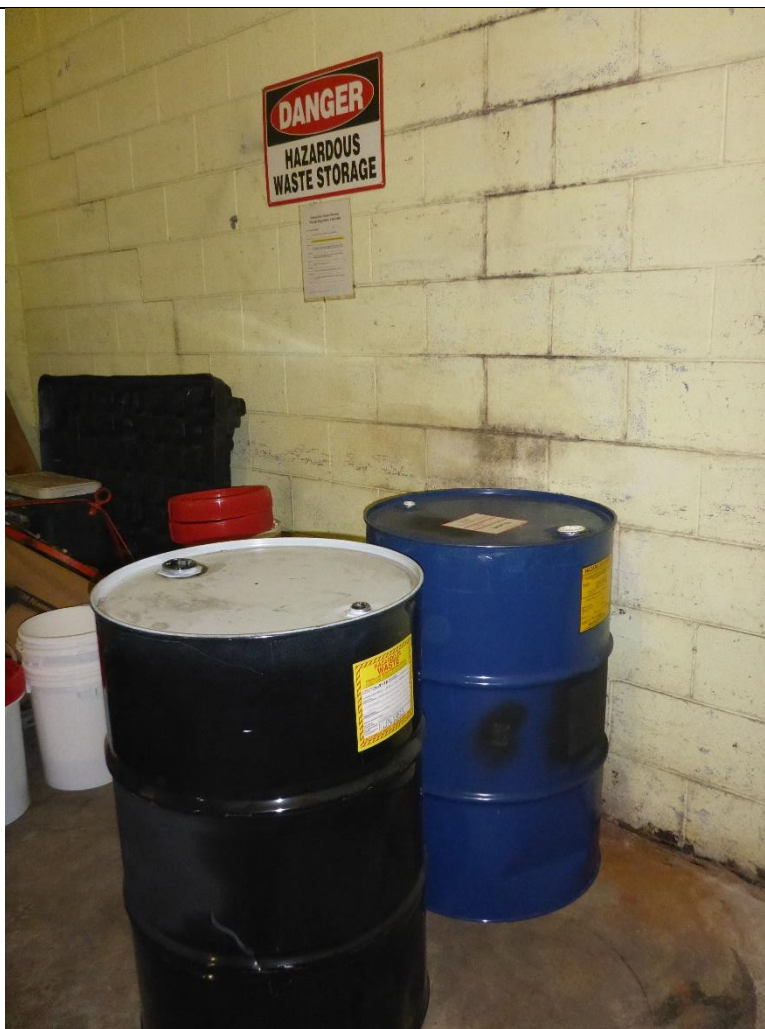
**Photo 19:** Two 55-gallon drums of hazardous waste in the Ink Shed CAA. The first drum was labeled as D001 / D035 / F005 hazardous waste flammable liquid (MEK) and identified with a flammable liquid hazard placard. The second drum was labeled F005 / F003 / D001 / D035 hazardous waste roll coat wash waste flammable liquid (MEK), and it was identified with a flammable liquid hazard placard. Both drums were closed and marked with an accumulation start date.
