# WASTEWATER TREATMENT SYSTEM COMPLIANCE EVALUATION INSPECTION REPORT

**Purpose:** NPDES Compliance Evaluation Inspection

**Facility:** City of Vermilion WPCF  
799 West River Road  
Vermilion, Ohio 44089

**NPDES Permit Number:** OH-0023612

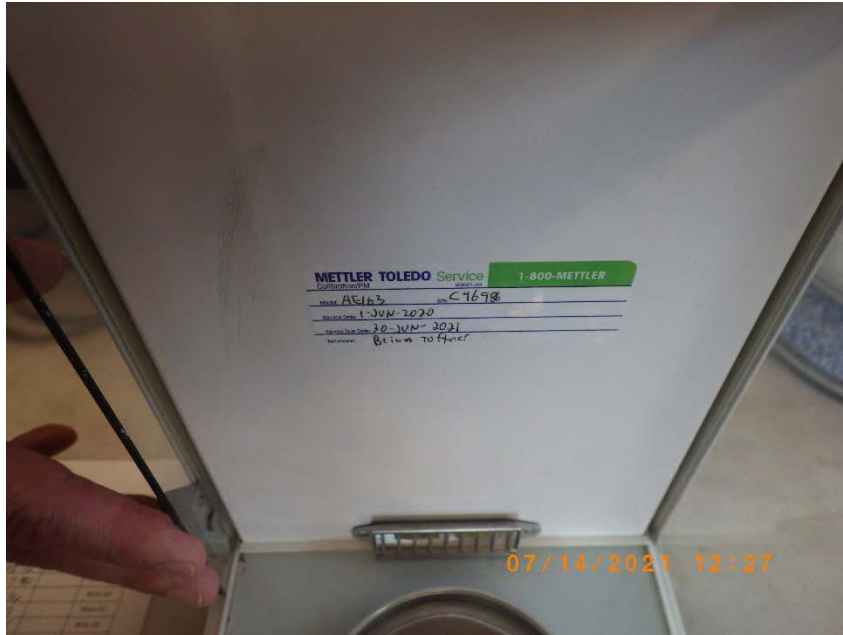
1: VWPC0001

Description: Analytical scale calibration certification.

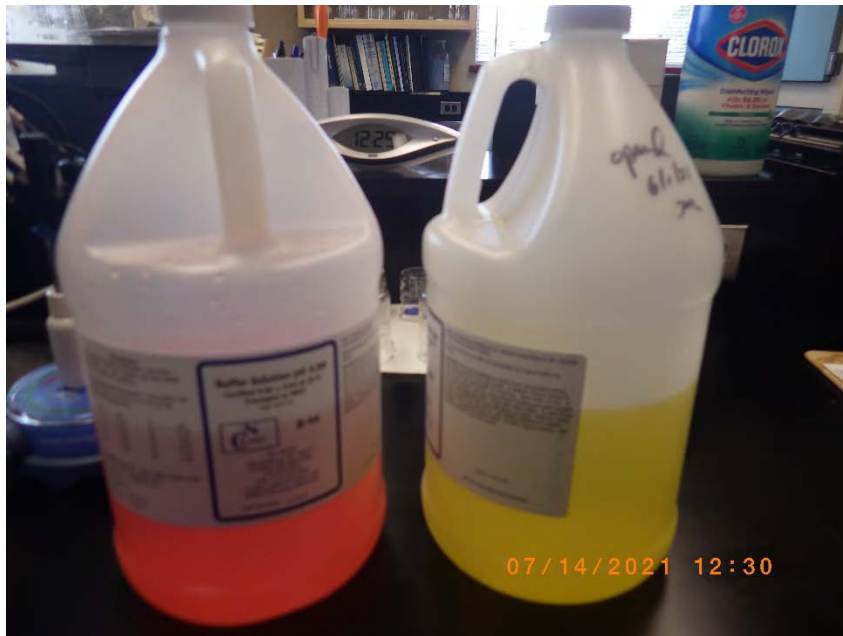
4: VWPC0004

Description: Buffer solutions documenting opening and expiration dates.

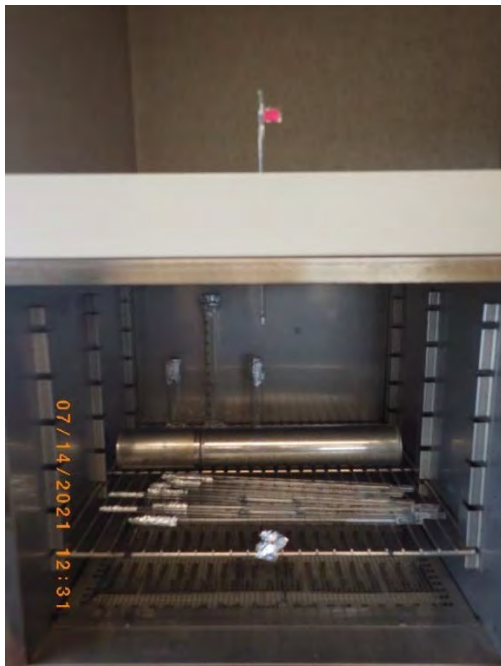
5: VWPC0005

Description: Drying oven with thermometer bulb located in open air.

Mr. Gunter pointed out that the laboratory should ensure that drying oven thermometers are equipped with appropriate heat sinks to ensure that temperature readings do not fluctuate when opening and closing the oven door, and recommended they document accurate oven temperatures are maintained (see Photograph VWPC0005.jpg – drying oven with thermometer bulb located in open air).

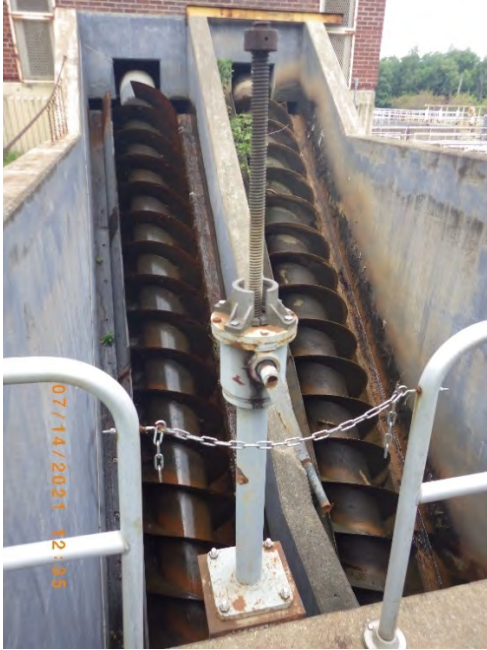
6: VWPC0006

Description: Twin screws pushing incoming gravity flow.

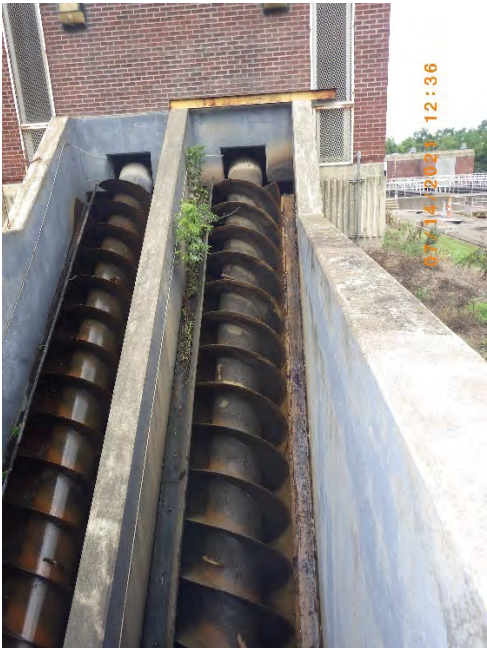
7: VWPC0007

Description: Twin screws pushing incoming gravity flow.

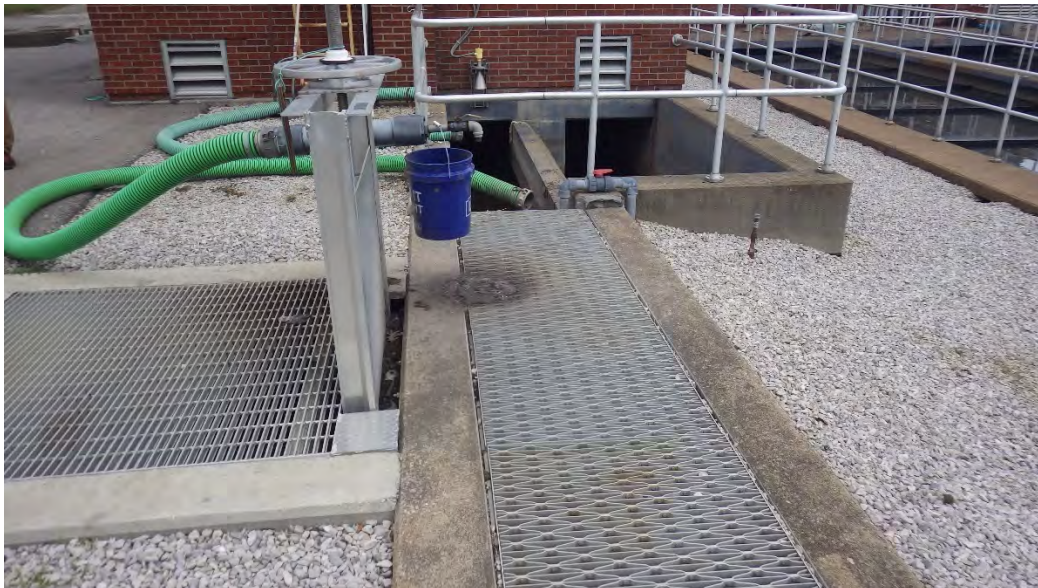
9: VWPC0009

Description: Influent flow channel and the point where sewage from the force main joins the gravity flow.

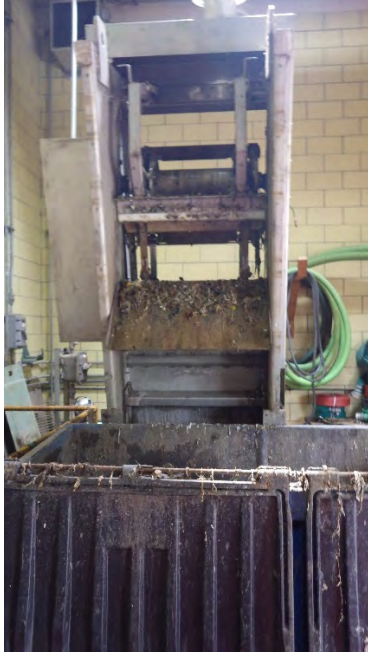
10: VWPC0010

Description: Operating bar screen.

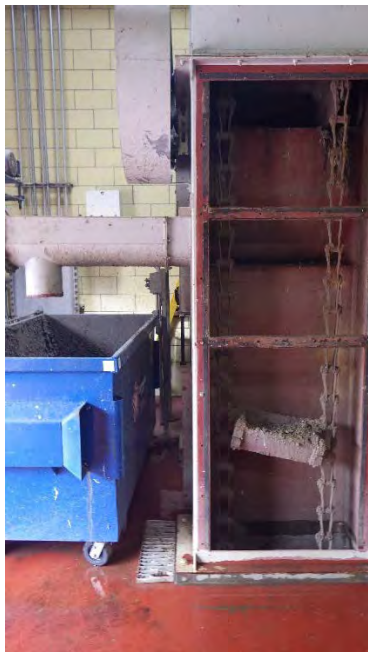
11: VWPC0011

(Photograph VWPC0011.jpg). Operators were manually cleaning grit while the grit removal system is down for repairs. The bar screen building also houses the influent composite sampler (Century 3000). I noticed the inside of the influent sample hose tubing was coated with debris (Photograph VWPC0012.jpg) and recommended replacement or cleaning on a routine basis to avoid sample contamination. The inside of the influent composite sampler is captured in Photograph VWPC0013.jpg.

Description: Inoperable grit removal system.

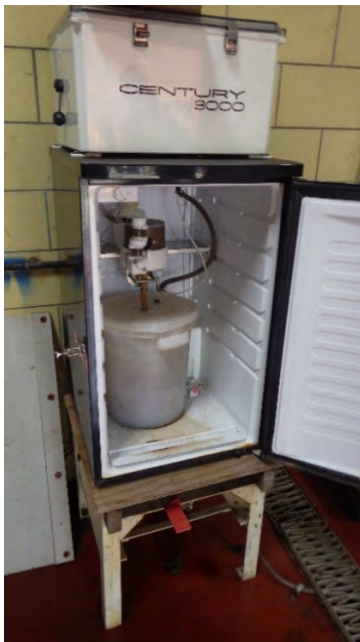
13: VWPC0013

Description: Inside of the influent composite sampler.

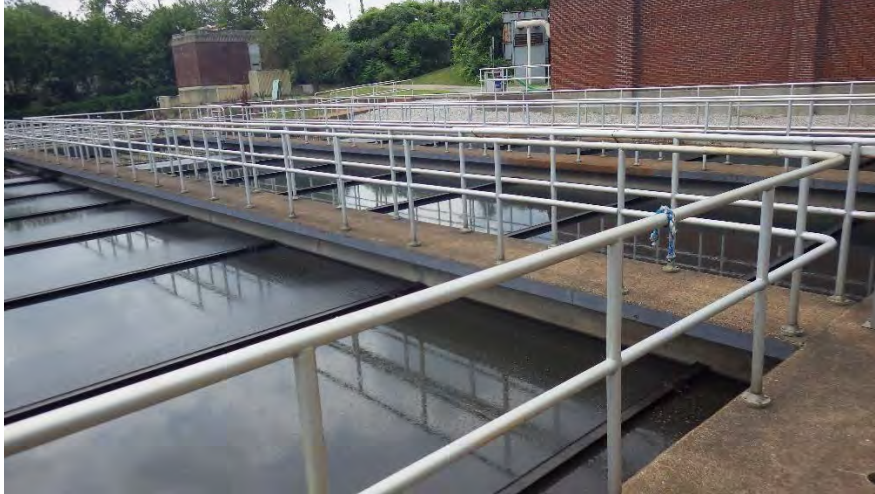
14: VWPC0014

Primary Clarifiers: Primary treatment consists of three primary clarifiers (Photograph VWPC0014.jpg, Clarifier #3 in foreground). Mr. Yost mentioned that Clarifier #3 was rebuilt two years ago, Clarifier #2 about seven years ago, and Clarifier #1 is due for a rebuild. I noted a PVC pipe with a significant flow of clear water appearing to flow into a grate-covered vault leading to the primary clarifiers (Photograph VWPC0015.jpg). Mr. Fannin explained that river water infiltrates the basement and is collected and pumped into the primary clarifiers to avoid flooding.

Description: Primary treatment consists of three primary clarifiers. Clarifier #3 in foreground.

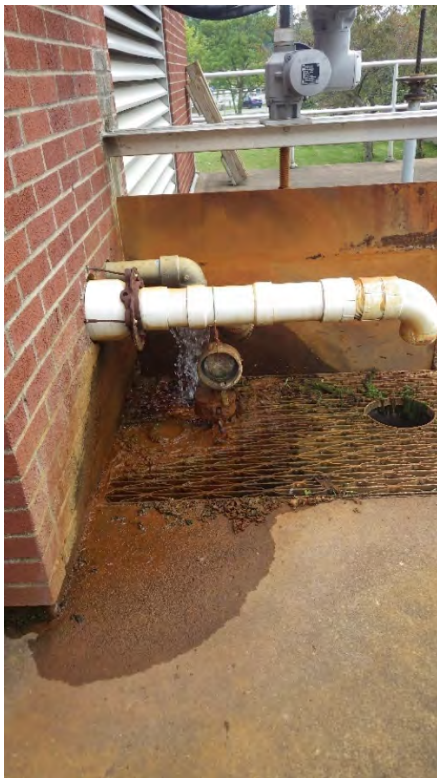
15: VWPC0015

- Clear river water is infiltrating into the Facility basement and pumped to the primary clarifiers, adding to amount of non-sanitary flow being treated at the Facility;

Description: Clear river water pumped from the basement and likely due to river infiltration into basement. Piped to the primary clarifiers.

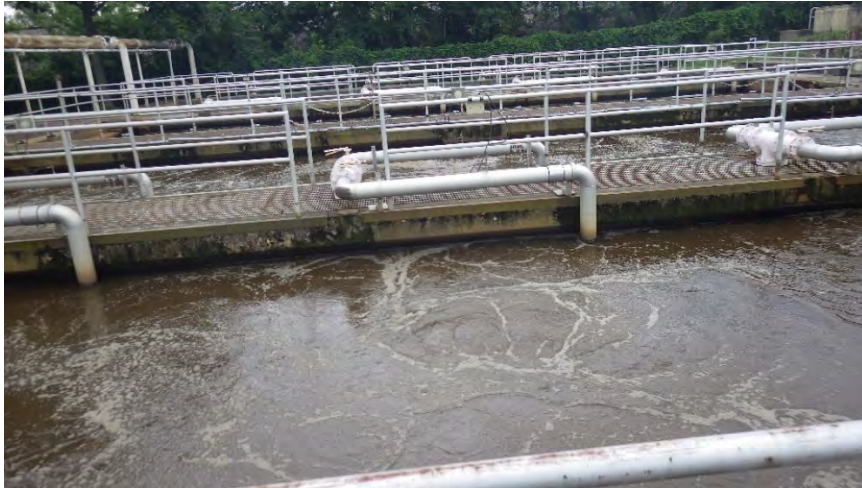
16: VWPC0016

Description: Aeration tanks. Aeration Tank #1 in foreground.

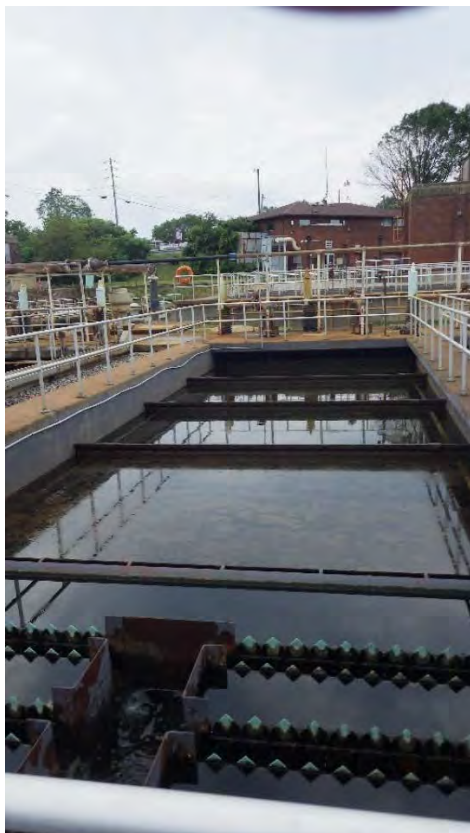
17: VWPC0017

Final Clarifiers: The final wastewater clarification system consists of six clarifiers (Photograph VWPC0017.jpg). Mr. Fannin explained that four clarifiers operate every day and one is shut down daily for routine maintenance. He added that Clarifier #6 is currently shut down for repairs. The rails in Clarifier #6 were rotted out (see the center area of Photograph VWPC0018.jpg) and they are waiting for new rail parts. I observed Clarifier #5 and noted significant debris and plant material (likely duckweed) in the effluent troughs and channels (Photograph VWPC0019.jpg). I asked if the clarifier had been cleaned recently and Mr. Yost replied that he was not sure and would make sure the clarifier is cleaned to remove the debris. I mentioned that at this point in the treatment process effluent exiting the clarifier should be free of visible debris.

Description: Final clarifiers.

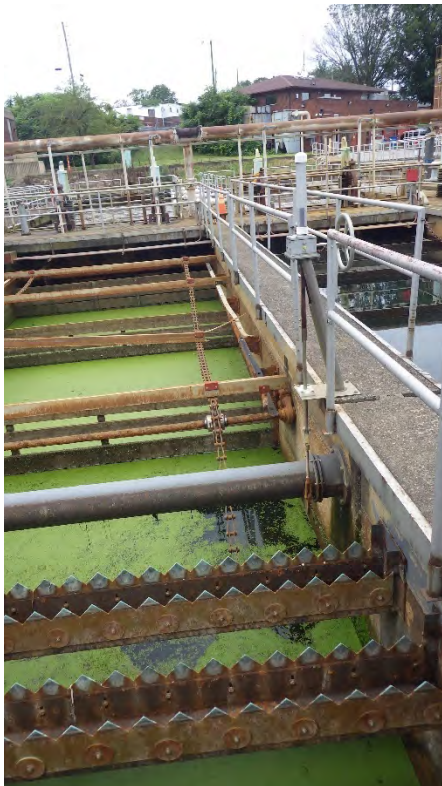
18: VWPC0018

Description: Final Clarifier #6. The rails were rotted out (see the center area of photograph).

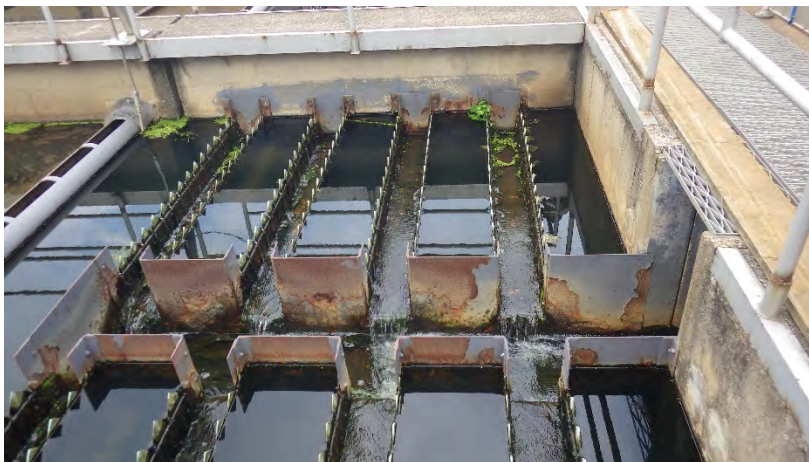
19: VWPC0019

- o I observed significant debris and plant material (likely duckweed) in the effluent troughs and channels in Clarifier #5;
  - o I observed floating plant material (likely duckweed) at the end of the chlorine contact tank, at the point where treated effluent exits the chlorine tank; and

Description: Clarifier #5. Noted significant debris and plant material (likely duckweed) in the effluent troughs and channels.

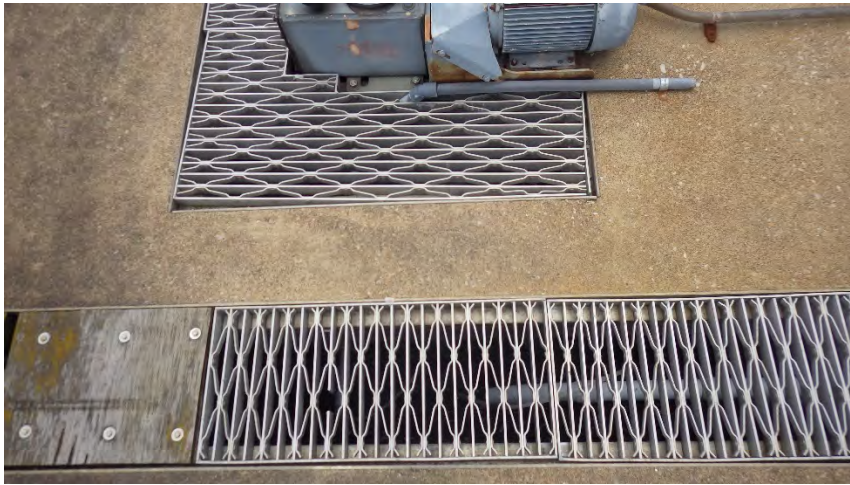
20: VWPC0020

Description: Liquid chlorine feed system. Note white feed pipe under channel grate cover.

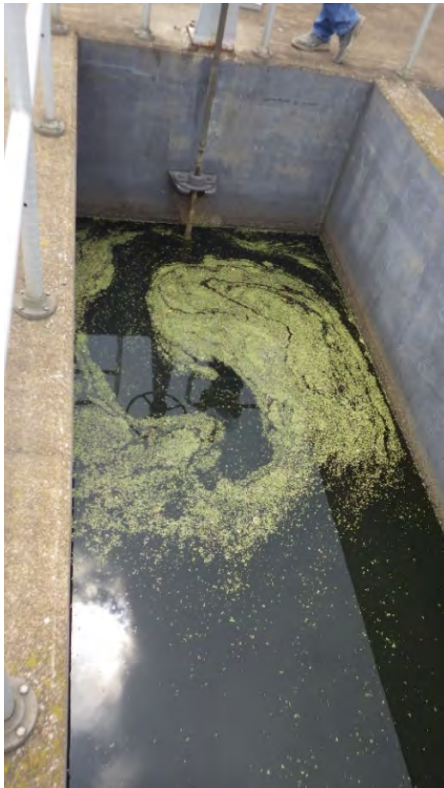
21: VWPC0021

Description: Floating plant material (likely duckweed) at the end of the chlorine contact tank, at the point where treated effluent exits the chlorine tank.

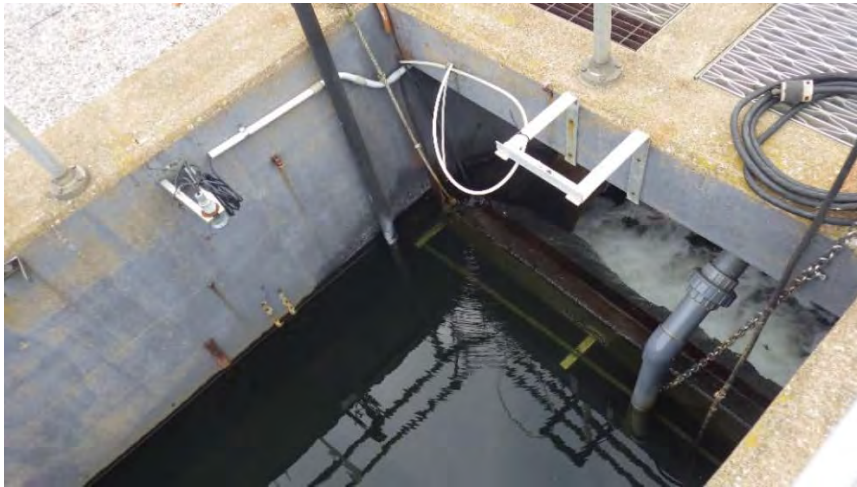
22: VWPC0022

Description: Dechlorination drip tubing in effluent channel after chlorine contact tank and prior to final outfall.

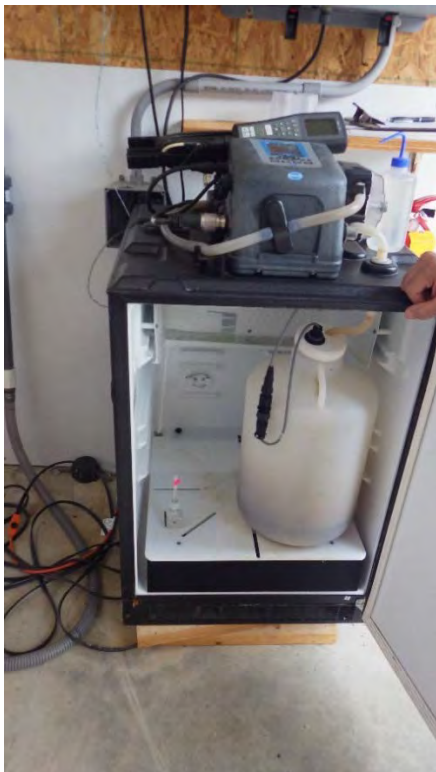
23: VWPC0023

Chemical Room: The chemical room contains process chemicals and the final effluent composite sampler (Hach, Photograph VWPC0023.jpg). I asked if the composite sampler is set up to collect time or flow-based composite samples. Mr. Fannin confirmed that the composite sampler is set up to collect flow-based samples, consistent with permit requirements. I noted that the sample container appeared to be heavily stained. I mentioned that the container should be cleaned routinely or replaced as needed, along with the effluent tubing.

Description: Final effluent composite sampler (Hach). Note staining in sample container.

- o The effluent sample container appeared to be heavily stained. The container should be cleaned routinely or replaced as needed, along with the effluent tubing.

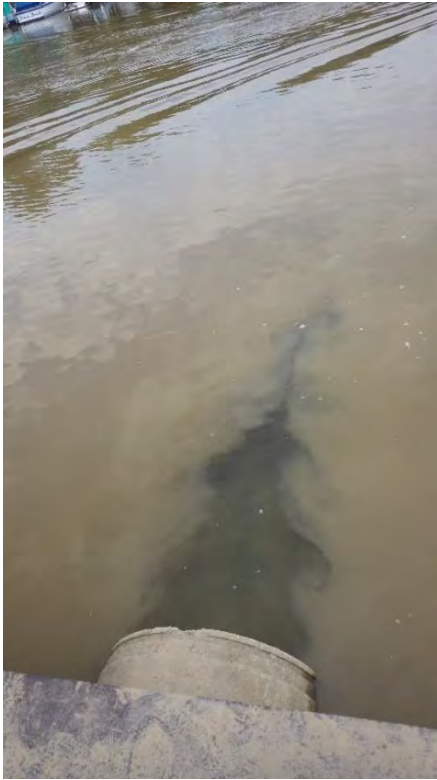
24: VWPC0024

Description: The final outfall (#001) to the Vermilion River. The river appeared to be high and murky (see contrast between effluent discharge and river water).

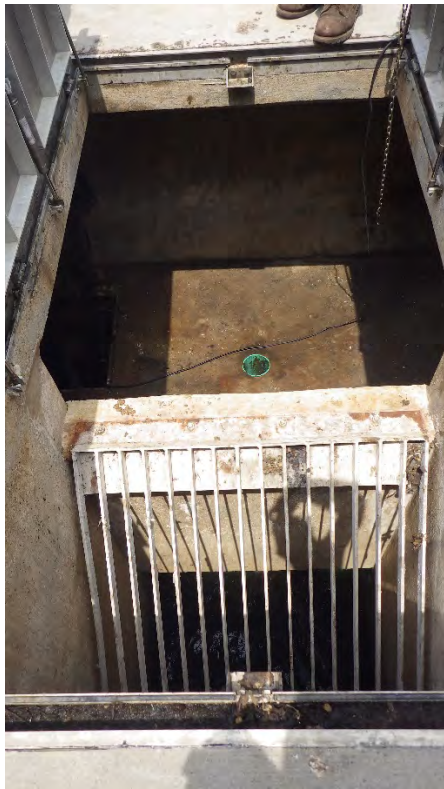
26: VWPC0026

Description: Lift station wet well.

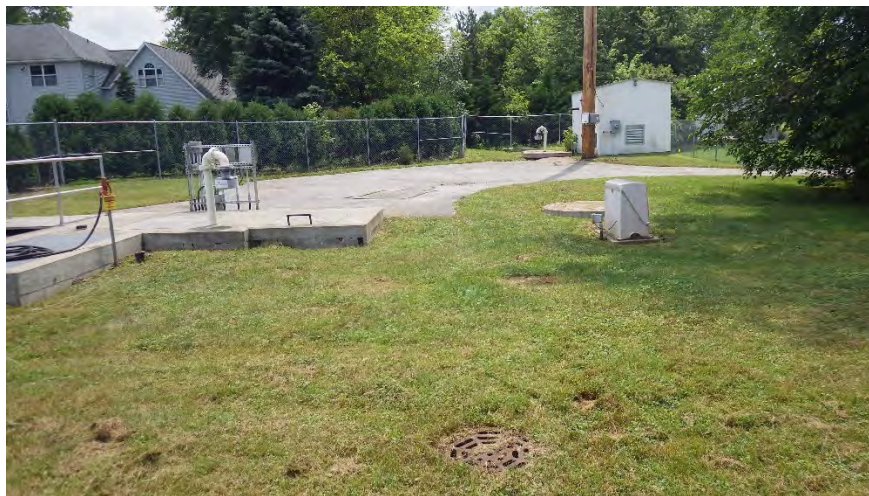
27: VWPC0027

Description: Lift station where overflows enter the sewer inlet in the foreground of photograph and flows via a pipe to an outfall to Lake Erie.

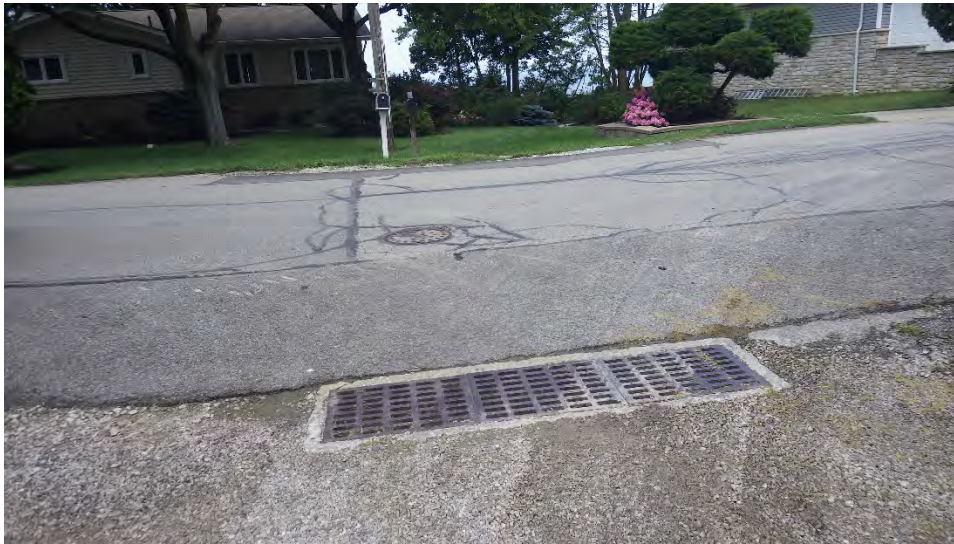
28: VWPC0028

Description: SSOs in this area enter the stormwater catch basin (in the foreground of photograph), along Edgewater Drive. The inlet sends flow through a pipe to an outfall to Lake Erie (behind the homes in the photograph).
