## NPDES Inspection Report – POTW

| Facility Location Information | |
|---|---|
| <b>Site/Facility Name &amp; Location:</b><br>Arapaho Community Lagoon<br>Wind River Reservation, Wyoming<br>42.9741° N, 108.477° W | <b>Email Report to:</b><br>Mike Quiver, Director<br>Northern Arapaho Utilities<br>(b) (6)<br>mike.quiver@northernarapaho.com |

## **Inspection Narrative and Site Description**

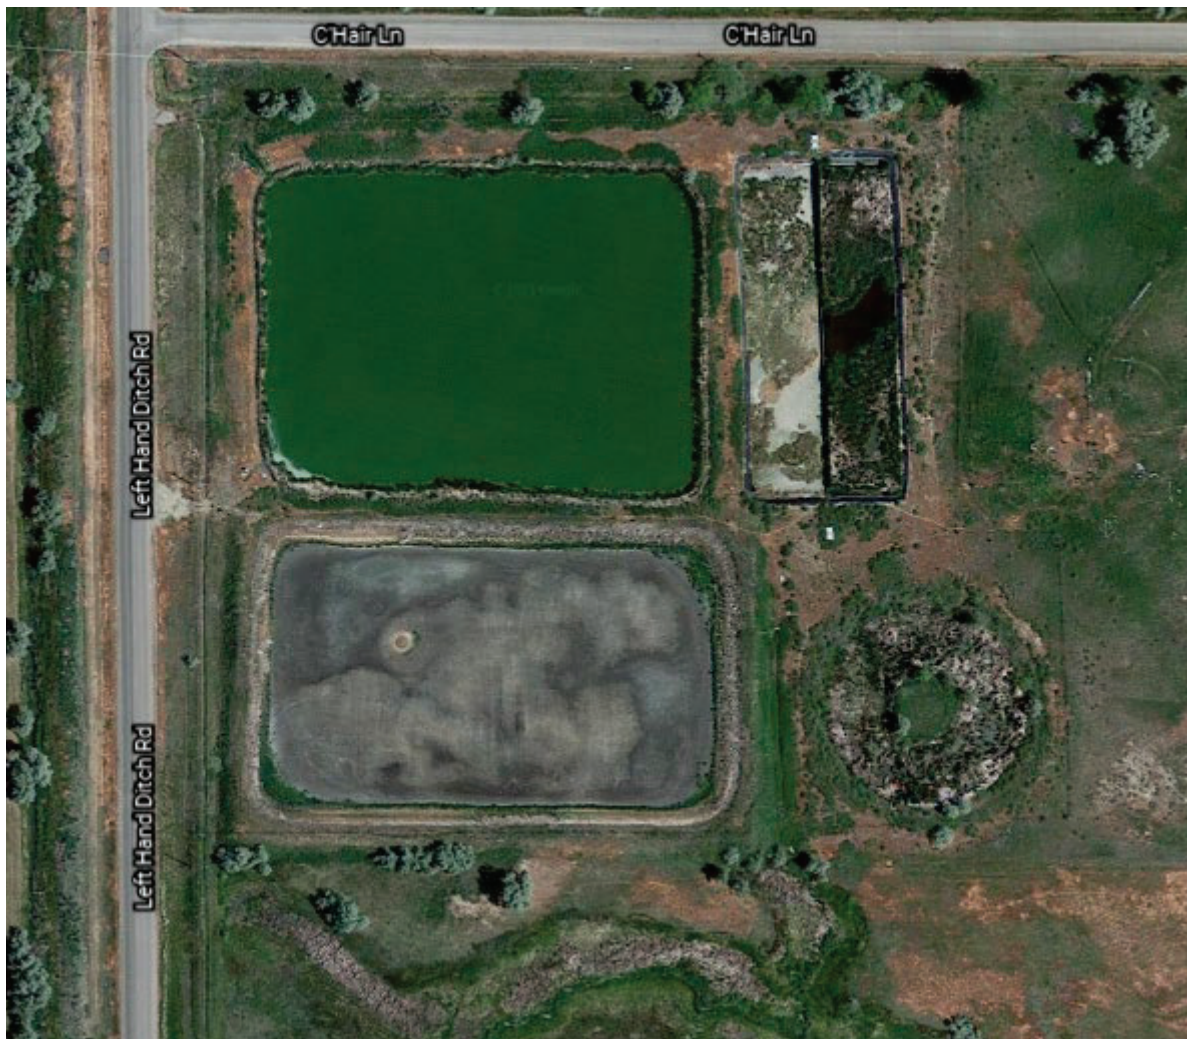
The facility is a four-cell lagoon system that serves a housing community of approximately 80 homes, health clinic, community center, senior center, and two schools. Twenty additional homes are planned for construction. The facility consists of a primary cell (Cell 1), secondary cell (Cell 2), and two wetlands, one rectangular (Cell 3) and one circular (Cell 4, also known as the Duck Pond). The facility was designed to allow influent wastewater to flow by gravity southeast to a lift station located on the northwest corner of the Cell 1. Following primary treatment, wastewater was intended to flow north to the Cell 2 before being routed east to the Cell 3 and south to Cell 4, consecutively. Discharge from the lagoon system would occur from Cell 4 and flow to an unnamed ditch prior to reaching the Little Wind River. However, NAU representatives indicated the lift station pump broke in 2017 and has not been repaired or replaced. Since that time, lagoon influent has been directed to Cell 2. Instead of routing wastewater from Cell 2 to Cell 3 in the lagoon system, NAU has elected to pump wastewater out of Cell 2 via vac truck and discharge it into another lagoon system operated by NAU on a weekly basis: the Arapaho Industrial Park Lagoon.

Inspectors and facility representatives began walking around the perimeter of the cells to evaluate berm integrity and the overall condition of the lagoon system. Solids were present in the influent and NAU representatives indicated the material had to be manually pushed into Cell 2 (photo 95). Inspectors walked along the perimeter of Cells 1 and 2 and confirmed Cell 1 was dry at the time of the inspection (photo 96). Vegetation, including cattails and trees were present in both cells and animal burrows were observed on the berm on the north side of Cell 2 (photos 96, 97, 98, 99, and 104). Additionally, there was evidence of erosion on the berm of Cell 2, possibly caused by a nearby irrigation ditch (photo 100 and 101).
