## RCRA COMPLIANCE EVALUATION INSPECTION

O-I Glass  
7134 County House Road  
Auburn, New York

NYD088662754

August 29-30, 2024

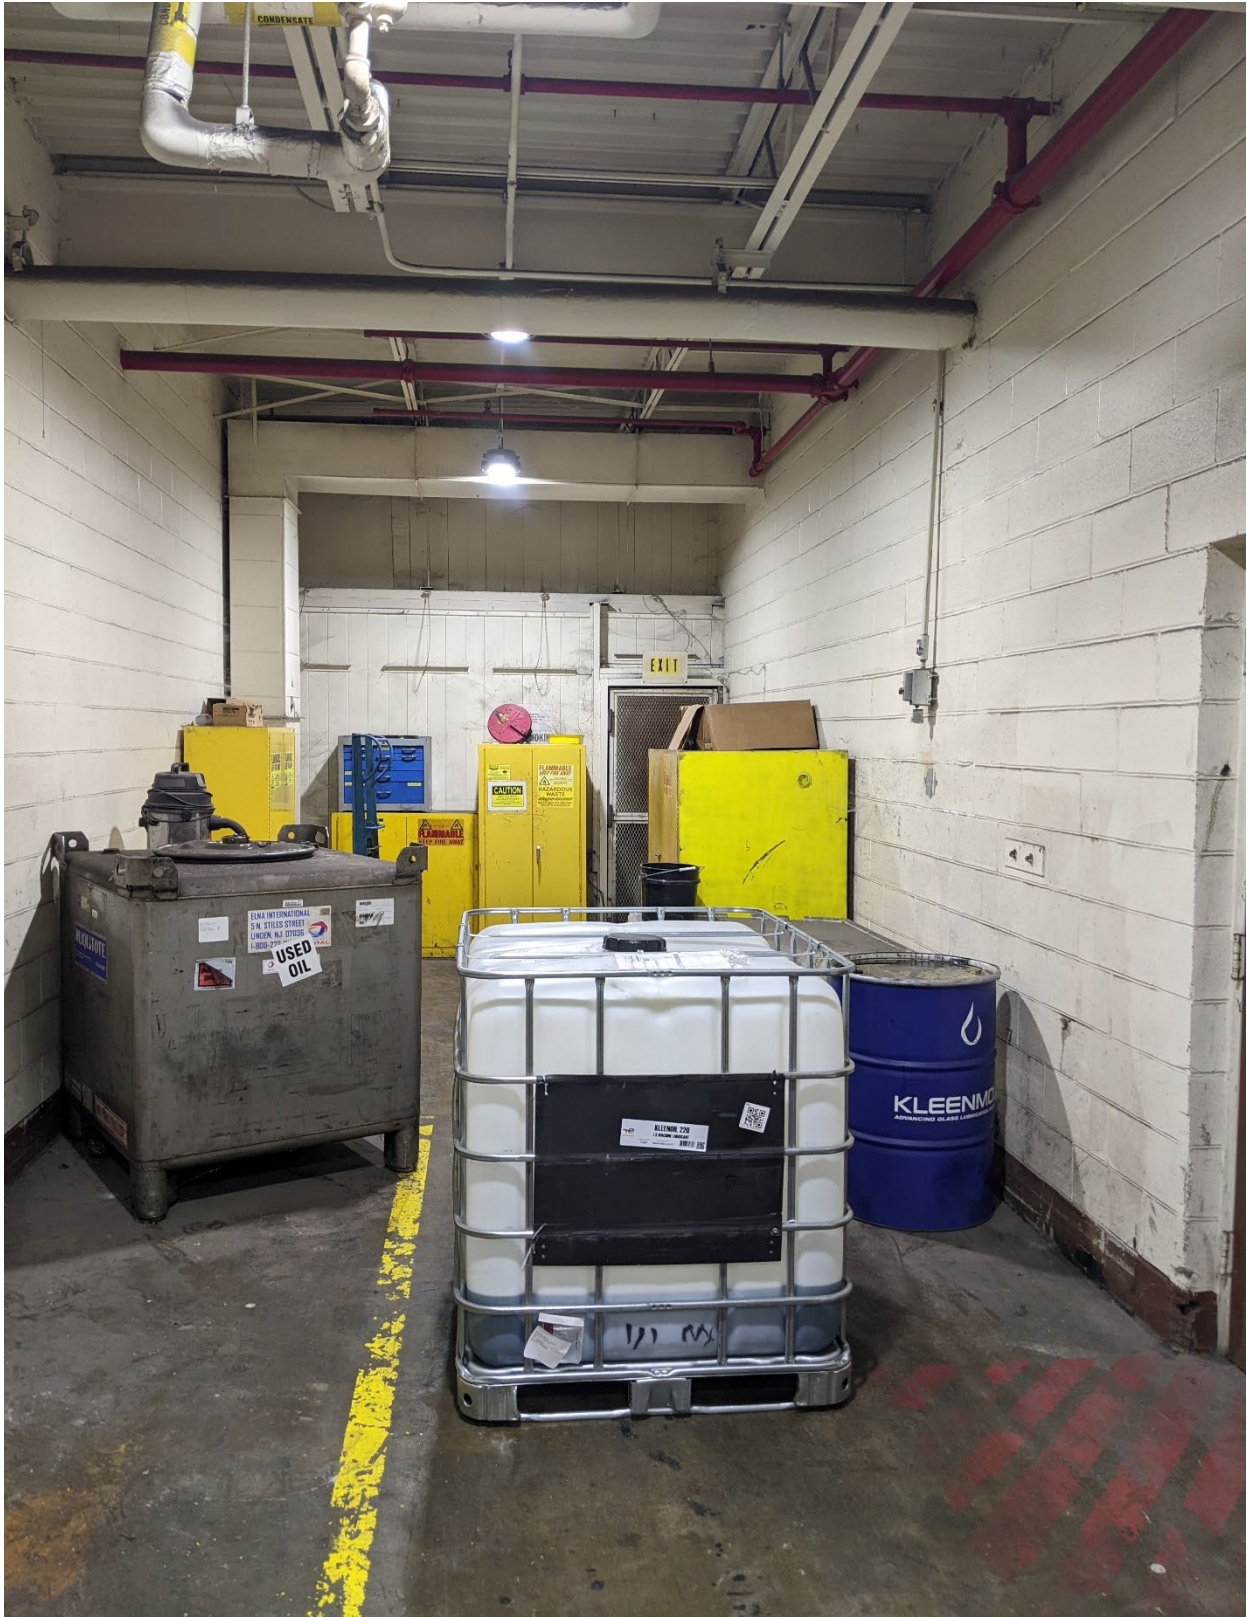
Photo #1: View of the Waste Accumulation Room (Oil Room).

There were no containers of hazardous waste being stored in the Waste Accumulation Room (Oil Room) on the day of the inspection.

The facility maintains a weekly inspection log of the Waste Accumulation Room.

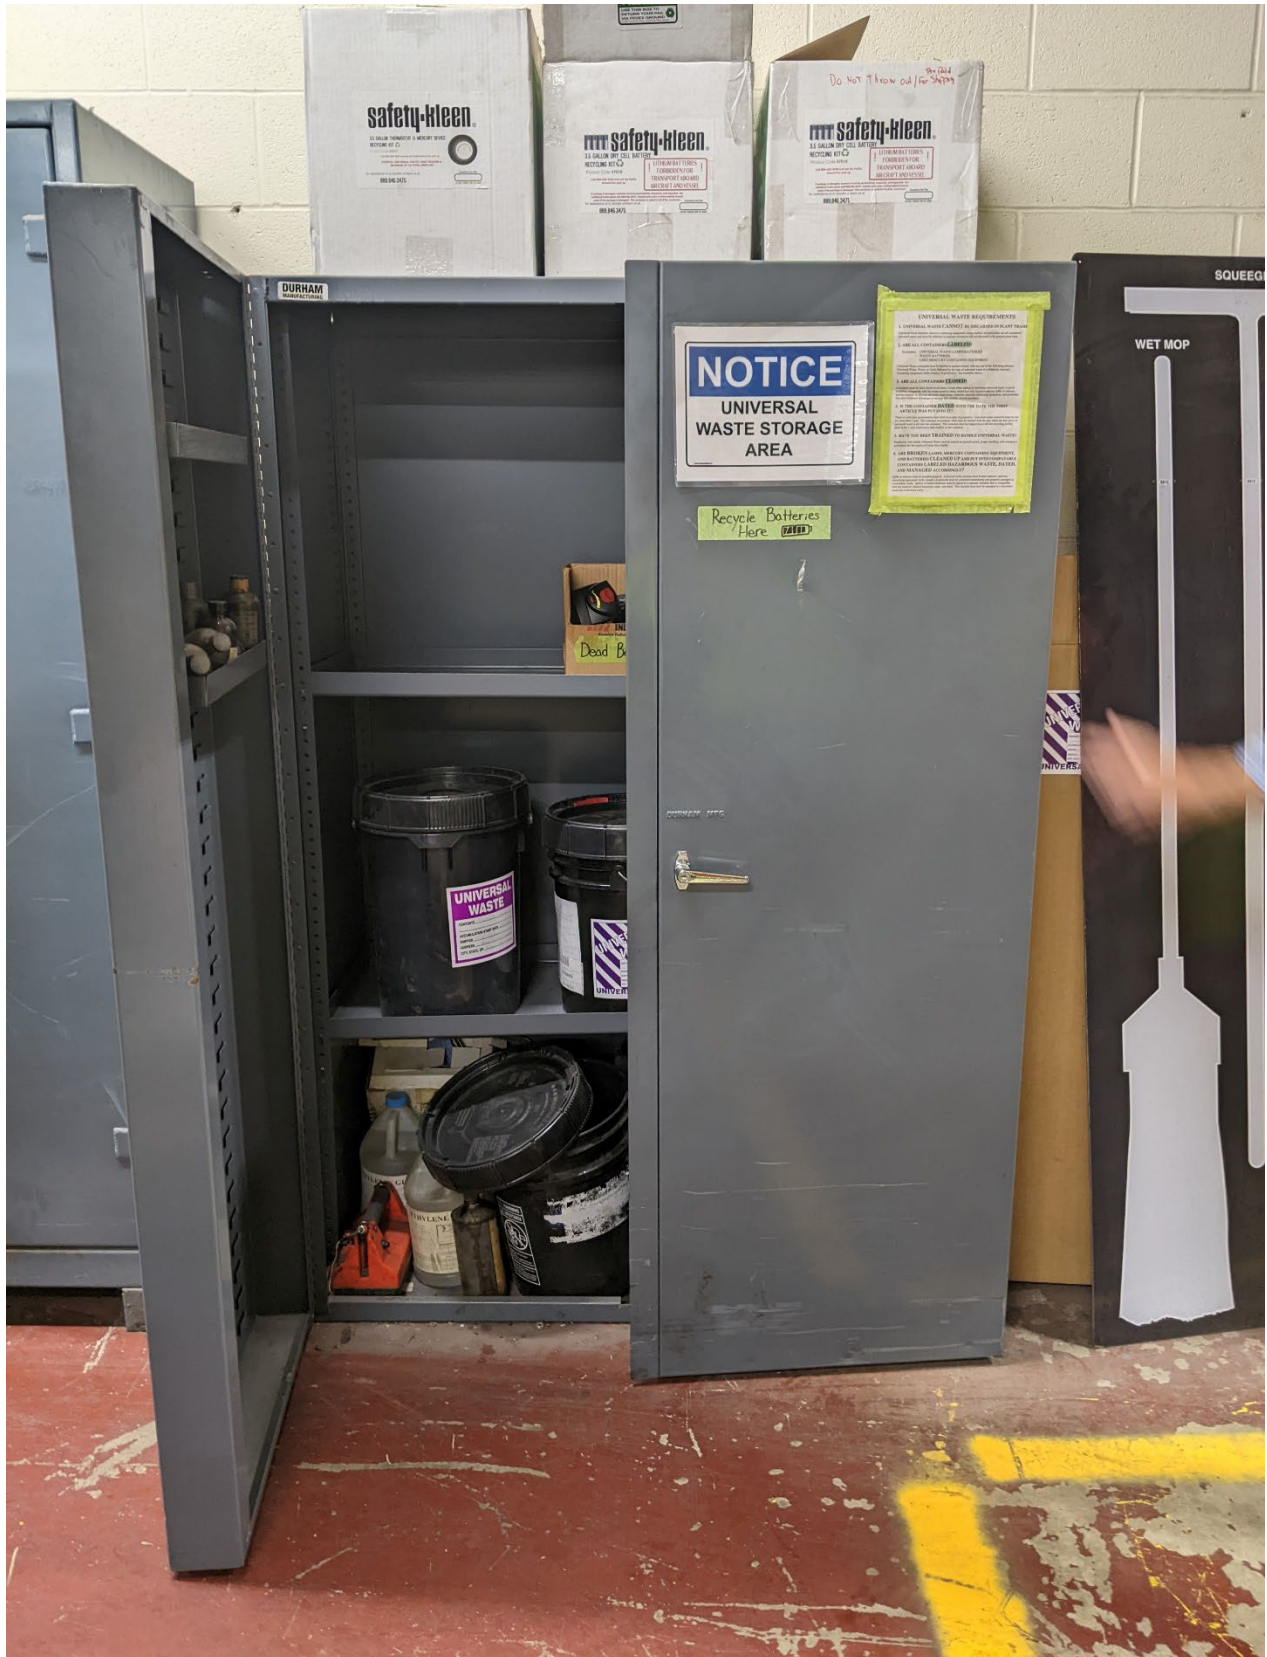
Photo #2: View of the universal waste cabinet.

Universal waste, consisting of spent batteries and fluorescent bulbs, is stored in the universal waste cabinet in the Storage Room.

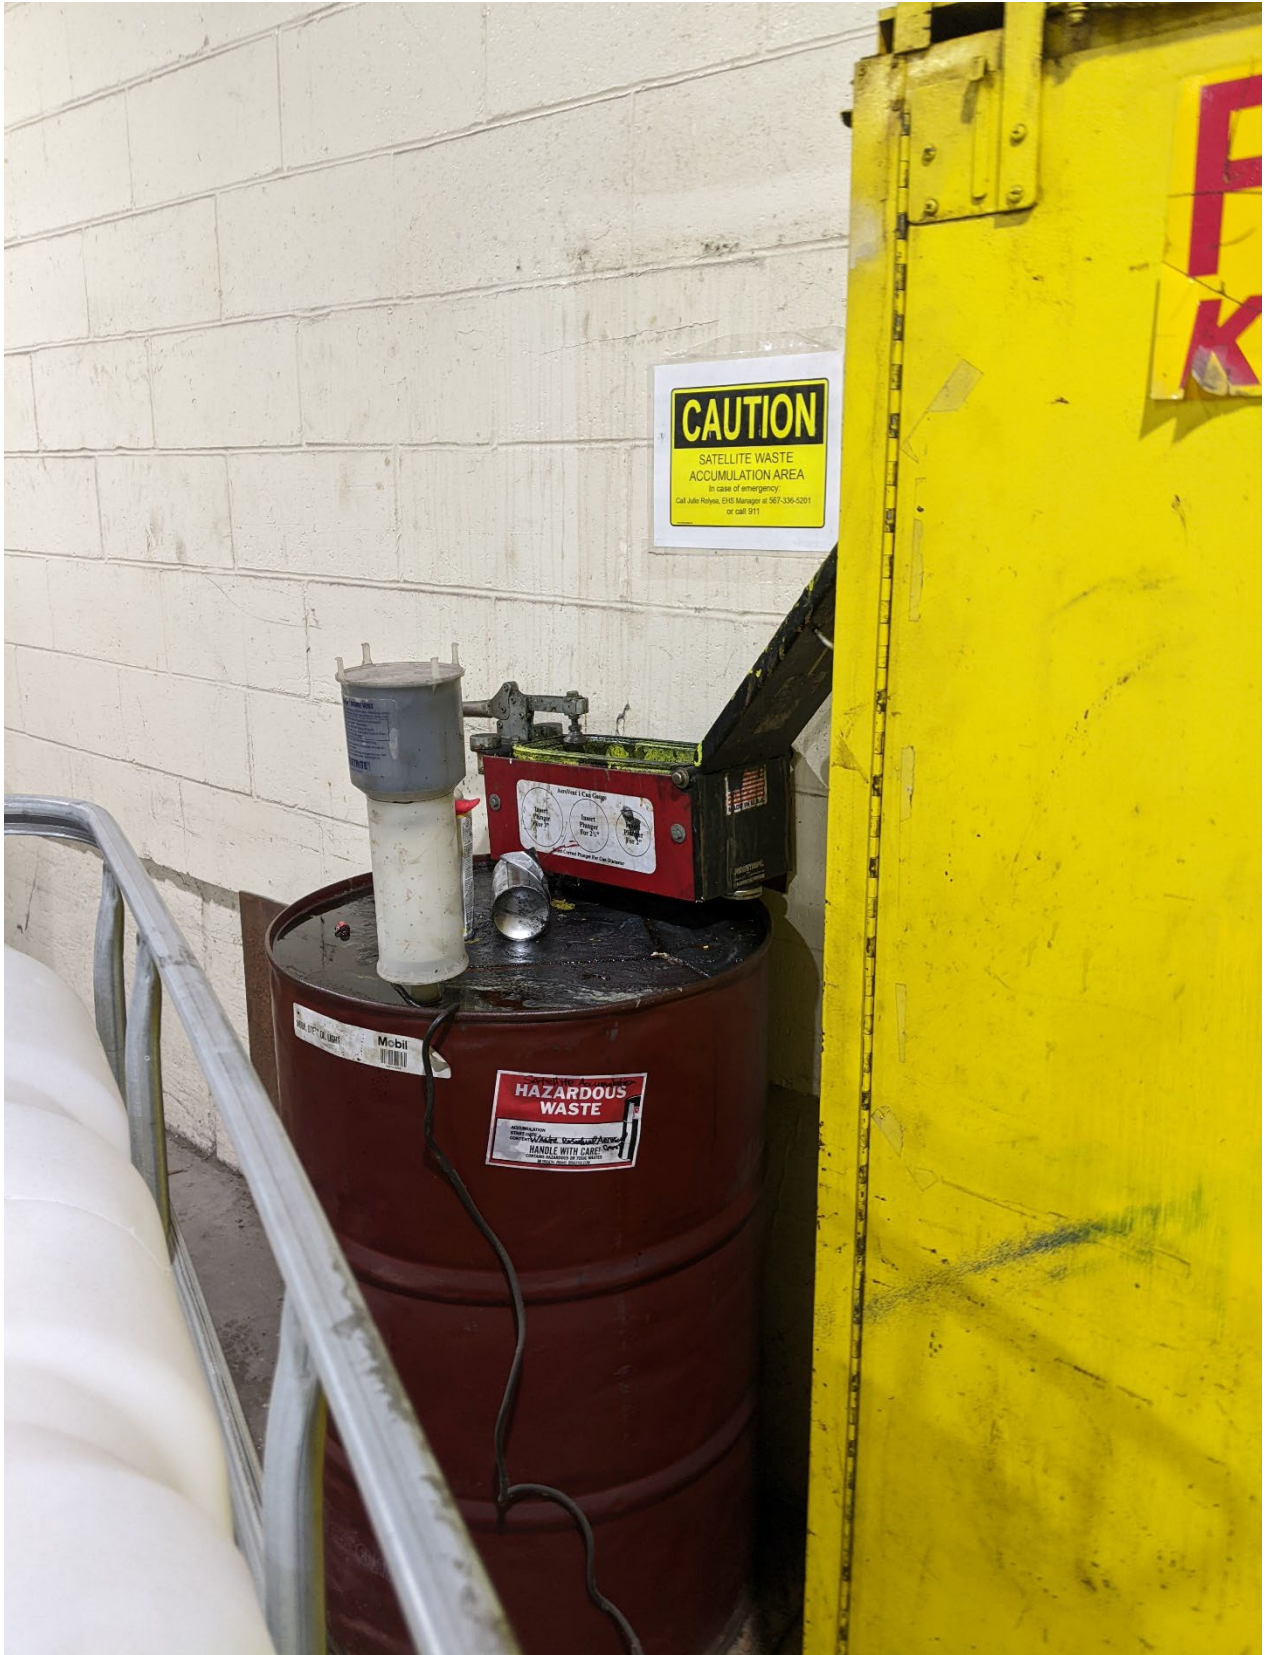
On the day of the inspection, there was a 55-gallon satellite container in the Storage Room. The container was half full of used aerosol cans. There was a hazardous waste label marked with the contents of the drum.

Photo #3: View of the satellite container in the Storage Room.

There were no violations or compliance issues found on the days of the inspection. The satellite container was in a room where product containers were being stored. It was recommended to facility representatives to relocate the satellite container to the adjacent Waste Accumulation Room. The container has since been relocated.

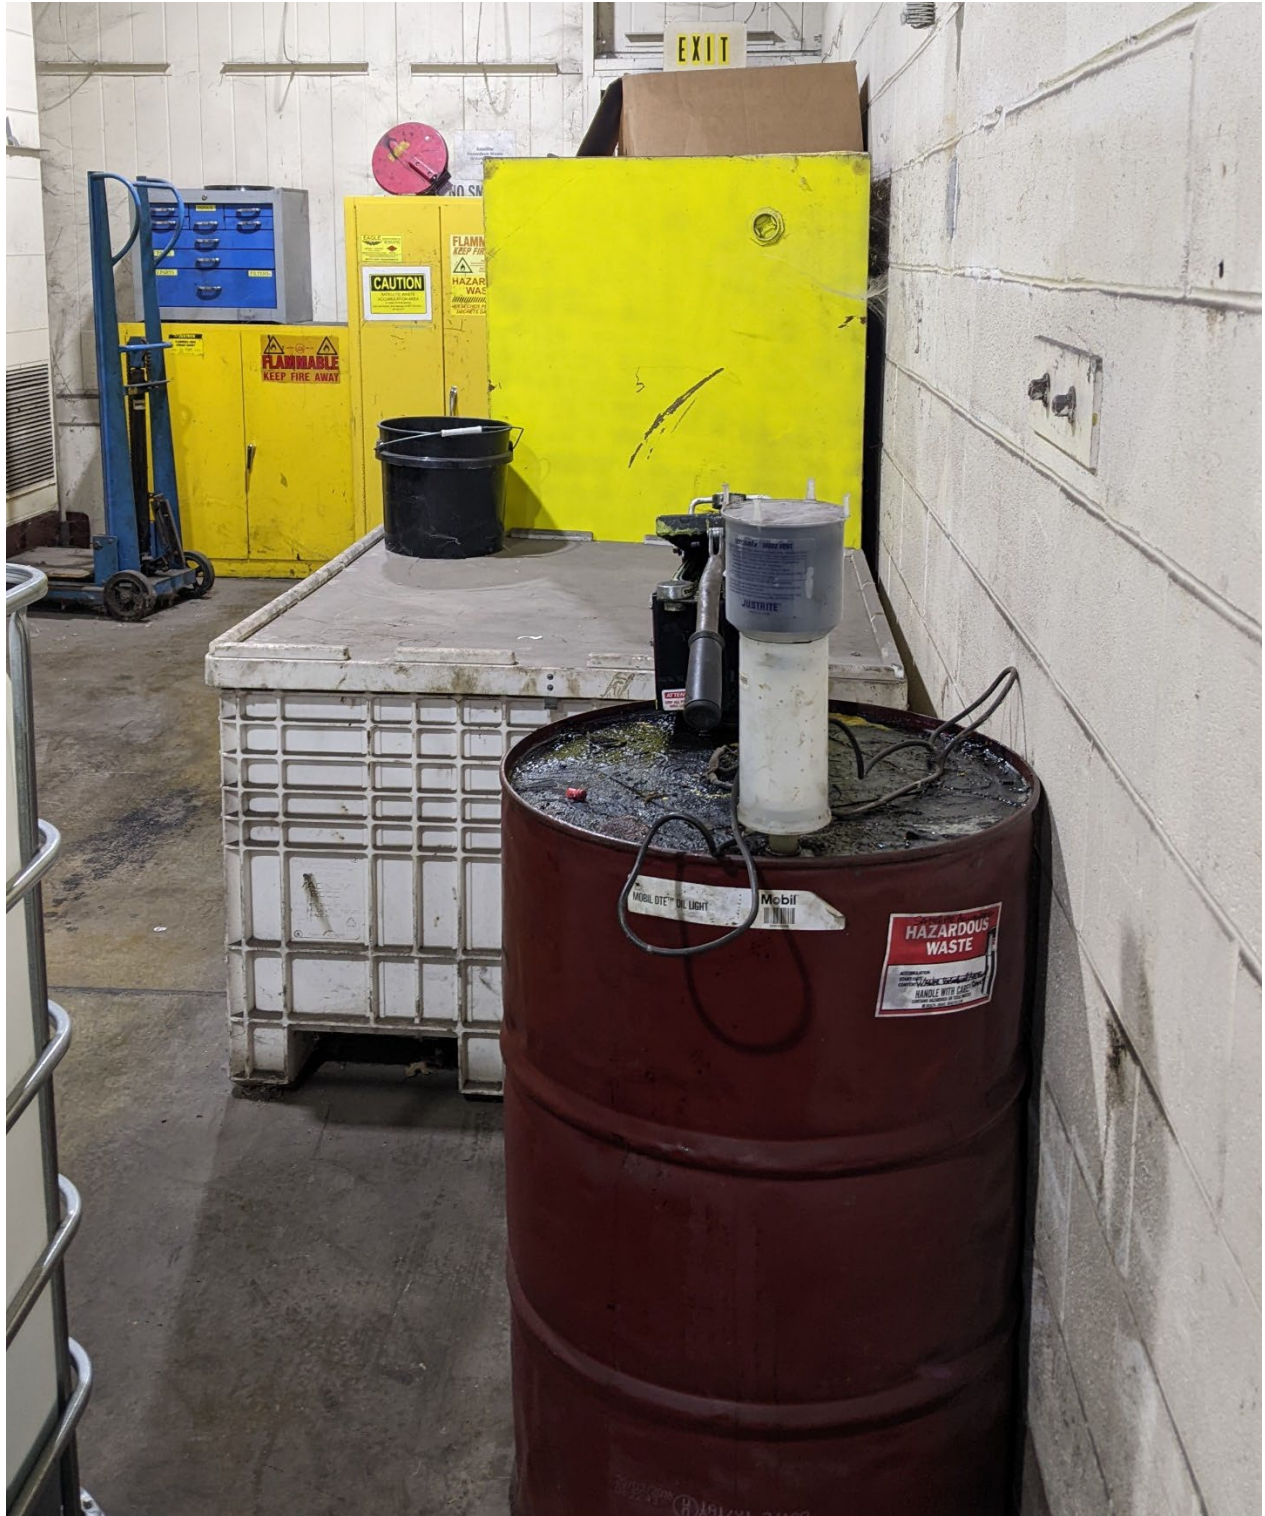
Photo #4: View of the relocated satellite container in the Waste Accumulation Room.
