INSPECTION REPORT

| Type of Inspection | Compliance Evaluation Inspection (CEI) | |
| Facility or Site Name | American Pollution Control Inc. (AMPOL) | |
| Type of Operation | American Pollution Control Inc. (AMPOL) decontaminates piping removed from offshore oil and gas exploration. | |

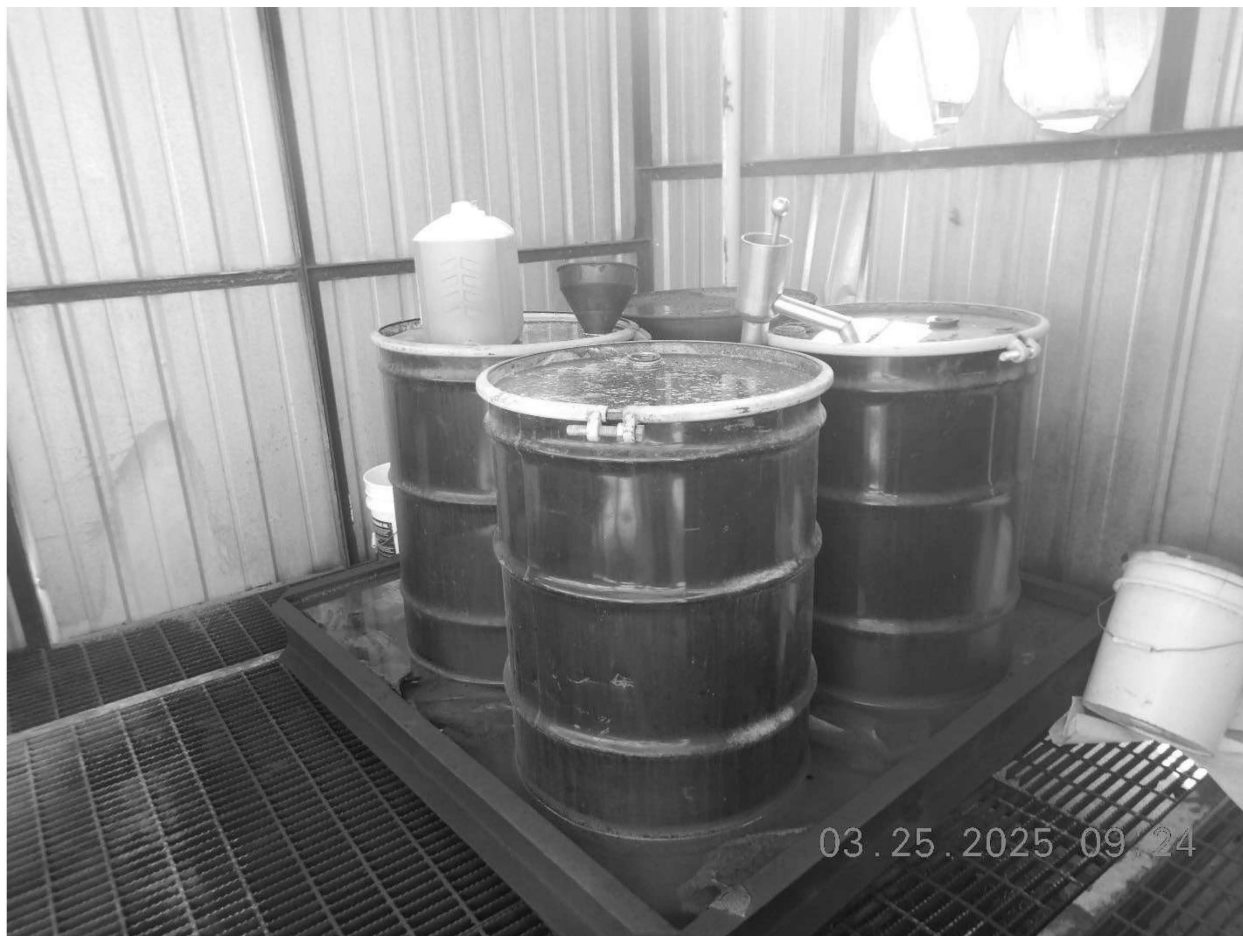
Photo No. 1

| <b>Facility:</b> AMPOL | | |
|---|---|---|
| <b>AOC #1</b> – AMPOL did not clearly label containers used to store used oil with the words “Used Oil.” | <b>Citation:</b> 40 CFR 279.45(g)(1) | Section: 2.1 |

Description: View of four half-full 55-gallon drums storing used oil in the used oil storage area. Three of which were not labeled as used oil.

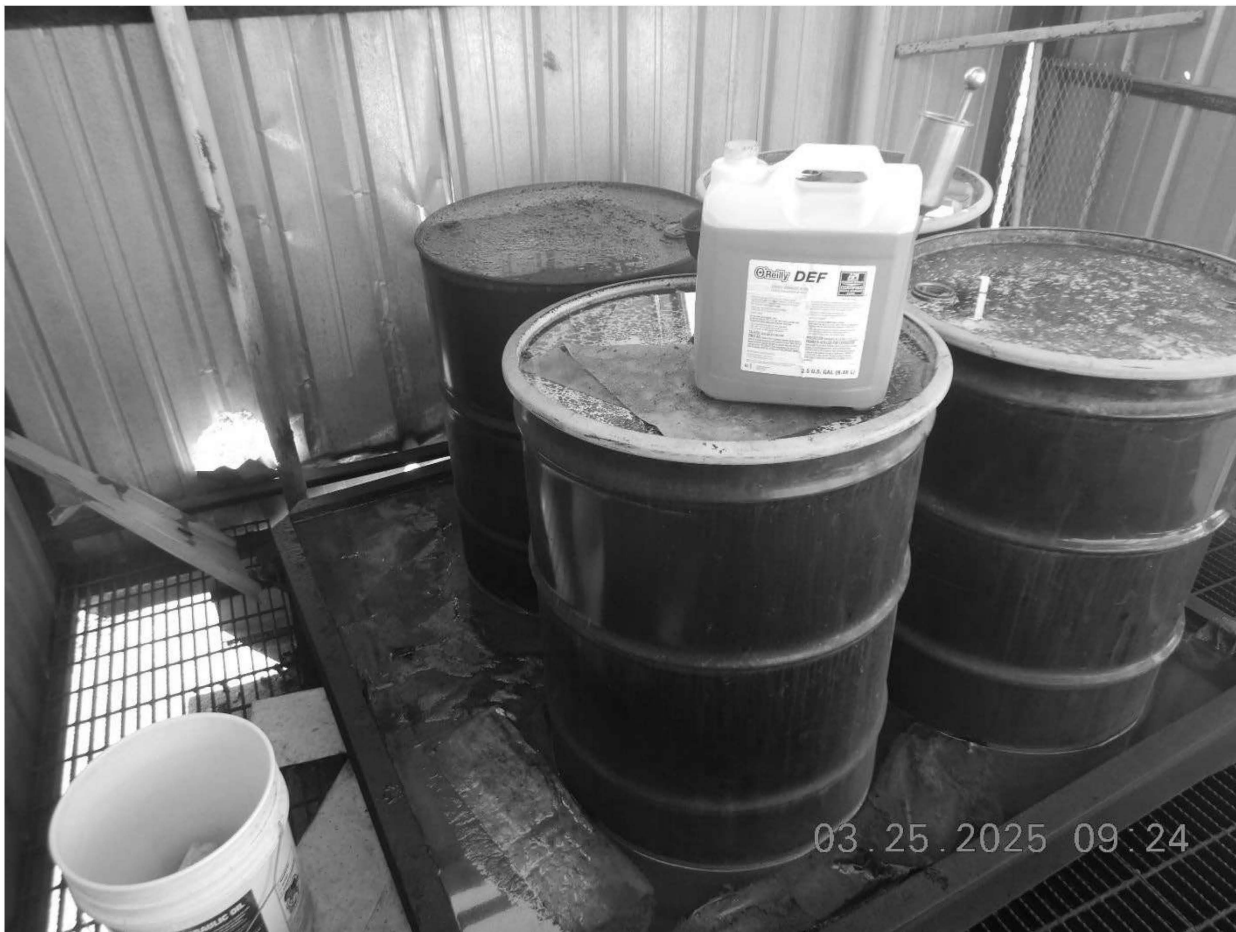
**Photo No. 2**

Description: Another view of four half-full 55-gallon drums storing used oil in the used oil storage area. Three of which were not labeled as used oil.

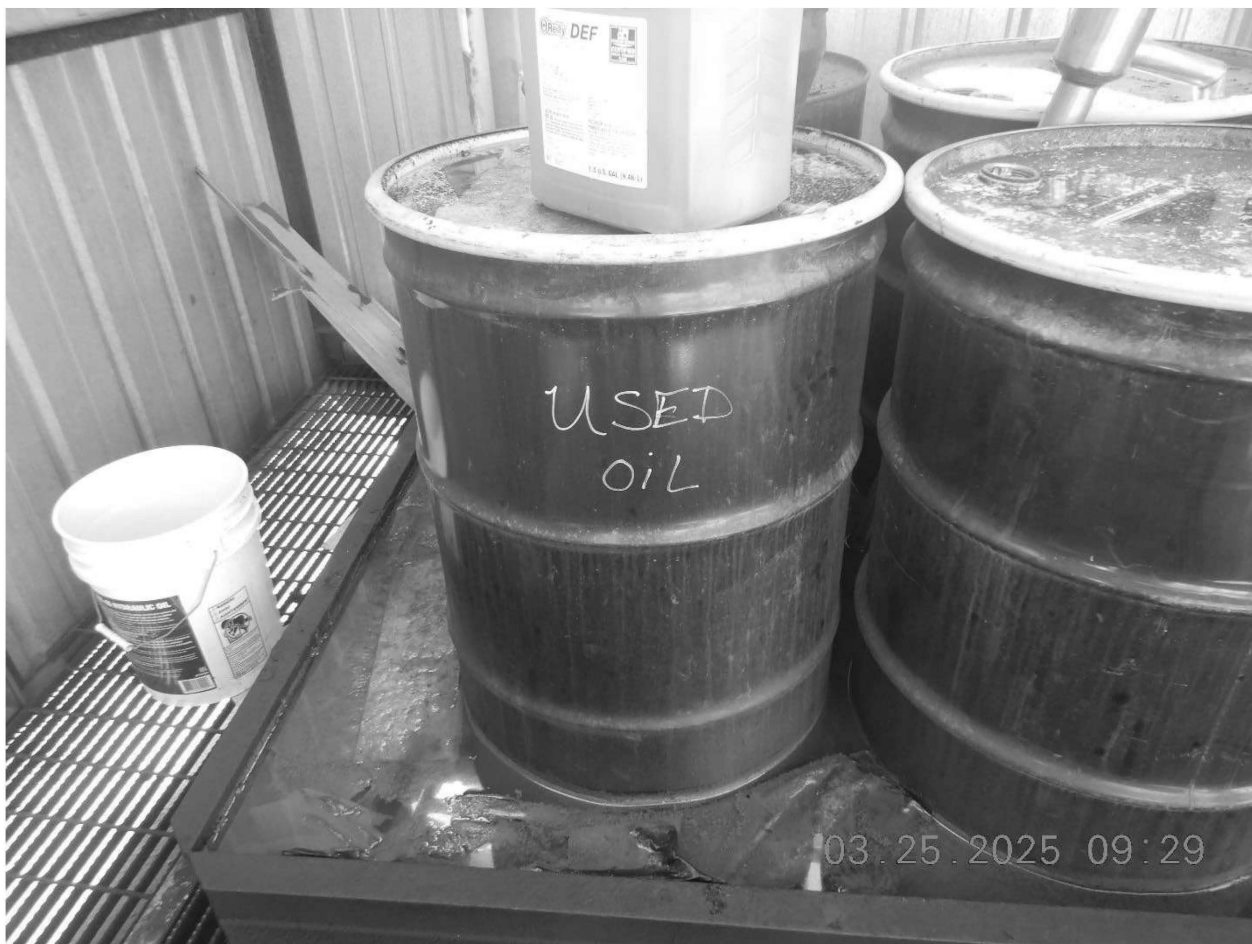
Photo No. 3

Description: View of the "Used Oil" label Mr. Guidry applied onto a previously unlabeled 55-gallon drum during the inspection.

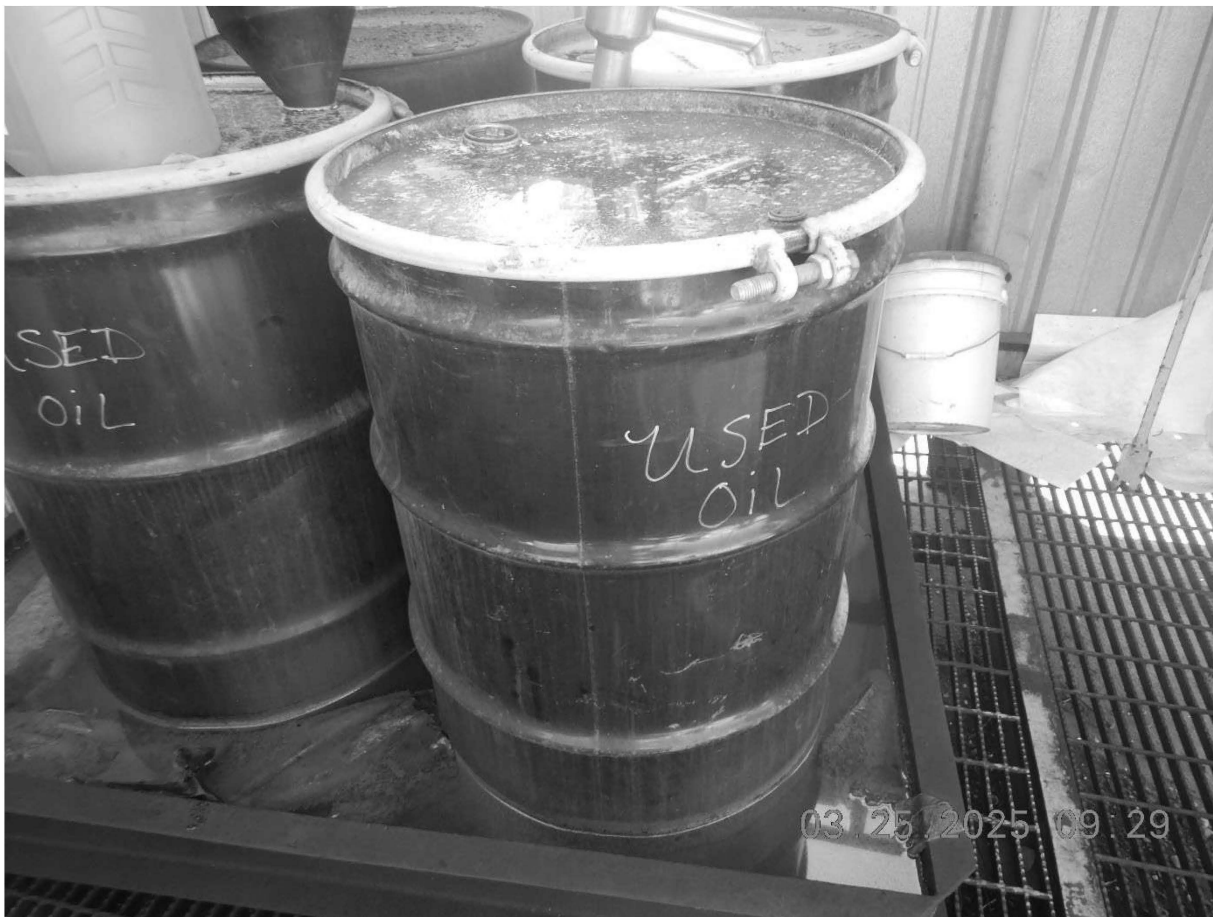
Photo No. 4

Description: View of the "Used Oil" label Mr. Guidry applied onto a previously unlabeled 55-gallon drum during the inspection.

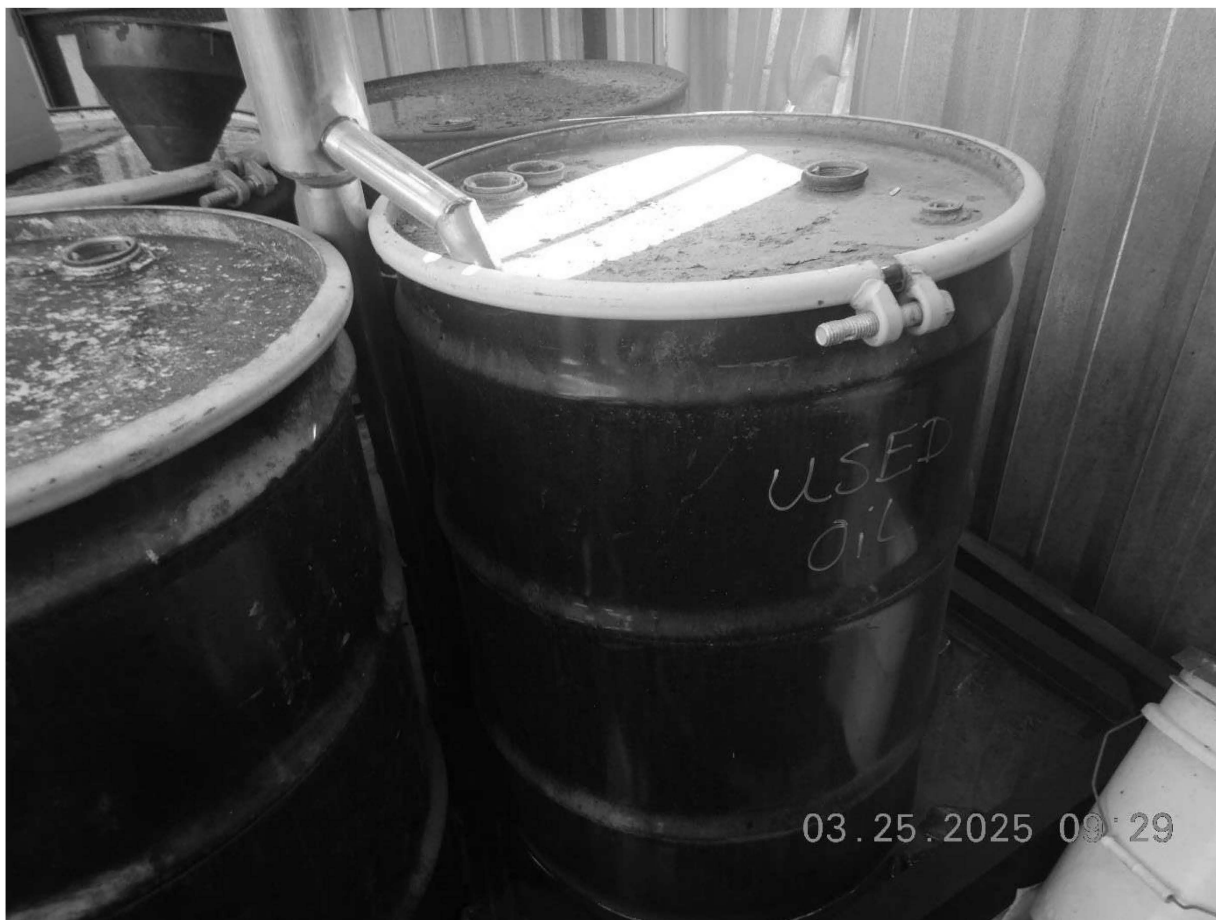
Photo No. 5

Description: View of the "Used Oil" label Mr. Guidry applied onto a previously unlabeled 55-gallon drum during the inspection.
