Re: **Sanitary Sewer System Compliance Evaluation Inspection
Haddon Township, Sanitary Sewer System
NJPDES Tracking ID No. NJP002586**

Clean Water Act (CWA) Inspection Report

Program: Sanitary Sewer System		Inspection Type: Compliance Evaluation Inspection	
Permittee Name: Haddon Township		NPDES/ICIS No.: NJP002586	
Inspection Entry Date: September 11, 2023 Inspection Entry Time: 9:10 AM		Inspection Exit Date: September 11, 2023 Inspection Exit Time: 2:50 PM	
Facility Inspected: Haddon Township 504 Oneida Avenue, Haddon Township, New Jersey 08108		Lat, Long: 39.91573, -75.04527 NAICS / SIC Code: NAICS Code: 221320 (Sewerage Treatment Facilities) SIC Code: 4952 (Sewerage Systems)	
EPA Representative(s): Zarine Ali, Physical Scientist, U.S. EPA Region 2, (212) 637-3919			
State Representative(s): None			
Representative(s): Jim Stevenson, Water/Sewer Superintendent, (856) 833-6260 Michael Baxter, Water Resource Management, (856) 444-0010			
Responsible Official: Jim Stevenson, Water/Sewer Superintendent, (856) 833-6260			
Name and Signature of Inspector		Agency/Office/Phone Number	Date

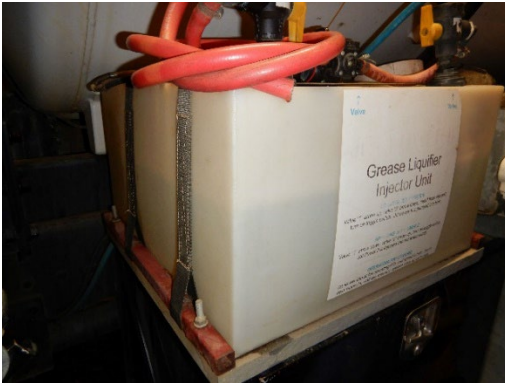
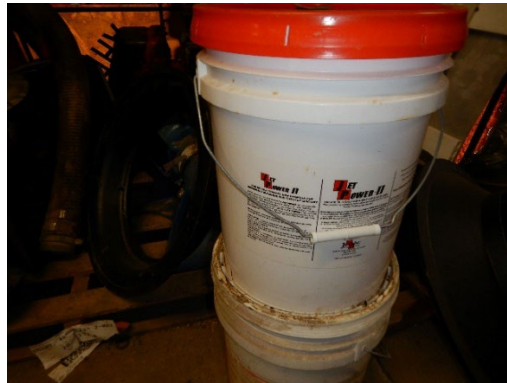
1. **The degreaser which the Township adds to its collection system (2 Photographs).**

20. Approximately 20% of the collection system is cleaned annually. The Township does preventative maintenance as well as quarterly hot spot cleaning. There are a few locations in the system where a degreaser is added on a quarterly basis.

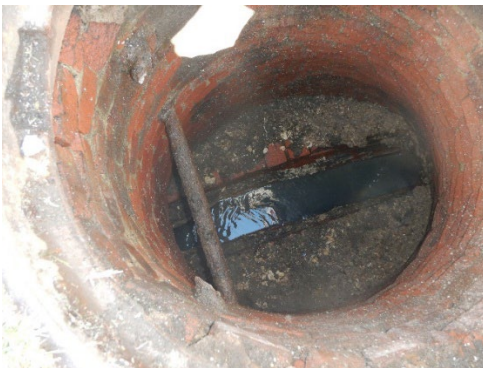
2. **Manhole at Severino Restaurant on Haddon Avenue where the degreaser is added (1 Photograph).**

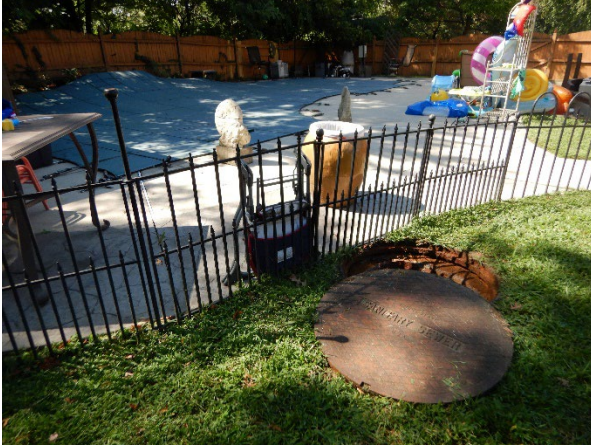
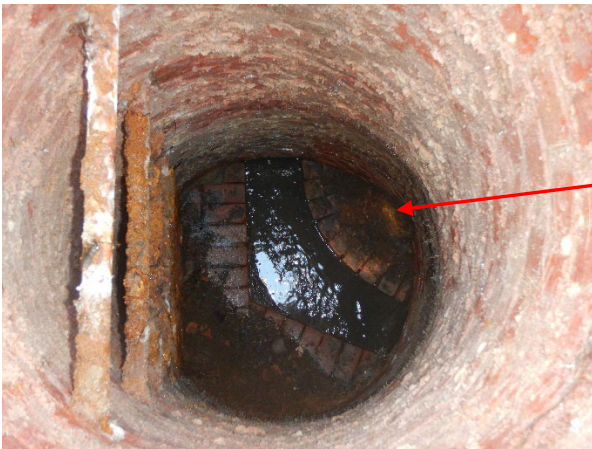
3. **Manhole on private property at 225 South Park Drive.**

The manhole is located in a backyard. This is the manhole that had the bypass piping (2 Photographs).

1. On 2/5/2022 NJDEP receive a complaint regarding sanitary sewage discharging into the Cooper River from an 8” diameter outfall pipe. While investigating this incident NJDEP notified the Township. EPA visited the manhole at 225 South Park Drive where an SSO location once existed. The Township plugged and used hydraulic cement to seal the bypass pipe. The Township was unaware that an SSO location existed at this location. In the past there were additional bypass locations which the Township calls underdrains that existed in its collection system. The Township said the underdrains that it knew of were plugged or completely removed. As the Township televises its collection system as needed, does the Township plan to televise its entire collection system to determine if additional bypass locations exist in its system?

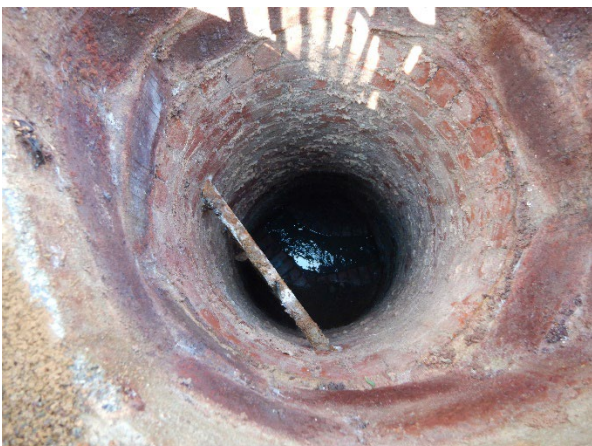
The piping for the bypass was plugged and the Township also used hydraulic cement.

Without the use of a flashlight the location where the bypass piping once existed is difficult to see (1 Photograph).

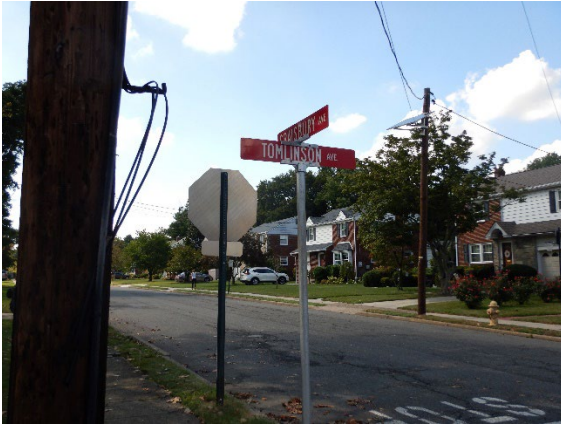
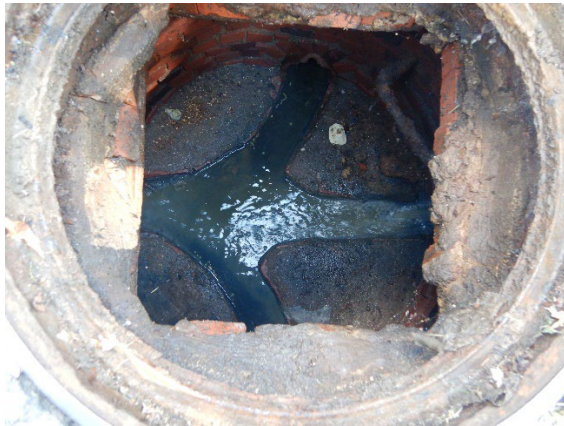
4. **Manhole at Tomlinson and Graisbury**

At the time of the CEI, sewage in the manhole was moving freely (2 Photographs).
