# Status of the PFC Assessment/Remediation Projects in Minnesota

Presented to: MPCA  
St. Paul, MN

Presented by: 3M Company

Date: July 23, 2013

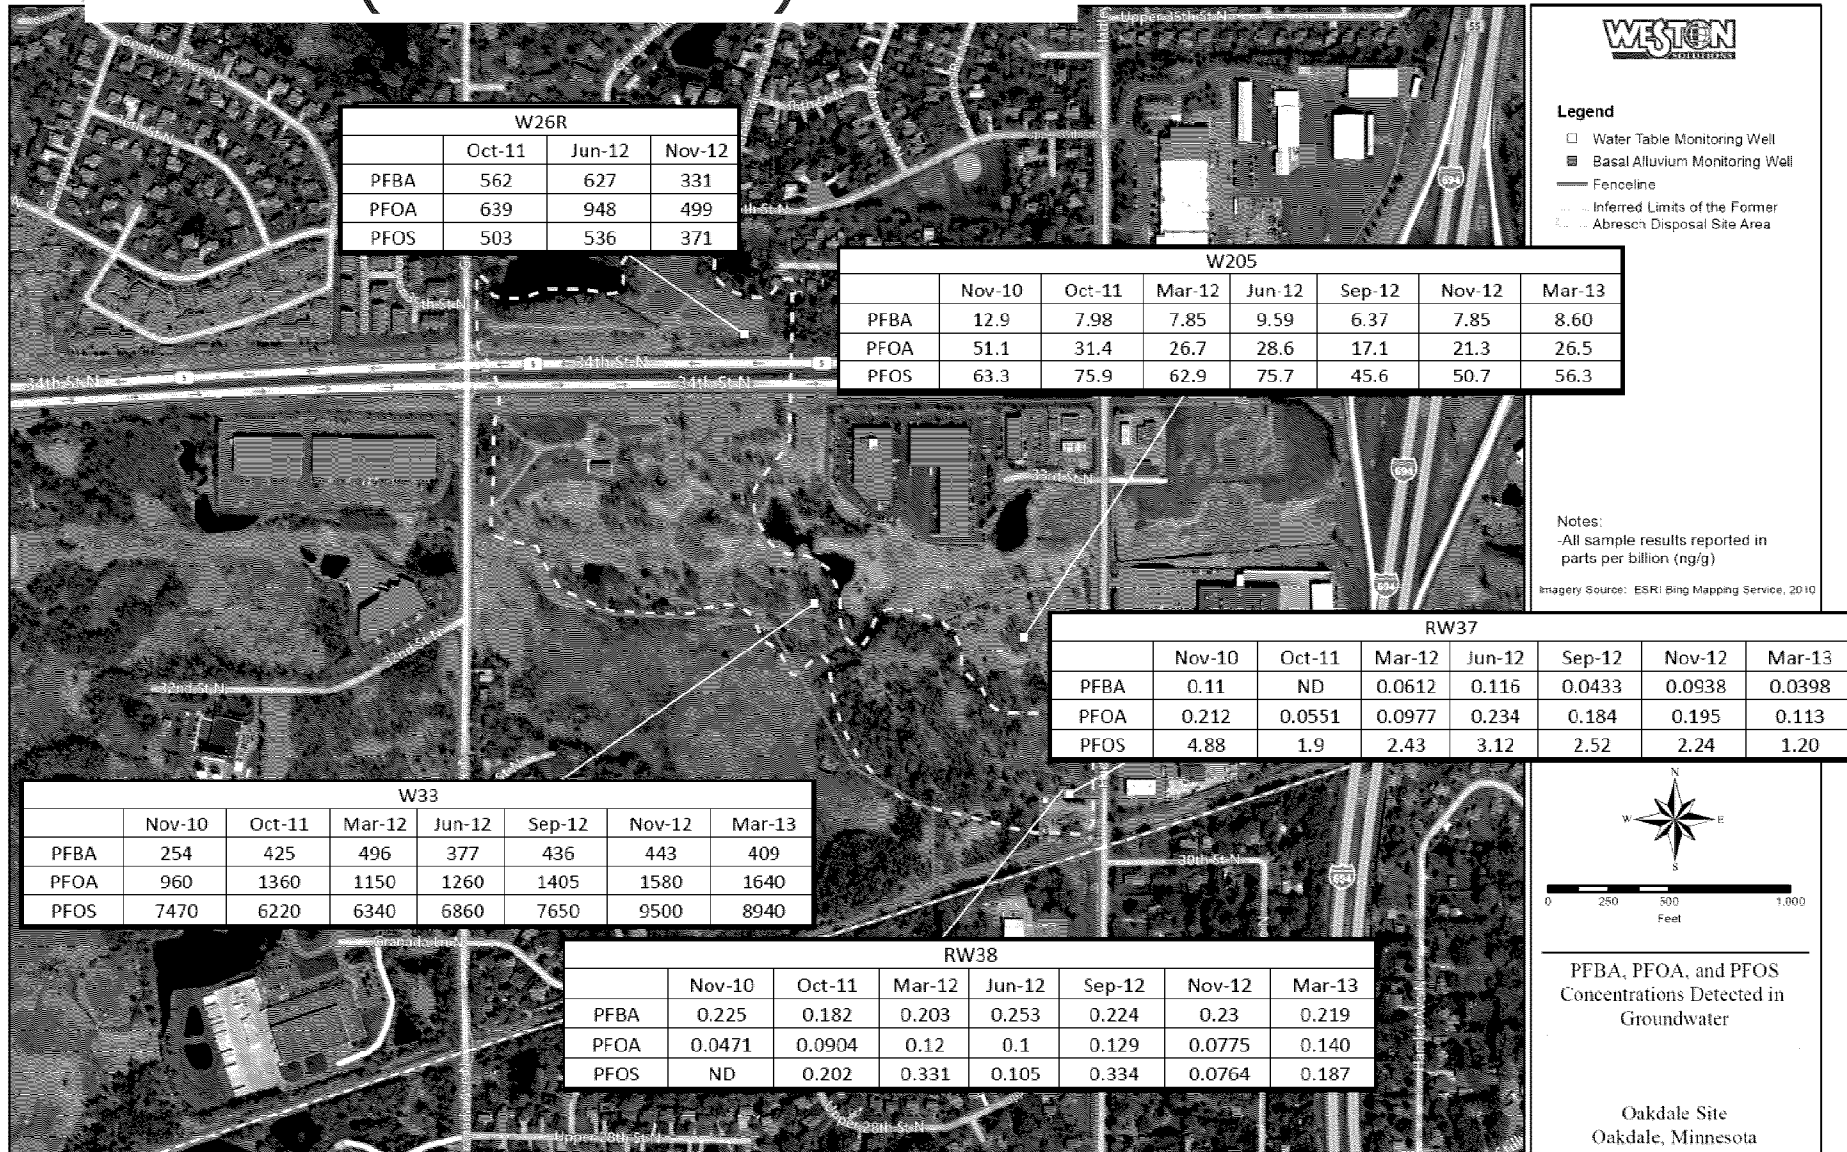
# Oakdale – Groundwater Results (2010 - 2013)

**W08**

**SP42**

**PL41**

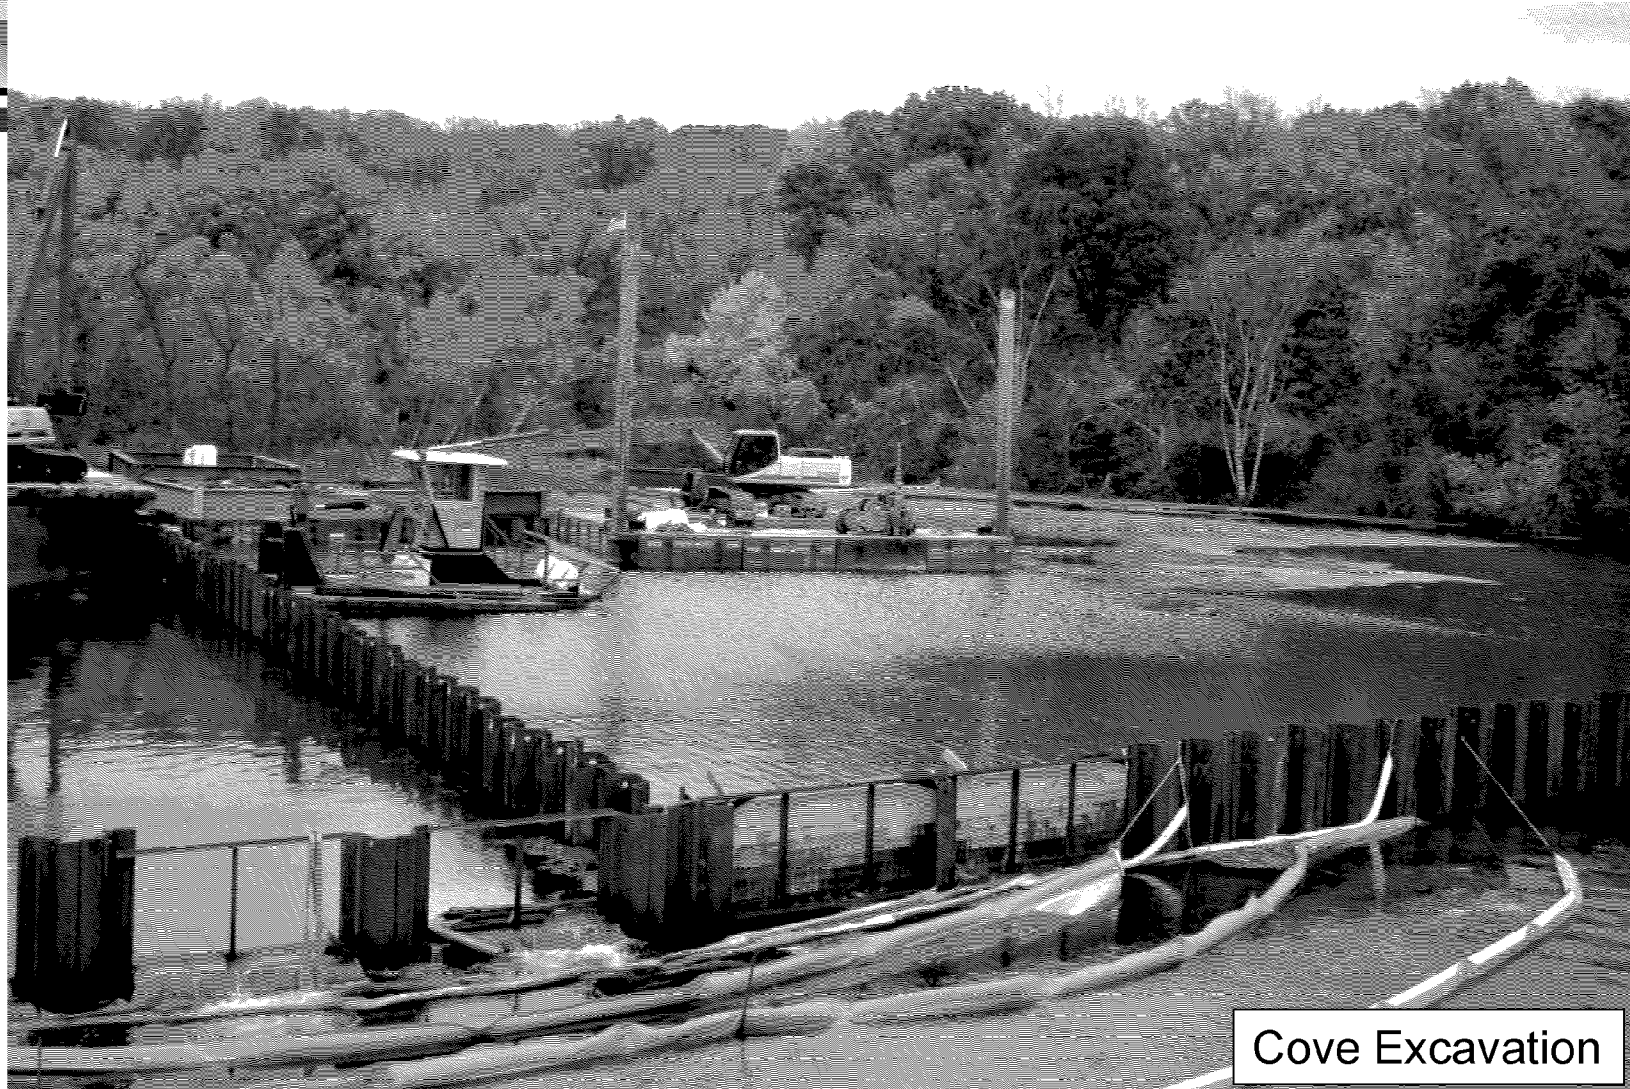
Cove Excavation

# East Cove Sediment Removal

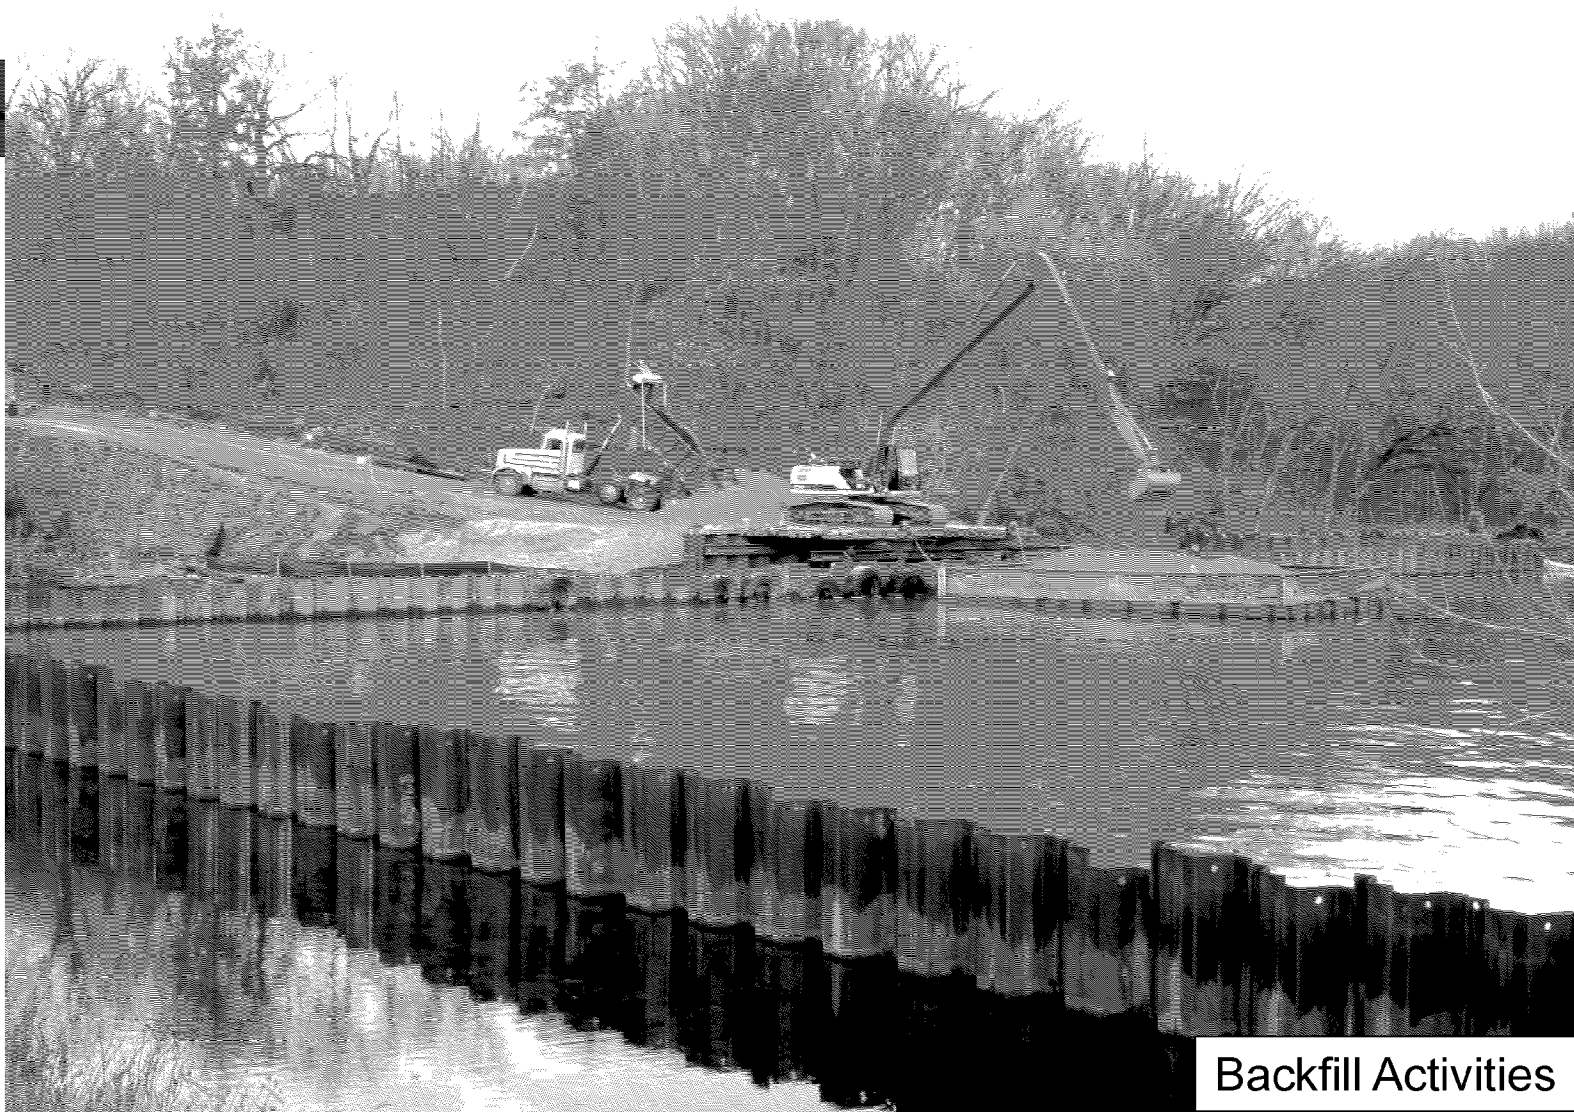
Backfill Activities

# East Cove Sediment Removal

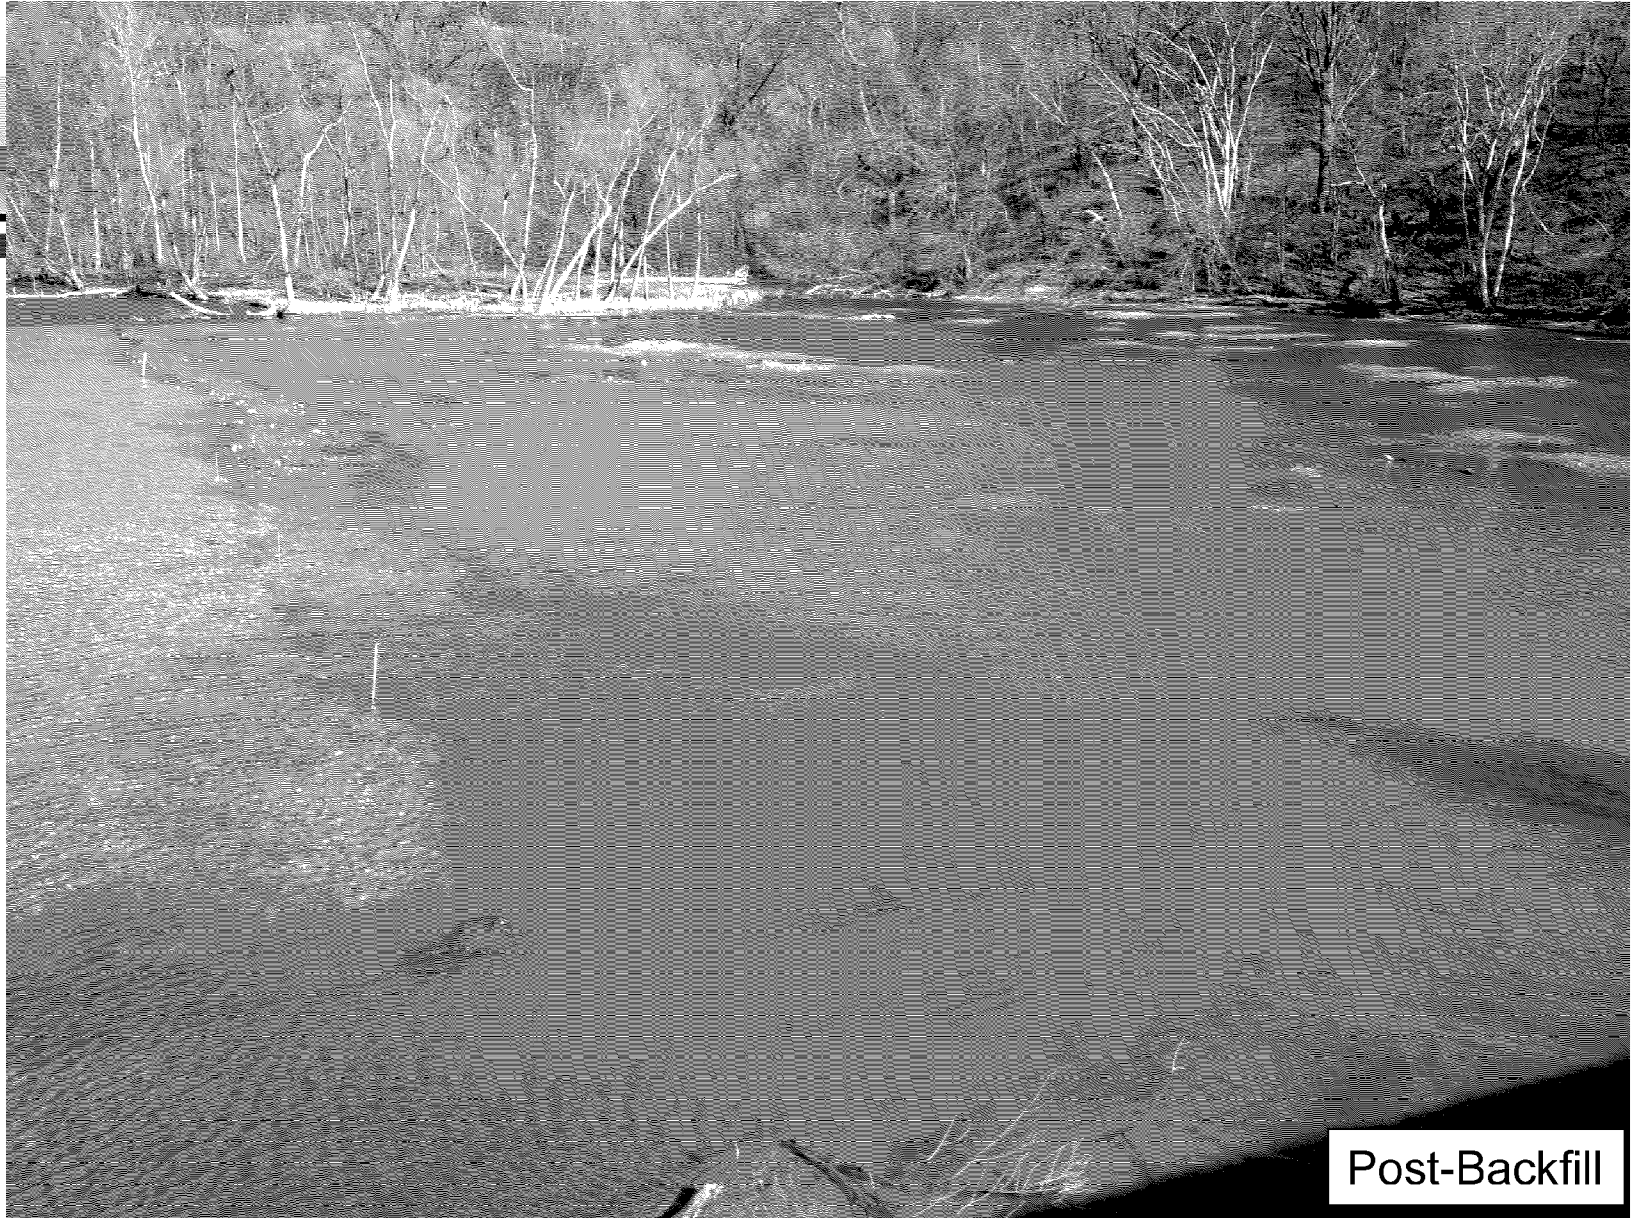
Post-Backfill

# East Cove Sediment Removal

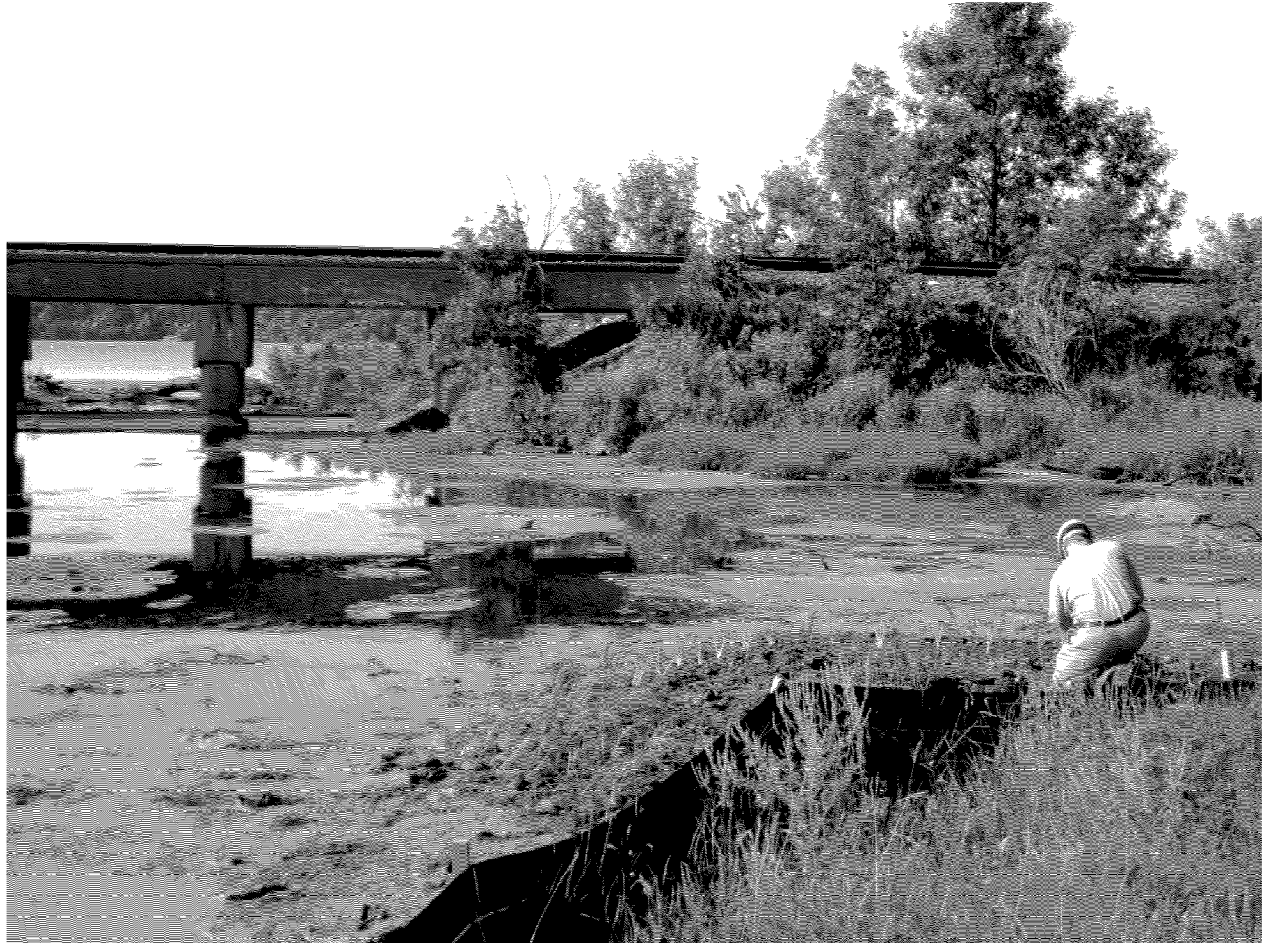
Planting  
Activities –  
Western Edge of  
Main Flow  
Channel  
(Looking South)
