## **RCRA Inspection Report**

PMC Organometallix, Inc. (PMC)  
13755-B Highway 43 North  
Axis, Alabama 36505

EPA ID# ALR000053371

March 28, 2023

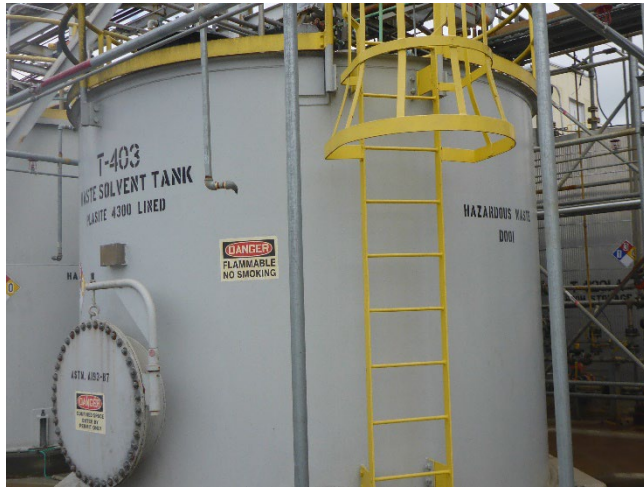
According to the contingency plan, PMC stores hazardous waste octyl solvent in a 7,880-gallon carbon steel, plastic lined, closed roof tank that is equipped with an overfill and leak detection system (Photo 1). The inspectors observed this tank within a secondary containment area shared with Arkema tank(s). Tank T-403 was labeled with the EPA Waste Code D001 and with words hazardous waste. The inspectors observed "flammable" and "no smoking" warning signs in this area and an NFPA diamond on the tank, which indicated the hazards of its contents. The tank appeared to be in good condition, and the inspectors observed metal tags identifying equipment subject to RCRA Subpart BB air monitoring (Photo 2).

**Photo 1:** 7,880-gallon carbon steel, plastic lined, closed roof hazardous waste storage tank (T-403) that is equipped with an overfill and leak detection system. The tank is labeled with the EPA Waste Code D001 and with the words hazardous waste. The hazards associated with the contents of the tank were indicated with a “no smoking” sign and an NFPA diamond.

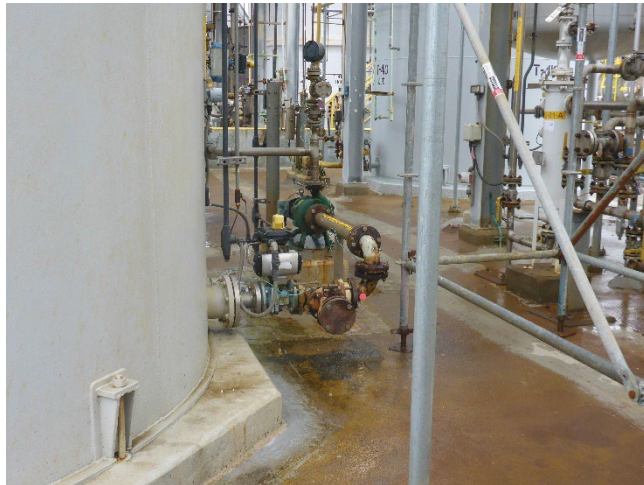
The RCRA Subpart BB records for Tank T-403 indicate that the system includes thirty-six valves and one pump which are subject to RCRA Subpart BB; that the line between P-262 and Tank T-403 is in light liquid service; and that the line from Tank T-403 and the tanker truck is in gas vapor service. In an email to the inspectors on April 13, 2023, Christopher McNeil submitted records of Leak Detection and Repair (LDAR) monitoring of each piece of equipment, which indicated that no leaks were detected on February 15, 2022.

**Photo 2:** Metal tags identifying equipment associated with Tank T-403 that is subject to RCRA Subpart BB monitoring.

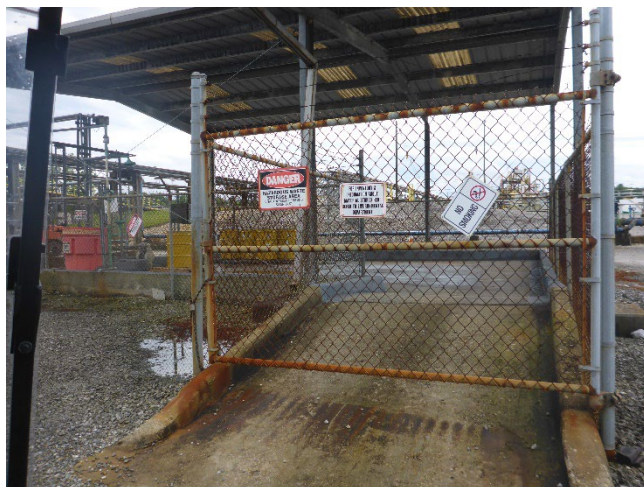
PMC's contingency plan describes the CAA as a concrete pad surrounded by a four-inch-high curbing and covered with a chemical resistant coating that is compatible with the waste stored in this area (Photo 3). The pad is equipped with a metal roof and surrounded by a locked, chain link fence. The floor is sloped to a sump, and material that collects in the sump is pumped to the on-site wastewater treatment plant. The area was identified with signs which read "danger -

hazardous waste storage area” and “no smoking.” The inspectors observed six 55-gallon drums of Arkema hazardous waste in this area, but no containers of PMC hazardous waste.

**Photo 3:** CAA located on concrete pad surrounded by a four-inch-high curbing and covered with a chemical resistant coating. The pad is equipped with a metal roof and surrounded by a locked, chain link fence. The floor is sloped to a sump, and the area is identified with a “no smoking” sign.
