**Compliance Evaluation Inspection Report**  
Sledge POTW  
Lagoon Road,  
Sledge, MS 38670  
NPDES Permit Number: MS0021016

**Project No. CV-MS0021016-08132024**

**Date of Inspection:**  
August 13, 2024

**COMPLIANCE EVALUATION INSPECTION REPORT**  
Sledge MS POTW, Project # CV-MS0021016-08132024

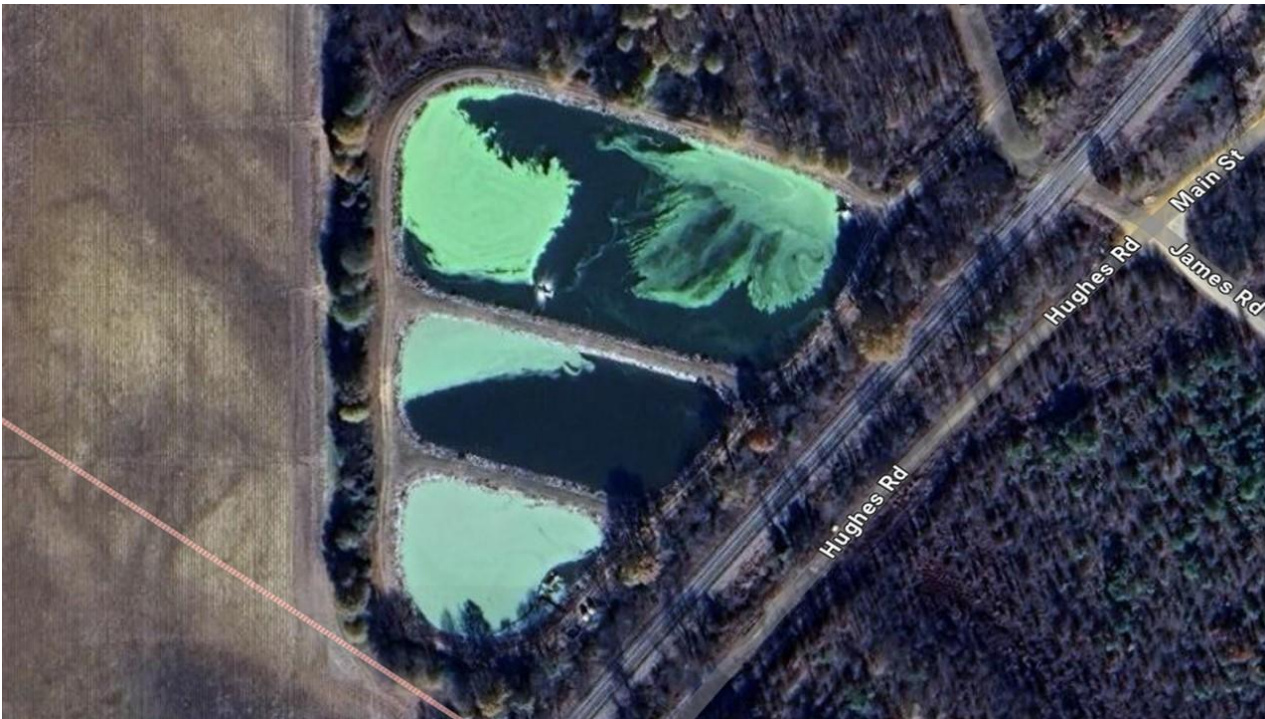
**Figure 1.** Aerial View of Facility

The Sledge POTW is a three-cell lagoon treatment system located on Lagoon Road in Sledge, MS. The facility is currently permitted under the National Pollutant Discharge Elimination System (NPDES) permit number MS0021016 to discharge 0.22 million gallons per day (MGD) from Outfall 001 into an unnamed creek then to David Bayou.

The POTW consists of a three-cell lagoon with aeration in the first cell and a rotating contactor in the third cell. The treated effluent passes through a chlorine contact chamber which uses gaseous chlorine for disinfection. The effluent is injected with SO<sub>2</sub> gas for de-chlorination prior to discharge. The effluent passes over a weir plate (primary flow measurement device) prior to discharge to the pipe leading to the receiving stream.

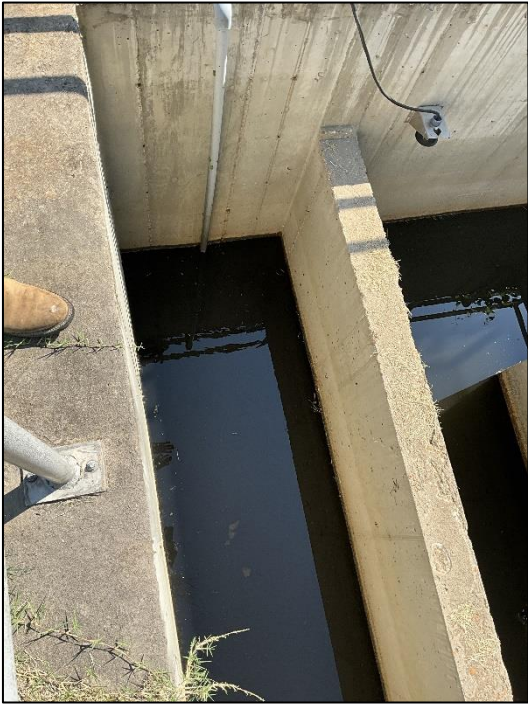
- Chlorine is injected at the head of the chlorine contact chamber (Photo 1) and SO<sub>2</sub> is injected at the end of the chlorine contact chamber for dechlorination (Photo 2). A spontaneous check for residual chlorine showed below detection limit (0.02 mg/L) for the handheld colorimeter Mr. West uses (Photo 3).
- Cell 1's two aerators were out of service (Photo 4) and the lagoon was completely covered in algae.
- Cell 2 was completely covered in algae (Photo 5).
- Cell 3's rotating contactor was out of service and the area of the berm there was covered in woody plants (Photo 6).

Photo 1: Chlorine injection point.

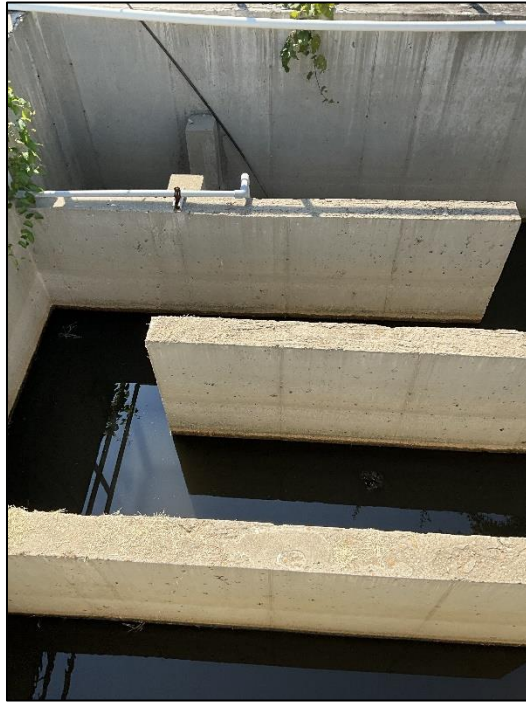
Photo 2: Sulfur Dioxide injection point.

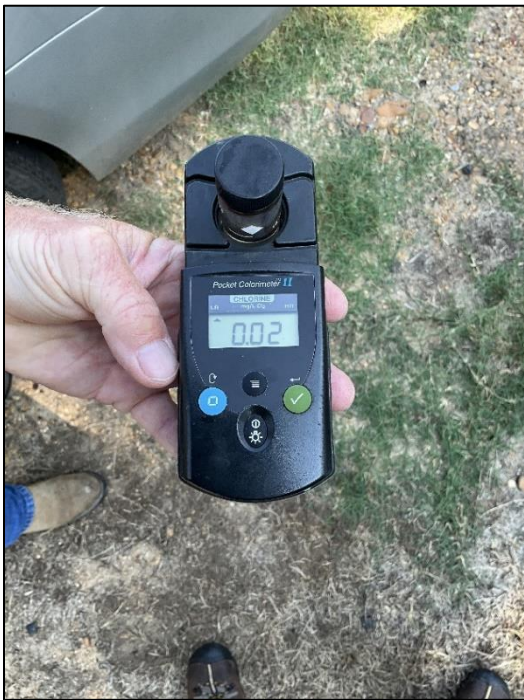
Photo 3: Residual Chlorine reading of 0.02 mg/L.

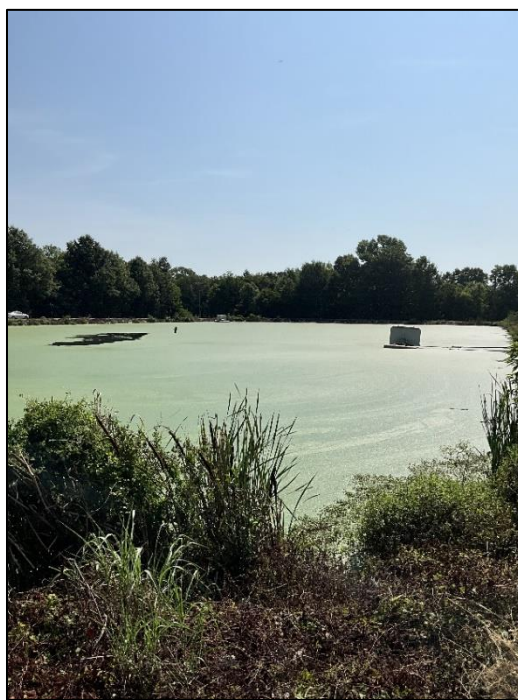
Photo 4: Cell 1 (location of non-functional aerators)

The facility DMR non-receipt Significant Non-Compliance (SNC) violations are due to not reporting laboratory analytical results into NetDMR. Most of the analytical results from Waypoint Analytical laboratory were produced, but Mr. West has not yet emailed to EPA three years of quarterly records as requested. Sledge should repair the two non-functioning aerators in Cell 1 and the non-functional rotating contactor in Cell 3.

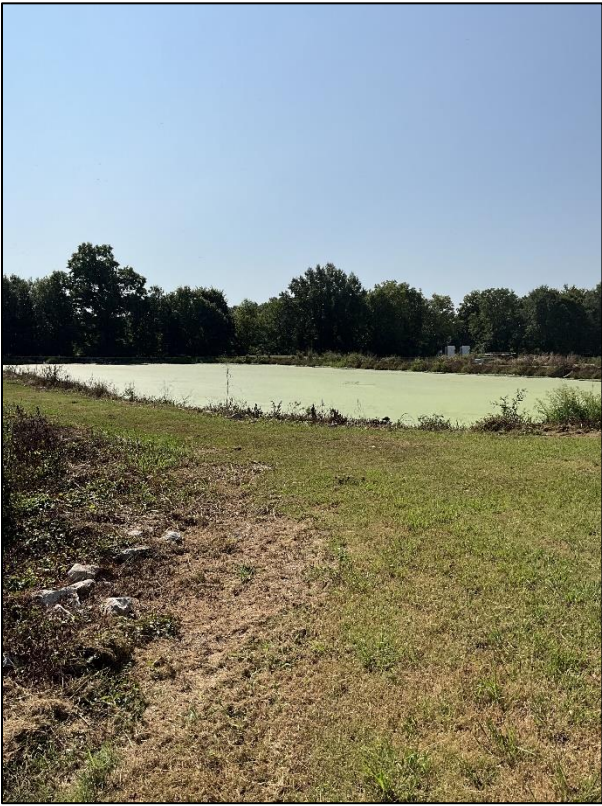
Algal blooms in a wastewater lagoon, especially an aerated lagoon, affects the treatment process and effluent quality. Algae create oxygen during the day and consume it at night, leaving less oxygen available for BOD-consuming bacteria to use. High algae can also create high TSS and BOD<sub>5</sub> effluent concentrations that will generate a high oxygen demand in the receiving water. Sledge should control algal blooms in their lagoon to support adequate wastewater treatment.

Photo 5: View of Cell 2 full of algae.

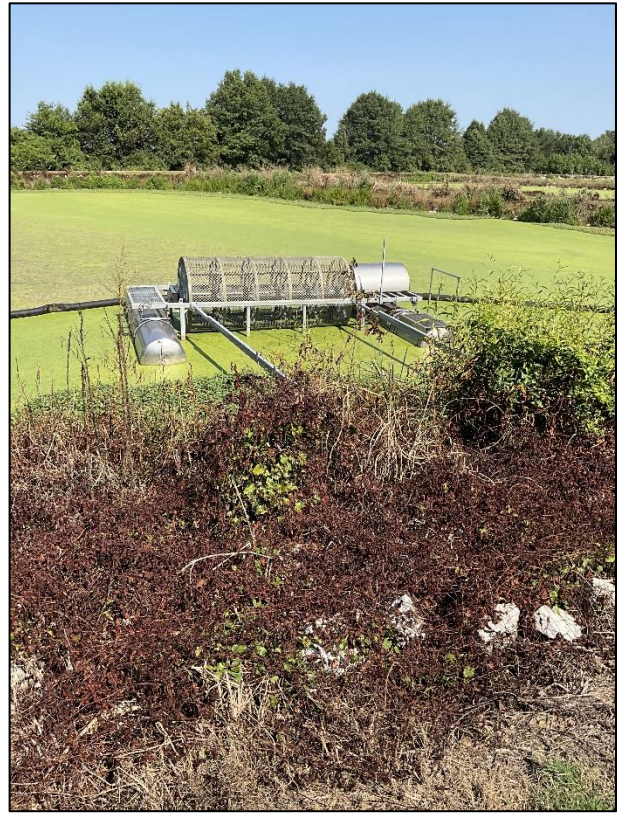
Photo 6: Lagoon- Cell 3 (non-functional rotating contactor and woody vegetation in berm).
