**Region 6 - Enforcement & Compliance Assurance Division**  
**INSPECTION REPORT**

| Company Name: | <b>Phillips 66</b> | |
| Facility Name: | <b>Spindletop Compressor Station</b> | |

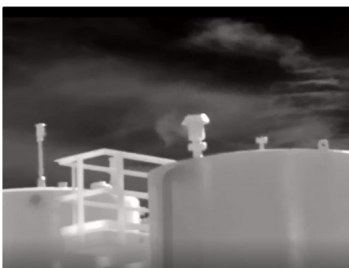
I used the OGIC to observe emissions from the slop oil tank's pressure release valve (FLIR0016.mp4). At 11:00AM, Mr. McPherson used a PID with a Draeger tube and observed a reading of 3.965 parts per million ("ppm") of benzene. [AOC 1]

Video File Name: [FLIR0016.mp4](#)  
Date of Video: 02/07/2024  
Time of Video: 10:45 AM  
Videographer: Benjamin Donaldson  
Description: Emissions observed from the pressure release valve of the slop oil tank.
