**UNITED STATES ENVIRONMENTAL PROTECTION AGENCY**  
New England Regional Laboratory  
Laboratory Services and Applied Sciences Division  
11 Technology Drive  
North Chelmsford, MA 01863-2431

**Drafted Date:** 2/16/2023  
**Finalized Date:** 4/17/2023

**Subject:** Sampling Summary Report - Arch Medical Solutions  
Compliance Sampling Inspection

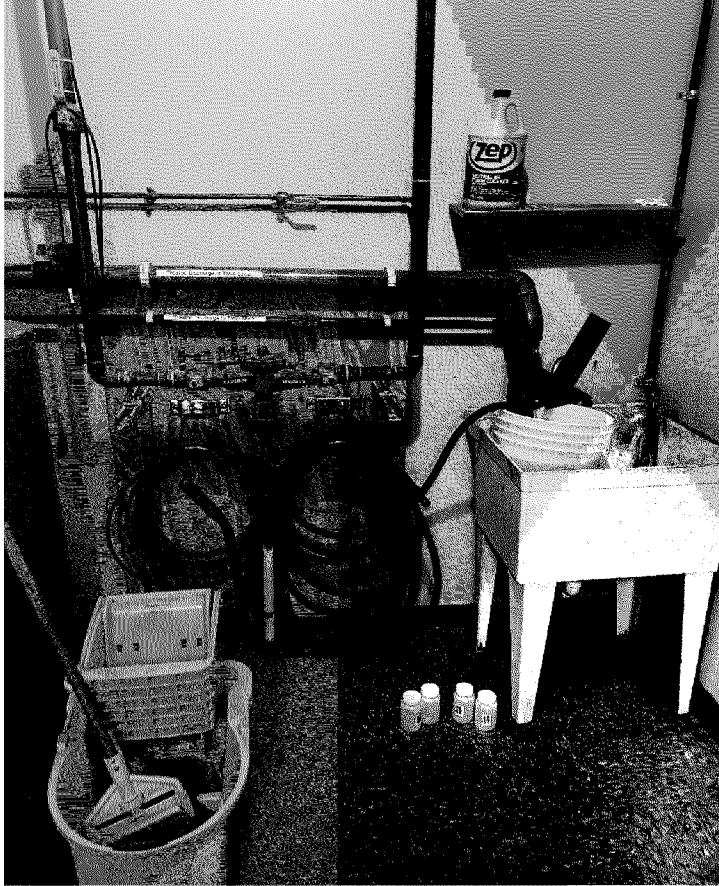
Photo 1: Utility room adjacent to facilities wastewater treatment room. Sample collected from bucket collection system located at the end of grey pipes labeled “treated discharge to town sewer”.

Mr. Leclerc, Mr. Michaud, and Ms. Saucier led the EPA inspection team on a tour of 35 Woodworkers Way beginning at 09:45. The tour began in the wastewater treatment room and an adjacent utility room. Piping from the neutralization system runs through the wall of the wastewater treatment room and drains into a sink located in the utility room. The piping consists of one 2-inch diameter plastic pipe and one 0.5-inch diameter plastic pipe, both labeled “treated discharge to town sewer” (photo 1).

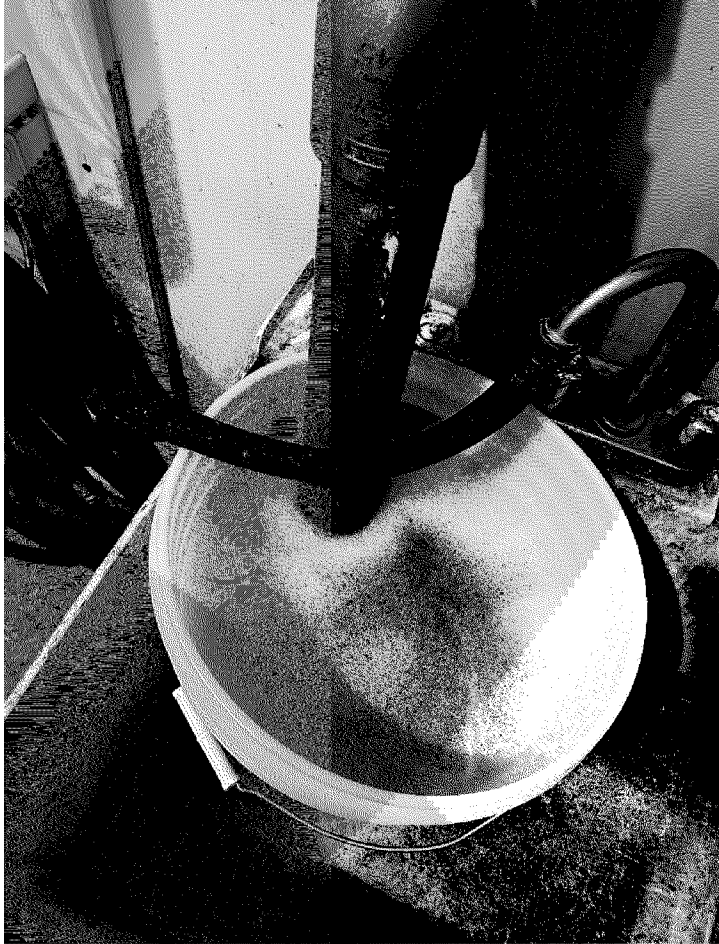
Photo 2: Bucket collection system located inside sink of utility room. Note: presence of bubbles on surface.

The EPA sampling team (Shannon Shea, and William Sommer) set up a bucket collection system at 09:55 to catch flow from the pipes labeled “treated discharge to town sewer” before draining into the sink due to low flow. Mr. Melcher and Mr. Bednarz continued the facility inspection with facility representatives while the EPA sampling team monitored flow to the collection system. Sample collection began at 10:28 and completed at approximately 10:50. Bubbles were present on the surface of the flow collected inside the bucket. Sample containers had a slippery film on the outside of the bottle from sample collection (photo 2).
