**UPR Mayagüez Campus, Mayagüez, Puerto Rico**

**PRD000691063**

**CEPD-RCRA-23-0440**

**Eduardo Gonzalez  
March 8 - 10, 2023**

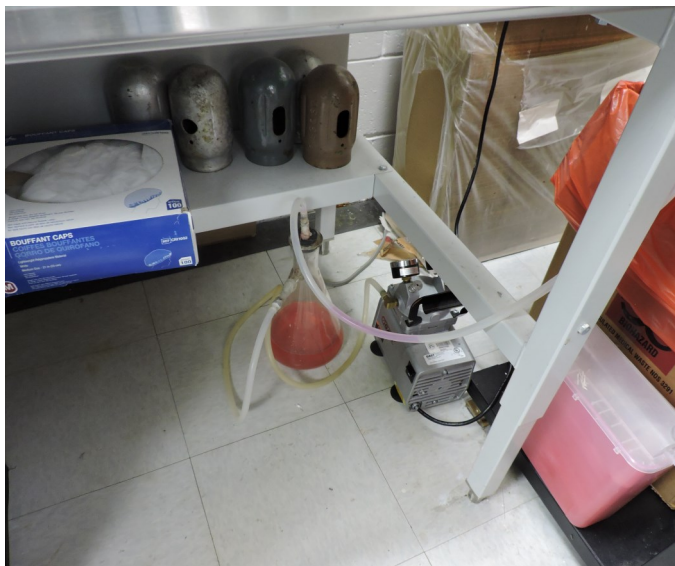
**Picture 1 - UPR CHEMICAL ENGINEERING-** At the Lab IQ-101 K there was one (1) 1-liter Erlenmeyer Flask with a “Biohazard Waste,” unlabeled and without hazardous waste determination if it is managed as an lab waste, the content and the container must be labeled and date as “Unwanted Material.”

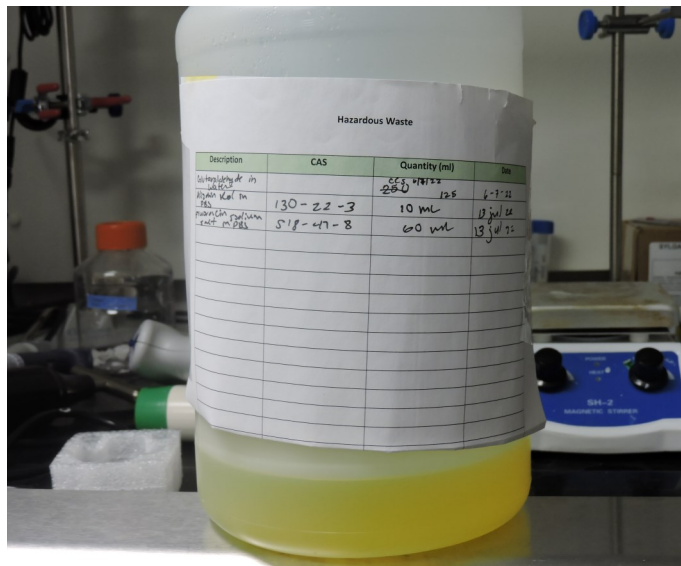
**Picture 2 - UPR CHEMICAL ENGINEERING-** At the Lab IQ-101 K there was one (1) 2-liter container with a yellow-colored spent solvent (PBS) labeled as “Hazardous Waste,” and with an accumulation start date of July 13, 2022, not managed as “Unwanted Material”

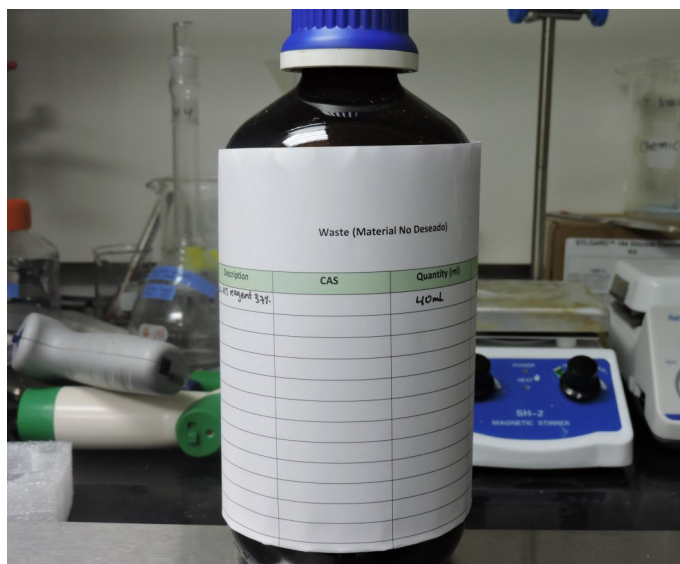
**Picture 3 - UPR CHEMICAL ENGINEERING-** At the Lab IQ-101 K there was one (1) 4-liter amber container with “ACS Reagent 37%” waste labeled as “Unwanted Material” but not dated with its accumulation start date.

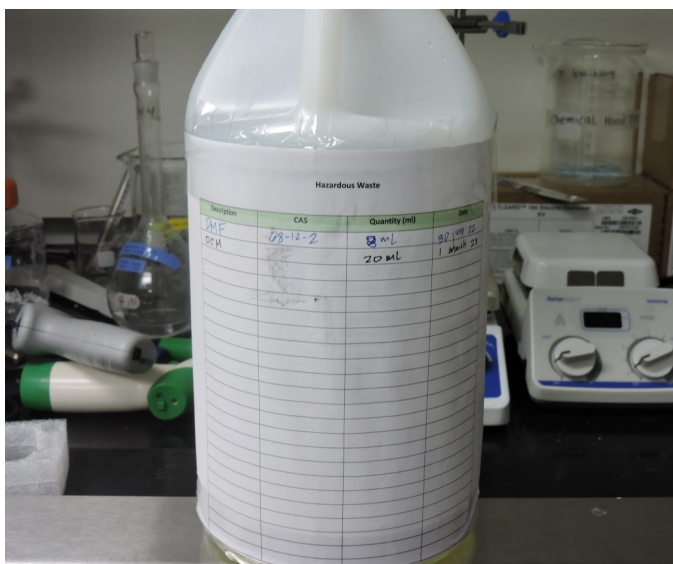
**Picture 4 - UPR CHEMICAL ENGINEERING-** At the Lab IQ-101 K there was one (1) 2.5-liter plastic container with “DMF/DCM” waste labeled as “Hazardous Waste” but not dated with its accumulation start date nor managed as “Unwanted Material.”

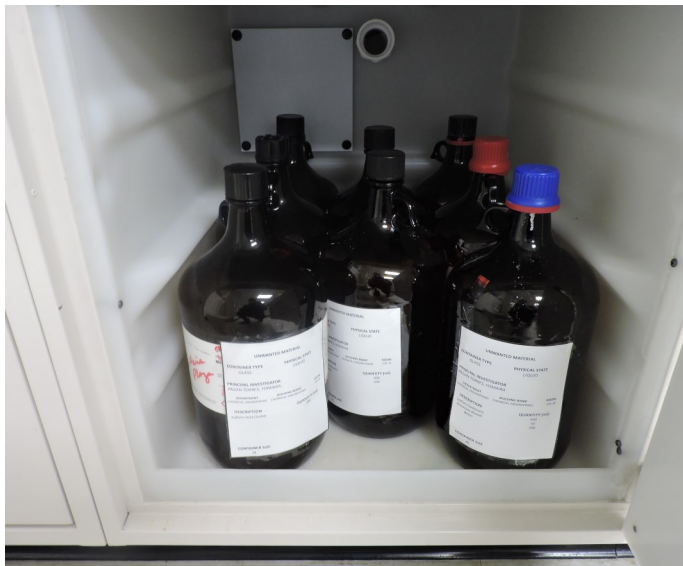
**Picture 5 - UPR CHEMICAL ENGINEERING-** At the Lab IQ-101 J there were eight 4-L containers stored inside a cabinet area all labeled as “Unwanted Materials” and without their dates. However, no compatibility characteristics protocols were followed in the storage area.

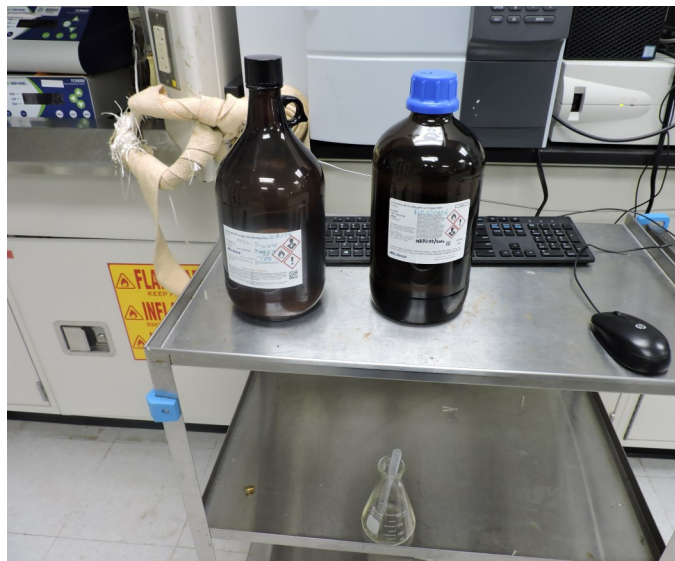
**Picture 6 - UPR CHEMICAL ENGINEERING-** At the Lab IQ-101 J there were four 4-L containers stored in trays containing THF and 1,4-Dioxane dated as July 16, 2019, and March 3, 2020, not in use and abandoned and not managed as “Unwanted Material,” without a hazardous waste determination.

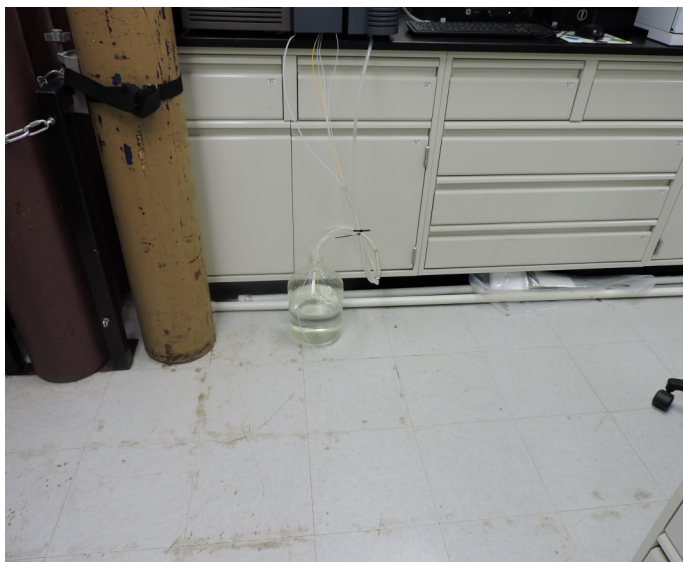
**Picture 7 - UPR CHEMICAL ENGINEERING-** At the Lab IQ-101 J there was one (1) 4-liter glass container with a spent mobile phase connected to a HPLC not in use since November 2022, unlabeled and without hazardous waste determination if it managed as an “Unwanted Material.”

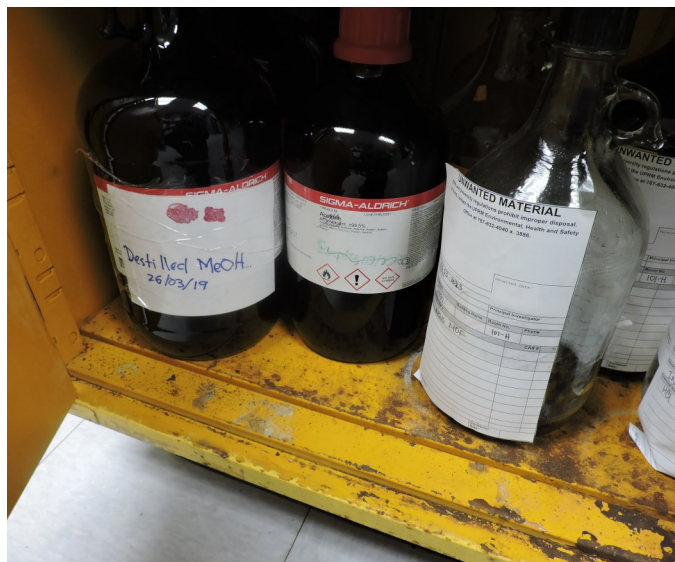
**Picture 8 - UPR CHEMICAL ENGINEERING—** At the Lab IQ-101 HI there were six (6) 4-liter ambar containers stored inside a cabinet area only two were labeled as “Unwanted Materials” and one with its accumulation start date of March 3, 26, 2019 which exceeded over six months of the LMP.

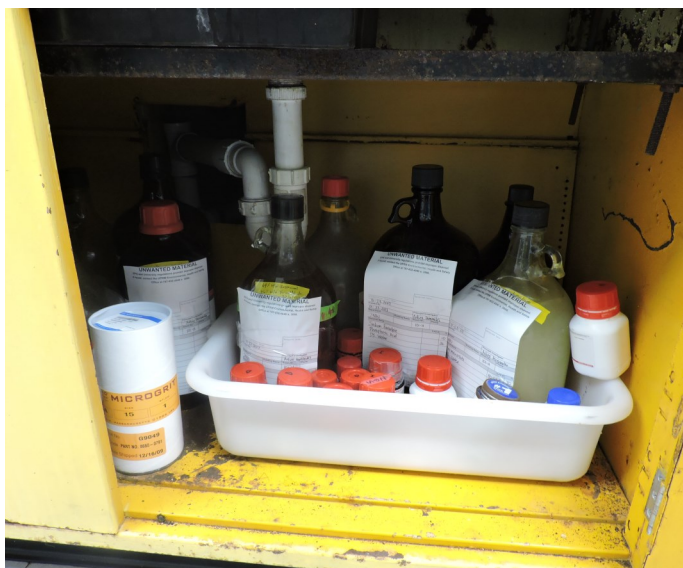
**Picture 9 - UPR CHEMICAL ENGINEERING-** At the Lab IQ-101 HI there were six (6) 4-liter ambar and glass containers stored inside a cabinet sink area only four were labeled as “Unwanted Materials” and with their accumulation start dates. However, three (3) were not labeled as “Universal Wastes,” nor dated .

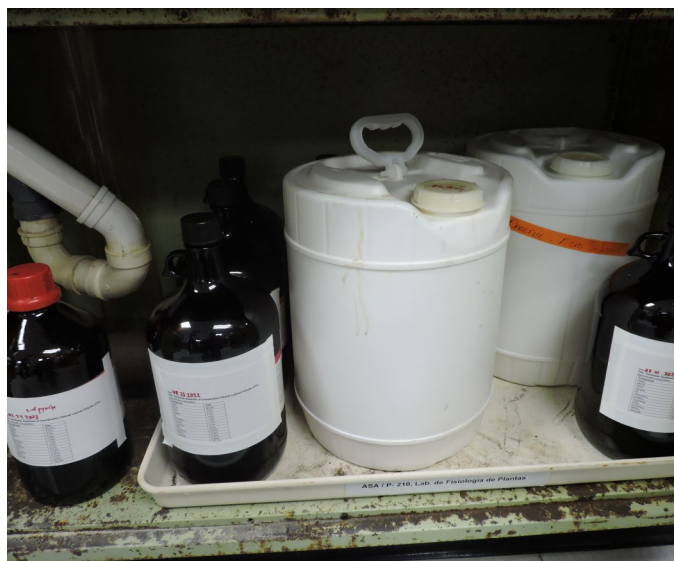
**Picture 10 - UPR CHEMICAL ENGINEERING-** At the Lab IQ-101 HI there were four (4) 4-L containers stored inside a cabinet sink not labeled as “Unwanted Materials,” and dated as of August 23, 2022, March 1, 2021, February 24, 2023, and other non-dated which exceeded over six months of the LMP collection protocols.

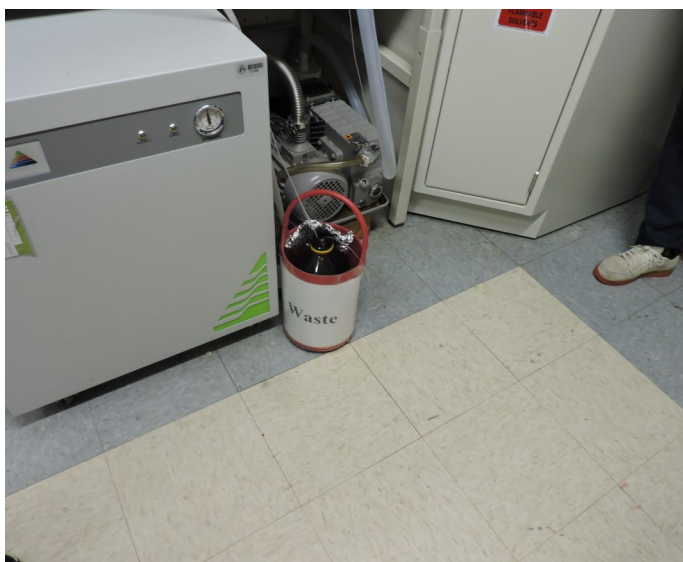
**Picture 11 - UPR CHEMICAL ENGINEERING-** At the Lab IQ-01 M there was one (1) 4-liter ambar container with a spent mobile phase (ACN/Water 90/10) connected to a HPLC labeled its holding jacket as “Waste,” but not dated with its accumulation start date nor managed as “Unwanted Material”

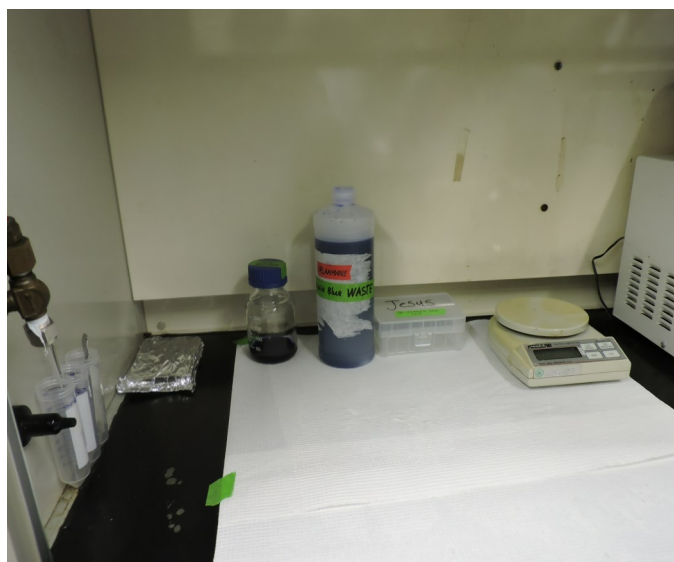
**Picture 12 - UPR CHEMICAL ENGINEERING—** At the Lab IQ-01 G there were two (2) 750 ml plastic bottle and 200 ml Erlenmeyer beaker containing “Coomassie Blue Ink Waste” with spent methanol solvent not labeled as “Unwanted Materials,” nor dated among other unlabeled and undated wastes.

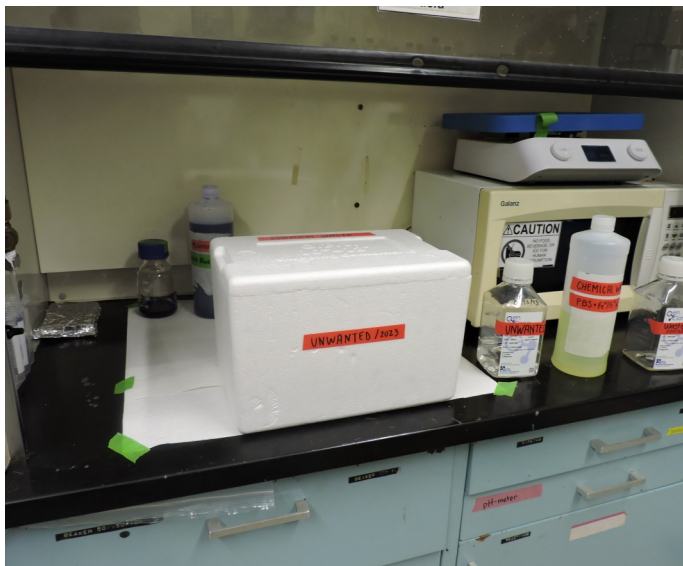
**Picture 13 - UPR CHEMICAL ENGINEERING-** At the Lab IQ-01 G there were one styrofoam box containing discarded vials an other waste bottles not properly labeled as “Unwanted Materials,” nor dated with its accumulation start date as required in the LMP protocols .

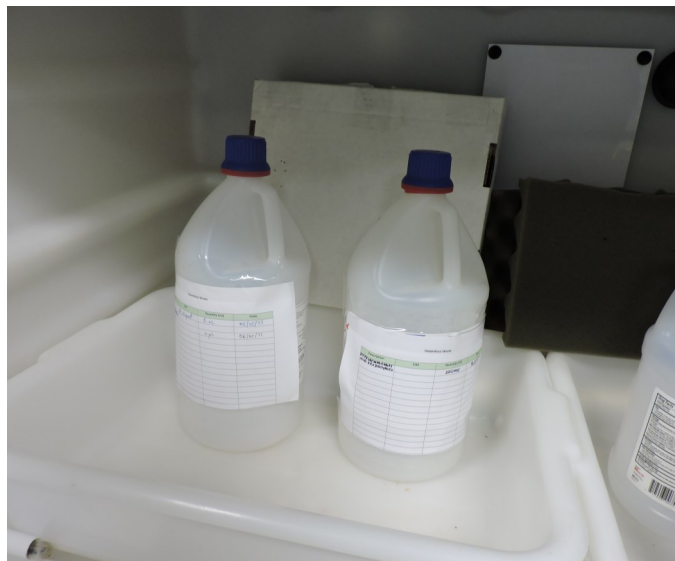
**Picture 14 - UPR CHEMICAL ENGINEERING-** At the Lab IQ-101 O there were two (2) 4-liter plastic containers with a spent petroleum ether and terpolymer labelled as “Unwanted Materials,” and dated with their accumulation start dates of May 15, 2022, which exceeded over six months of the LMP collection protocols.

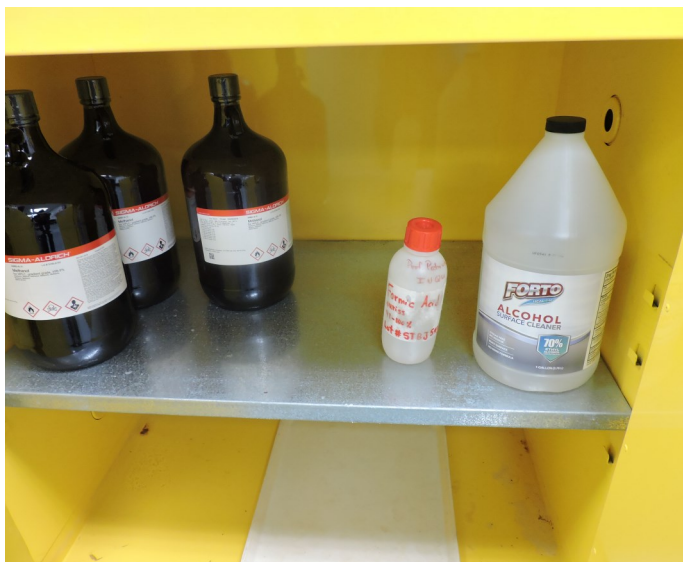
**Picture 15 - UPR CHEMICAL ENGINEERING-** At the Lab IQ-103 A there were three 4-L ambar containers with Methanol stored next to one (1) 500-ml bottle with Formic Acid and next to one (1) 1-gallon plastic bottle container Ethy Alcohol 70% without following any safety protocols or compatibility characteristic.

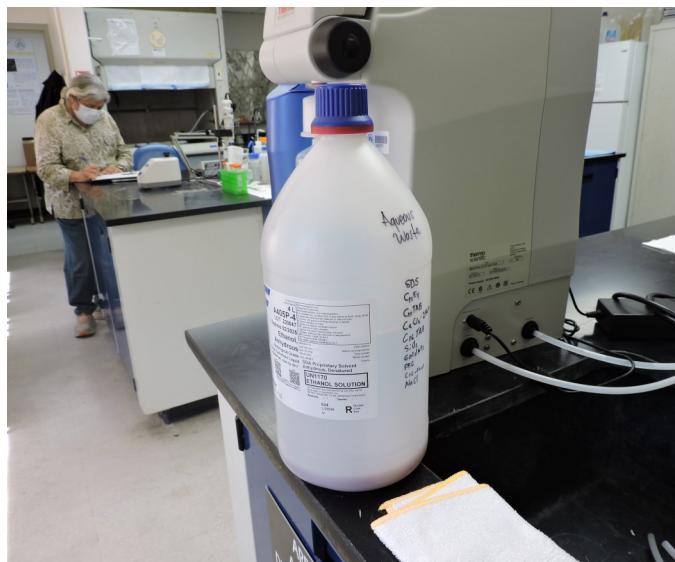
**Picture 16 - UPR CHEMICAL ENGINEERING—** At the Lab IQ-102 A there was one (1) 2-gallon plastic container with a spent Ethanol aqueous waste no labeled as “Unwanted Materials,” nor dated with its accumulation start date.

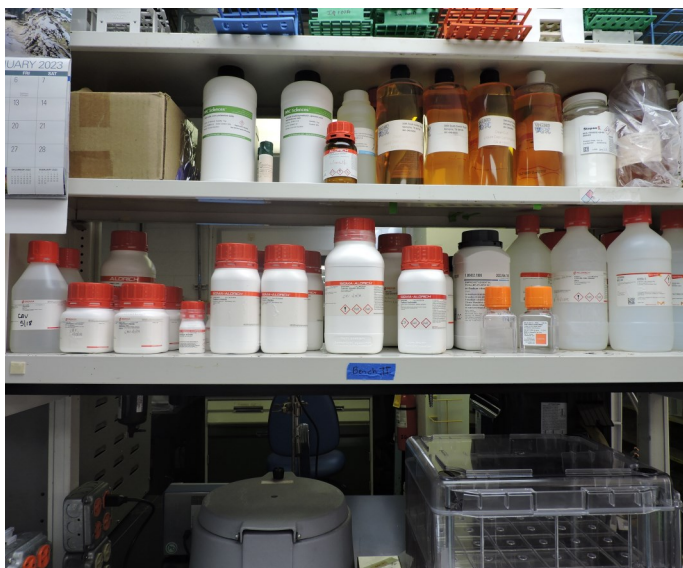
**Picture 17 - UPR CHEMICAL ENGINEERING-** At the Lab IQ-102 A it was observed the storage of chemical reagents at laboratory cabinets was conducted without following any safety protocols or compatibility characteristics (Flammable, Corrosives and Toxics – NaOH, Hydrochloric Methylcellulose, KCl) of the reagents.

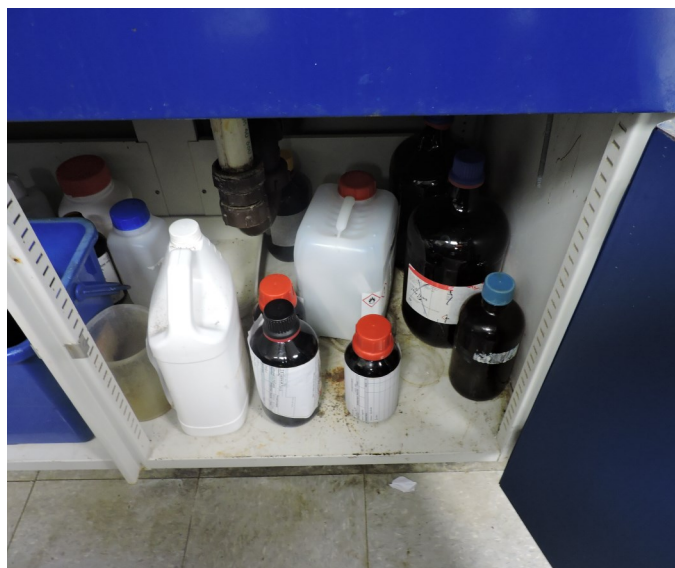
**Picture 18 - UPR CHEMICAL ENGINEERING-** At the Lab IQ-102 D there were three 1-L ambar bottles with unknown wastes, one labelled “Unwanted Materials,” and dated as February 28, 2022, which exceeded over six months of the LMP collection protocols. The other two were not labeled as “Unwanted Materials.”

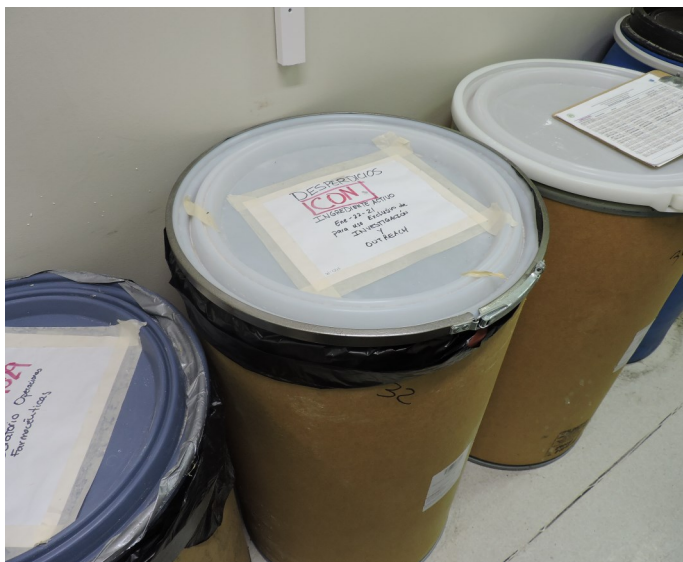
**Picture 19 - UPR PHARMACY BUILDING -** At the FARM 109 there was one 40-gallon cardboard drum containing wastes with “Active Ingredients” not labelled as “Unwanted Materials,” and dated with its accumulation start date of January 22, 2021, which exceeded over six months of the LMP collection protocols.

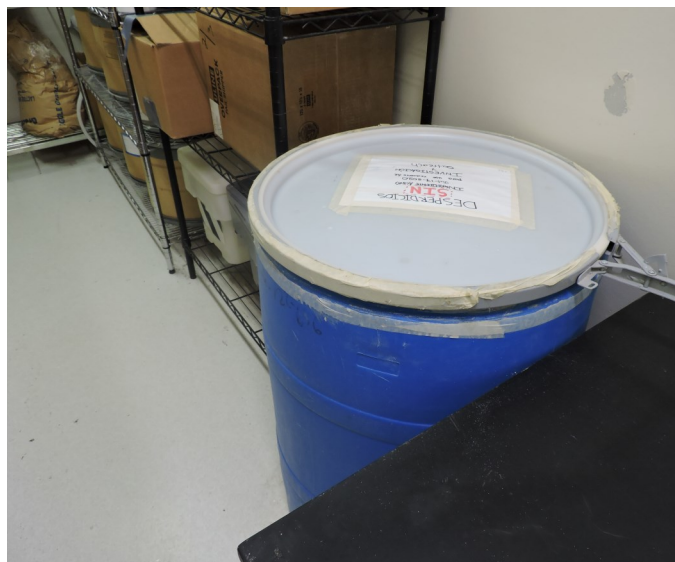
**Picture 20 - UPR PHARMACY BUILDING —** At the FARM 109 there was one (1) 40-gallon blue drum containing wastes with “No Active Ingredients” not labelled as “Unwanted Materials,” and dated with its accumulation start date of July 17, 2020, which exceeded over six months of the LMP collection protocols.
