## Region 6 - Enforcement & Compliance Assurance Division

### INSPECTION REPORT

| Company Name: | <b>Cypress Operating, Inc.</b> | |
| Facility Name: | <b>Fouke Estate #2 Tank Battery</b> | |

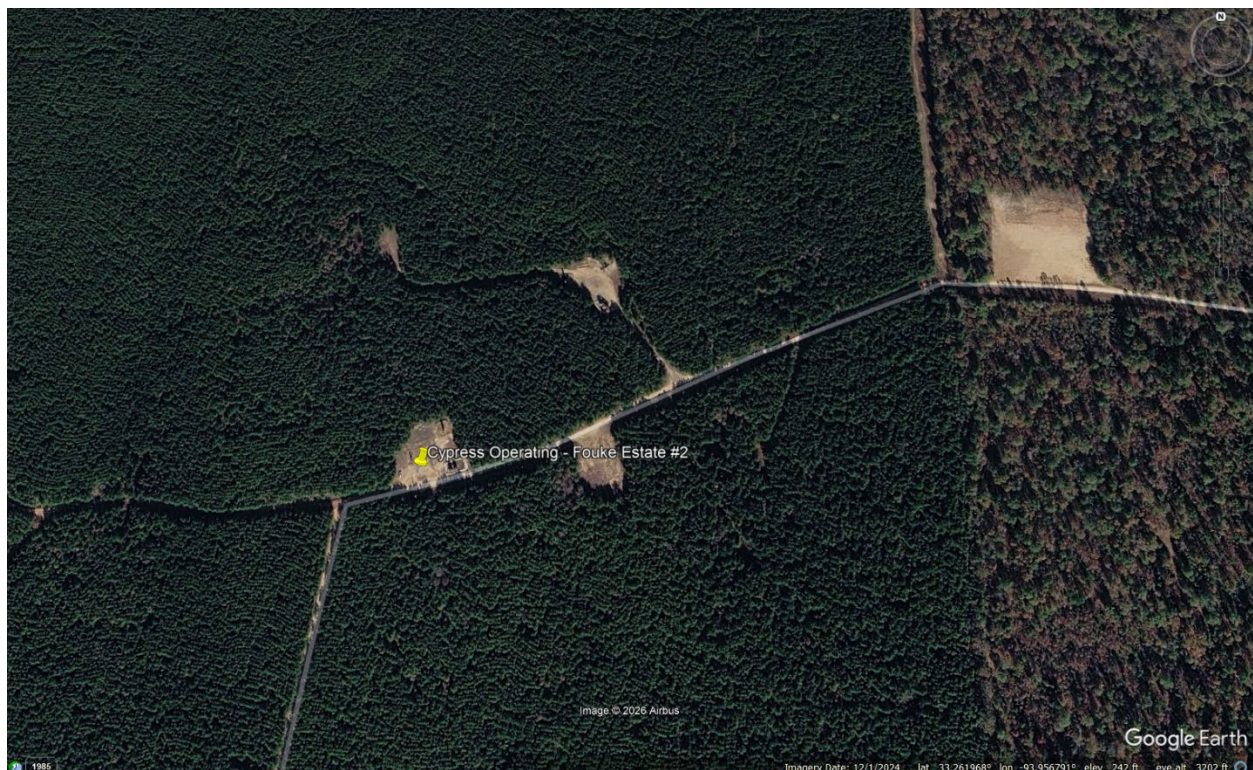
**Map 1.** Aerial imagery (Google Earth dated 12/01/2024) of the Cypress Operating, Inc. / Fouke Estate #2 Tank Battery facility.

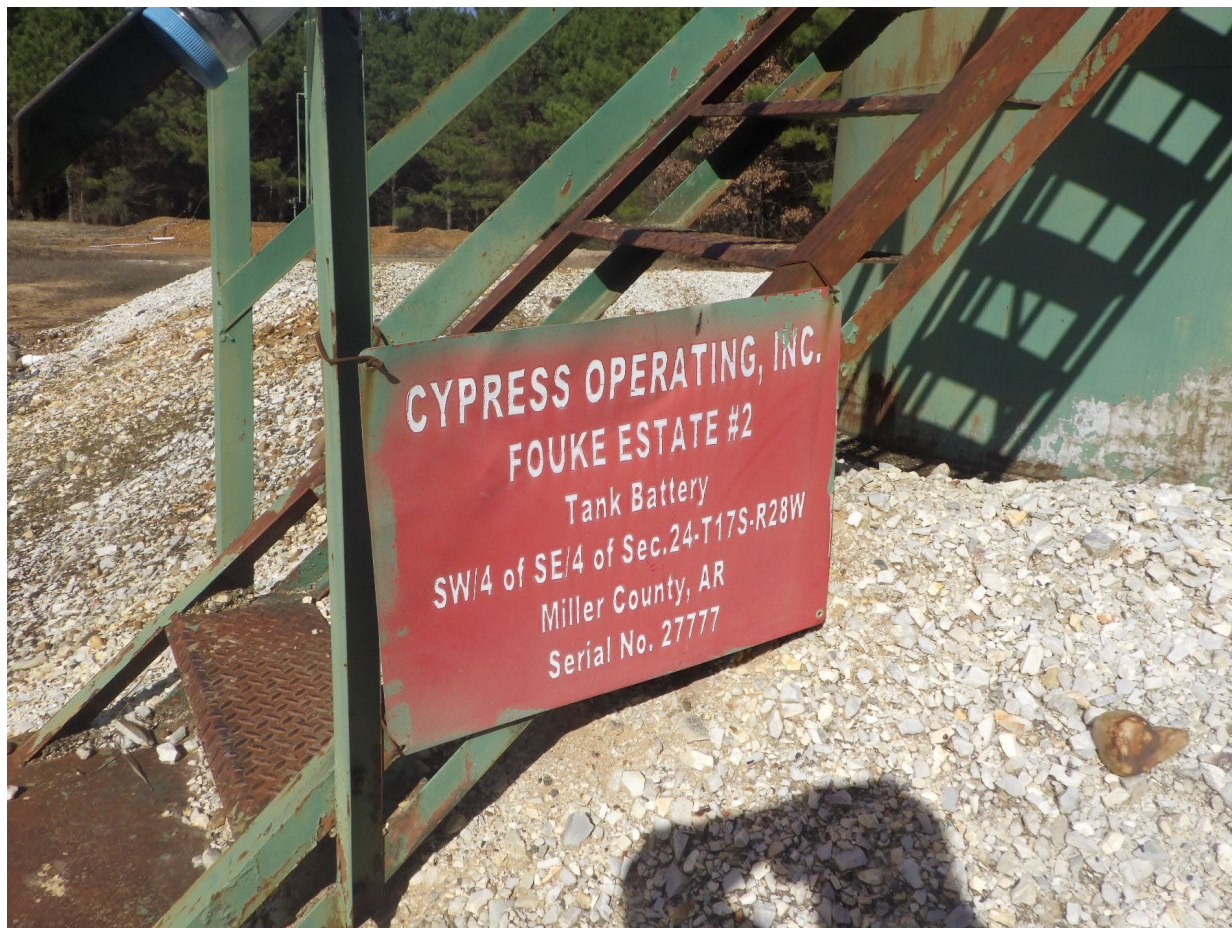
Photo No. 1

I observed the facility signage and an overview of the facility; see Appendix 1 (Photographs Log), Photos No. 1 and No. 2. For additional GPS location and photo metadata, see Appendix 1.

| Description: | Looking N, this photo shows the signage for the Fouke Estate #2 Tank Battery ("facility"). | | |

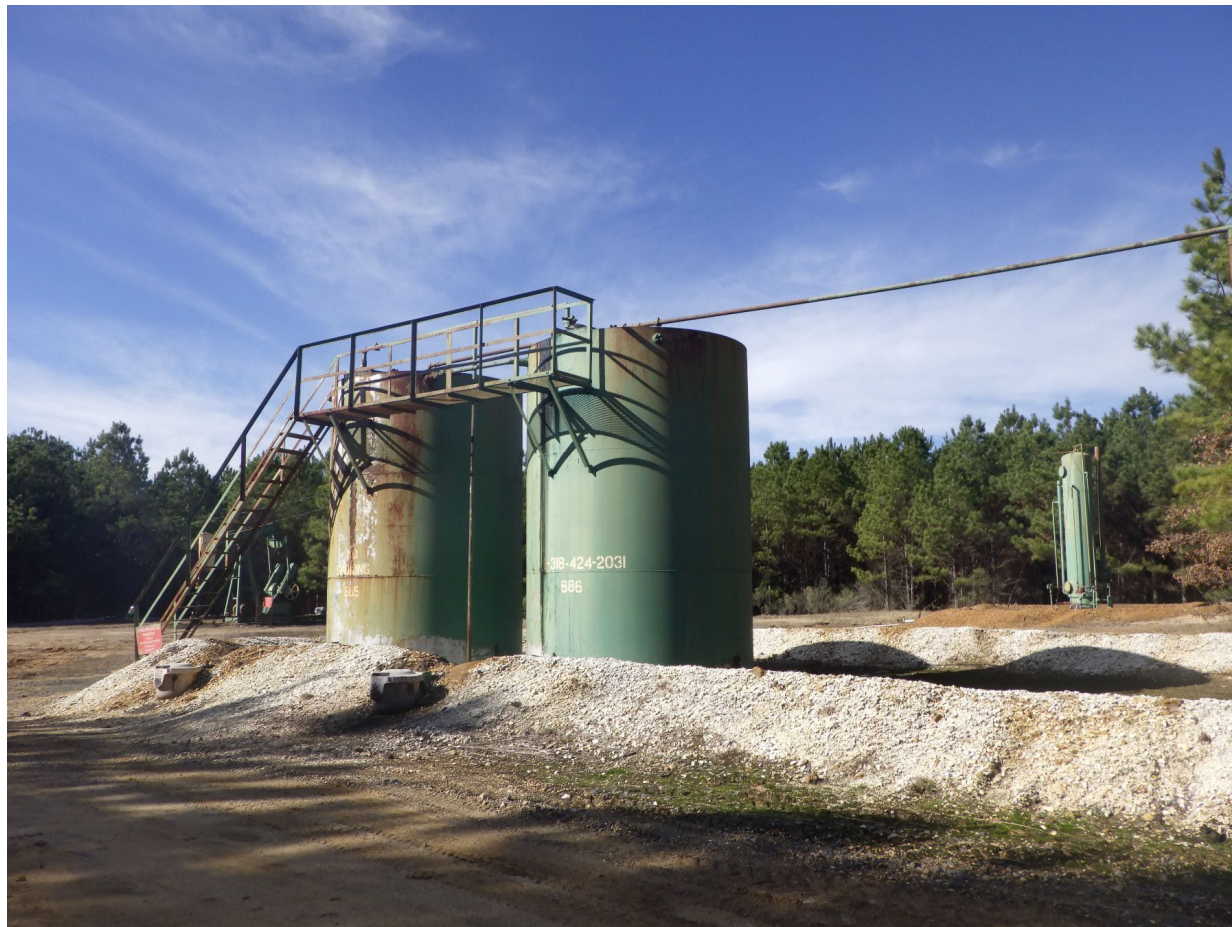
Photo No. 2

| Description: | Looking NW, this photo shows an overview of the facility. | | |

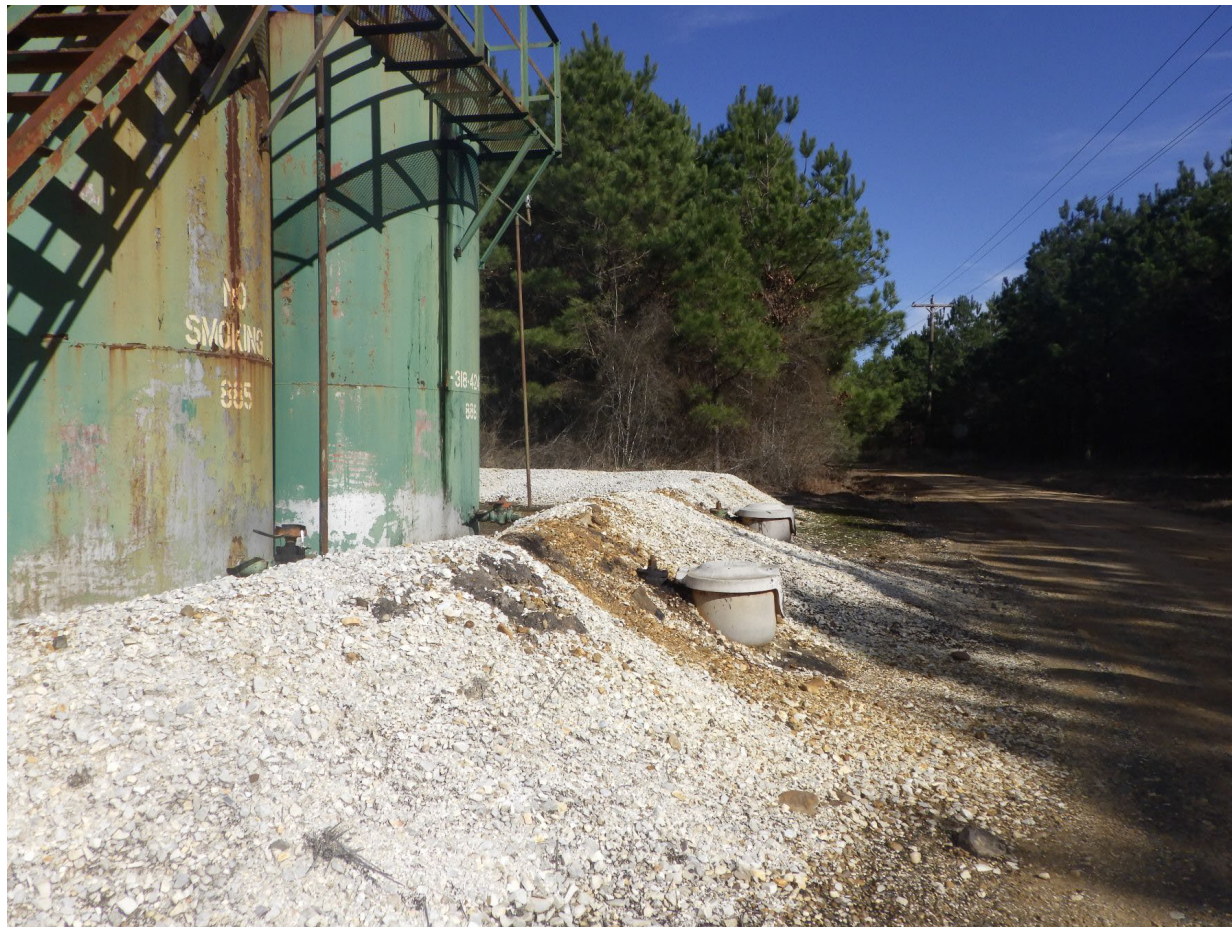
Photo No. 3

I observed the loading lines outside the oil storage tank battery with catchment buckets, see Photos No. 3 and No. 4.

| Description: | Looking ESE, this photo shows the exterior of the facility (front view). | | |

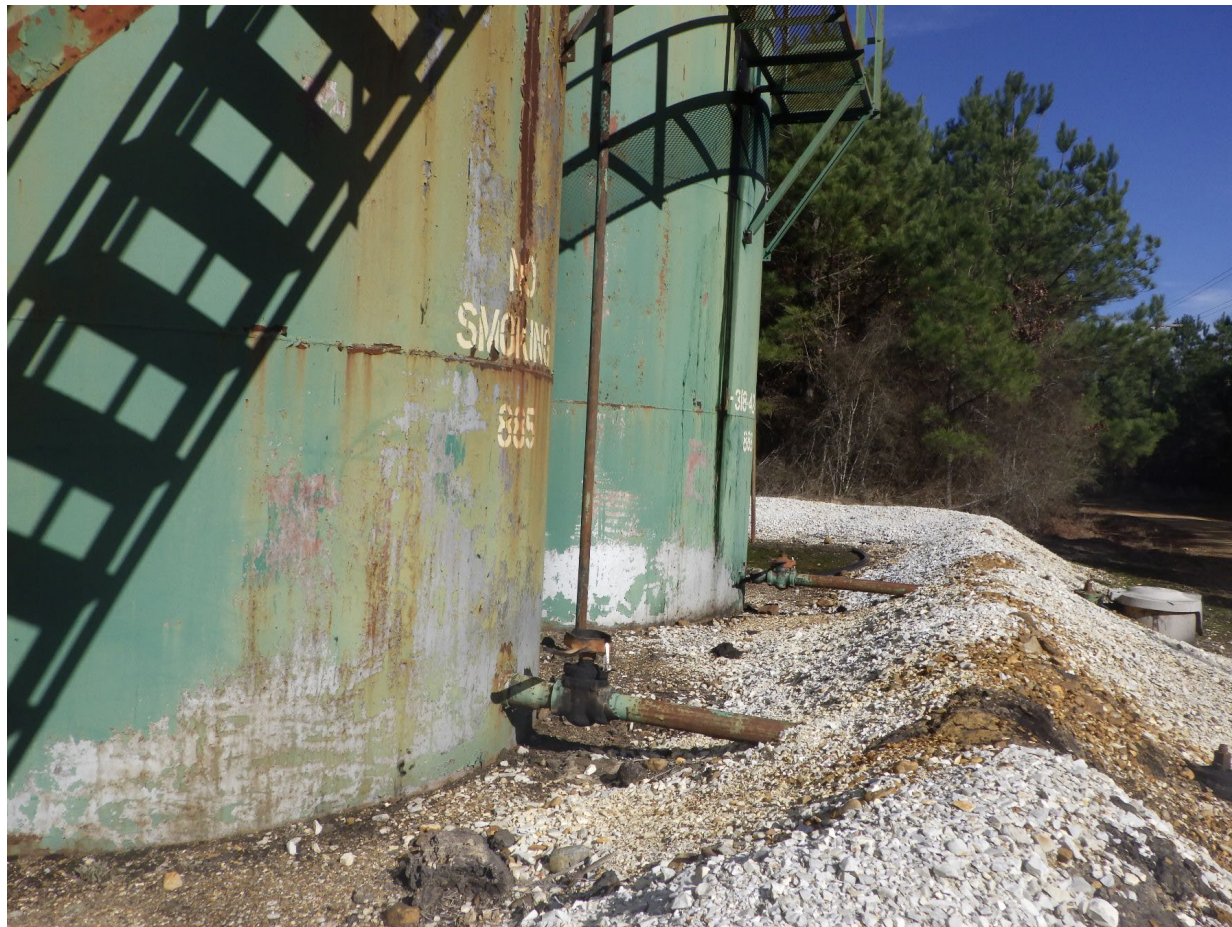
Photo No. 4

I observed the interior of the oil storage tank battery (front view), see Photo No. 4.

| Description: | Looking ENE, this photo shows the interior of the tank battery (front view). | | |

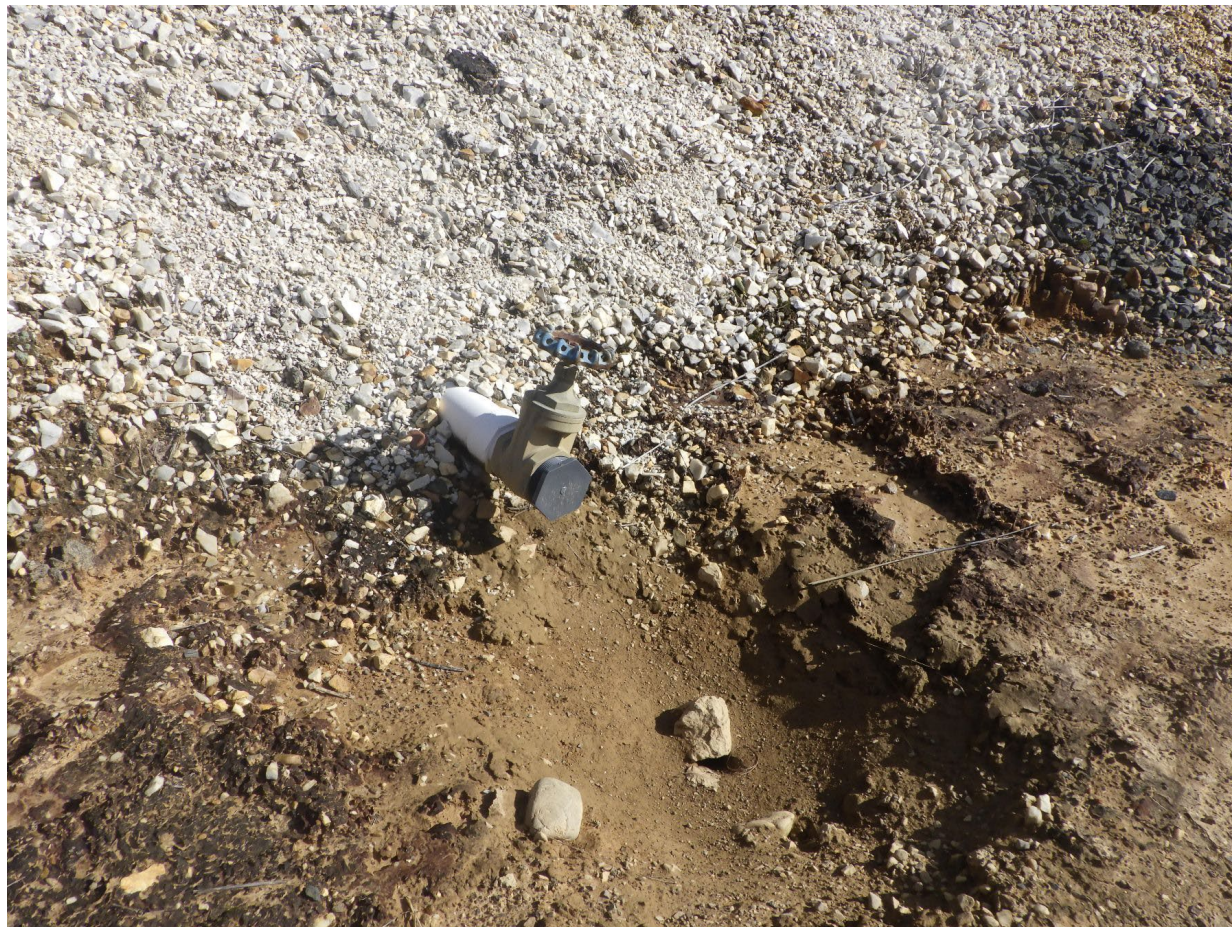
Photo No. 5

I observed the drainpipe for the oil storage tank battery with a valve and closed cap, see Photo No. 5.

| Description: | Looking NNE, this photo shows the drainpipe for the containment berm. | | |

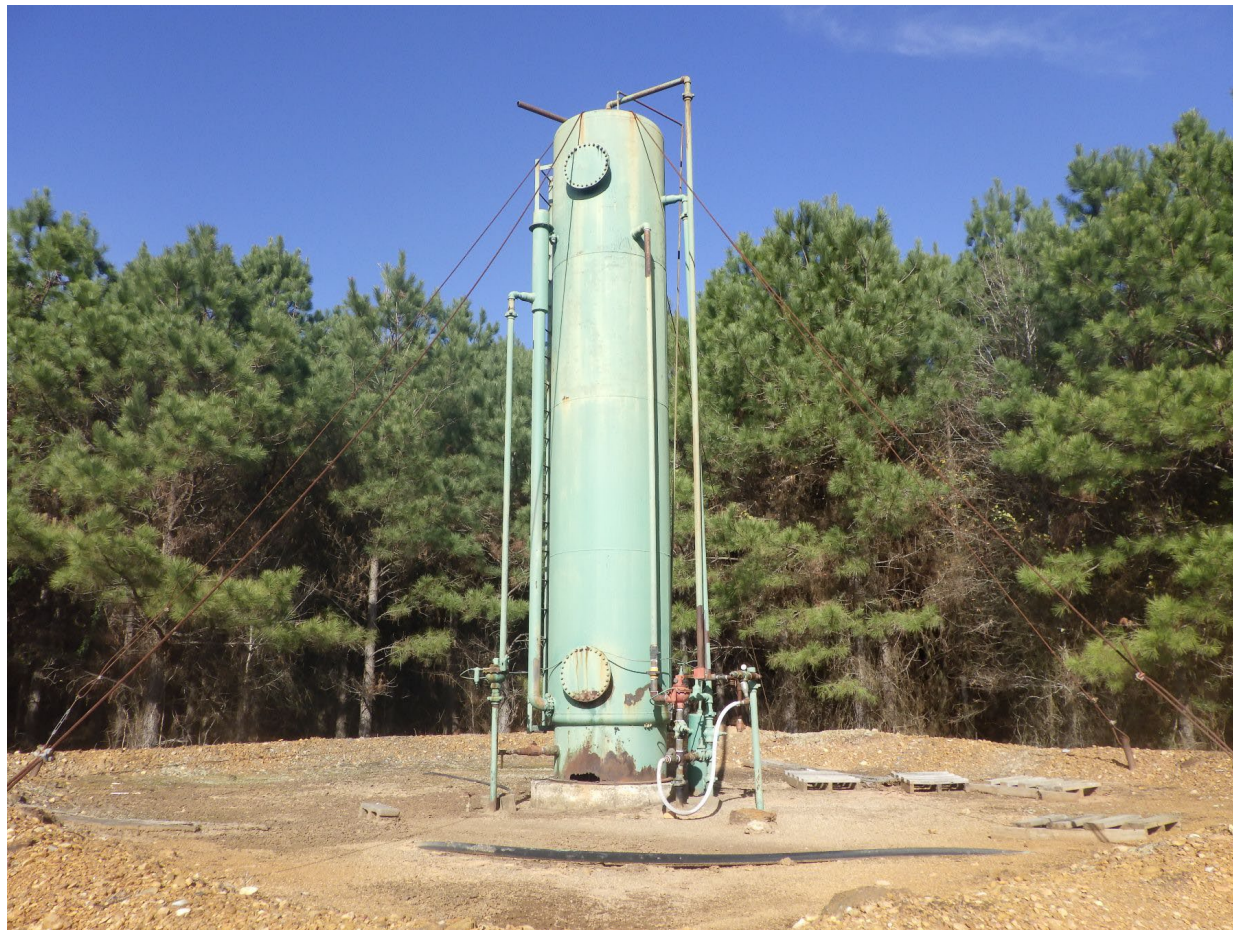
Photo No. 6

I observed a separator inside a separate tank battery, see Photo No. 6.

| Description: | Looking SSW, this photo shows an anchored separator inside containment. | | |

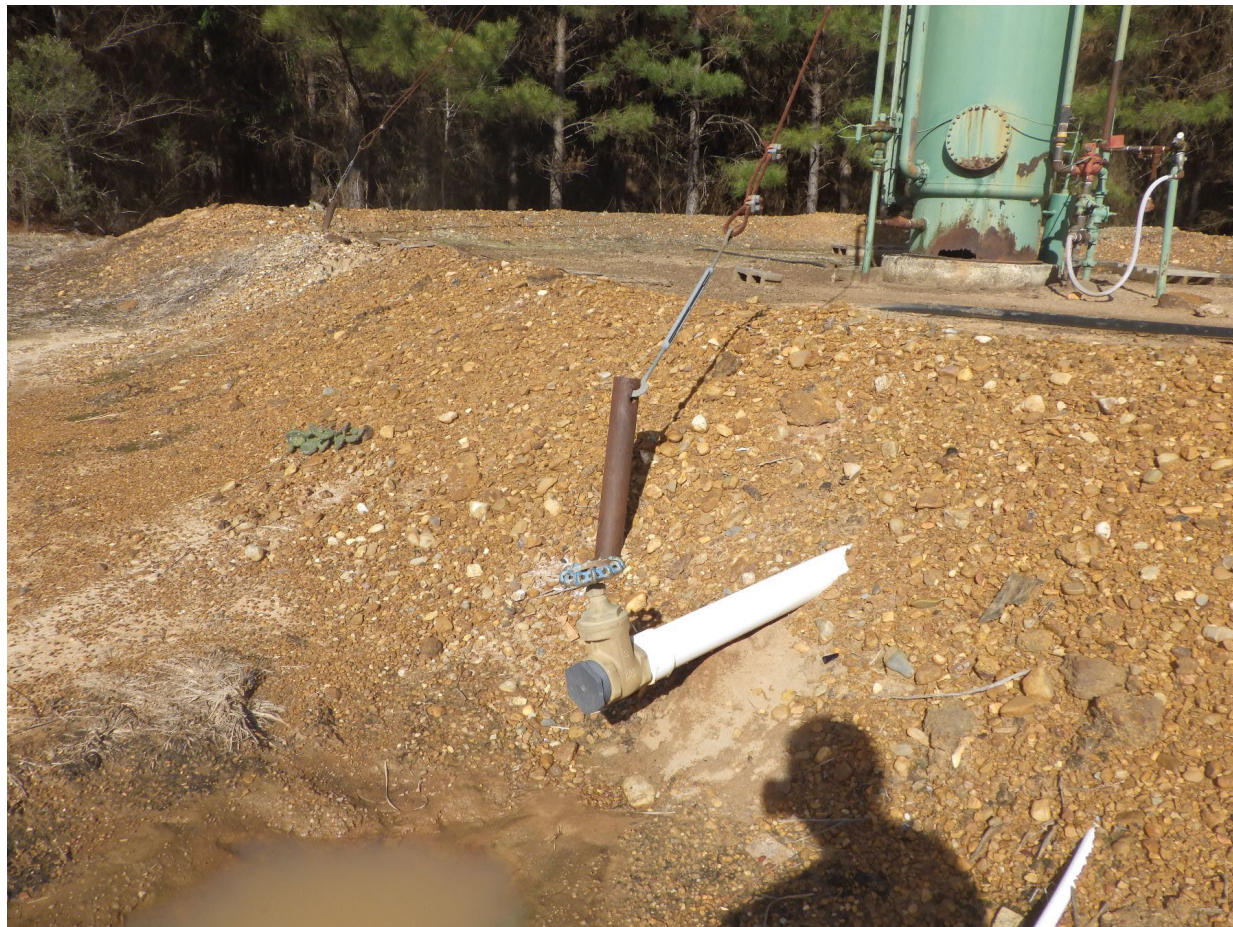
Photo No. 7

I observed the drainpipe for the separator tank battery with a valve and closed cap, see Photo No. 7.

| Description: | Looking N, this photo shows the drainpipe for the separator tank battery. | | |

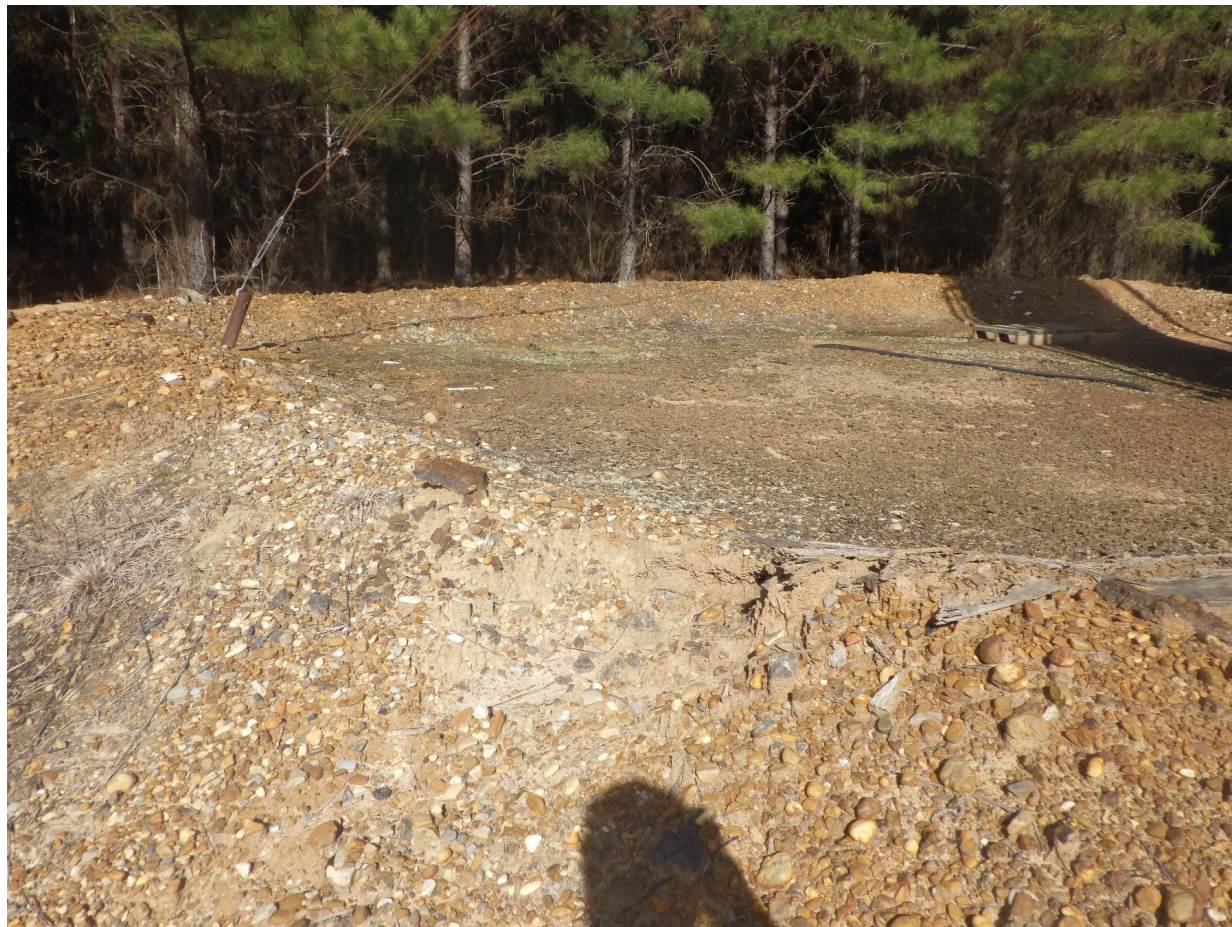
Photo No. 8

I observed a low area in the containment berm for the separator tank battery, see Photo No. 8.

- A low area in the containment berm for the separator tank battery, 40 CFR 112.9(c)(2) (Photo No. 8).

| Description: | Looking N, this photo shows a low area in the separator containment berm. | | |

Inspector will conduct follow-up phone calls with the company representative(s) over the coming weeks and months to ensure areas of concern are properly addressed.

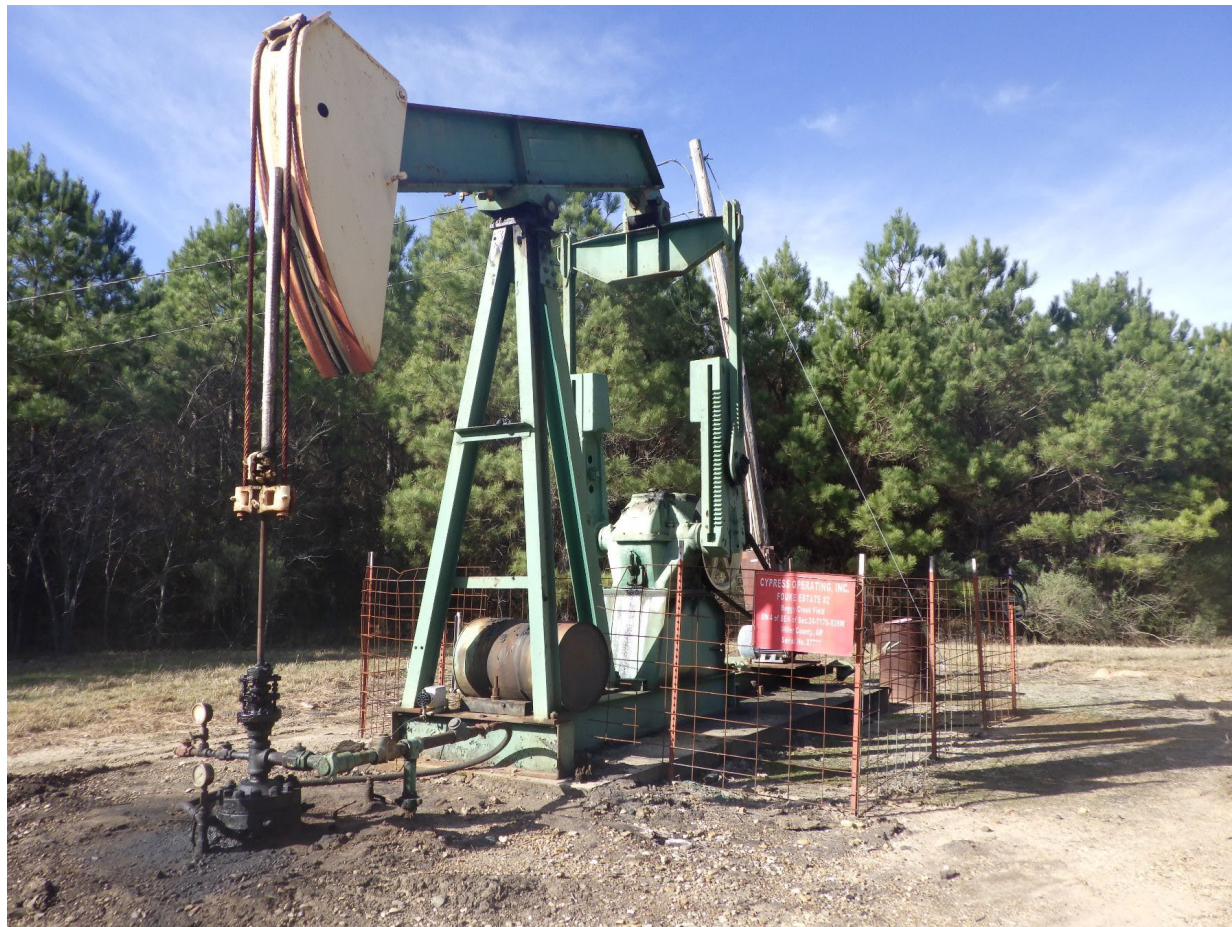
Photo No. 9

I observed an active production well at the facility, see Photo No. 9.

| Description: | Looking W, this photo shows an active well located at the facility. | | |
