## Region 6 - Enforcement & Compliance Assurance Division

### INSPECTION REPORT

| Company Name: | <b>Berg, Laney and Brown Company</b> | |
| Facility Name: | <b>Baugh Tank Battery</b> | |

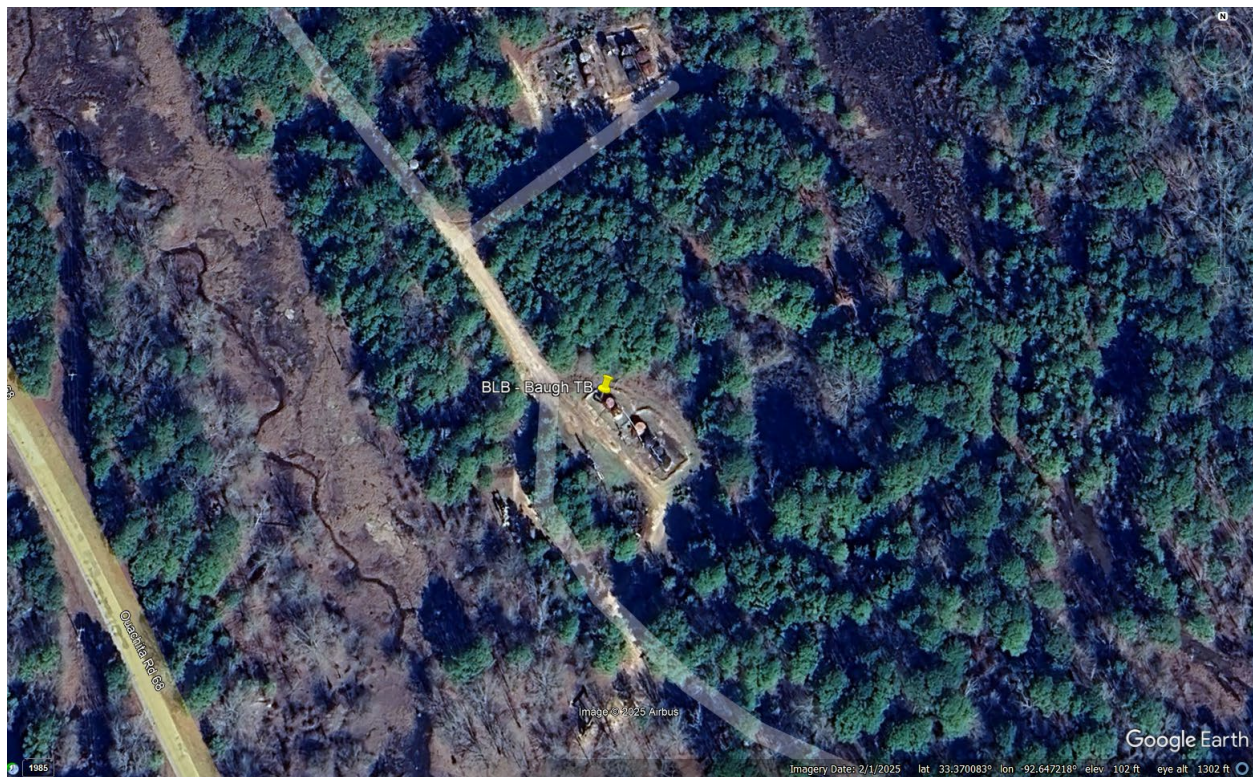
**Map 1.** Aerial imagery (Google Earth dated 02/01/2025) of the Berg, Laney and Brown Company / Baugh Tank Battery facility.

EPA conducted an inspection on the Berg, Laney and Brown Company / Baugh Tank Battery facility, which contains three (3) tanks for crude oil and saltwater separation and storage and one (1) saltwater disposal (SWD) well pump shared by the Snyder Tank Battery. One tank was outside containment and appeared to be out of service.

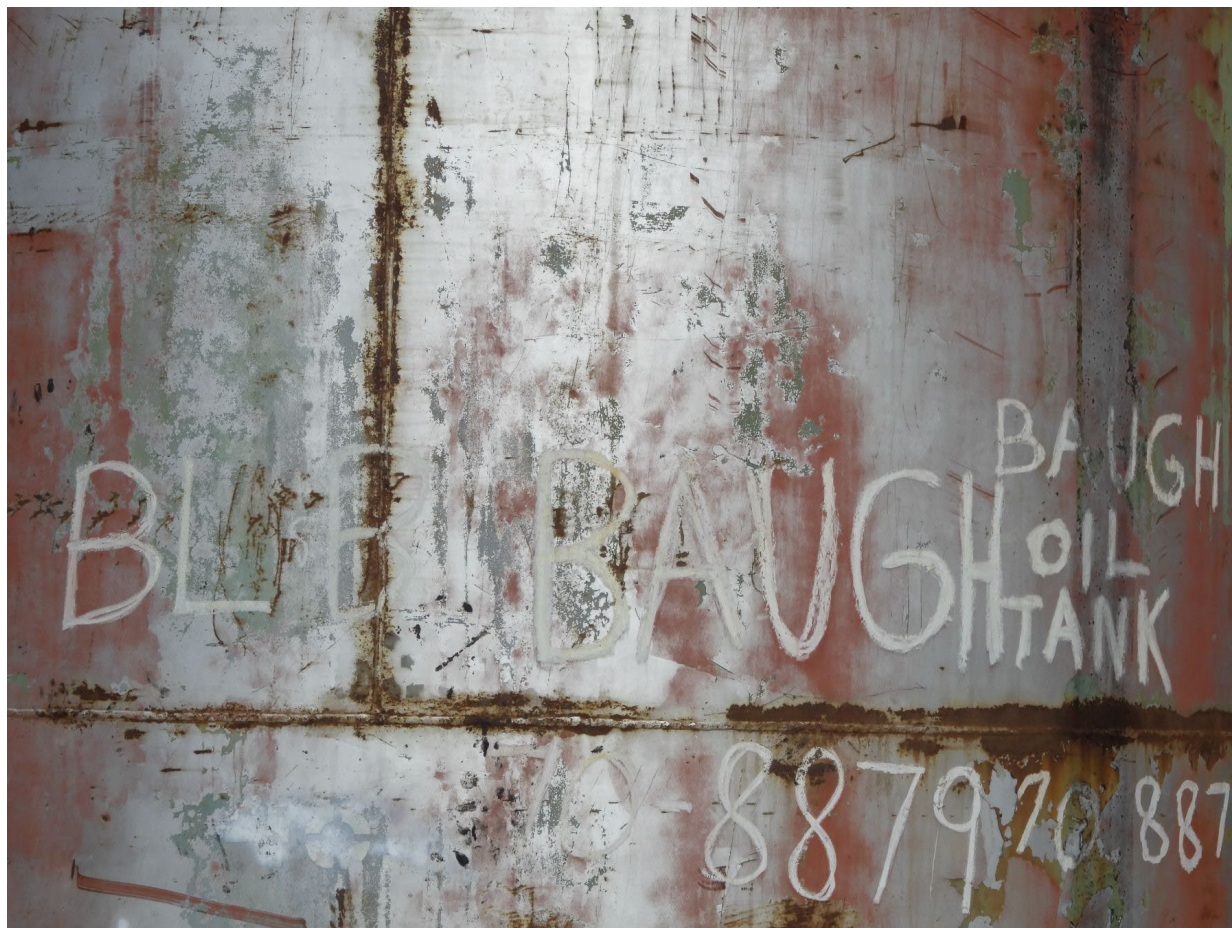
Photo No. 1

I observed the facility signage and an overview of the facility; see Appendix 1 (Photographs Log), Photos No. 1 and No. 2. For additional GPS location and photo metadata, see Appendix 1.

| Description: | Looking SSE, this photo shows a tank labeled with the lease name for the facility. | | |

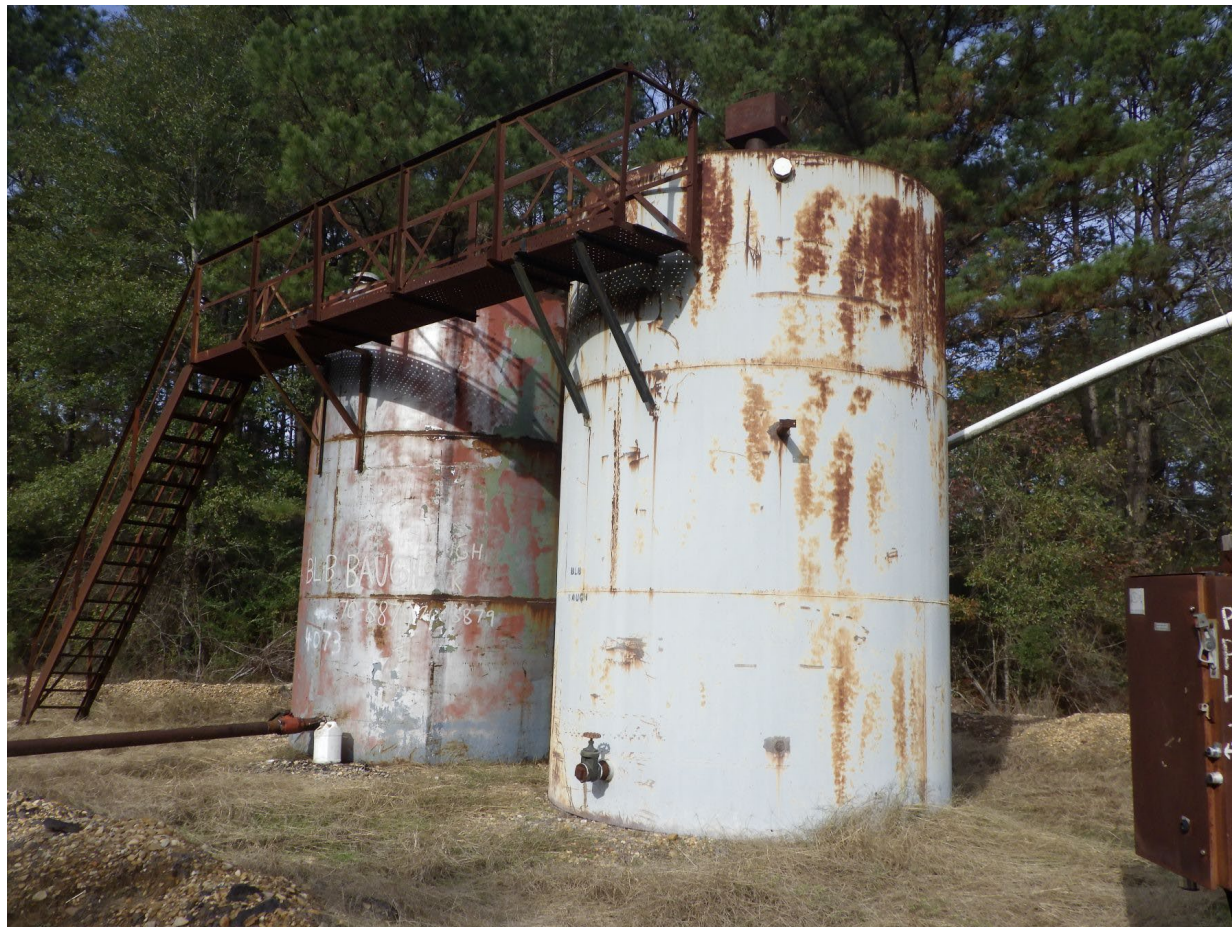
Photo No. 2

| Description: | Looking SW, this photo shows an overview of the Baugh Tank Battery. | | |

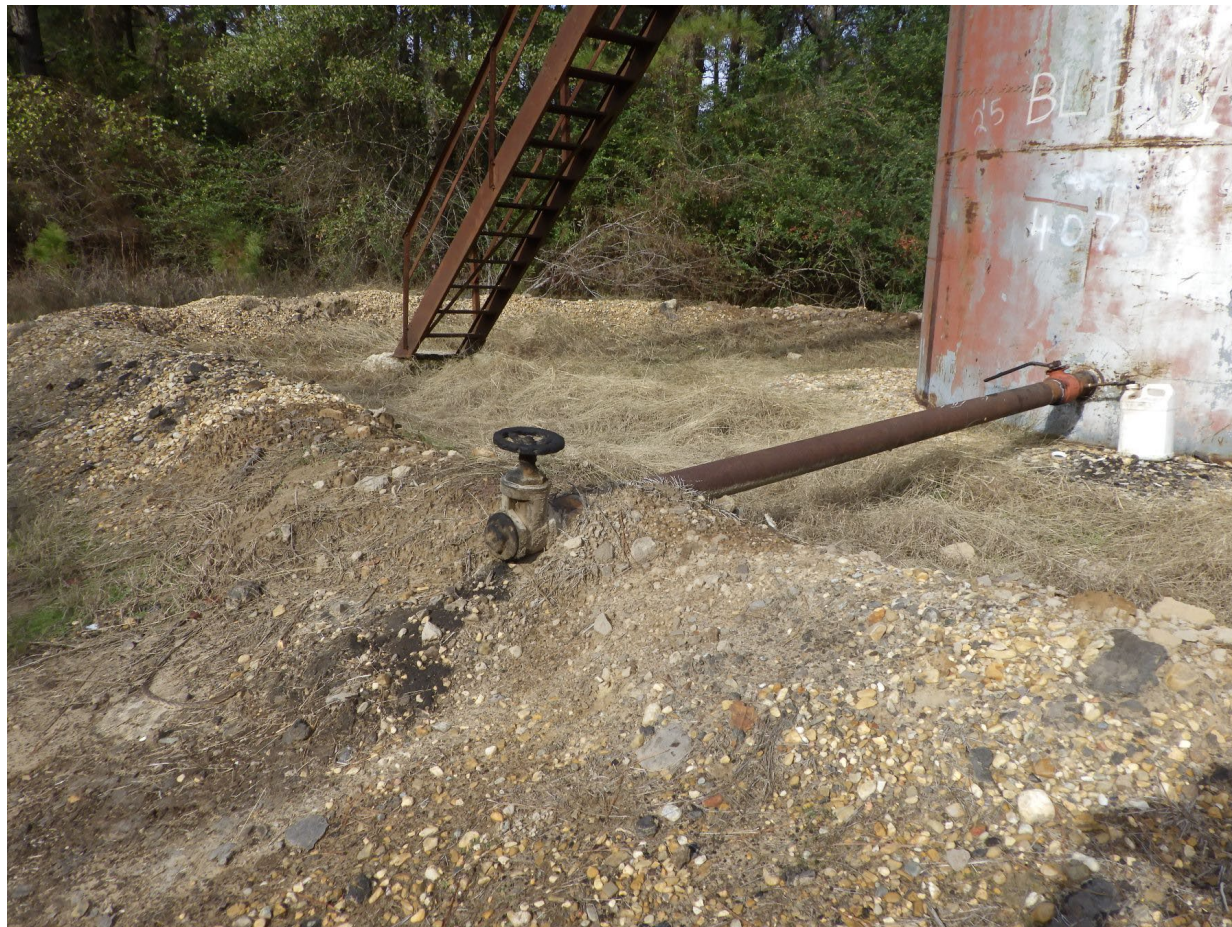
Photo No. 3

I observed the transfer/production line outside secondary containment without a catchment bucket, see Photo No. 3.

- The transfer/production line without a catchment bucket (Photo No. 3), and
- One (1) tank outside secondary containment not properly marked as “out of service” (Photo No. 4).

| Description: | Looking NNW, this photo shows the transfer/product line for the crude oil storage tank without a catchment bucket. | | |

Inspector will conduct follow-up phone calls with the company representative(s) over the coming weeks and months to ensure areas of concern are properly addressed.

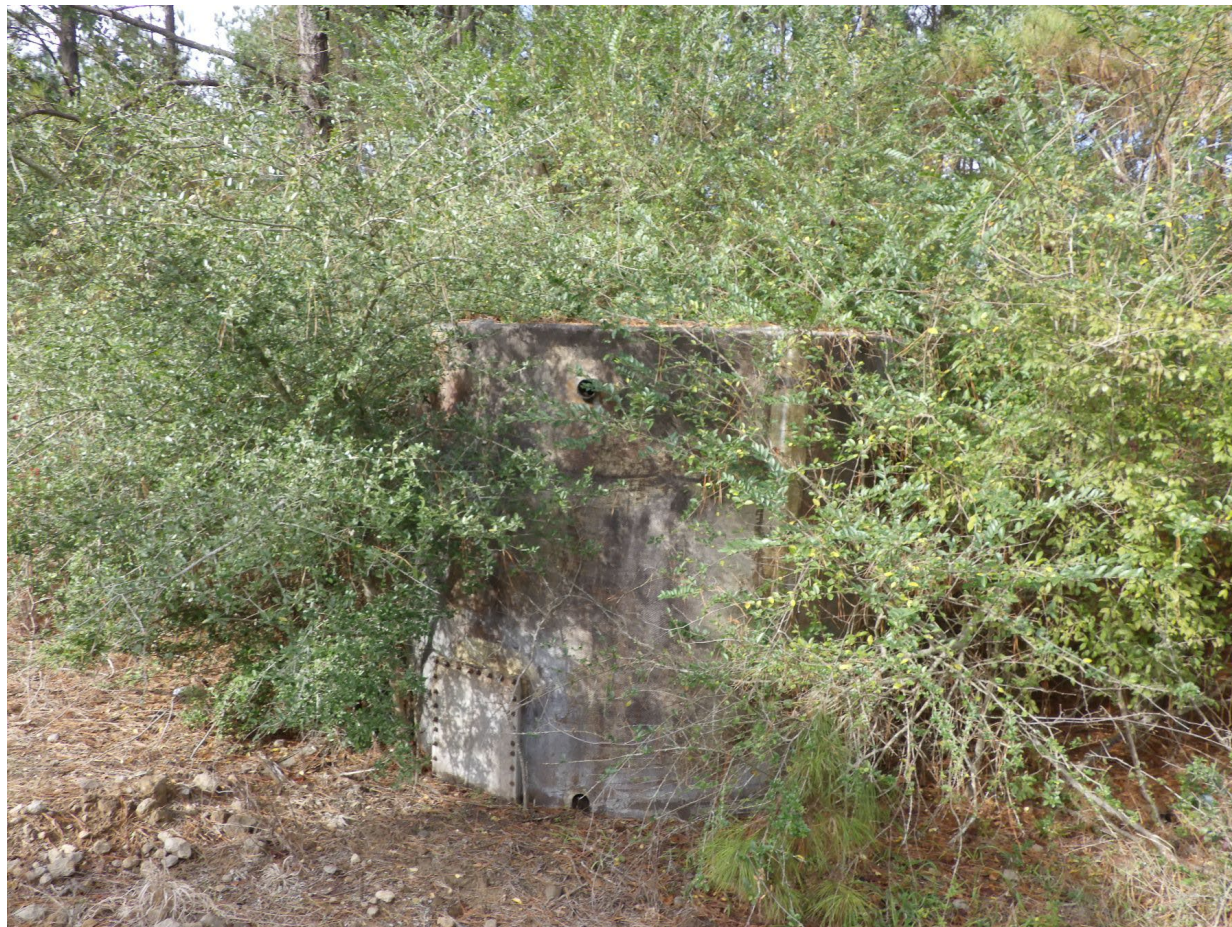
Photo No. 4

I observed one (1) tank outside secondary containment that appeared to be out of service that was not properly marked, see Photo No. 4.

| Description: | Looking WNW, this photo shows a tank outside containment that was not in use. The tank was not marked, as required, indicating "out of service." | | |
