Subject: April 13, 2022, NPDES SSO Inspection Trip Report for City of Cahokia Heights

**Purpose:** NPDES SSO Inspection Trip Report

**Facility:** Cahokia Heights, Illinois

**Date of Inspection:** April 13, 2022

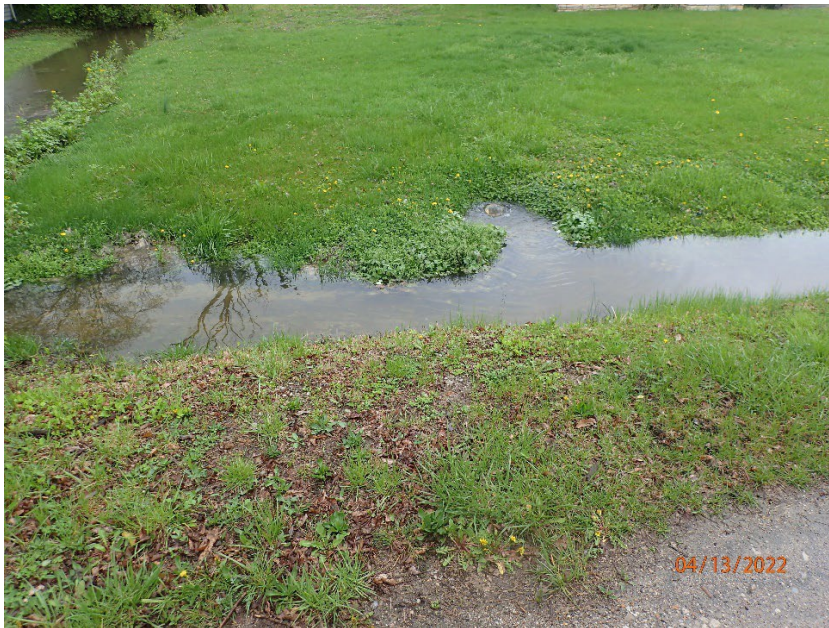
1: P4130248

EPA inspectors arrived at the cleanout overflow location on North 82<sup>nd</sup> Street at 4:45 P.M. The cleanout was discharging. EPA inspectors observed the flowing water flow from the ditch next to the street to the ditch along the side yard.

Description: The cleanout on North 82<sup>nd</sup> Street was overflowing on the day of the inspection.

Location: North 82<sup>nd</sup> Street.

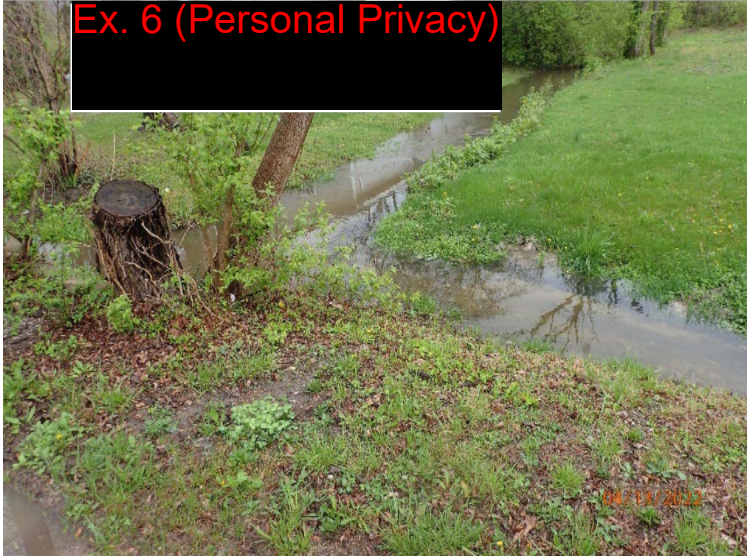
2: P4130249

Description: The flow from the cleanout flowed to the ditch on the side yard of the residence.  
Location: North 82<sup>nd</sup> Street.  
Camera Direction: West.  
Date/Time: April 13, 2022/4:46 P.M.

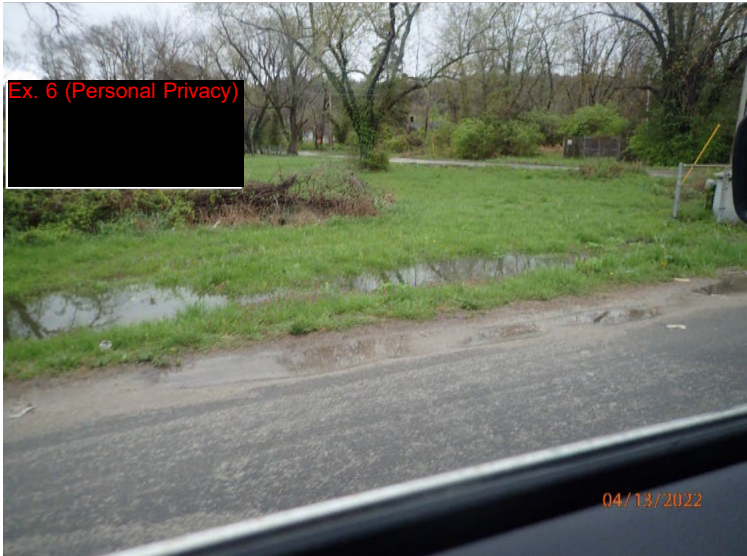
3: P4130250

EPA inspectors arrived at the lift station at North 82<sup>nd</sup> Street and Bluff Street at 4:53 P.M. EPA inspectors observed standing water in the ditch next to the street.

Description: Standing water by lift station at Bluff Street and North 82<sup>nd</sup> Street  
Location: Bluff Street and North 82<sup>nd</sup> Street.  
Camera Direction: North.  
Date/Time: April 13, 2022/4:53 P.M.

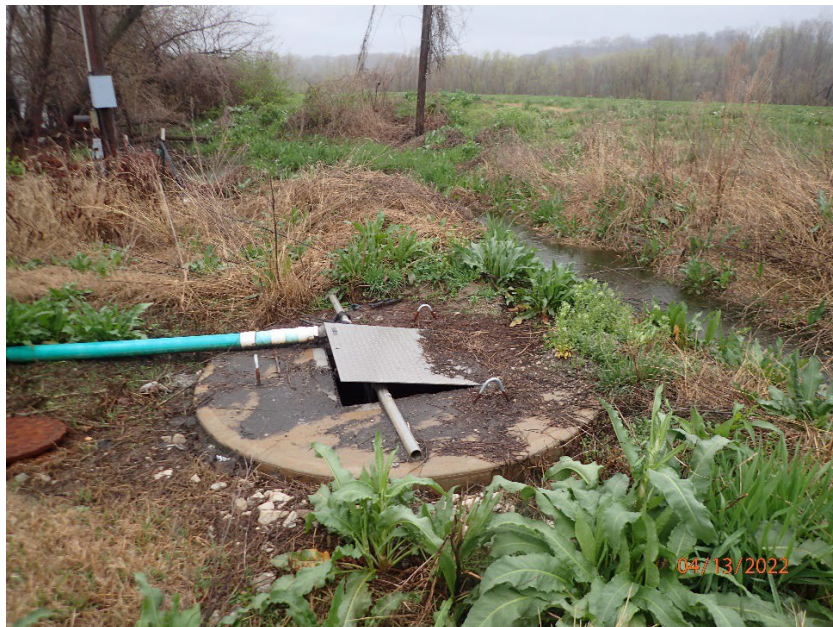
4: P4130251

EPA inspectors arrived at the Lady of Snows Lift Station on Old Missouri Avenue at 5:00 P.M. This lift station is #49 in the City of Cahokia Heights lift station list. The lift station was not overflowing, and the wet well was not secured.

Description: Lady of Snows Lift Station is not secured.
