**Well Inspection**  
**Osage DNR / Environmental Protection Agency**  
**1201 Elm Street, Suite 500**  
**Dallas, Texas 75270**

| | | <b>Well ID</b> | CI-3 | | |
| <b>Inspection Reason</b> | Plugging Witnessed | <b>Responsible Company at Time of Inspection</b> | Bandwheel Production Company | | |

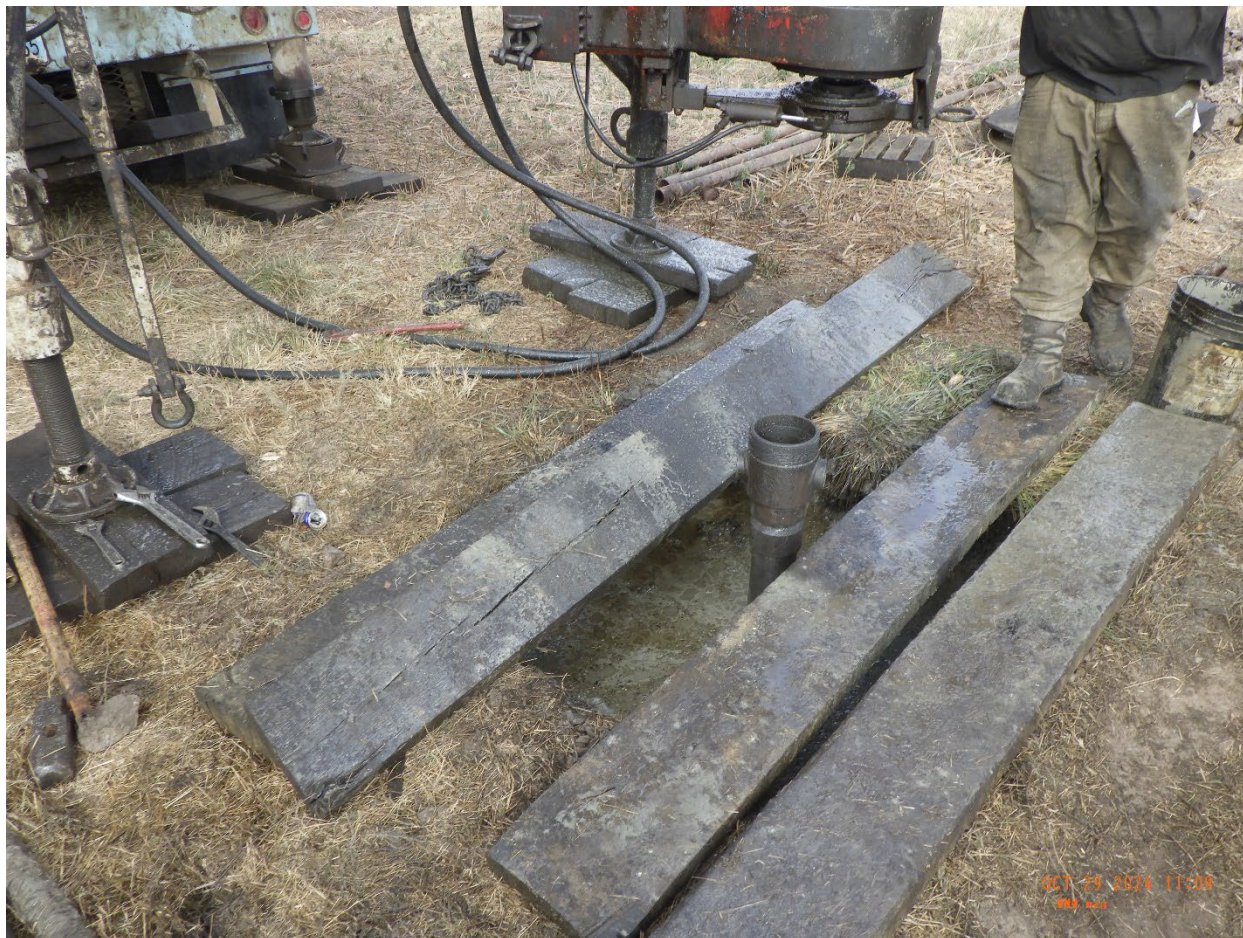
Photo No. 1

**Description:** This was well OS3259000 at the time of the inspection.

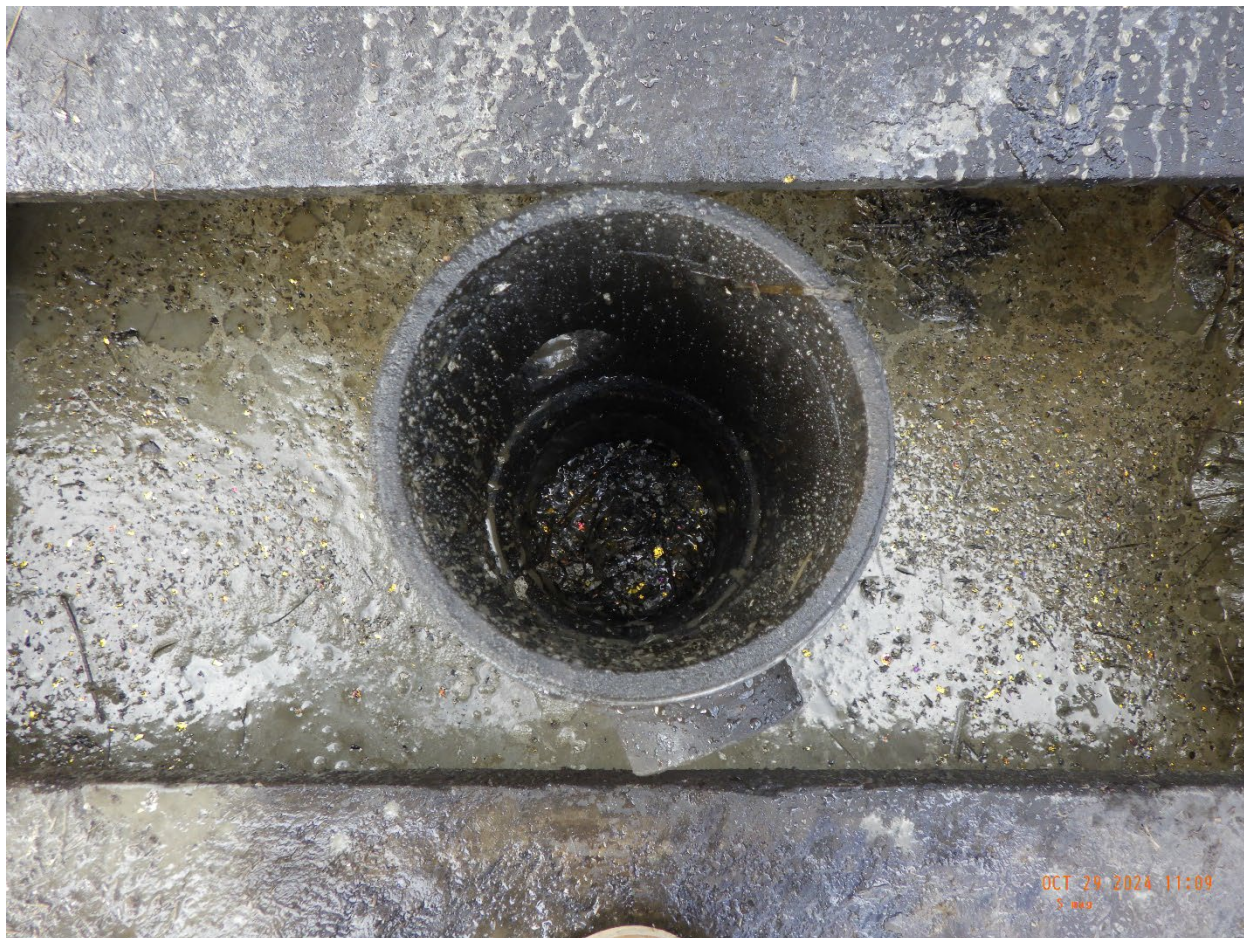
Photo No. 2

| <b>Inspection Comments</b> | Inspector observed Lester Well Service run in well OS3259000 to 360 feet below the surface and circulate 35 sacks of class A cement to the surface as required by the EPA approved plugging plan. Inspector observed cement standing at the surface with no fallback. EPA inspector previously observed the bottom and middle cement plug placement in the well. | | | | |

**Description:** This was well OS3259000 at the time of the inspection, standing full of cement to approximately 1 foot below the surface.
