## RCRA Compliance Evaluation Inspection Report

Renesas Electronics of America Inc.  
1650 Robert J Conlan Blvd NE  
Palm Bay, Florida 32905

On July 13, 2021, Miranda Rothenberger, Florida Department of Environmental Protection (FDEP), and Parvez Mallick, U.S. EPA, conducted a routine compliance evaluation inspection of Renesas Electronics of America Inc. (Renesas or the facility) to determine the facility's compliance with state and federal hazardous waste regulations. This was an EPA lead inspection. Renesas was represented by Wayman Aldridge, Principal EHS Engineer, Renesas Electronics of America Inc. and Layza Irizarry, EHS Intern, Renesas Electronics of America Inc. Upon entering the facility, the inspectors introduced themselves, showed their credentials and explained the purpose of the visit and a description of the facility's process was discussed. The inspectors described the anticipated use of digital camera during the inspection. The inspectors briefly discussed the company's ability, pursuant to 40 C.F.R. § 2.203, to assert a business confidentiality claim for information submitted to EPA. The company did not assert a business confidentiality claim. The inspection par

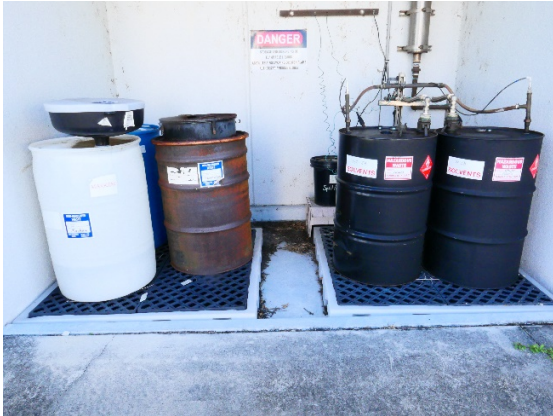
Probe assembly and testing is conducted in this building. The waste from wet benches located on the test floor is piped to the central accumulation area (CAA) located outside the building. The building is equipped with fire suppression sprinklers, fire extinguishers, and a fire alarm system. During the inspection the following wastes were present (Photo #1):

- One 55-gallon container of non-regulated waste Markem Remover, a non-hazardous ink remover;
- One 55-gallon container of hazardous waste flammable wipes managed as excluded solvent-contaminated wipes. The container was not marked with the words "Excluded Solvent-Contaminated Wipes." **Pursuant to Pursuant to Fla. Admin. Code Ann. r. 62-730.030(1) [40 C.F.R. § 261.4(a)(26)(i)], the solvent-contaminated wipes, when accumulated, stored, and transported, are contained in non-leaking, closed containers that are labeled "Excluded Solvent-Contaminated Wipes." The containers must be able to contain free liquids, should free liquids occur. During accumulation, a container is considered closed when there is complete contact between the fitted lid and the rim, except when it is necessary to add or remove solvent-contaminated wipes. When the container is full, or when the solvent-contaminated wipes are no longer being accumulated, or when the container is being transported, the container must be sealed with all lids properly and securely affixed to the container and all openings tightly bound or closed sufficiently to prevent leaks and emissions.** On July 15, 2021, Mr. Aldridge submitted a photo via

- One 55-gallon container marked “Hazardous Waste Flammable” and dated 6/21/21.

The inspectors observed that all containers were located on secondary containment and under a metal awning. A fire extinguisher and spill kit were noted in the area. There was one empty 55-gallon drum labelled “Hazardous Waste Flammable” for use when the existing drum is full. The facility maintains an automatic switchover system for their piped central accumulation areas. When one drum is full the device will automatically switch the flow of waste to the second empty drum. At that time a yellow flashing light is activated to alert staff to mark the new accumulation drum with an accumulation start date and have the full drum moved to the main CAA.

Photo #1 – Building 58 - Probe Assembly and Testing CAA area containers.

email of the container now properly marked “Excluded Solvent-Contaminated Wipes;” and

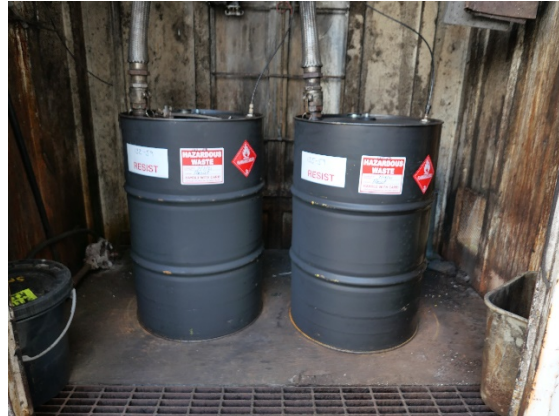
- Two 55-gallon containers marked “Hazardous Waste Flammable” and dated 06/28/21 and 05/25/21 (Photo #2);
- One 55-gallon container marked “Hazardous Waste Corrosive” and “moat etch” dated 05/17/21;
- There was one empty 55-gallon drum marked “Hazardous Waste Flammable;” and
- One empty 55-gallon container labeled “Hazardous Waste Corrosive” that will be used when the existing containers are full.

The containers were located on secondary containment and under a metal awning. A fire extinguisher and spill kit were noted in the area.

Photo #2 – Two hazardous waste containers outside Building 59 - CAA.

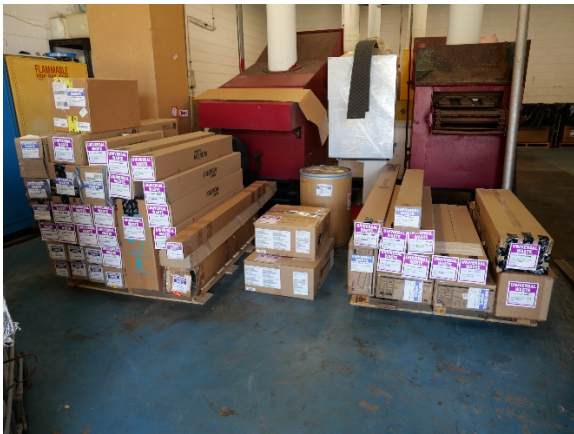
- Forty-seven closed containers marked “Universal Waste Lamps” and dated 09/30/20 through 07/07/21 (Photo #3);
- Two closed containers labeled “Universal Waste Batteries” and dated 01/02/21 and 02/07/21;

Photo #3 – Boxes of universal wastes in Building 55, inside CAA.

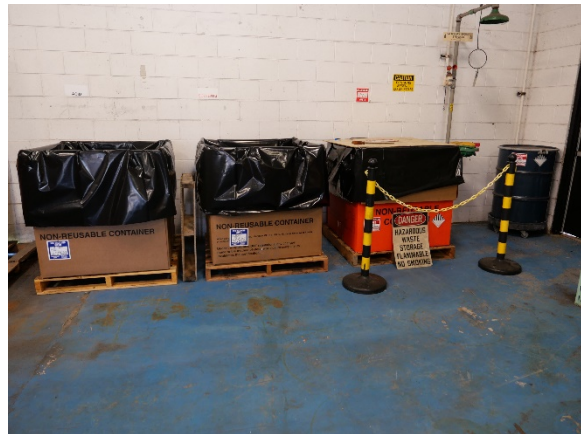
- One cubic yard box labeled non-hazardous corrosive solids (Photo #4);
- One closed cubic yard box of excluded solvent-contaminated wipes that was not marked “Excluded Solvent-Contaminated Wipes” (Photo #4). **Pursuant to Pursuant to Fla. Admin. Code Ann. r. 62-730.030(1) [40 C.F.R. § 261.4(a)(26)(i)], the solvent-contaminated wipes, when accumulated, stored, and transported, are contained in non-leaking, closed containers that are labeled “Excluded Solvent-Contaminated Wipes.” The containers must be able to contain free liquids, should free liquids occur. During accumulation, a container is considered closed when there is complete contact between the fitted lid and the rim, except when it is necessary to add or remove solvent-contaminated wipes. When the container is full, or when the solvent-contaminated wipes are no longer being accumulated, or when the container is being transported, the container must be sealed with all lids properly and securely affixed to the container and all openings tightly bound or closed sufficiently to prevent leaks and emissions.** On July 15, 2021, Mr. Aldridge submitted a photo via email of the container now properly marked “Excluded Solvent-Contaminated Wipes;”

- One closed cubic yard box marked “Hazardous Waste Toxic” arsenic waste and dated 06/01/21 (Photo #4); and
- One closed 55-gallon drum labeled “Hazardous Waste Toxic” arsenic waste and dated 06/05/21.

Photo #4 – Hazardous and non-hazardous cubic yard boxes in Building 55, inside CAA.

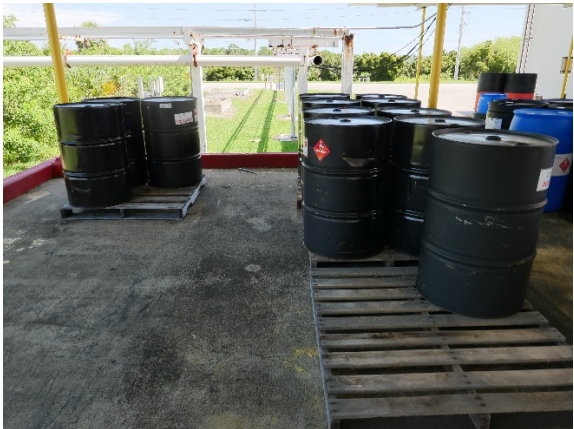
- Three closed 55-gallon containers marked “Hazardous Waste Ignitable” solvents dated 05/13/21, 05/23/21 and 06/10/21 (Photo #5);
- Nine closed 55-gallon containers marked “Hazardous Waste Ignitable” and “resist” dated 05/17/21 through 07/02/21 (Photo #5);
- Twenty-four closed 55-gallon containers marked “Hazardous Waste Corrosive” and dated 05/12/21 through 07/08/21 (Photo #6); and

Photo #5 – Flammable containers in Building 55, outside CAA.

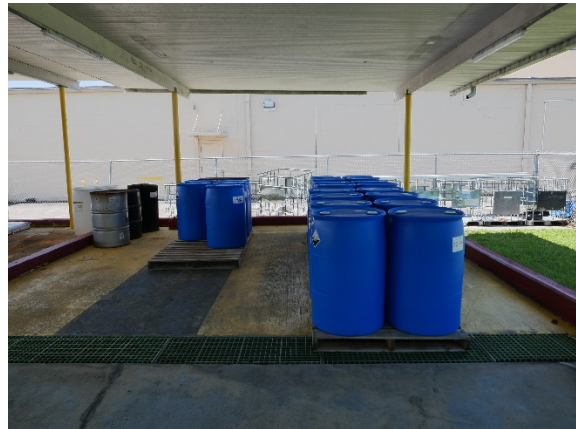
Photo #6 – Corrosive containers in Building 55, outside CAA.
