REPORT OF COMPLIANCE EVALUATION INSPECTION  
(INDUSTRIAL STORMWATER)

**12<sup>th</sup> & Haskell Recycling Center, Inc.**

NPDES General Permit: **KSR000176**

U.S. ENVIRONMENTAL PROTECTION AGENCY

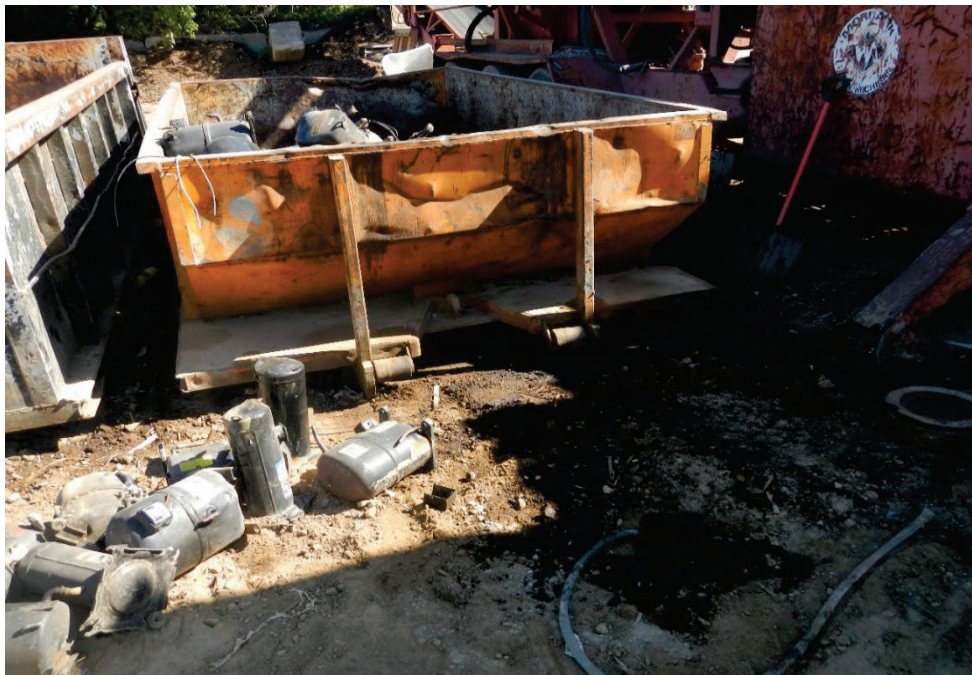
7. During our visual site inspection, I pointed out to site personnel the location of a surface runoff discharge point where water discharged from the site near the south fence line into the railroad tracks. I also pointed out that this discharge point should be included in the site map as a permitted outfall.
8. I issued NOPF #2 because during our visual inspection of the site, I pointed out to facility personnel evidence of poor housekeeping practices and significant ground discoloration near the scrap compressor collection area caused by mishandling of leaking compressors as shown in Photo 2 below. I pointed out to facility personnel that the NPDES Permit Section 2.4.3.a and the SWPPP Section 9.0 requires good housekeeping practices and spill management.

**Photo 2, evidence of spills and ground discoloration**

1. Managerial/administrative best management practices (BMPs), structural control BMPs, and non-structural control BMPs did not exist on site.
2. The SWPPP should include a site map that shall comply with the requirement of Section 4.42.b of the NPDES permit.
3. 12<sup>th</sup> & Haskell Recycling Center personnel shall conduct the annual comprehensive site compliance evaluation, the quarterly inspections of stormwater outfalls and process areas, visual evaluation of water quality, and employee training.
4. Based on the aboveground storage capacity of aggregate petroleum products stored on site, the facility must prepare in writing and implement a SPCC plan in accordance with §112.7 and any other applicable sections of 40 CFR Part 112, §112.3.
