**Region 6 - Enforcement & Compliance Assurance Division**  
**INSPECTION REPORT**

| Regulatory Program(s) | Water (CWA) Brine Program (Oil & Gas inspection) | |
| Company Name: | <b>Berg, Laney and Brown Company</b> | |
| Facility Name: | <b>Snyder Tank Battery</b> | |

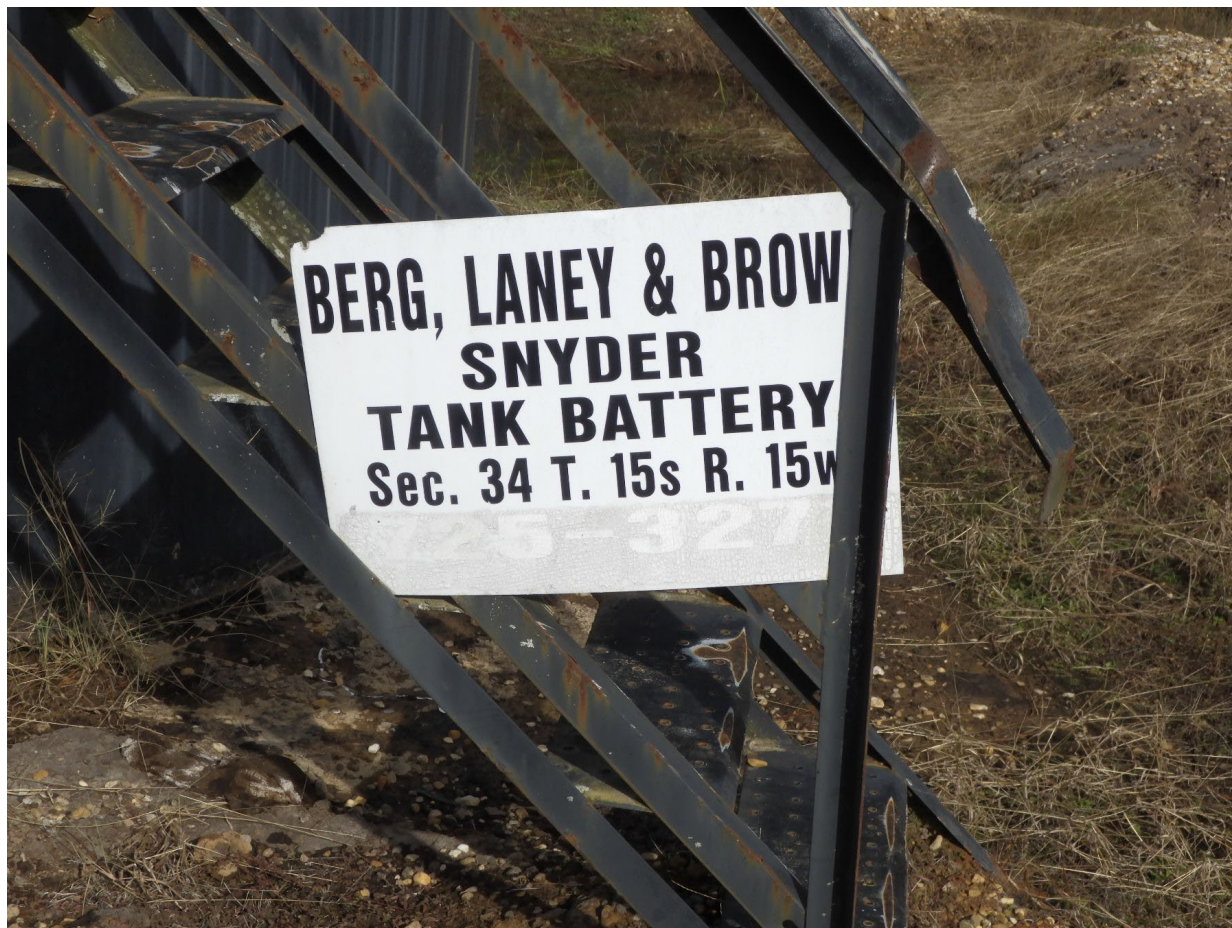
Photo No. 1

| Description: | Looking NNE, this photo shows the signage identifying the company and lease name for the facility. | | |

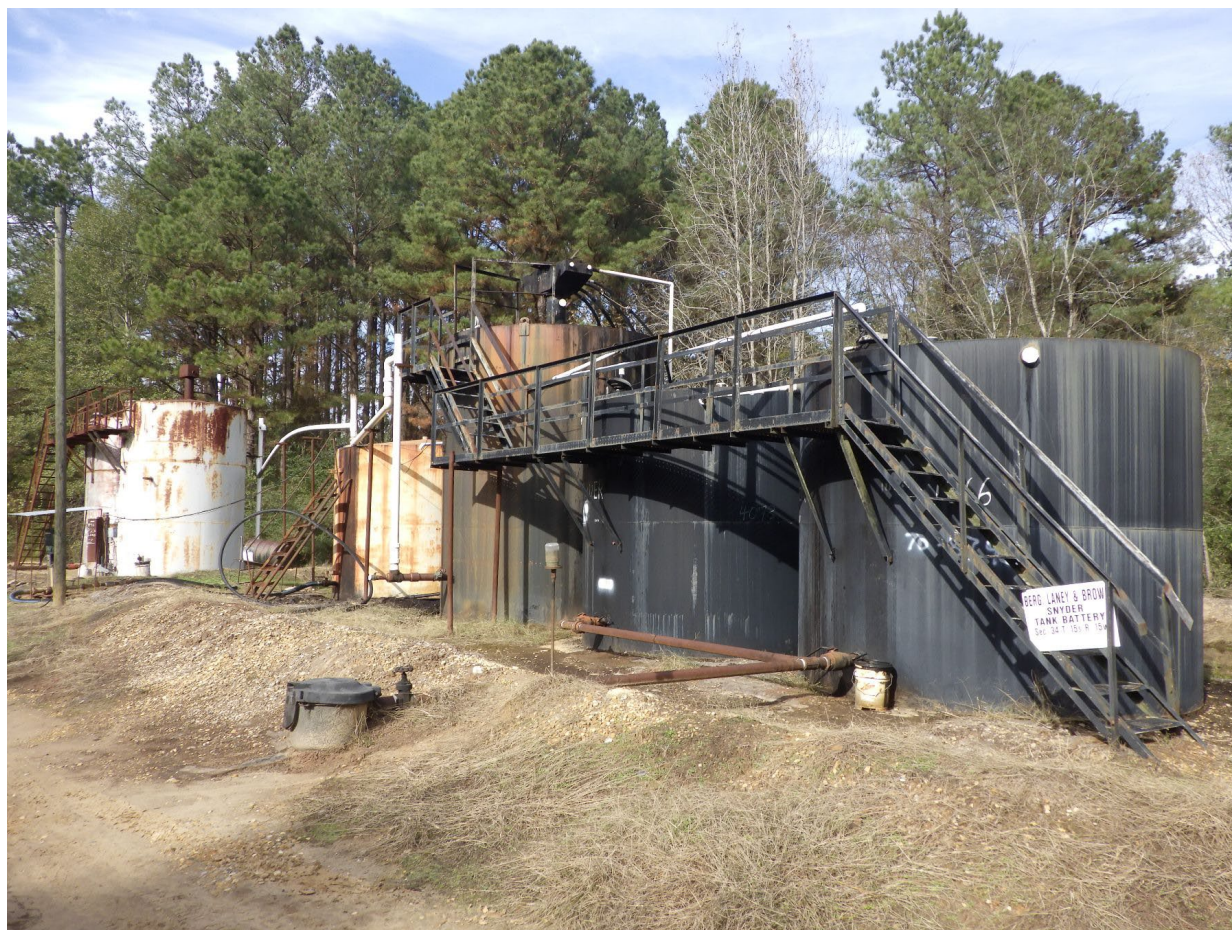
Photo No. 2

| Description: | Looking NNW, this photo shows an overview of the Baugh-Snyder tank batteries. The Snyder Tank Battery is in front. | | |

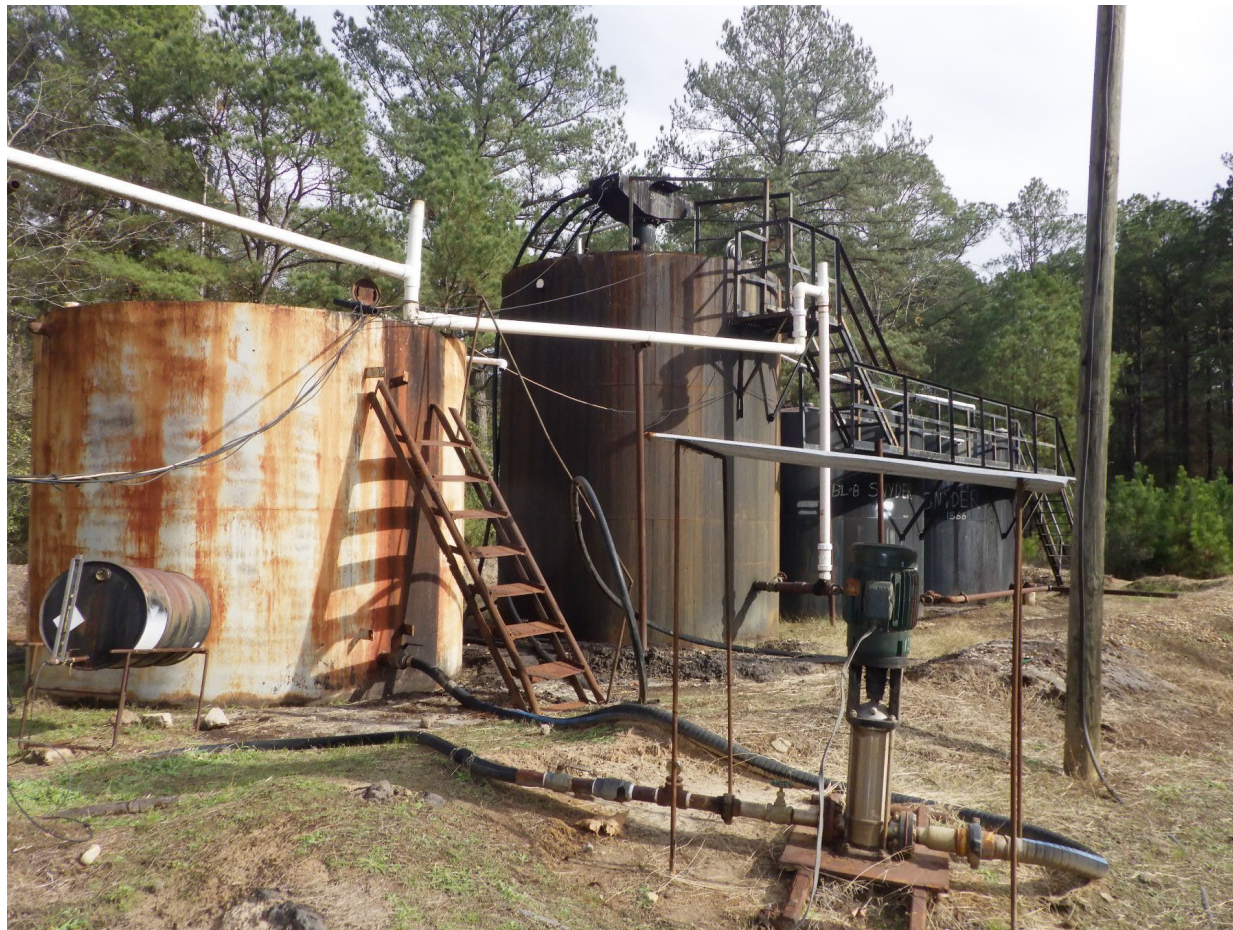
Photo No. 3

I observed the front side of the tank battery with the SWD well pump located outside containment, see Photo No. 3.

| Description: | Looking SSE, this shows the front view of the containment structure with the saltwater disposal (SWD) well pump adjacent to the facility. | | |

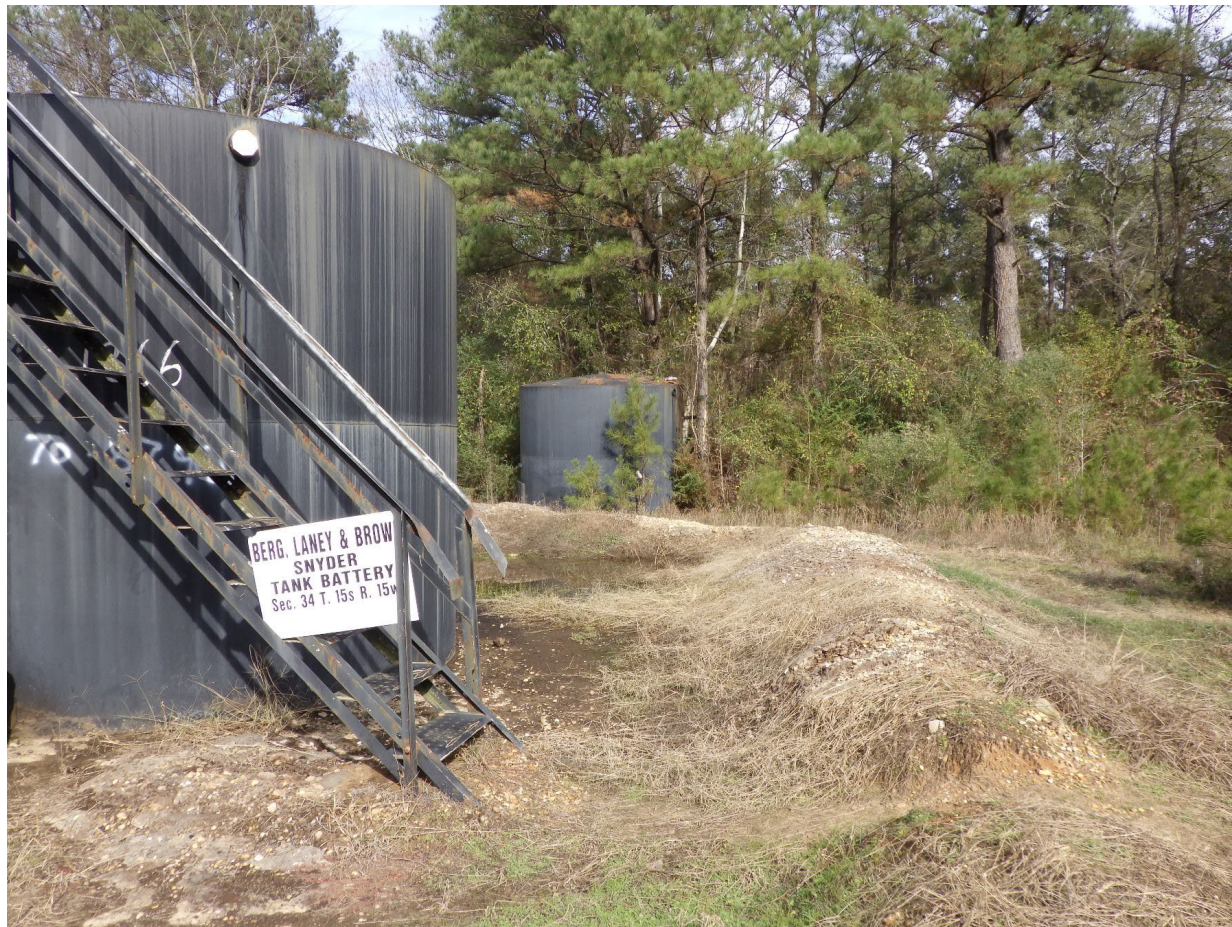
Photo No. 4

I observed the right side of the tank battery with a low area in the berm, see Photo No. 4.

- A low area on the secondary containment berm (Photo No. 4), and
- One (1) tank outside secondary containment not properly marked as “out of service” (Photo No. 7).

| Description: | Looking ENE, this photo shows the right-side view of the containment structure with a low area in the berm levee. | | |

Inspector will conduct follow-up phone calls with the company representative(s) over the coming weeks and months to ensure areas of concern are properly addressed.

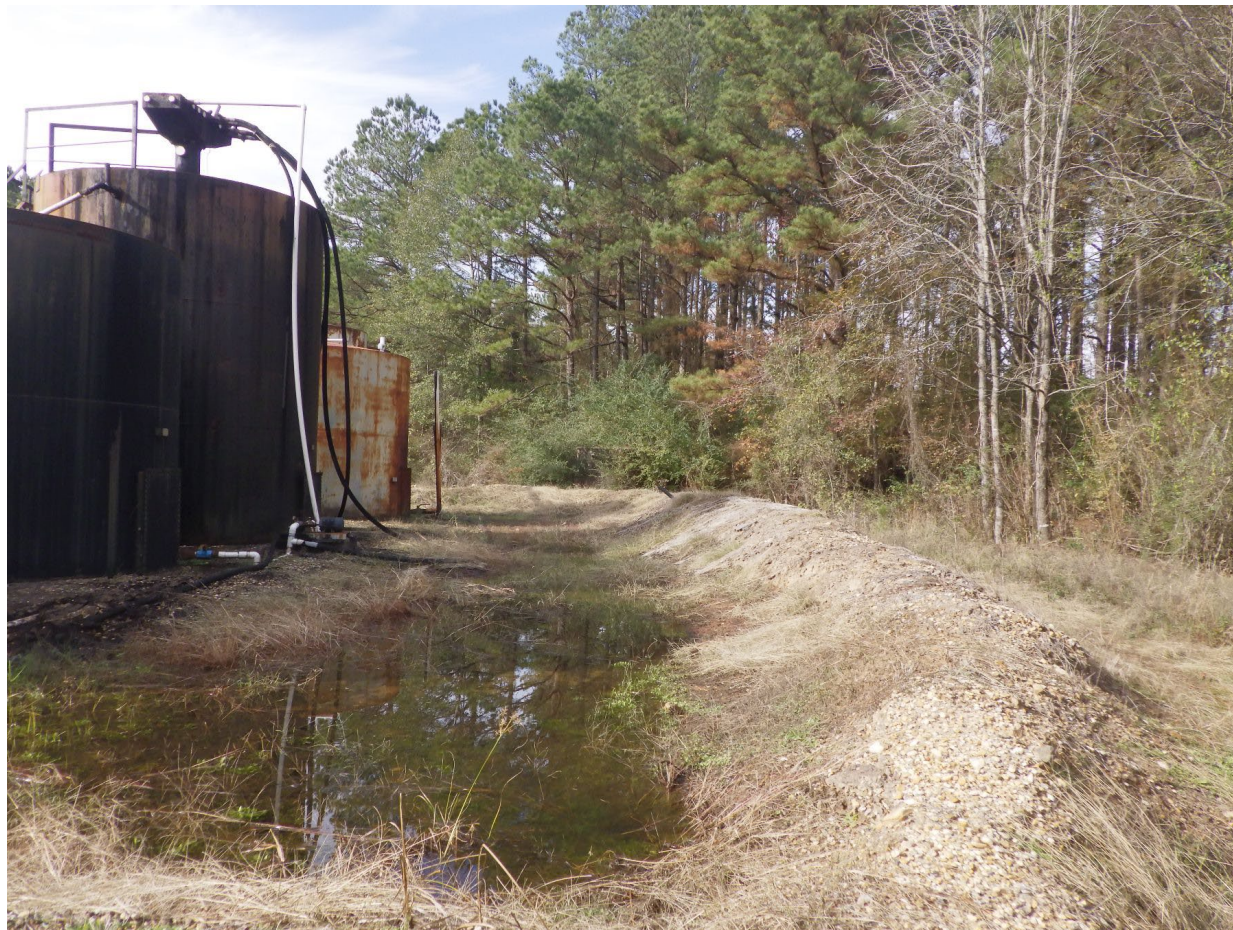
Photo No. 5

I observed the backside of the tank battery with a sump area in the corner, see Photos No. 5 and No. 8.

| Description: | Looking W, this photo shows the back view of the containment structure with a sump area in the corner. | | |

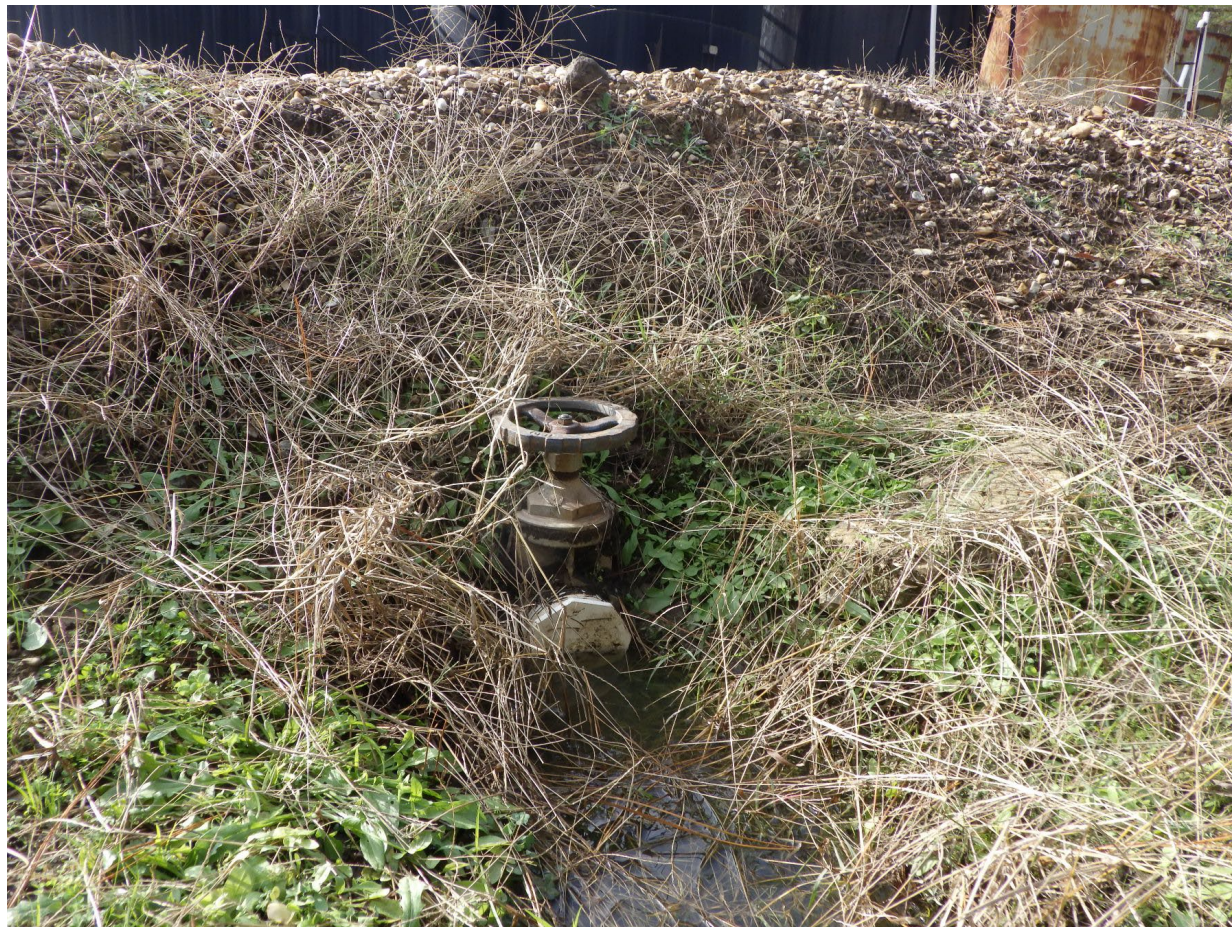
Photo No. 6

I observed the drainpipe for secondary containment with a cap and valve, see Photo No. 6.

| Description: | Looking WNW, this photo shows the drainpipe with valve and cap used to drain the sump area of the containment structure. | | |

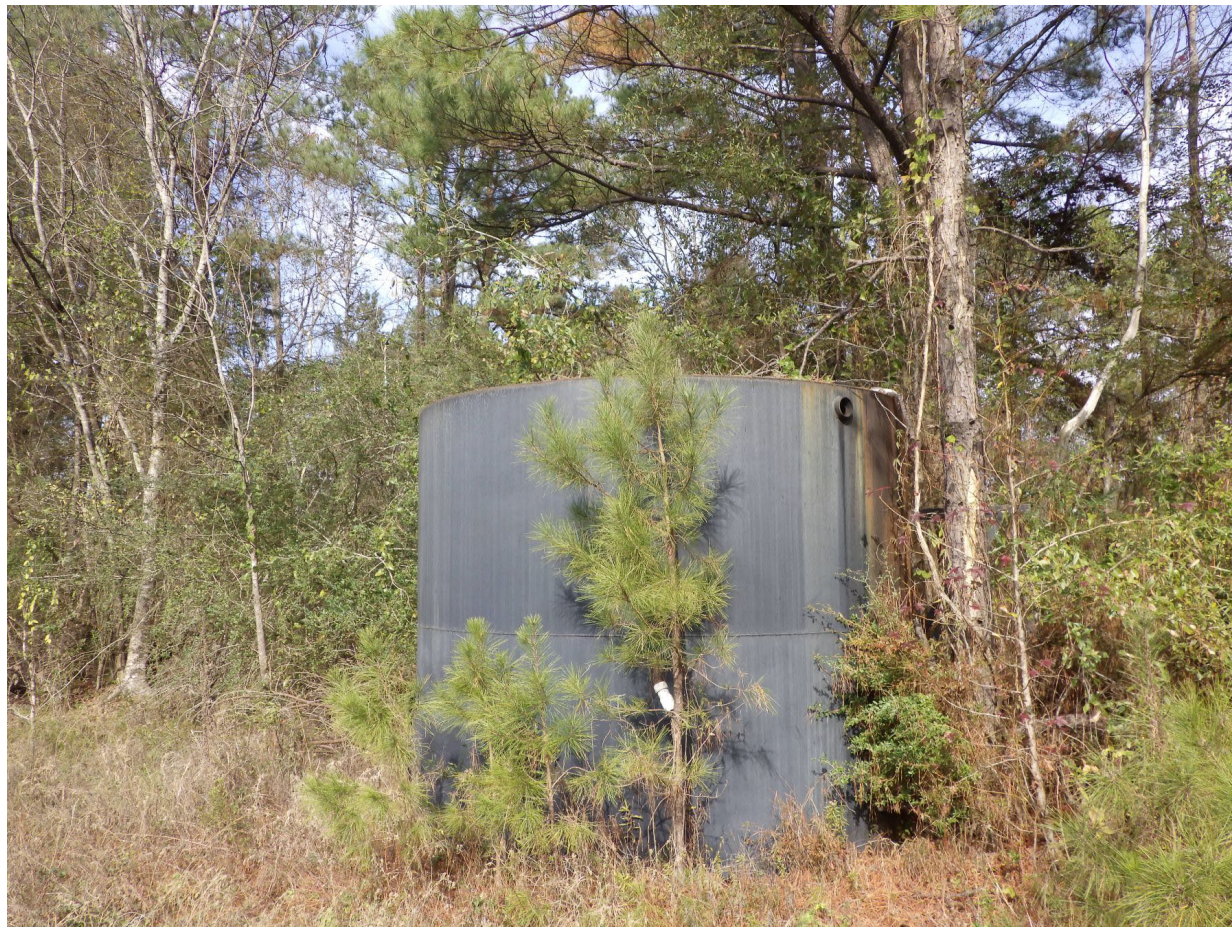
Photo No. 7

I observed one (1) tank outside secondary containment that appeared to be out of service that was not properly marked “out of service,” see Photo No. 7.

| Description: | Looking SSW, this photo shows a tank outside containment that was not in use. The tank was not marked, as required, indicating "out of service." | | |

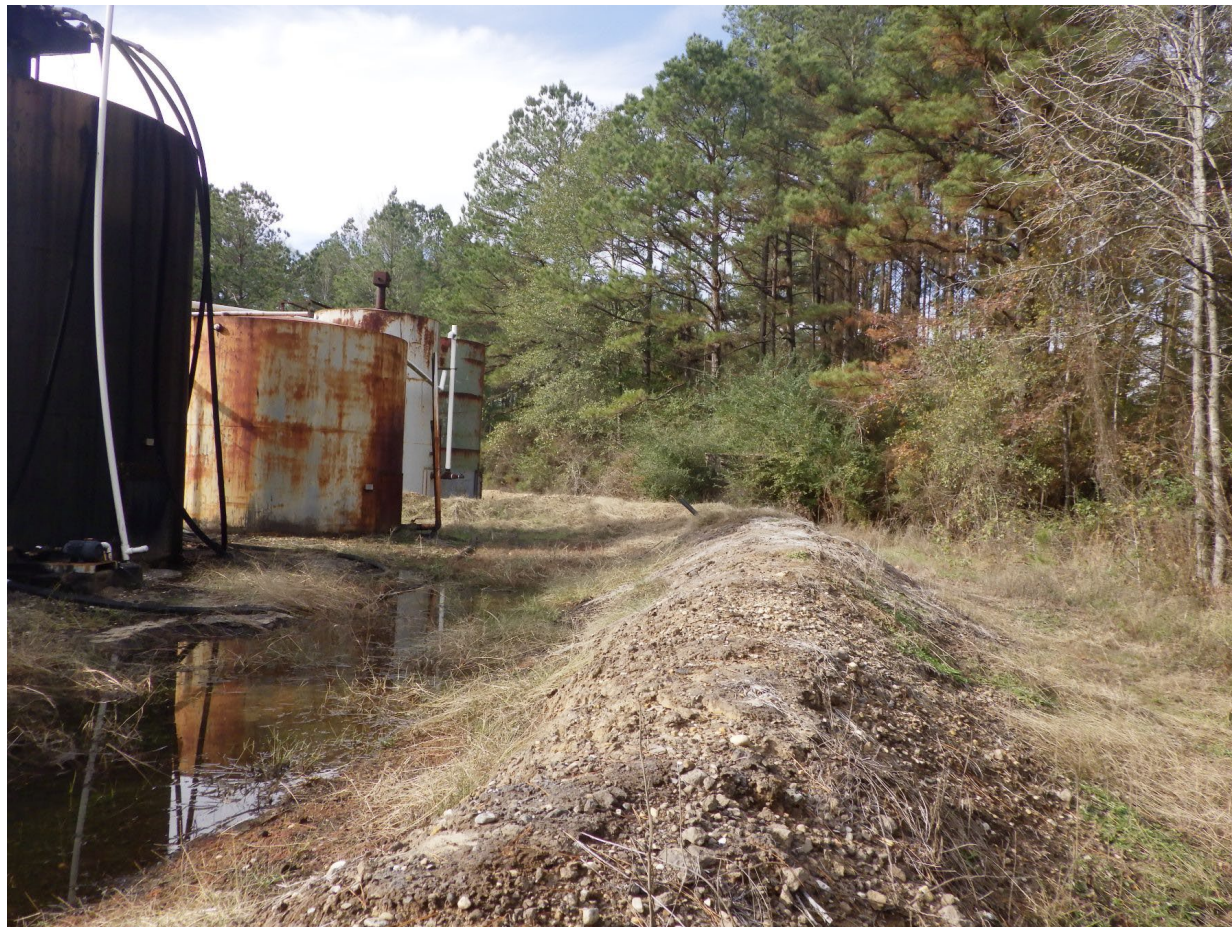
Photo No. 8

| Description: | Looking W, this photo shows an additional back view of the containment structure. | | |

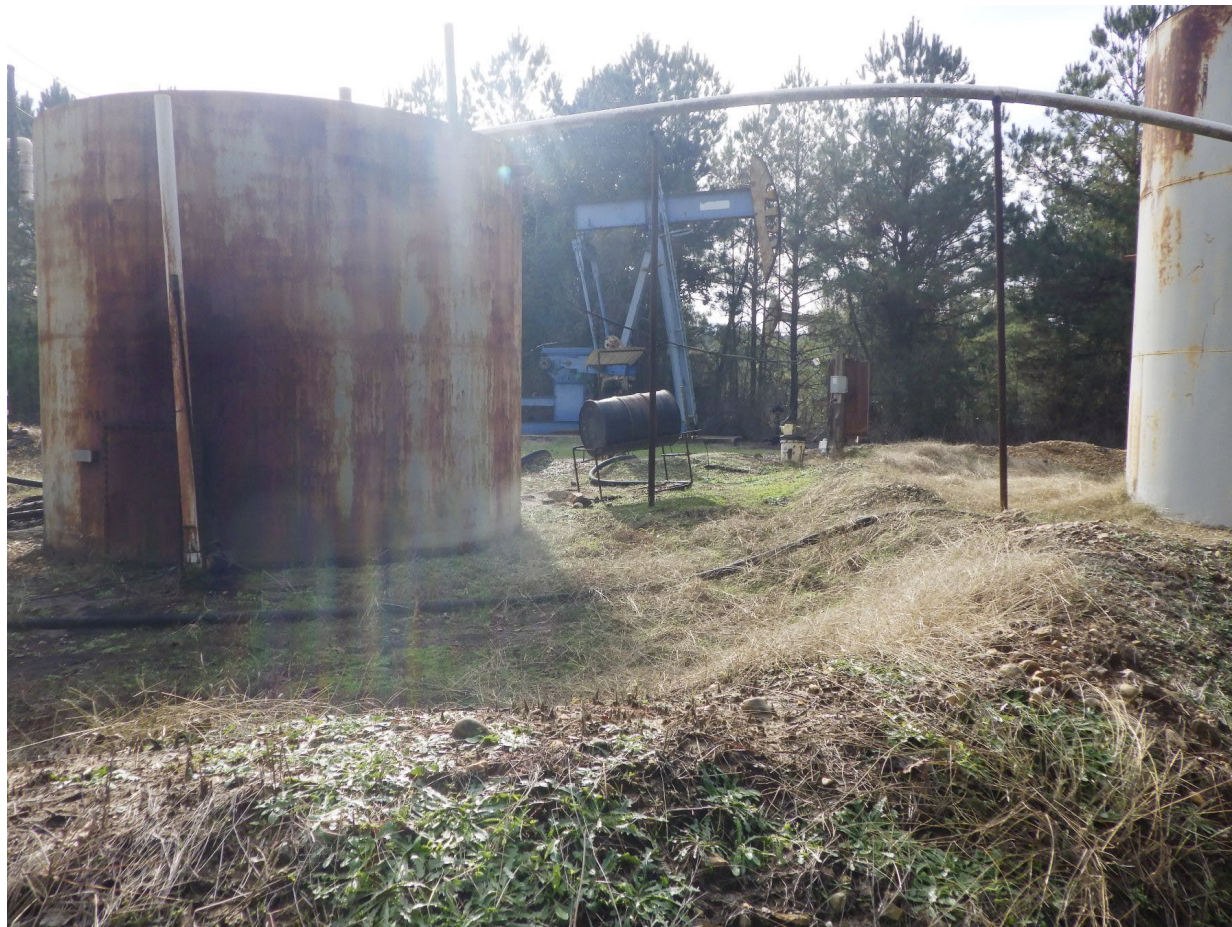
Photo No. 9

I observed overhead piping support, an active production well, and a berm shared with the Baugh Tank Battery, see Photo No. 9.

| Description: | Looking SW, this photo shows overhead piping with supports, an active production well, and a berm shared with the Baugh Tank Battery. | | |
