DOCUMENT DESCRIPTION: Journal Article - Asbestos Exposures During Reprocessing of Automobile Brakes and Clutch - International Journal of Occupational and Environmental Health

# Asbestos Exposures during Reprocessing of Automobile Brakes and Clutches

INT J OCCUP ENVIRON HEALTH 2006;12:95–106

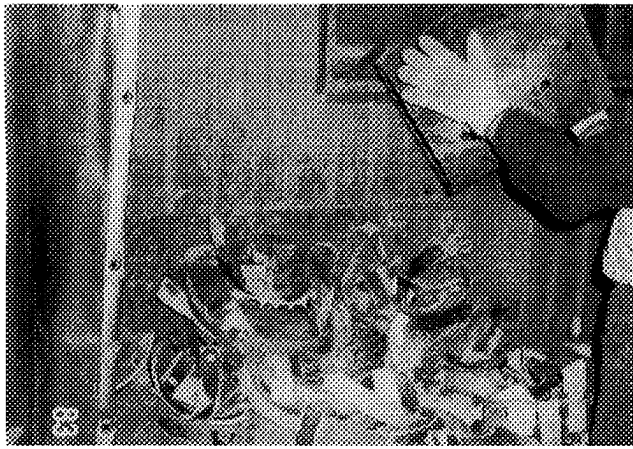
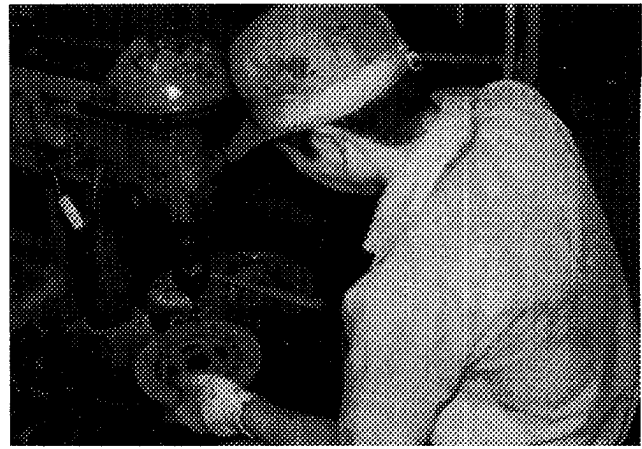
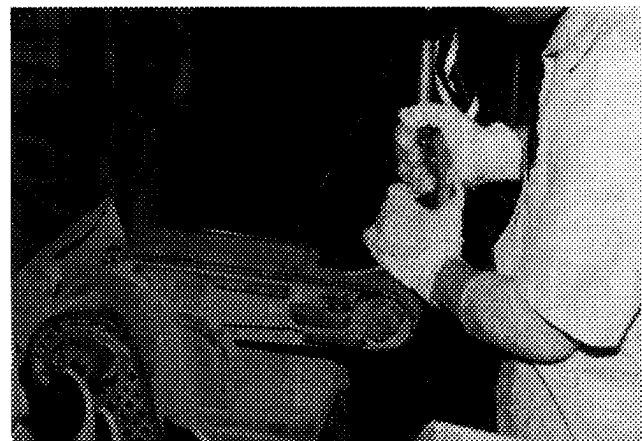
*Figure 2—Operations comprising reprocessing of brakes and clutches.*

*A. Stripping worn linings from brake shoes on a table after heating used brakes in a furnace.*

*B. Loosening of the rivets in a used clutch using a drilling machine.*

*C. Grinding the lining of a reassembled brake with a grindstone.*

*D. Grinding the lining of reassembled brake using a band grinder.*

*E. Drilling holes in a new clutch facing for the riveting.*
