## **RCRA Inspection Report**

Safety Kleen – St. Pauls  
934 North 5<sup>th</sup> Street  
St. Pauls, North Carolina 28384

June 13, 2024, at 10:30 AM

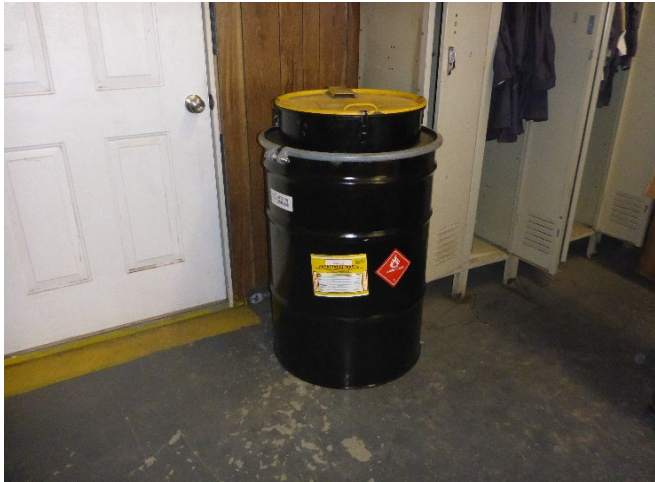
SK St. Pauls manages one SAA in the Warehouse for managing hazardous waste retain samples that are generated when oil retain samples are purged. SK St. Pauls personnel explained that oil and vac truck samples are collected from each customer and retained on-site for ninety days. After ninety days, the oil retain samples are accumulated as hazardous waste in a SAA. The inspectors observed one 55-gallon container in this SAA (Photo 1). The container was labeled hazardous waste retain/oil samples and identified with a flammable liquid DOT hazard sticker.

**Photo 1:** One 55-gallon container for accumulating hazardous waste retain/oil samples in the Warehouse SAA.

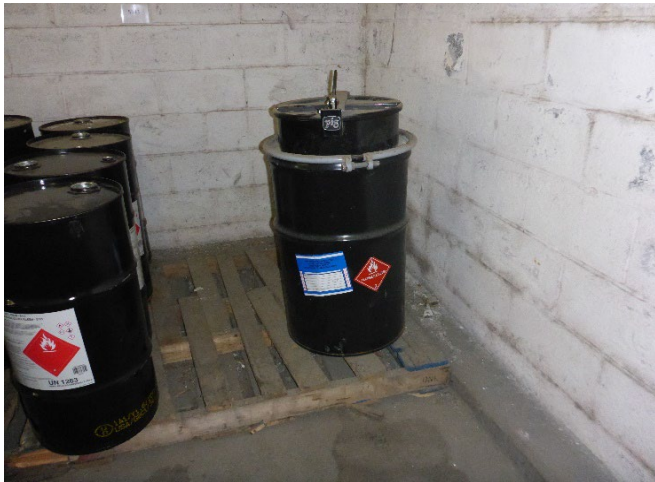
Container Storage Area No. 2, the class 1B flammable container storage, is permitted to store up to 4,480 gallons of paint-related waste, compatible 10-day transfer waste, used parts washer solvent, drum washer sediment, and dry-cleaning waste. The inspectors observed only one waste container in this area during the inspection (Photo 2): one 30-gallon container labeled universal waste aerosols and identified with a flammable DOT hazard sticker. Facility

**Photo 2:** One 30-gallon container of universal waste aerosols in the Container Storage Area No. 2.

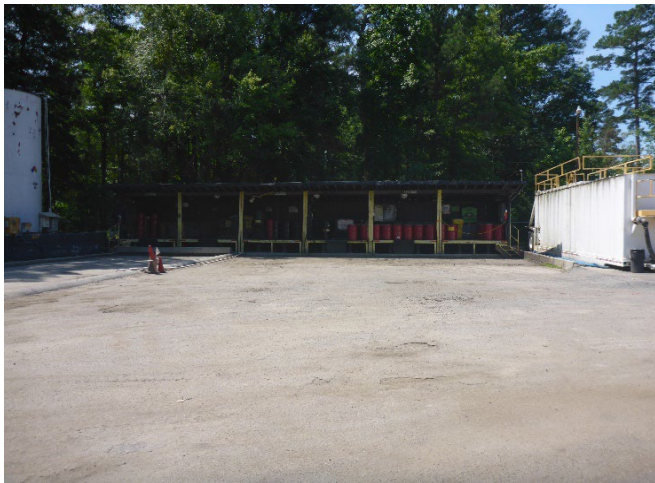
The canopy covered Return and Fill Station, which is located directly across from the Warehouse along the southern most portion of the facility, consists of a sheet metal structure comprising a roof and three sides (Photo 3). The fourth side is open to allow for truck loading/unloading onto the elevated metal grating floor, which is supported over twelve six-inch deep galvanized metal containment pans on a concrete pad. The area contains two tank-like Subpart X drum washer/dumpster units, and one drum rinsing unit.

**Photo 3:** Return and Fill Station.

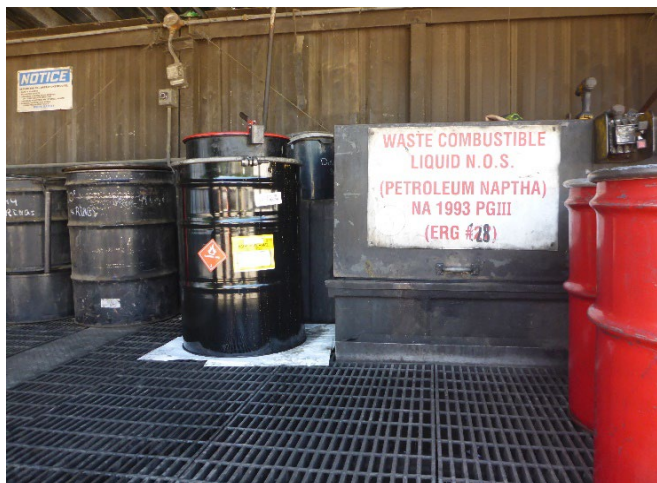
SK manages one SAA for accumulating hazardous waste generated in and around the Return and Fill Station. The inspectors observed one 55-gallon container in this SAA (Photo 4). The container was closed, labeled hazardous waste branch debris, and marked with an indication that the contents are flammable and toxic.

**Photo 4:** One 55-gallon container for accumulating hazardous waste branch debris in the Return and Fill SAA.

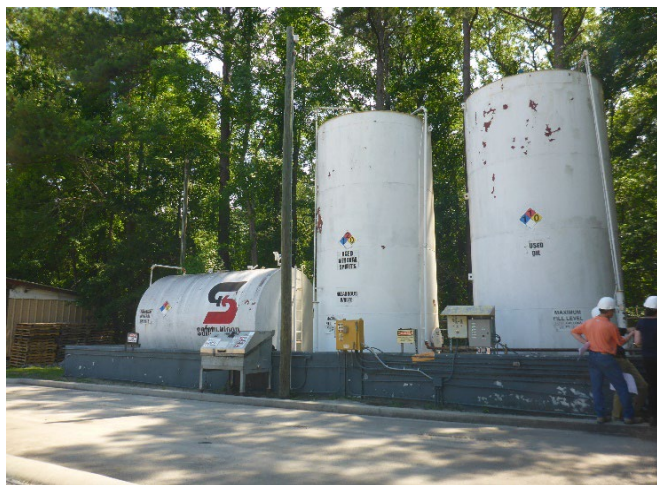
The Tank Farm is located immediately northeast of the Return and Fill station. The Tank Farm consists of three storage tanks within a concrete containment structure (Photo 5): Tank No. 1 is

a 10,000-gallon capacity horizontal steel aboveground tank used to store clean parts washer solvent; Tank No. 2 is a 15,000-gallon capacity RCRA regulated vertical steel aboveground storage tank used to store used parts washer solvent; and Tank No. 3 is a 15,000-gallon capacity vertical steel aboveground tank used to store used oil. Tank No. 2 may also be utilized on an as-needed basis to store stormwater that has collected within the Tank Farm or the Return and Fill Station.

**Photo 5:** Three storage tanks at the Tank Farm.
