Compliance Evaluation Inspection Report

Inspection Date(s):	08/02/2022 - 08/03/2022	Announced: Yes
Time:	Entry: 01:01 PM (ET)	Exit: 09:30 AM (ET)
Media:	Water	
Statute(s)/Program(s):	Clean Water Act, NPDES, WWTF	
Type of inspection:	CEI - Compliance Evaluation Inspection	
Access:	Granted	
Permittee Name:	GUN LAKE TRIBAL GAMING AUTHORITY WASTEWATER TREATMENT FACILITY	
Facility or Site Name:	GUN LAKE TRIBAL GAMING AUTHORITY WASTEWATER TREATMENT FACILITY	
Facility/Site Physical Address:	1123 129TH AVENUE	
(City, state, zip code)	WAYLAND, MI 49348	
County/Parish:	ALLEGAN	
Facility GPS Coordinates:	42.63042, -85.65445	
Facility/Site Identifier:	110039145430	
Permit Number:	MI0058661

GUN LAKE TRIBAL GAMING AUTHORITY WWTF

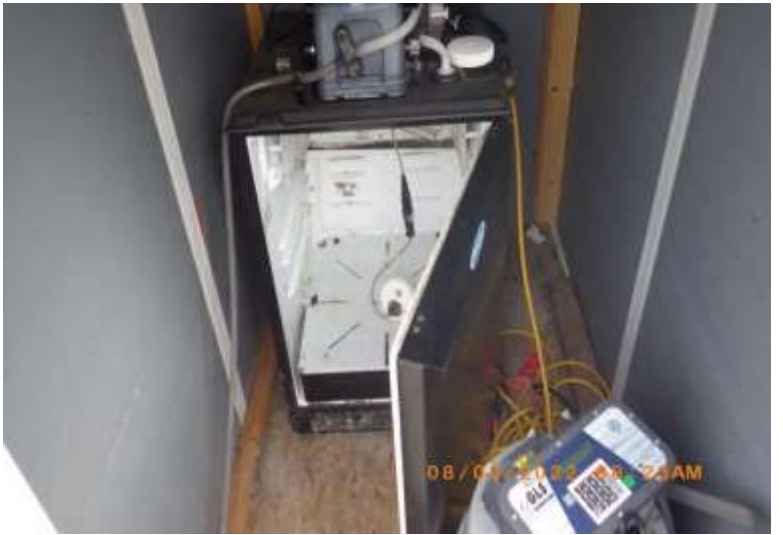
<p>GUNL0079.JPG</p>	
<p>08/03/2022 08:23 AM (ET)</p>	
<p>Dean Maraldo</p>	
<p>Physical WWTP Inspection/Headworks/Primary Treatment</p>	
<p>No CBI</p>	
<p>No PII</p>

We began the physical inspection at the Equalization Tank ("EQ Tank") area. I observed the influent sampling house and the ISCO Influent Auto Sampler. The sampler was refrigerated and had a thermometer (see Photo Log image GUNL0079). However, Mr. Row said they do not maintain a temperature log.

<p>Influent Auto Sampler</p>

<p>Unit: Physical WWTF Inspection</p>	<p>Area: Headworks/Primary Treatment</p>
<p>DM1-OB-005</p>	
<p>I observed the influent sampling house and the ISCO Influent Auto Sampler. The sampler was refrigerated and had a thermometer (see PhotoLog image GUNL0079). However, Mr. Row said they do not maintain a temperature log for the influent and effluent auto samplers.</p>	<p>Citations: 40 CFR Part 136 NPDES Permit Part II.C.3 (Monitoring Procedures)</p>

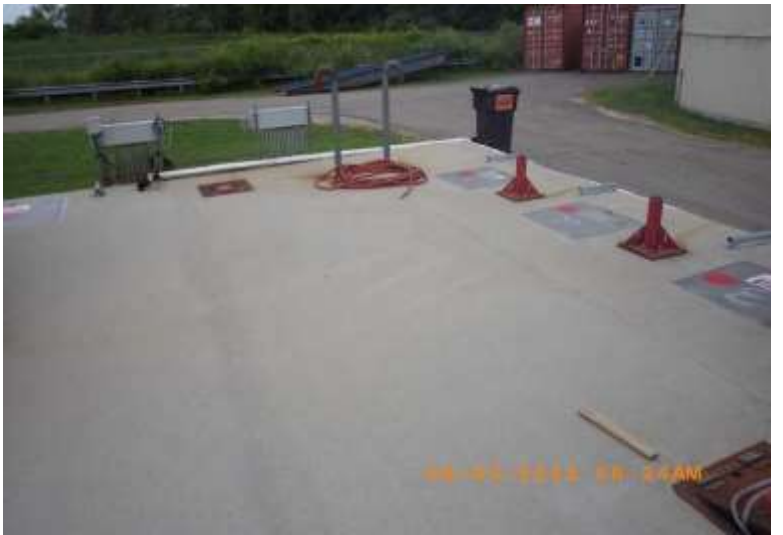
The EQ basin is covered under a concrete slab and could not be easily observed (see Photo Log image GUNL0080). There is a grinder in the EQ basin, prior to the Fine Screen.

<p>EQ Basin (under concrete slab)</p>	
<p>GUNL0080.JPG</p>	
<p>08/03/2022 08:24 AM (ET)</p>	
<p>Dean Maraldo</p>	
<p>Physical WWTP Inspection/Headworks/Primary Treatment</p>	
<p>No CBI</p>	
<p>No PII</p>

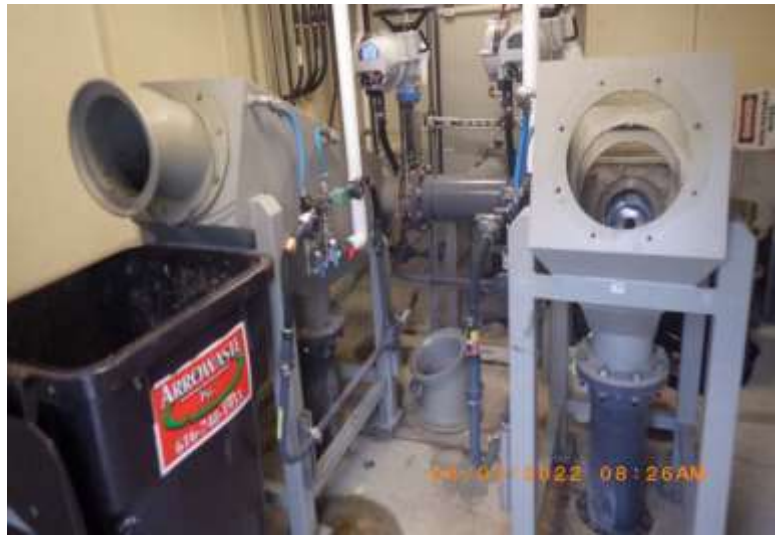
Next, we walked to the fine screen room, where the twin fine screen units are located (see Photo Log image GUNL0081). One of the twin screen units was off line for servicing. Mr. Row said that they only run one fine screen unit under normal operating conditions.

Twin Fine Screen Units
GUNL0081.JPG
08/03/2022 08:26 AM (ET)
Dean Maraldo
Physical WWTP Inspection/Headworks/Primary Treatment
No CBI
No PII
The unit on the right of the photo was off line at the time of inspection.

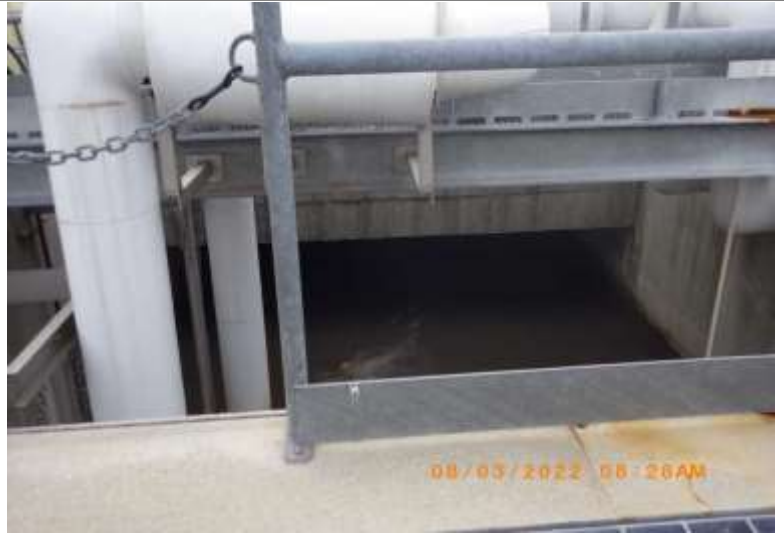
I observed the anoxic tank, which is partially covered by the fine screen room (see Photo Log image GUNL0082), and the two aeration tanks (see Photo Log image GUNL0083). Mr. Row pointed out the various dedicated DO meters used to monitor conditions in the aeration tanks.

Anoxic Tank
GUNL0082.JPG
08/03/2022 08:28 AM (ET)
Dean Maraldo
Physical WWTP Inspection/Secondary Treatment
No CBI
No PII

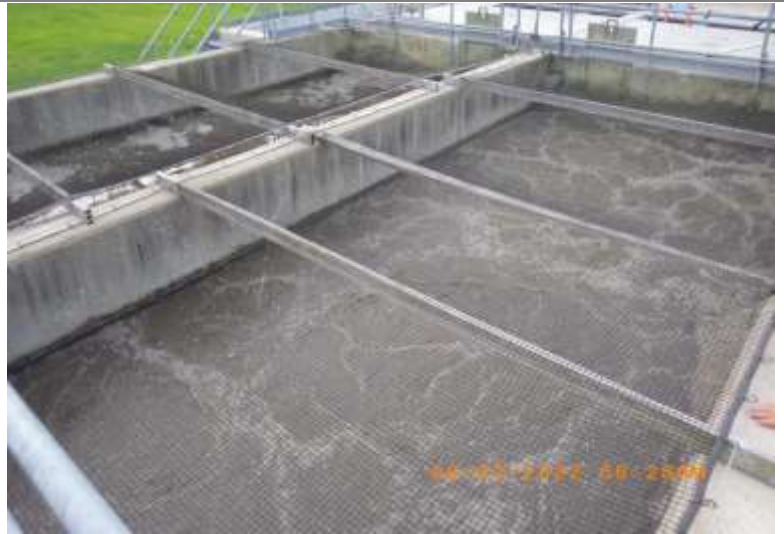
Aeration Basins (2)
GUNL0083.JPG
08/03/2022 08:28 AM (ET)
Dean Maraldo
Physical WWTP Inspection/Secondary Treatment
No CBI
No PII

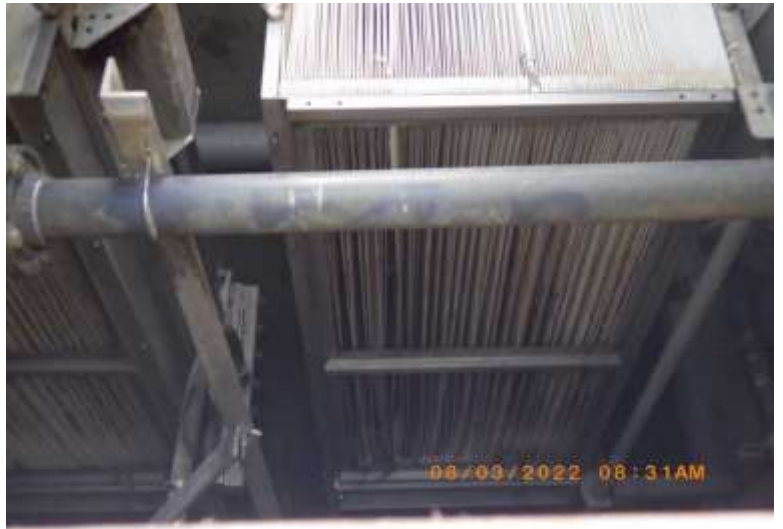
After the aeration tanks, effluent flows to the MBR system, consisting of two MBR cassette systems, each with twin cassettes. Mr. Row mentioned that there are tears in both of the cassettes in one of the MBR cassette systems (see Photo Log image GUNL0084). As a result, one of the MBR cassette systems is out of service due to the tears. He confirmed that both of the MBR cassette systems are used under normal operating conditions. I asked when the torn MBR was first noticed. Mr. Row said sometime in June 2022, when they started seeing higher turbidity and phosphorus concentrations. We walked on to the concrete pad above the MBR system and I captured a photograph of the area above the MBRs (see Photo Log image GUNL0085).

MBR Cassette
GUNL0084.JPG
08/03/2022 08:31 AM (ET)
Dean Maraldo
Physical WWTP Inspection/Secondary Treatment
No CBI
No PII
Note torn or split membranes on the left side of cassette.

We have ruptured membranes in our MBR units. This has resulted in high bacteria and phosphorus levels.

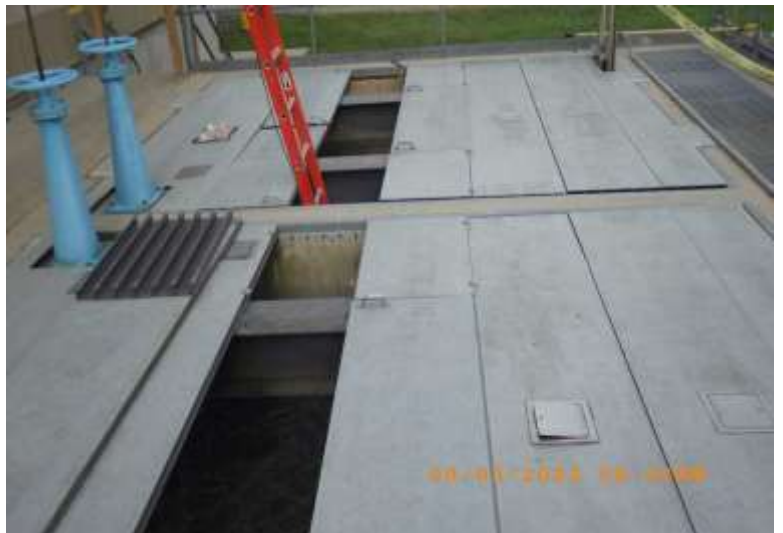
View of the covered MBR system
GUNL0085.JPG
08/03/2022 08:33 AM (ET)
Dean Maraldo
Physical WWTP Inspection/Secondary Treatment
No CBI
No PII

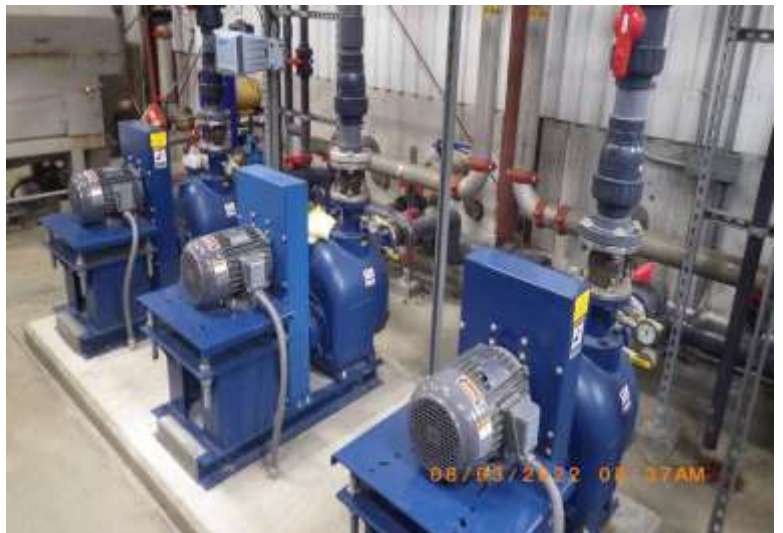
Next, we walked into the Plant Building and observed the three MBR system pumps (see Photo Log image GUNL0086) and the two effluent magnetic flow meters (see Photo Log image GUNL0087). Two of the pumps send flow to dedicated effluent flow meters, and the third pump can be used in place of the two other pumps, as needed. Total flow from the two effluent magnetic flow meters are measured every day to provide the Facility's daily total effluent flow. Effluent from the MBR system is pumped to the UV treatment system.

MBR Pumps (3)
GUNL0086.JPG
08/03/2022 08:37 AM (ET)
Dean Maraldo
Physical WWTP Inspection/Secondary Treatment
No CBI
No PII

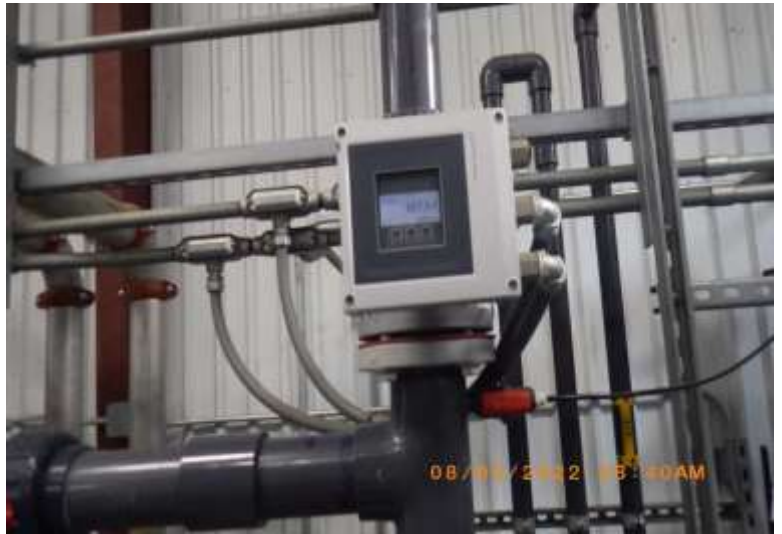
Effluent Magnetic Flow Meter
GUNL0087.JPG
08/03/2022 08:40 AM (ET)
Dean Maraldo
Physical WWTP Inspection/Secondary Treatment
No CBI
No PII
One of two magnetic flow meters used to provide the facility's total daily effluent flow.

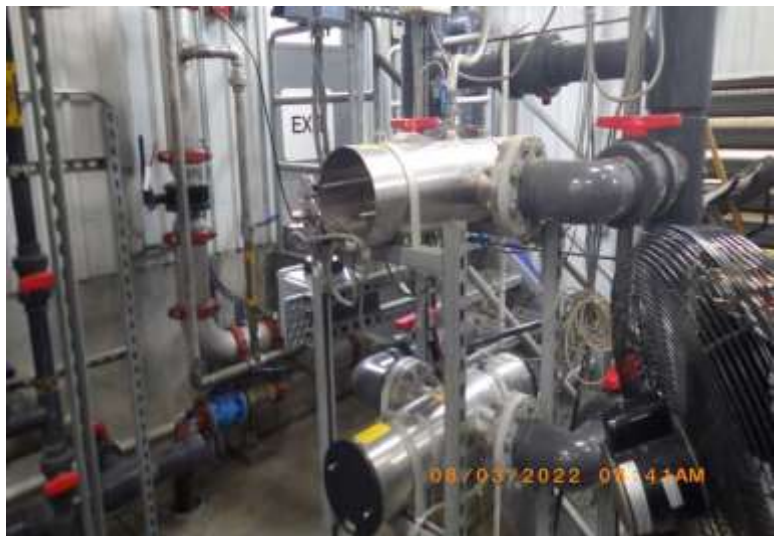
Unit: Physical WWTF Inspection/UV Treatment	Contains CBI: No
Observation #: DM1-OB-007	Date: 08/03/2022
<p>Final effluent is pumped to the stainless steel, two bank, ultra-violet light ("UV") disinfection system (see Photo Log image GUNL0088). There is a turbidity meter prior to the UV system. The final effluent auto sampler is next to the UV system. The Hach Sigma 1600 auto sampler is refrigerated and I noted a thermometer in the sample bin (see Photo Log image GUNL0089). The effluent auto sampler is set up for time-based composite sampling.</p>	
<p>Photo(s)</p> <ol style="list-style-type: none"> 1. GUNL0088.JPG 2. GUNL0089.JPG

UV Treatment System
GUNL0088.JPG
08/03/2022 08:41 AM (ET)
Dean Maraldo
Physical WWTP Inspection/UV Treatment
No CBI
No PII

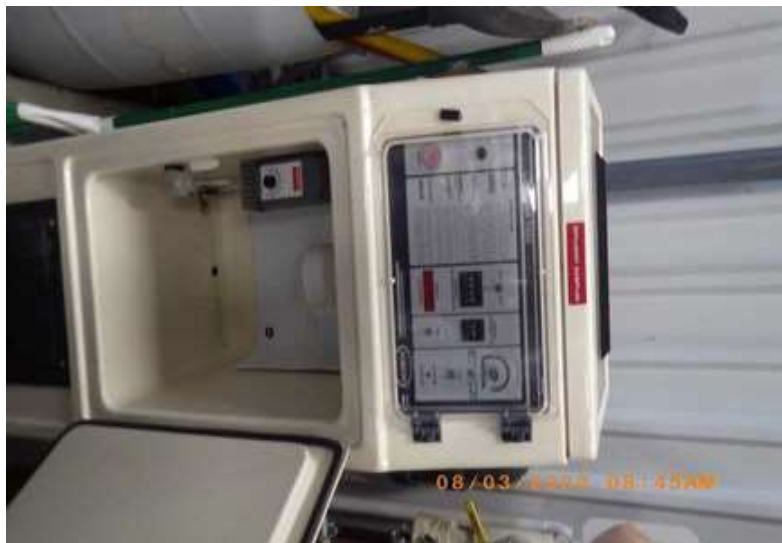
Effluent Autosampler (Hach Sigma 1600)
GUNL0089.JPG
08/03/2022 08:45 AM (ET)
Dean Maraldo
Physical WWTP Inspection/UV Treatment
No CBI
No PII
Note the thermometer inside the auto sampler.

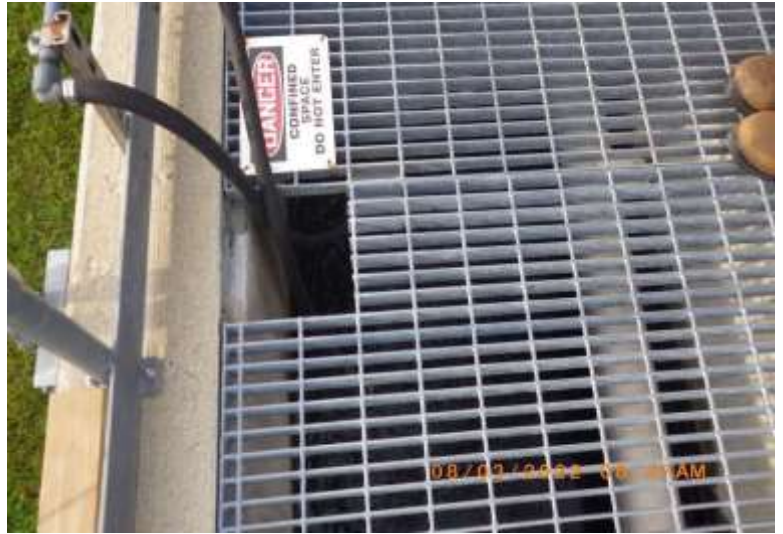
Unit: Physical WWTF Inspection/Final Effluent Trough and Outfall 001	Contains CBI: No
Observation #: DM1-OB-008	Date: 08/03/2022
<p>After UV treatment, effluent flows to final Outfall 001 via an effluent trough. We walked out of the Plant Building on top of a metal grated walkway that covered the flowing effluent trough (see Photo Log image GUNL0090). The effluent in the trough is also aerated prior to discharge to Outfall 001.</p> <p>I observed the discharge from Outfall 001 into Buskirk Creek (see Photo Log image GUNL0091). The discharge and receiving water appeared clear.</p> <p>I asked about return flows from the sludge process. Mr. Row said all water from the sludge dewatering process returns to the EQ basin, after the influent flow meter.</p> <p>From here we took a short drive to the casino to observe the lift station.</p>	
<p>Photo(s)</p> <ol style="list-style-type: none"> 1. GUNL0090.JPG 2. GUNL0091.JPG

Effluent trough to Outfall 001
GUNL0090.JPG
08/03/2022 08:47 AM (ET)
Dean Maraldo
Physical WWTP Inspection/Final Effluent Trough and Outfall 001
No CBI
No PII
Trough conveys effluent from UV treatment to final outfall 001. The trough is covered by a metal grate.

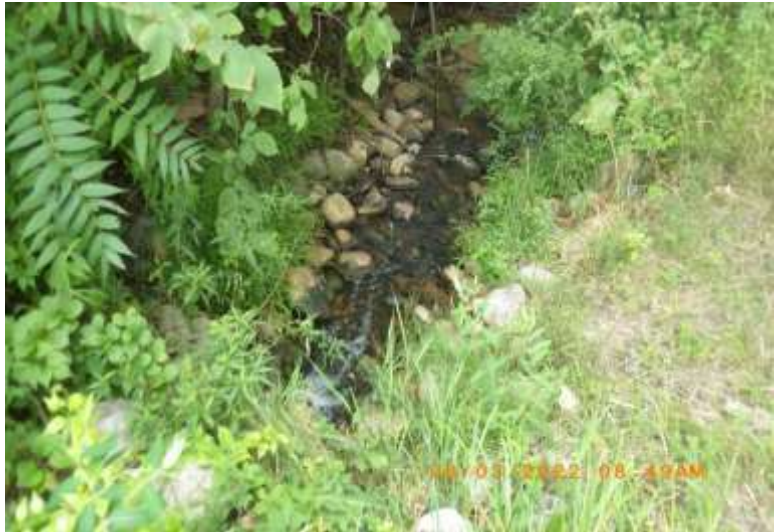
Final Outfall 001
GUNL0091.JPG
08/03/2022 08:49 AM (ET)
Dean Maraldo
Physical WWTP Inspection/Final Effluent Trough and Outfall 001
No CBI
No PII
Effluent discharge and Buskirk Creek appeared clear.

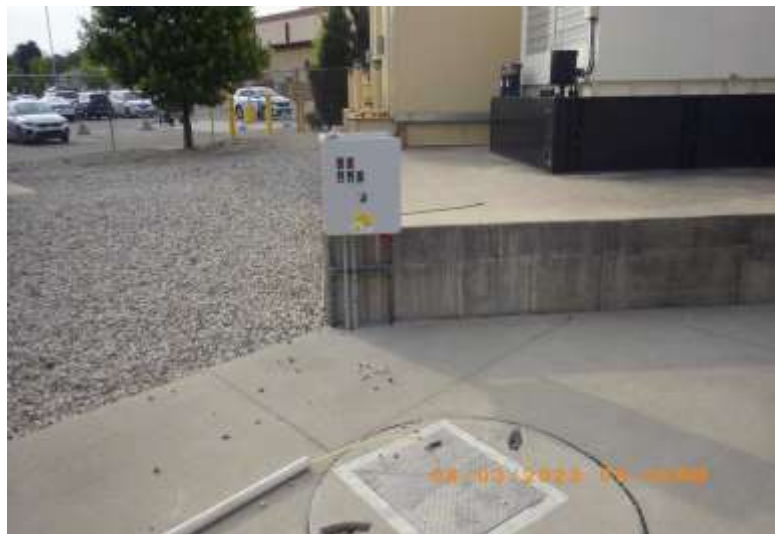
Unit: Physical WWTF Inspection/Lift Station	Contains CBI: No
Observation #: DM1-OB-09	Date: 08/03/2022
<p>I observed the Facility's only lift station which, according to James Lombard, helps to convey flow from the casino buffet area, cafeteria, dish rooms, and administrative areas. Mr. Row said all other flows are conveyed to the wastewater treatment plant via gravity flow. The lift station includes a grinder (Muffin Monster) and two submersible pumps. The grinder controls and manhole are shown in Photo Log image GUNL0092. I captured an image looking down into the lift station wet well (Photo Log image GUNL0093).</p>

Lift Station Grinder
GUNL0092.JPG
08/03/2022 09:00 AM (ET)
Dean Maraldo
Physical WWTP Inspection/Lift Station
No CBI
No PII
The lift station includes a grinder (Muffin Monster). The grinder controls and manhole are captured in this image.

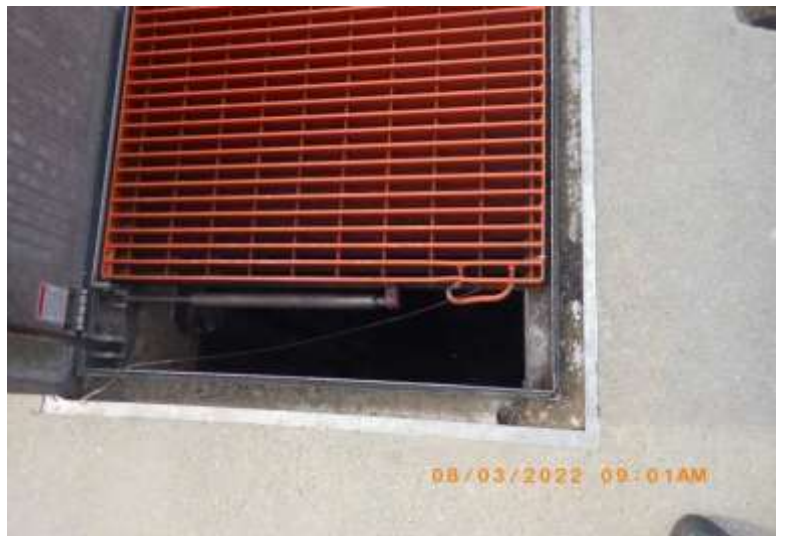
View inside Lift Station wet well
GUNL0093.JPG
08/03/2022 09:01 AM (ET)
Dean Maraldo
Physical WWTP Inspection/Lift Station
No CBI
No PII

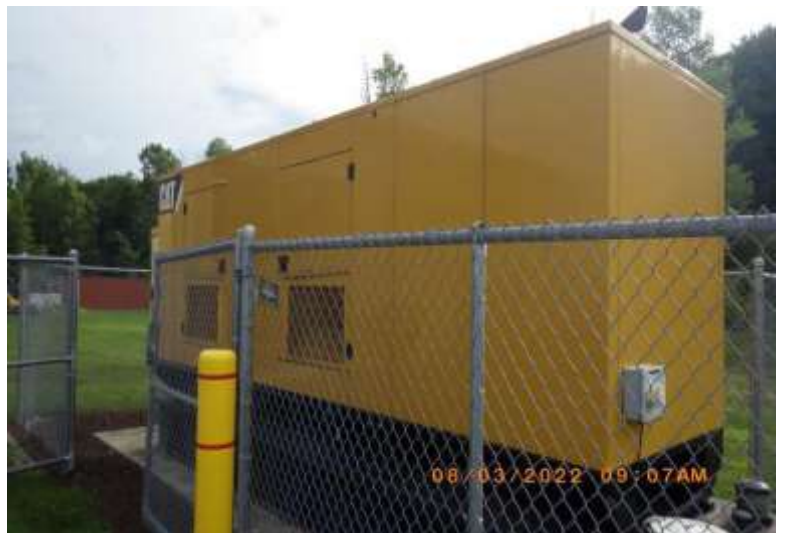
The last stop on the physical inspection of the wastewater plant was the backup generator (see Photo Log image GUNL0094). The diesel generator is automatically tested every Thursday.

Wastewater Treatment Plant Backup Generator
GUNL0094.JPG
08/03/2022 09:07 AM (ET)
Dean Maraldo
Physical WWTP Inspection/Wastewater Plant Backup Generator
No CBI
No PII
Diesel powered generator.
