## **RCRA Inspection Report**

Howard Industries  
3225 Pendorff Rd  
Laurel, Mississippi 39441

EPA ID # MSD043417476  
NAICS # 335311 - Power  
Distribution and Specialty  
Transformer Manufacturing

November 14, 2023

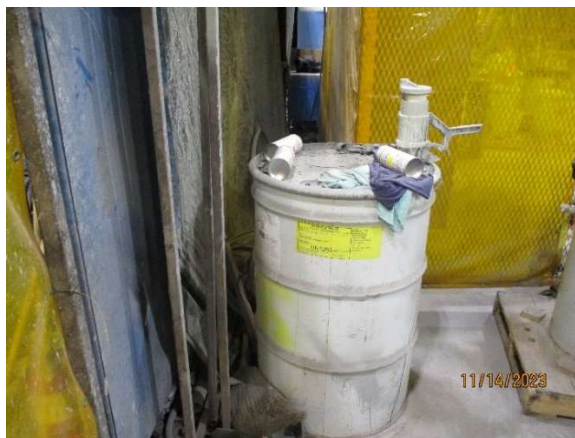
One 55-gallon container (used to puncture and drain the aerosol cans) with waste paint and thinner (D001, D035, F03, and F005) was observed to be closed and labeled with the words "Hazardous Waste" and with an indication of the hazards of the contents. Photo #1

Three aerosol cans (awaiting puncture process) were on top of the container. Photo #1

Photo #1 – Division 1: Container used to puncture and drain the aerosol cans.  
Aerosol cans on top of the container

**Pursuant to 11 Miss. Admin. Code Pt. 3, R. 1.21 [40 C.F.R. § 273.13(e)(4)(ii)], a SQHUW who punctures and drains their aerosol cans must establish and follow a written procedure detailing how to safely puncture and drain the universal waste aerosol can (including proper assembly, operation and maintenance of the unit, segregation of incompatible wastes, and proper waste management practices to prevent fires or releases); maintain a copy of the manufacturer's specification and instruction on site; and ensure employees operating the device are trained in the proper procedures.**

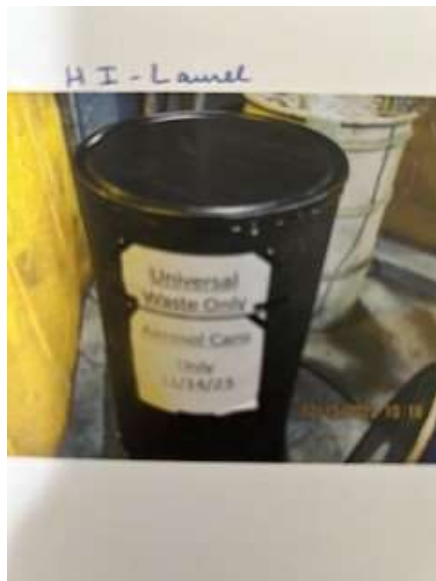
By the end of the day, a drum labeled as "universal waste only, aerosol cans" and dated November 14, 2023, was put in place to store the aerosol cans. Photo #2

Photo #2 – New container labeled as “universal waste only, aerosol cans” and  
dated November 14, 2023

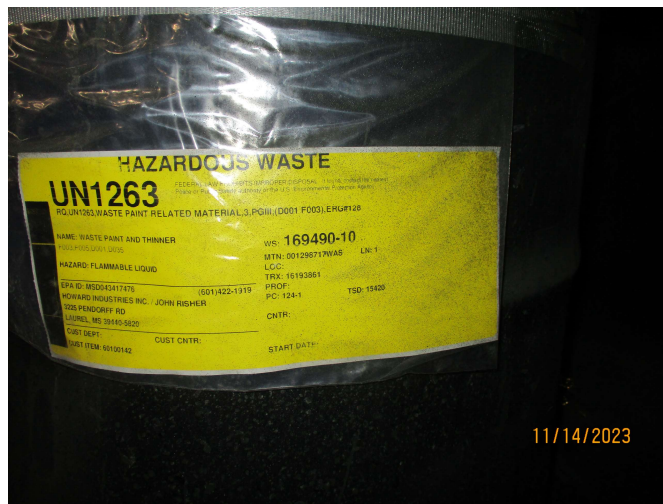
- SA2-001 – Waste stream generated from the robot paint booth northernmost (AB005, paint & solvents). One 55-gallon container with waste paint and thinner (D001, D035, F03, and F005) was observed to be closed and labeled with the words "Hazardous Waste" and with an indication of the hazards of the contents. Photo #3
- SA2-002 – Waste stream generated from the robot paint booth middle (paint & solvents). One 55-gallon container with waste paint and thinner (D001, D035, F03, and

Photo #3 – Container with hazardous waste label

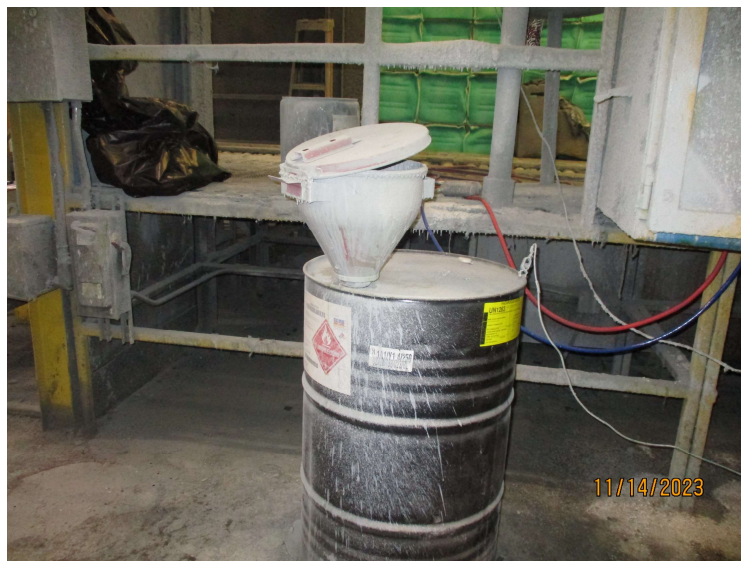
- SA3-002 - Waste stream generated from the tank paint booth. One 55-gallon container with funnel lid that was closed. The container was marked as waste paint and thinner (D001, D035, F03, and F005), with the words “Hazardous Waste”, and with an indication of the hazards of the contents.
- SA3-005 - Waste stream generated from the large side paint (paint & solvents, AB017). One 55-gallon container with funnel lid that was opened (damaged, Photo #4) at the time of the inspection. The container was marked as waste paint and thinner (D001, D035, F03, and F005), with the words “Hazardous Waste”, and with an indication of the hazards of the contents. The funnel was replaced the same day (Photo #5).

Photo #4 – Division 3 SA3-005, open container

**Pursuant to 11 Miss. Admin. Code Pt. 3, R. 1.3 [40 C.F.R. § 262.15(a)(4)], which is a condition of the SAA Permit Exemption, a generator is required to keep containers of hazardous waste closed at all times during accumulation, except when adding, removing, or consolidating waste; or when temporary venting of a container is necessary for the proper operation of equipment, or to prevent dangerous situations, such as build-up of extreme pressure.**

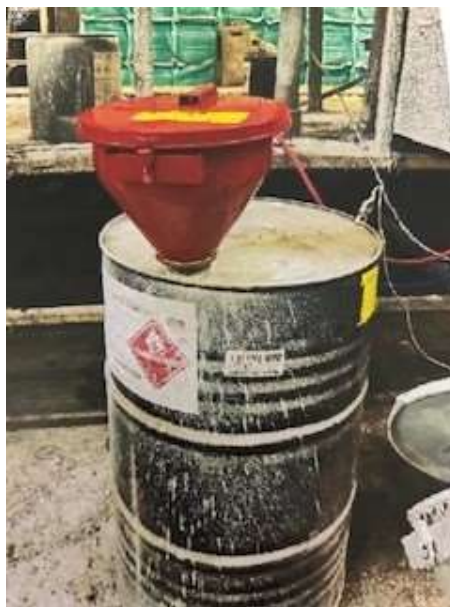
Photo #5 – Division 3 SA3-005, closed container (new funnel)

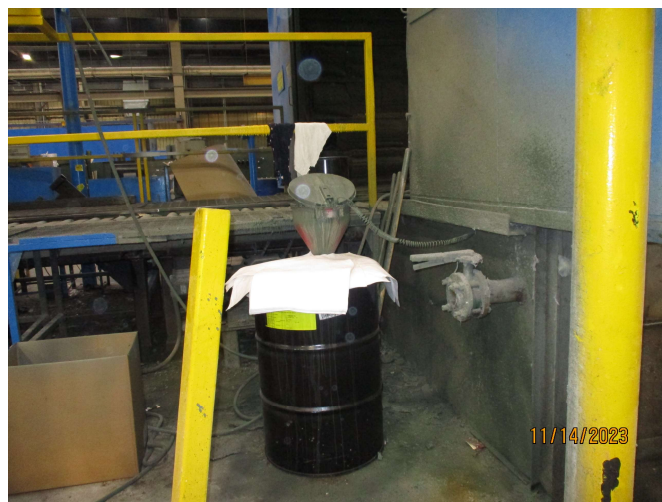
- SA3-006 - Waste stream generated from the large side cover primer and column A9/10 (paint & solvents). One 55-gallon container with funnel lid that was opened

(damaged, Photo #6) at the time of the inspection. The container was marked as waste paint and thinner (D001, D035, F03, and F005), with the words “Hazardous Waste”, and with an indication of the hazards of the contents. The funnel was replaced the same day (Photo #7).

Photo #6 – Division 3 SA3-006, open container

**Pursuant to 11 Miss. Admin. Code Pt. 3, R. 1.3 [40 C.F.R. § 262.15(a)(4)], which is a condition of the SAA Permit Exemption, a generator is required to keep containers of hazardous waste closed at all times during accumulation, except when adding, removing, or consolidating waste; or when temporary venting of a container is necessary for the proper operation of equipment, or to prevent dangerous situations, such as build-up of extreme pressure.**

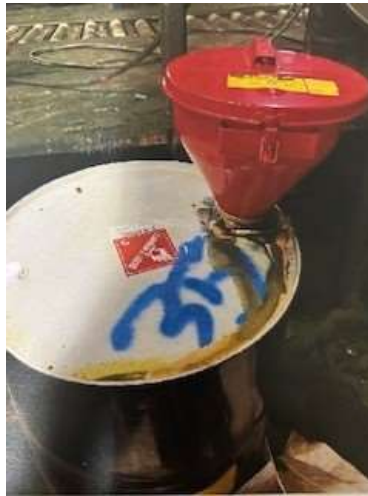
Photo #7 – Division 3 SA3-006, closed container (new funnel)

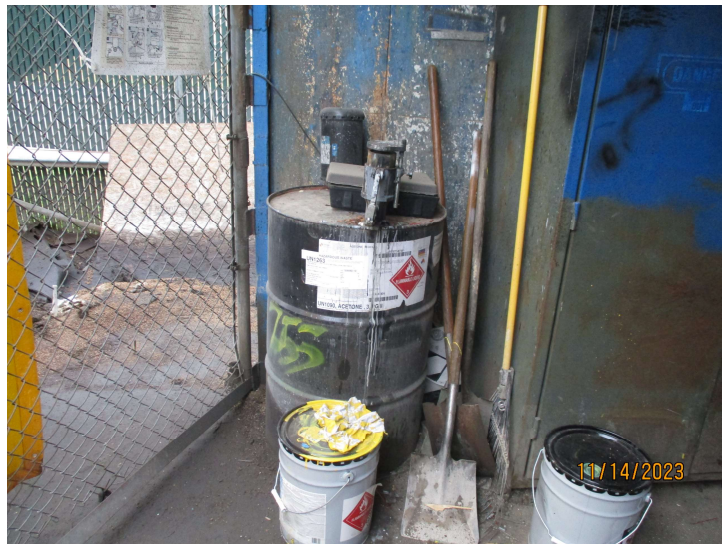
Visited the north shed SAA where one 55-gallon container (used to puncture and drain the aerosol cans) with waste paint and thinner (D001, D035, F03, and F005) was observed to be closed and labeled with the words “Hazardous Waste” and with an indication of the hazards of the contents. Photo #8

Photo #8 – North Shed Aerosol cans container

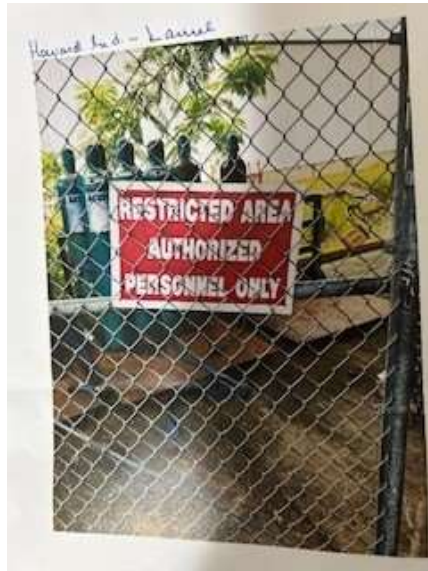
The inspectors visited the 90 days CAA. It is located outside away from facility operations, covered with an overhead roof, and a locked, gated entrance for access. The area was identified with a sign that read “Restricted Area Authorized Personnel Only”. HI manages ignitable waste in this CAA; however, the “No Smoking” sign was not posted in this area. Photo #9

Photo #9 – CAA Sign

**Pursuant to 11 Miss. Admin. Code Pt. 3, R. 1.3 [40 C.F.R. § 262.17(a)(1)(vi)(B)], The large quantity generator must take precautions to prevent accidental ignition or reaction of ignitable or reactive waste. This waste must be separated and protected from sources of ignition or reaction including but not limited to the following: Open flames, smoking, cutting and welding, hot surfaces, frictional heat, sparks (static, electrical, or mechanical), spontaneous ignition (e.g., from heat-producing chemical reactions), and radiant heat. While ignitable or reactive waste is being handled, the large quantity generator must confine smoking and open flame to specially designated locations. “No Smoking” signs must be conspicuously placed wherever there is a hazard from ignitable or reactive waste.**

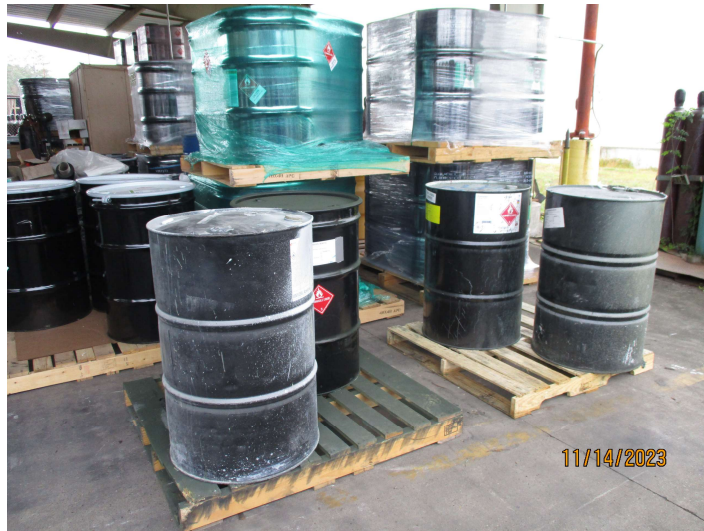
Four 55-gallon containers marked as “flammable”, waste paint and thinner (F003, F005, D001, and D035) were observed closed and dated. The oldest date observed was November 5, 2023.

On two of these containers, the flammable label was partially or covered on paint. This was an area of concern that was corrected at time of the inspection. Photos #10 and #11.

Photo #10 – Containers in CAA

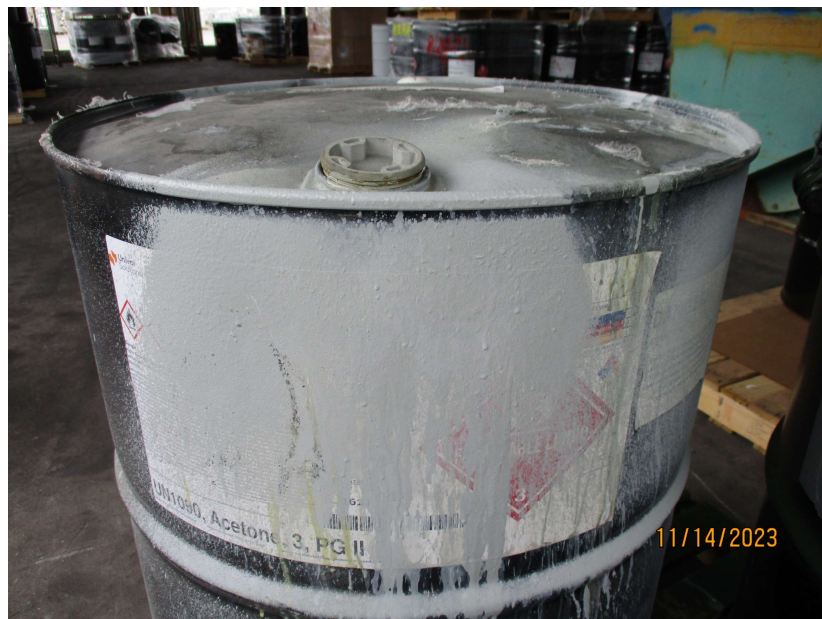
Photo #11 – Area of concern, label covered with paint

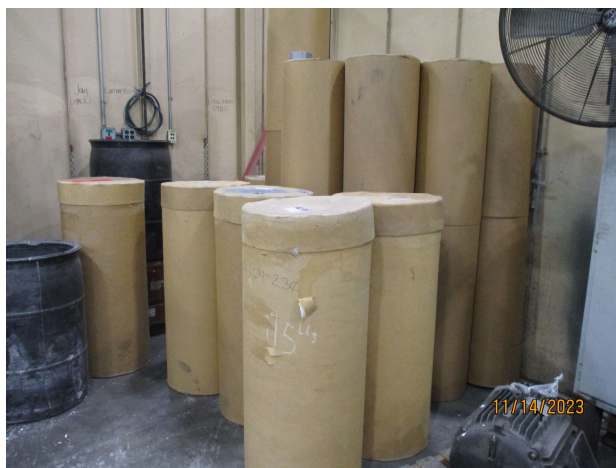
Visited the area designated to store the universal waste lamps. The inspectors observed six containers with 4-foot lamps, one container with 8-foot lamps, and one box with bulbs. The containers were labeled "Universal Waste Lamps", were closed, and marked with the accumulation starting date. The oldest date observed was August 1, 2023. Photo #12.

Photo #12 – Universal Waste Lamps

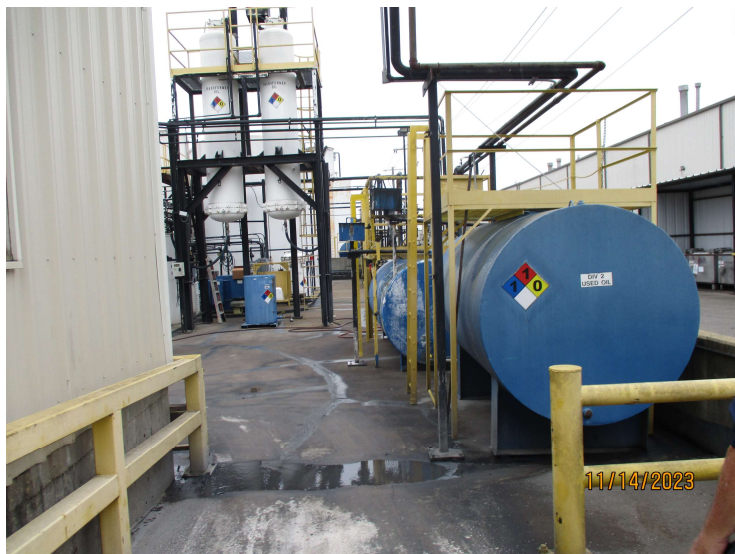
The inspectors visited the tank farm area and observed six single-walled tanks used to store used oil. The tanks range from approximately, 300-gallons to 5,000-gallons in capacity and are located within a concrete secondary containment (Photo #13). The tanks were marked as "Used Oil". Several cracks were observed in the secondary containment that could be compromising its integrity. Photo #14. HI uses Fluids, Inc. (ID MSR000103457) to pick up the used oil. Last shipment was on November 10, 2023.

Photo #13 – General view used oil tanks in secondary containment.

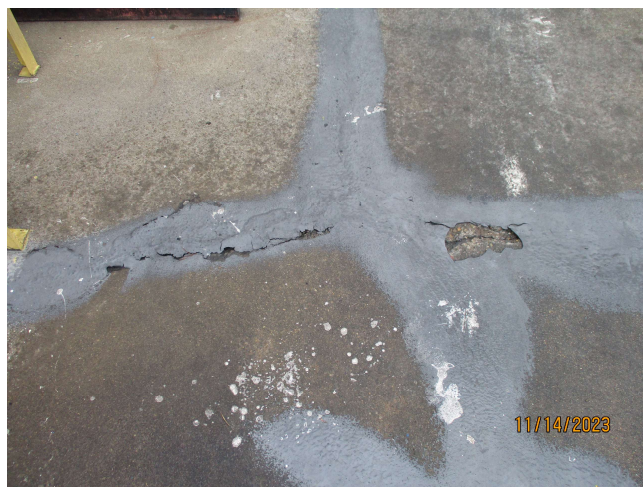
Photo #14 – Cracks on secondary containment

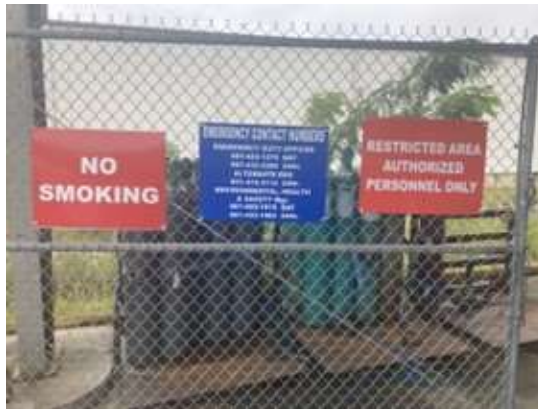
Photo #16 – New Signage in the CAA  
(received by email on November 29, 2023)
