## **RCRA Inspection Report**

| Sentury Reagents, Inc. | EPA ID#: SCD982085136 |

November 16, 2021

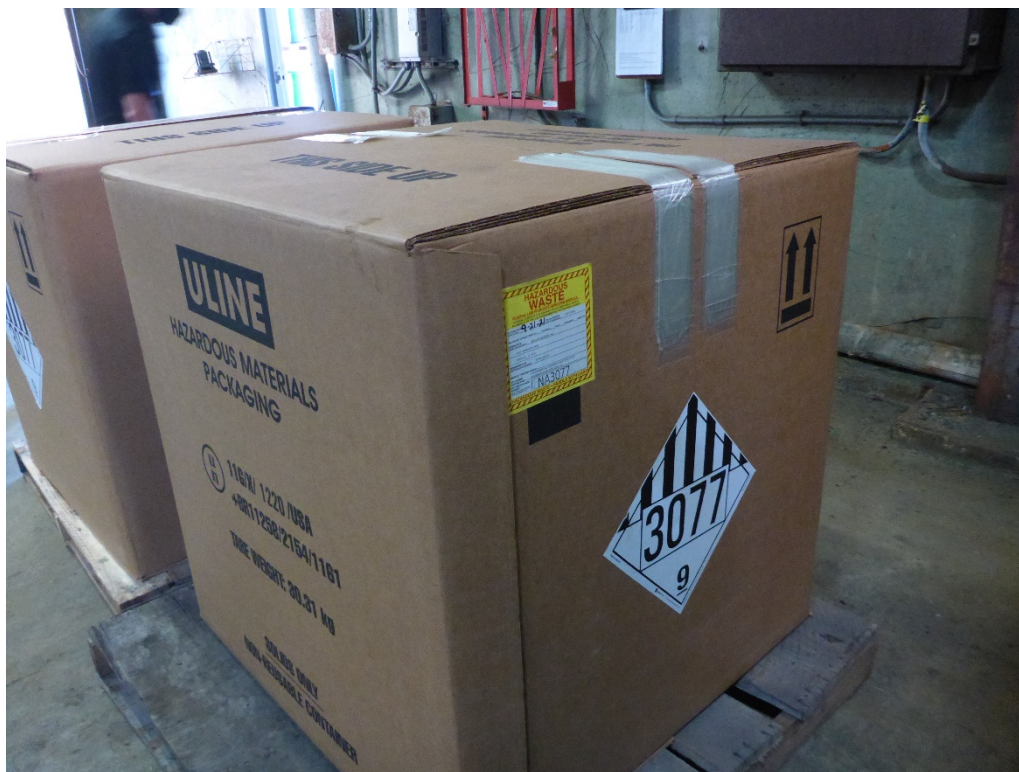
The inspectors observed two cubic yard boxes on wooden pallets in the designated CAA (Photos 3 and 4). Mr. Ellis stated that the boxes contain used gloves, respirator cartridges and other PPE, empty product bags and other contaminated trash. Each box was labeled D007 / D008 hazardous waste solid and identified with a DOT class 9 hazard placard. One box was dated 11/16/2021 and the other was dated 09/21/2021.

**Pursuant to 25 S.C. Code Ann. Regs. 61-79.262.16(b)(6)(i)(B) [40 C.F.R. § 262.16(b)(6)(i)(B)], which is a condition of the SQG Permit Exemption, a generator is required to mark or label its containers with an indication of the hazards of the contents.**

**Photo 4:** Two cubic yard boxes of used gloves, respirator cartridges and other PPE, empty product bags and contaminated trash in the CAA. Each box was labeled D007 / D008 hazardous waste solid and identified with a DOT class 9 hazard placard. One box was dated 11/16/2021 and the other was dated 09/21/2021.

On the day following the inspection, Mr. Ellis sent an email to the inspectors which included a photograph to show that the hazardous waste labels had been modified to indicate that the contents of these containers are toxic.
