**Well Inspection**  
**Osage DNR / Environmental Protection Agency**  
**1201 Elm Street, Suite 500**  
**Dallas, Texas 75270**

| <b>Operator Info</b> | Thunder Petroleum, LLC<br>5100 E. Skelly Dr., Suite 600<br>Tulsa, OK 74135<br>Phone: 918-638-7054 | <b>Inventory ID</b> | OS5574000 | | |
| | | <b>Well ID</b> | 9-A | | |
| <b>Location</b> | NE 24 25N 09E | <b>Status</b> | Inactive | <b>Well Type</b> | Disposal |

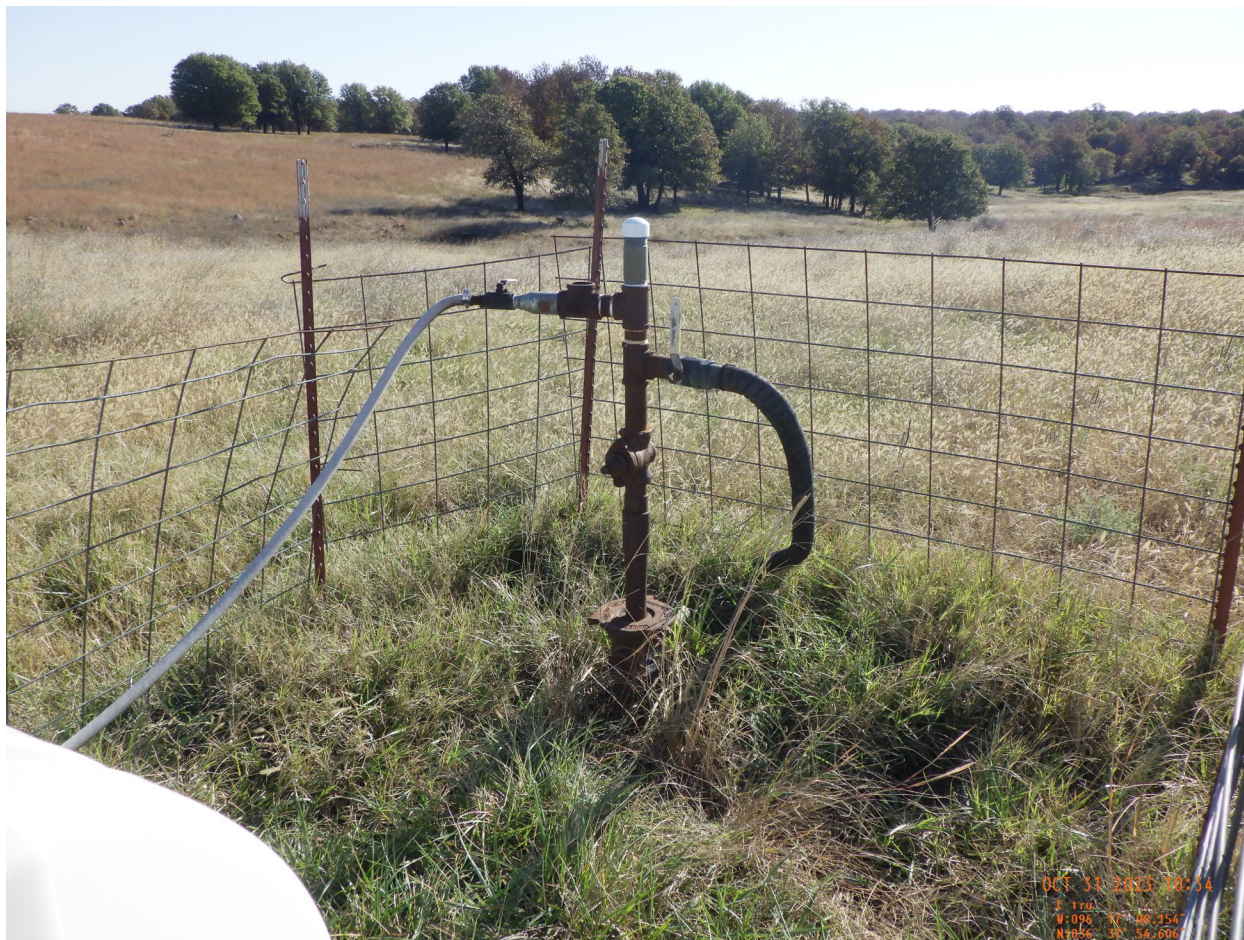
Photo No. 1

| <b>Inspection Comments</b> | At the time of the inspection, well OS5574000 was connected but not injecting, there was no well sign present. At the time of the inspection, the tubing valves were not working and there was no access to observe the fluid level in the tubing. Inspector was able to access the annulus of the well and observed no pressure or vacuum present through an open valve. Inspector shot the annular fluid level with the EPA Echometer but the return was immediate indicating the liquid level was very near the land surface, less than 30 feet down hole. | | | | |

**Description:** This was well OS5574000 at the time if the inspection.
