## **RCRA Inspection Report**

MacLean Power Systems  
7801 Park Place Road  
York, South Carolina 29745

EPA ID# SCD987579109

May 19, 2022

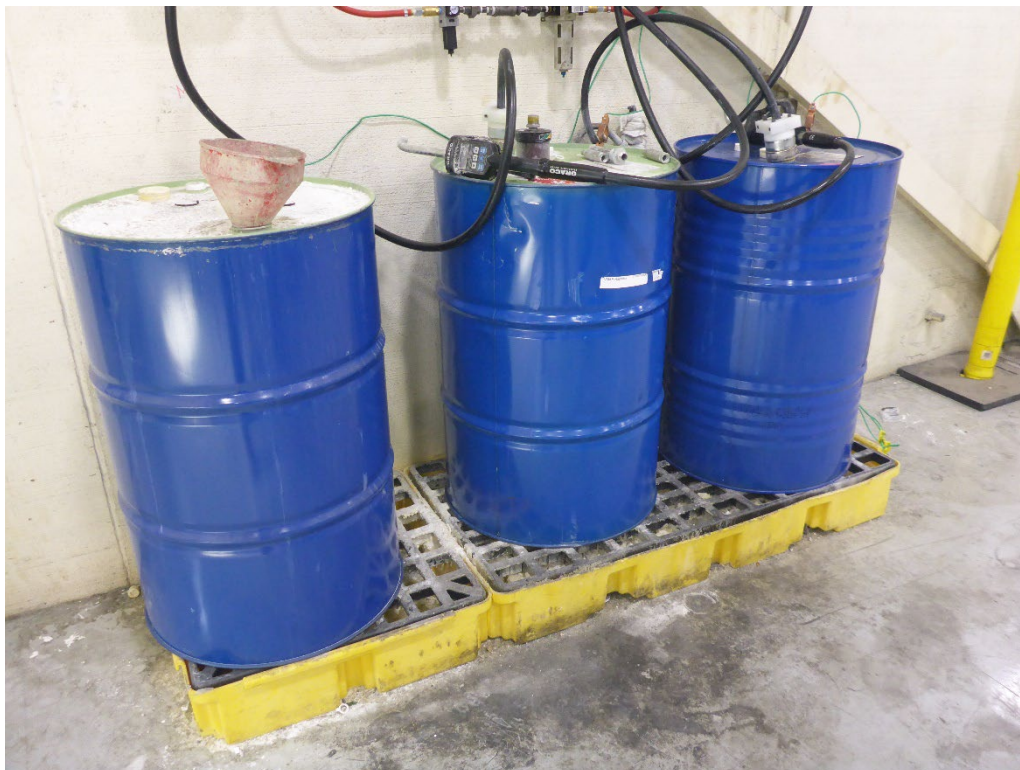
The inspectors observed three 55-gallon drums on portable secondary containment pallets at this SAA (Photo 1). The first 55-gallon drum contained virgin naphtha, the second contained virgin prime coat, and the third contained hazardous waste naphtha primer mixture. The 55-gallon drum containing hazardous waste naphtha primer liquid mixture was equipped with a funnel to receive hazardous waste naphtha primer liquid mixture (Photo 2). The container was not labeled; and although hazardous waste was not being actively added to or removed from the container, the funnel was open. The inspectors observed material filling the portable secondary containment pallet, which was open and not labeled. It appeared that this material had spilled from the containers and into the secondary containment pallet, where it had hardened.

**Photo 1:** Three 55-gallon drums on portable secondary containment pallets at the Fiber One Single Spin Machine Area SAA. The drum on the left, which contains hazardous waste naphtha primer liquid mixture, was not closed or labeled.

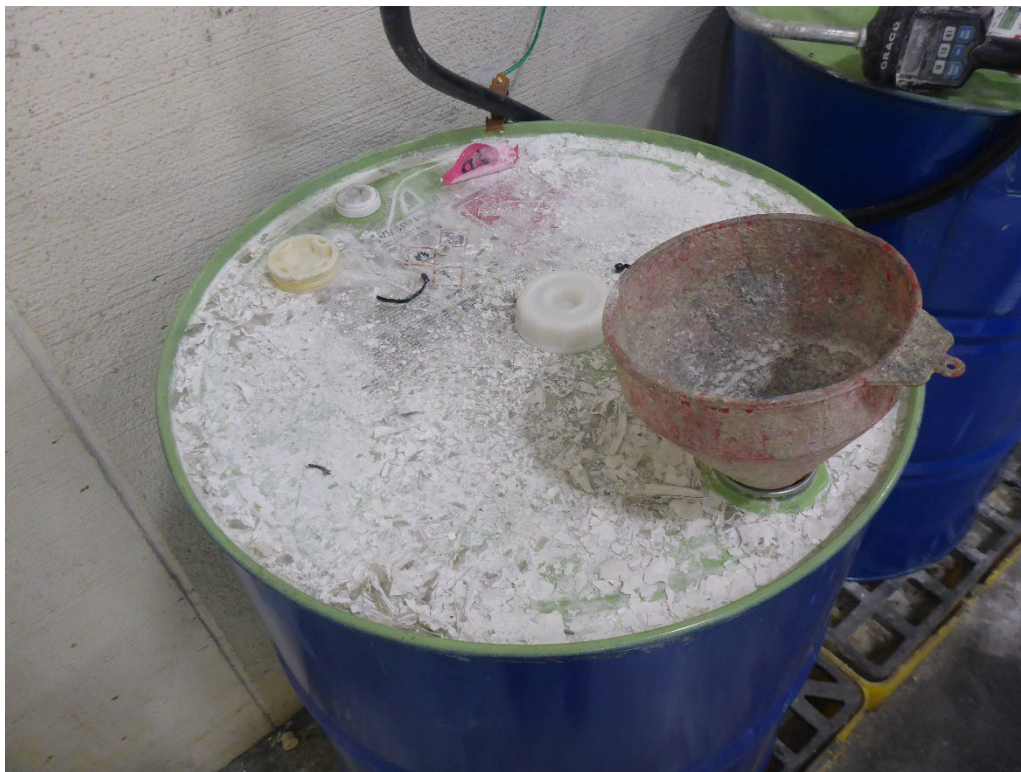
- **(Page 4)** The inspectors observed one 55-gallon drum of hazardous waste naphtha primer liquid mixture equipped with a funnel to receive hazardous waste naphtha primer liquid mixture in the Fiber One Single Spin Machine Area SAA. The container was not labeled; and although hazardous waste was not being actively added to or removed from the container, the funnel was open. The inspectors also observed material filling the portable secondary containment pallet, which was also open and not labeled. **(Photo 2)**

**Photo 2:** Open funnel in the container of hazardous waste naphtha primer liquid mixture at the Fiber One Single Spin Machine Area SAA.

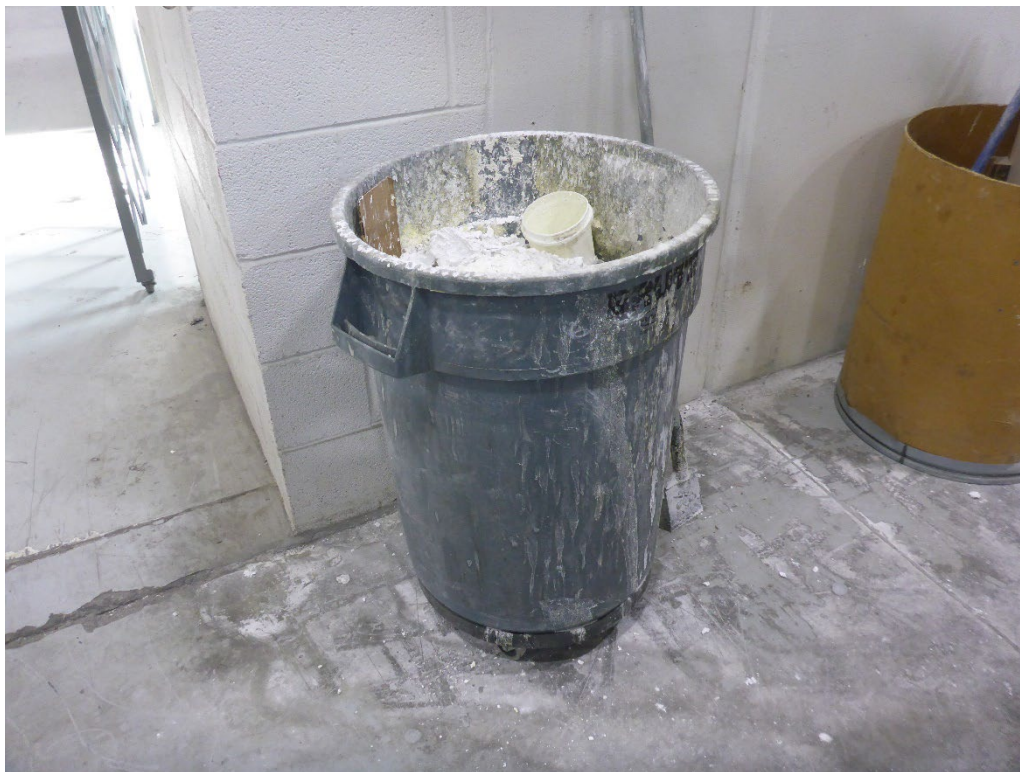
1388 Area: The inspectors observed an open trash can containing hardened primer in the 1388 Area (Photo 3). Facility personnel explained that this material is swept up from the floor beneath the molding unit. On June 3, 2022, SCDHEC sent an email to MPS requesting documentation that would support the determination that this material is not a hazardous waste, but the inspectors have not yet received this documentation.

- **(Page 4)** The inspectors observed an open trash can containing hardened primer in the 1388 Area. On June 3, 2022, SCDHEC sent an email to MPS requesting documentation that would support the determination that this material is not a hazardous waste, but the inspectors have not yet received this documentation.

**Photo 3:** Open trash can containing hardened primer in the 1388 Area.

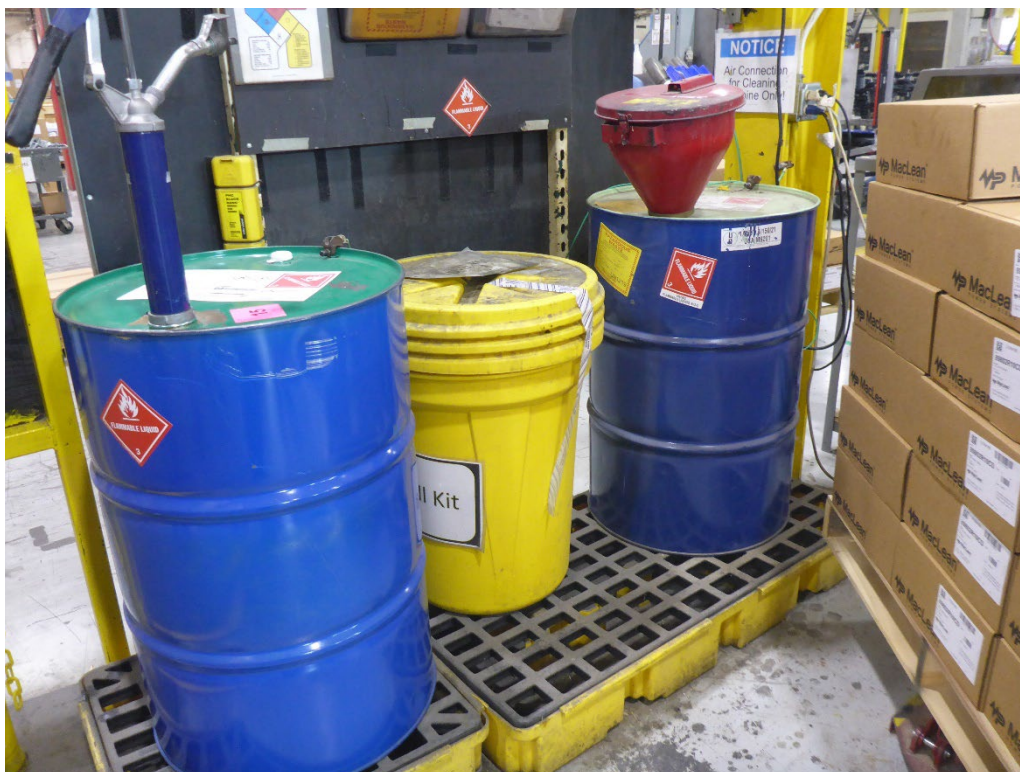
The inspectors observed two 55-gallon drums and a spill kit on portable secondary containment at this SAA (Photo 4). The first 55-gallon drum contained virgin isopropyl alcohol and the second contained hazardous waste isopropanol. The 55-gallon drum containing spent isopropyl alcohol was labeled D001 hazardous waste isopropanol, identified with a DOT flammable liquid hazard placard, and equipped with a latched funnel.

**Photo 4:** Two 55-gallon drums and a spill kit at the Cut Out Area SAA. The drum on the right contains D001 hazardous waste isopropanol.

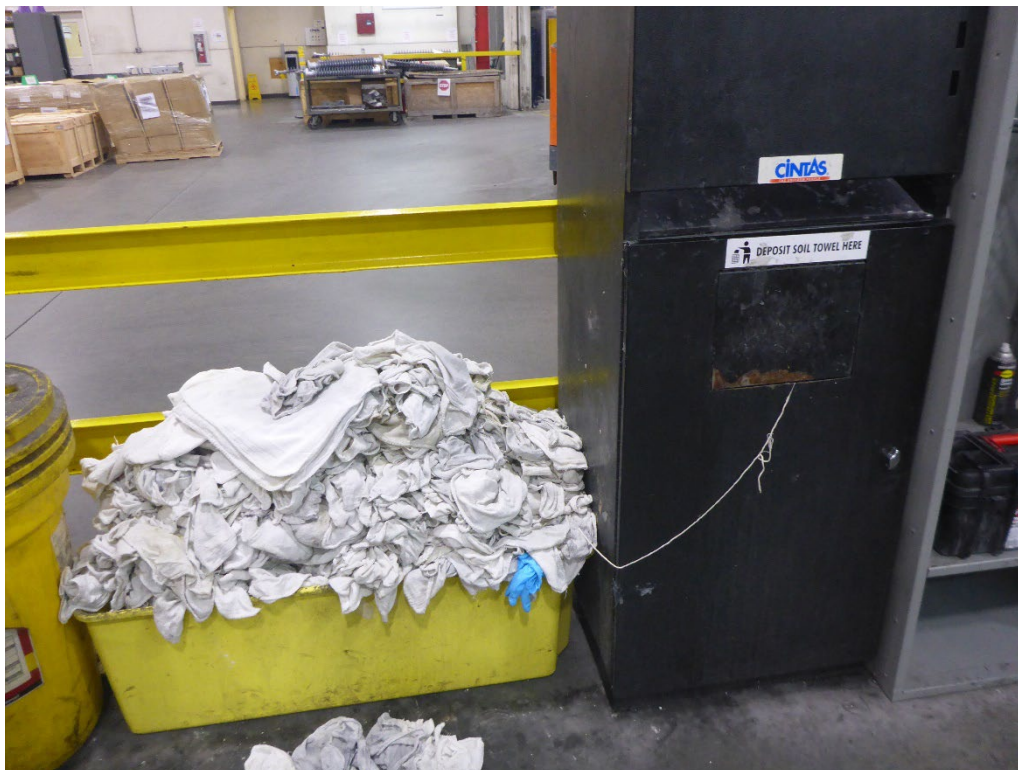
The inspectors observed two 55-gallon drums on portable secondary containment at this area. The first 55-gallon drum contained virgin isopropyl alcohol and the second contained hazardous waste isopropanol. The 55-gallon drum containing spent isopropyl alcohol was labeled D001 hazardous waste isopropanol and identified with a DOT flammable liquid hazard placard. The drum was equipped with a latched funnel, and the area was equipped with a spill kit. The inspectors also observed an open bin of used solvent contaminated wipes in the SAA (Photo 5). Facility personnel explained that Cintas picks up the used wipes and replaces them with clean ones. Cintas takes the used wipes off-site to be laundered for reuse. The inspectors noted that the used wipes were damp, they were in an open bin, and the bin was not labeled.

- **(Page 5)** The inspectors observed an open bin of used solvent contaminated wipes in the Compositz SAA. The used wipes were damp, they were in an open bin, and the bin was not labeled. **(Photo 5)**

**Photo 5:** Bin of used solvent contaminated wipes observed at the Compositz SAA.

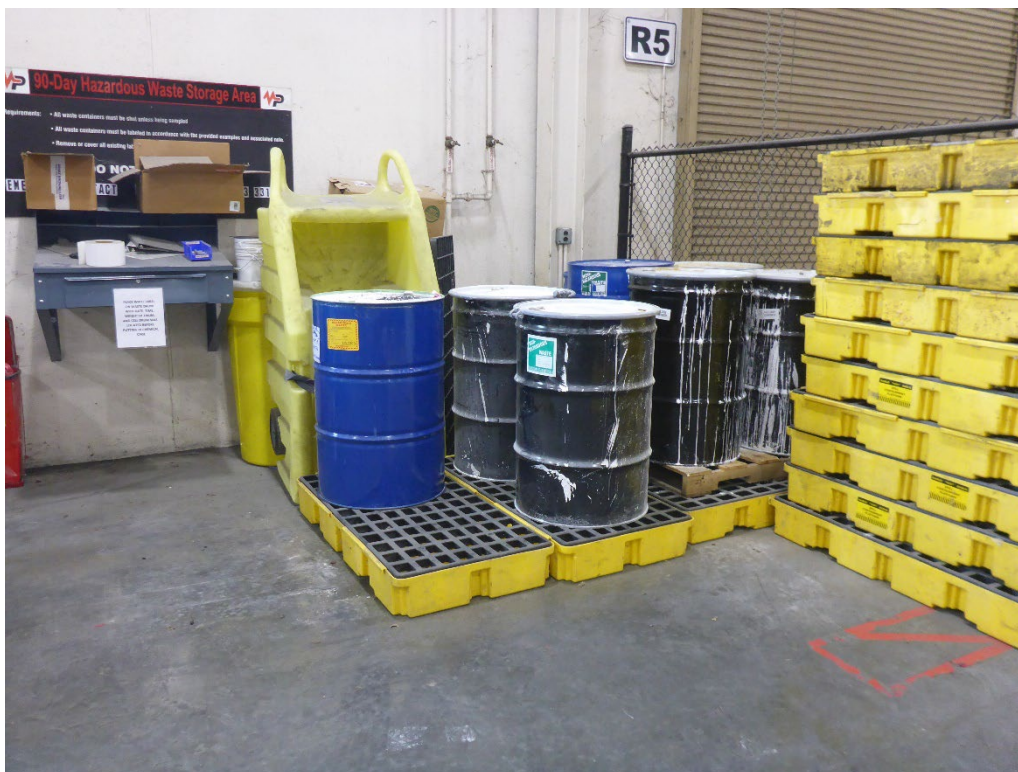
In the far corner immediately to the left inside the entrance to the caged CAA, the inspectors observed eight 55-gallon drums (Photo 6). One drum was labeled D001 hazardous waste flammable liquids (naphtha, propyl acetate), identified as flammable liquids, and dated May 19, 2022. The remaining drums were labeled nonhazardous waste.

**Photo 6:** Eight 55-gallon drums located in the far corner immediately to the left inside the entrance to the caged CAA. The drum on the left contains D001 hazardous waste flammable liquids (naphtha, propyl acetate), and the remaining seven drums contain nonhazardous waste.

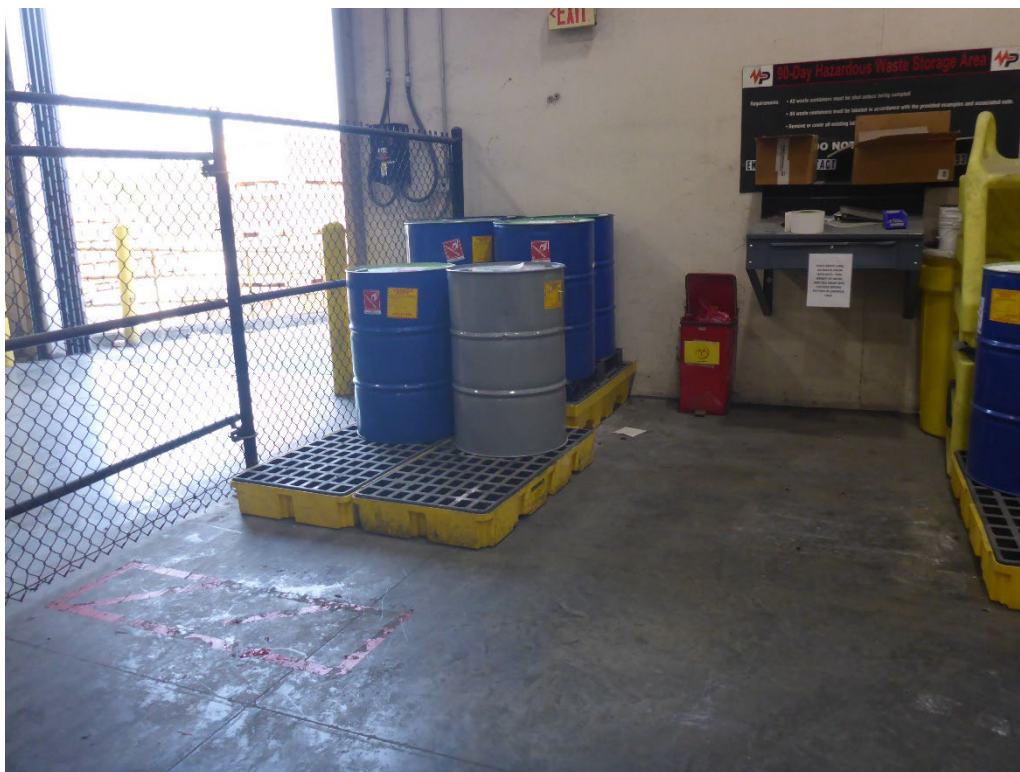
In the near corner immediately to the left inside the entrance to the caged CAA, the inspectors observed six 55-gallon drums on portable secondary containment pallets (Photo 7):

- One labeled hazardous waste flammable liquid and dated May 17, 2022;
- One identified as flammable liquid, dated May 18 without a year, and not labeled as hazardous waste;
- One with a ripped hazardous waste label, identified as flammable liquid and dated May 19, 2022;
- One labeled D001 hazardous waste isopropyl alcohol, identified as flammable liquid, and dated May 18 without a year;

- One labeled D001 hazardous waste IPA, identified as flammable liquid, and dated May 18 without a year; and
- One with a hazardous waste label facing the wall, with no visible indication of hazards, and dated May 14, 2022.

**Photo 7:** Six 55-gallon drums on portable secondary containment pallets in the near corner immediately to the left inside the entrance to the caged CAA.

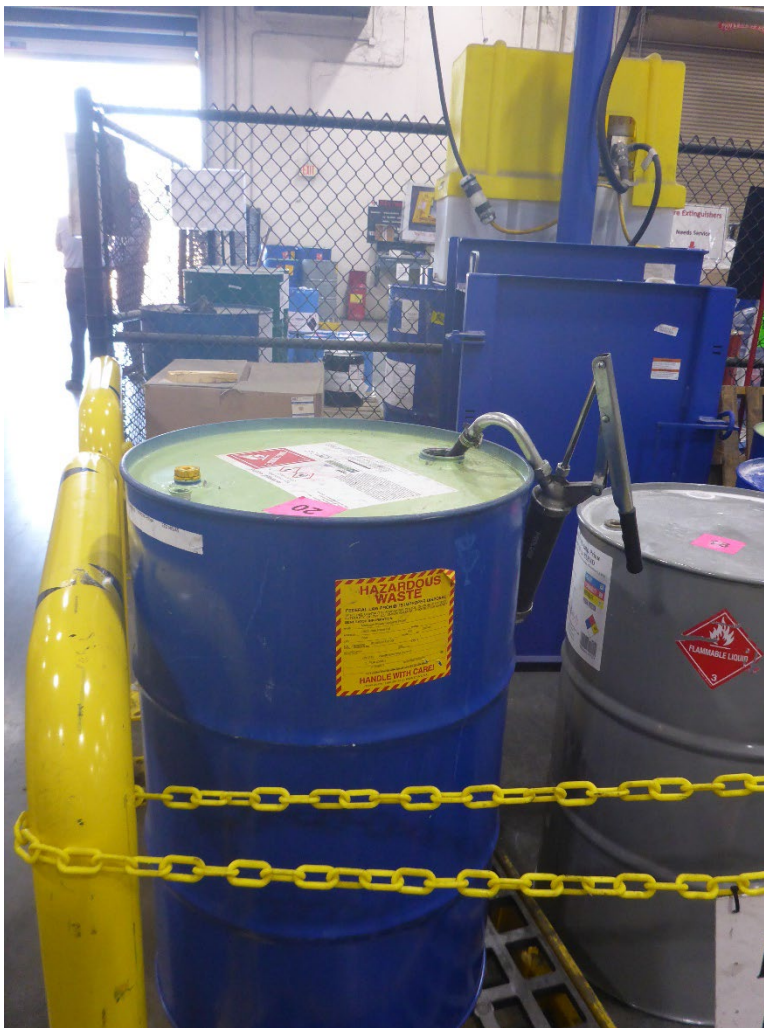
Outside Caged Area SAA: MPS manages one SAA for accumulating heels left in 55-gallon drums of virgin isopropanol. The inspectors observed one 55-gallon drum on a portable secondary containment pallet in this area, which is located outside the caged CAA (Photo 8). The 55-gallon drum was labeled D001 hazardous waste isopropyl alcohol and identified with a DOT flammable liquid hazard placard. Although hazardous waste was not being actively added to or removed from the container, the bung had been removed from the drum, leaving the container open.

- **(Page 7)** The inspectors observed one 55-gallon drum on a portable secondary containment pallet in the SAA located outside the caged CAA. The container was labeled D001 hazardous waste isopropyl alcohol and identified with a DOT flammable liquid hazard placard. The bung had been removed from the drum, leaving the container open. **(Photo 8)**

**Photo 8:** One 55-gallon drum of hazardous waste isopropanol in the SAA located outside of the caged CAA. The bung had been removed from the drum, leaving the container open.

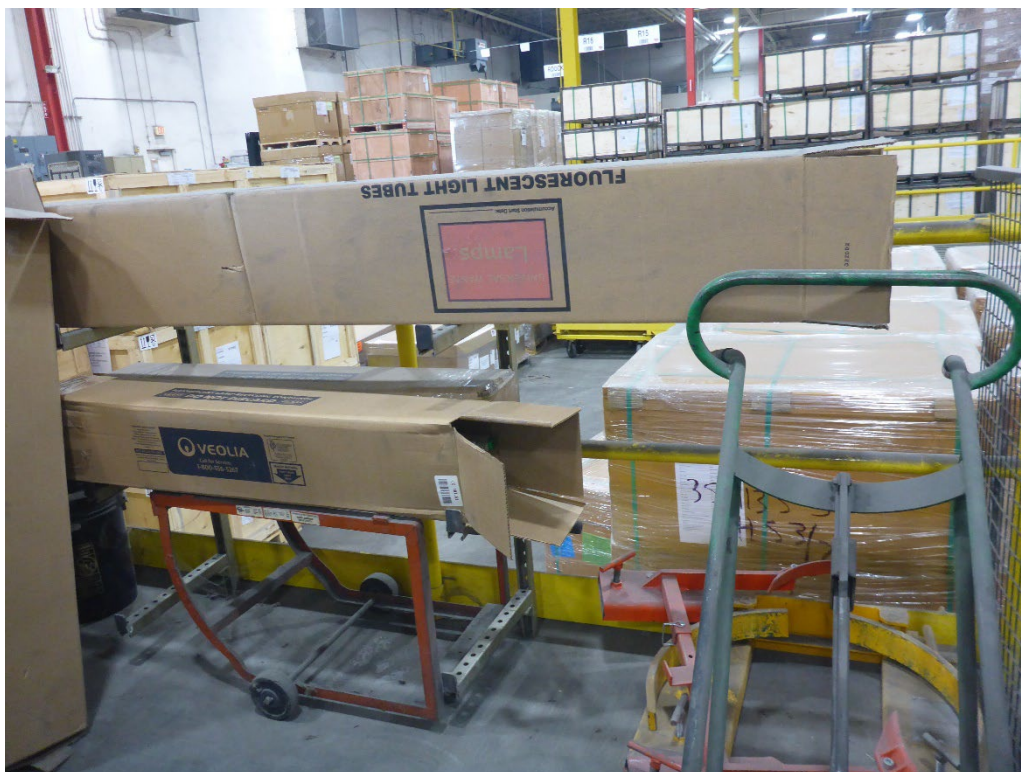
MPS also manages universal waste outside the caged CAA. The inspectors observed one box of 8-ft spent fluorescent lamps, two boxes of 4-ft spent fluorescent lamps, one 5-gallon bucket of broken lamps, and one 5-gallon bucket of mercury containing equipment in this area (Photos 9 and 10). Each box of spent lamps was labeled universal waste fluorescent lamps, but the bucket of broken lamps was labeled universal waste broken bulbs (not “lamps”). The bucket of mercury containing equipment was labeled universal waste mercury containing equipment. The 8-ft box and one 4-ft box were open.

**Photo 9:** One open box of 8-ft universal waste fluorescent lamps, one open box of 4-ft universal waste lamps, and one closed box of 4-ft universal waste lamps in the area just outside of the caged CAA.

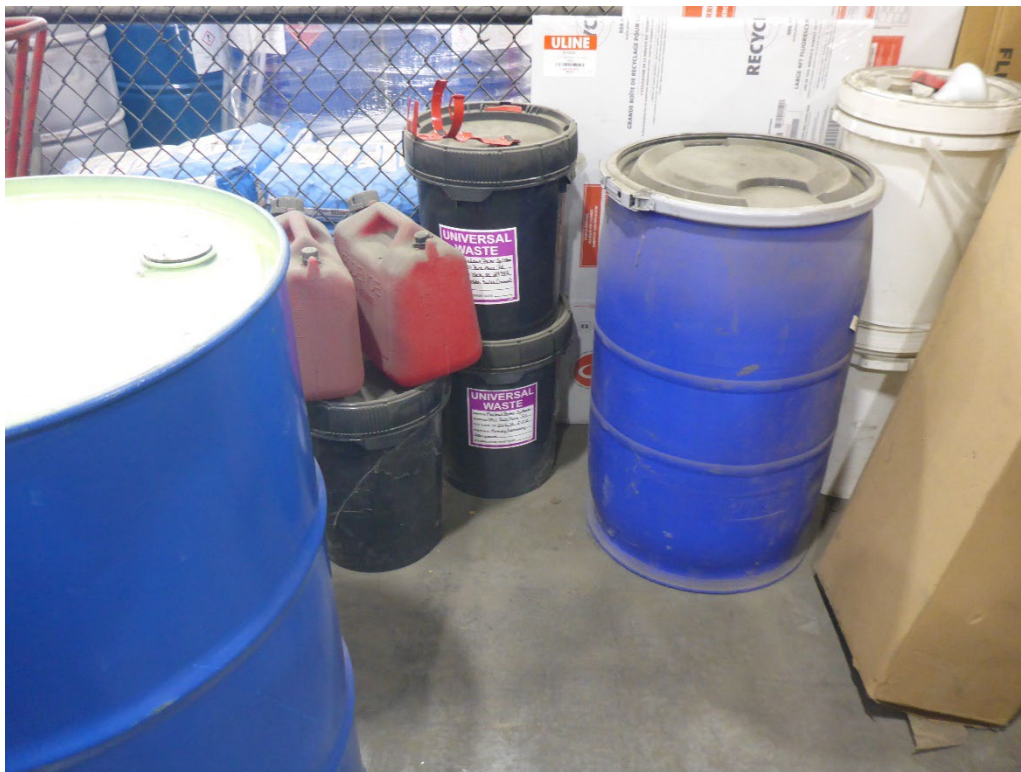
**Photo 10:** One 5-gallon bucket of broken fluorescent lamps and one 5-gallon bucket of universal waste batteries in the area just outside of the caged CAA.

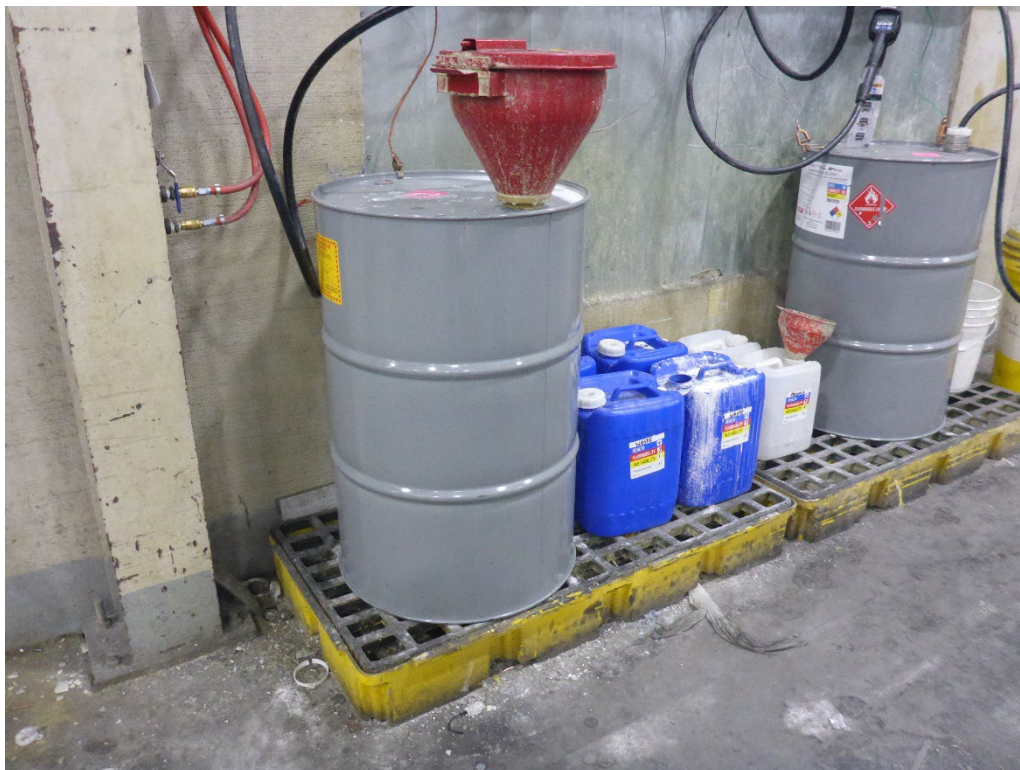
The inspectors observed two 55-gallon drums and six 5-gallon containers on portable secondary containment at this SAA (Photo 11). The first 55-gallon drum contained virgin naphtha propyl acetate, and the second contained hazardous waste naphtha propyl acetate. All of the 5-gallon containers were empty. The 55-gallon drum containing spent naphtha propyl acetate was labeled D001 hazardous waste isopropanol and identified with a DOT flammable liquid hazard placard. The drum was equipped with a funnel, and although hazardous waste was not being actively added to or removed from the container, the funnel was not latched (Photo 12).

**Photo 11:** Two 55-gallon drums, four empty blue containers and two empty white containers at the Molded Area Primer Station SAA. The drum on the left contains hazardous waste isopropanol.

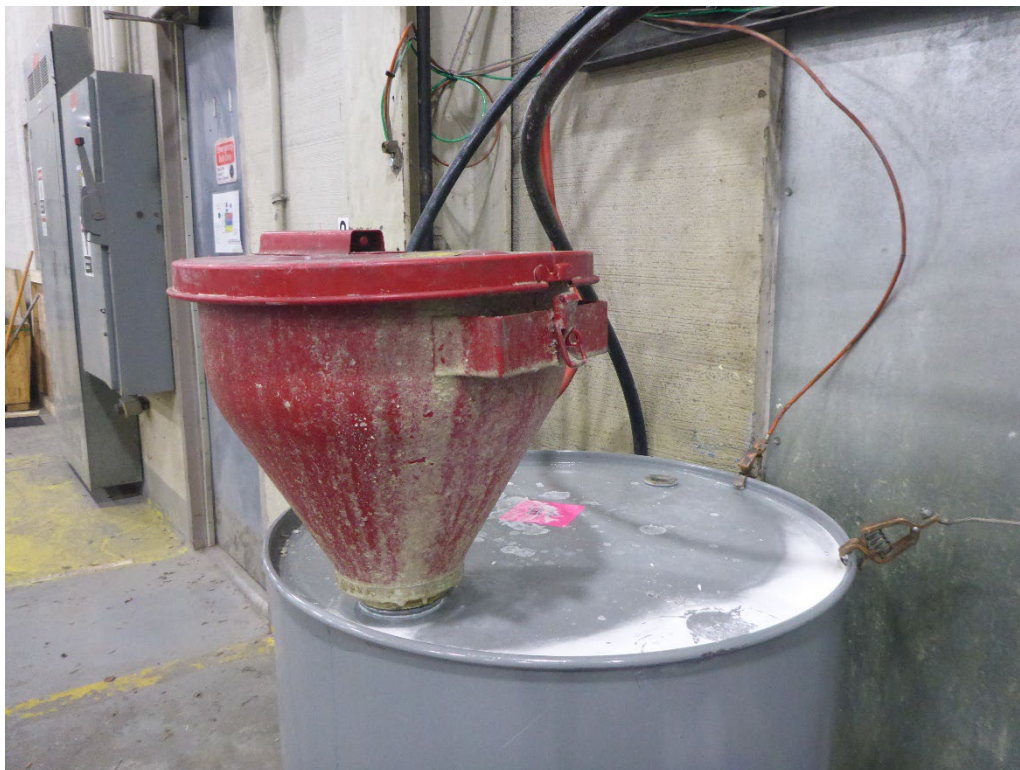
- **(Page 8)** The inspectors observed one 55-gallon drum of hazardous waste naphtha propyl acetate on a portable secondary containment unit in the Molded Area Primer Station SAA. The drum was labeled D001 hazardous waste isopropanol and identified with a DOT flammable liquid hazard placard. The drum was equipped with a funnel, and although hazardous waste was not being actively added to or removed from the container, the funnel was not latched **(Photo 12)**.

**Photo 12:** Unlatched funnel on the drum of hazardous waste isopropanol in the Molded Area Primer Station SAA.

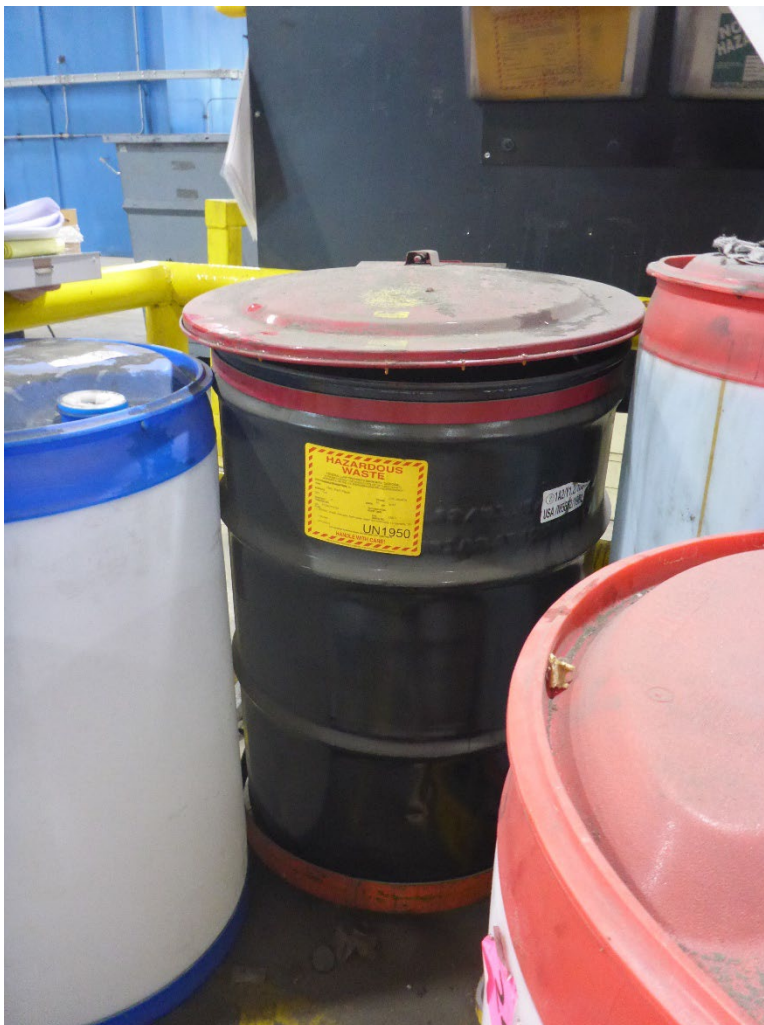
SmartFoam Part A & B SAA: MPS manages one SAA for accumulating spent aerosol cans in the SmartFoam Part A & B Area. The inspectors observed three 55-gallon drums on portable secondary containment at this SAA. The first two 55-gallon drums contained non-RCRA SmartFoam A & B liquid wastes, and the third contained spent aerosol cans (Photo 13). The inspectors reviewed waste profiles for the SmartFoam A & B wastes. The 55-gallon drum containing spent aerosol cans was labeled D001 hazardous waste aerosols and identified as flammable. The drum was equipped with a flip-top lid that did not make complete contact between the lid and the rim all around the top of the container.

**Photo 13:** One 55-gallon drum of D001 hazardous waste aerosols in the SmartFoam Part A & B SAA. The lid did not make complete contact between the lid and the rim of the drum.

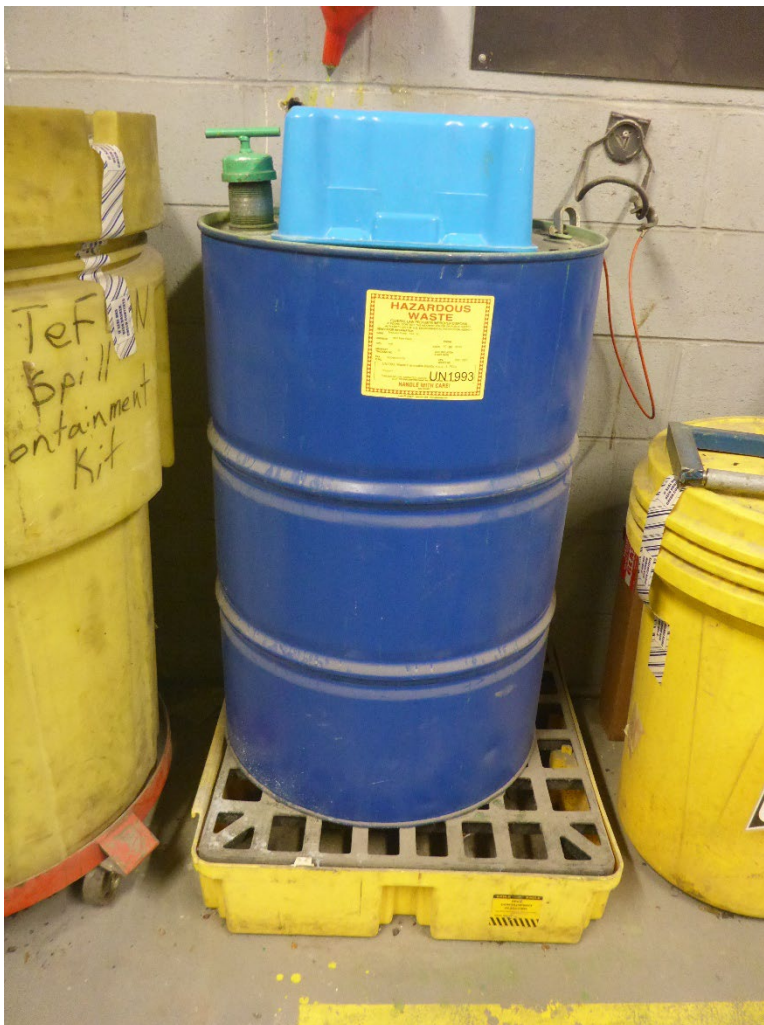
The inspectors observed one 55-gallon drum on a portable secondary containment pallet in the first SAA (Photo 14) and another 55-gallon drum on a drum compactor in the second SAA (Photo 15). The first drum was labeled D001 / D007 hazardous waste and identified with a DOT flammable liquid hazard placard, but it was not marked to indicate that the contents are toxic. The second drum was labeled D007 hazardous waste solid (chromium) and identified with a DOT class 9 hazard placard, but it was not marked to indicate that the contents are toxic.

**Photo 14:** One 55-gallon drum of D001 / D007 hazardous waste flammable liquids in one of two SAAs inside the Teflon Room. The drum is labeled hazardous waste and identified as a flammable liquid, but it is not marked with an indication that the contents are toxic.

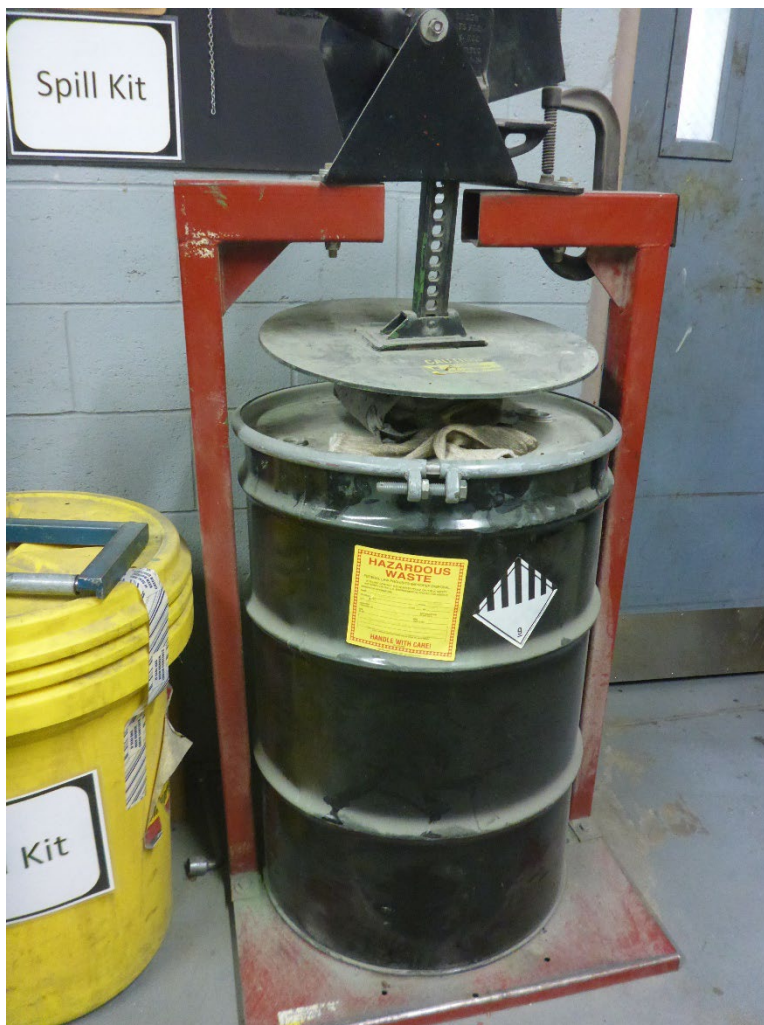
Class 9 hazard placard, but it was not marked to indicate that the contents are toxic.  
(Photo 14-15)

**Photo 15:** One 55-gallon drum of D007 hazardous waste solids in one of two SAAs inside the Teflon Room. The drum is labeled hazardous waste and identified with a DOT class 9 hazard placard, but it is not marked with an indication that the contents are toxic.
