## **Murrells Inlet WWTP**

# **NPDES Compliance Evaluation Inspection**

**1441 Pond Rd. Murrells Inlet, SC**

**Project Date(s): July 23<sup>rd</sup>, 2024**

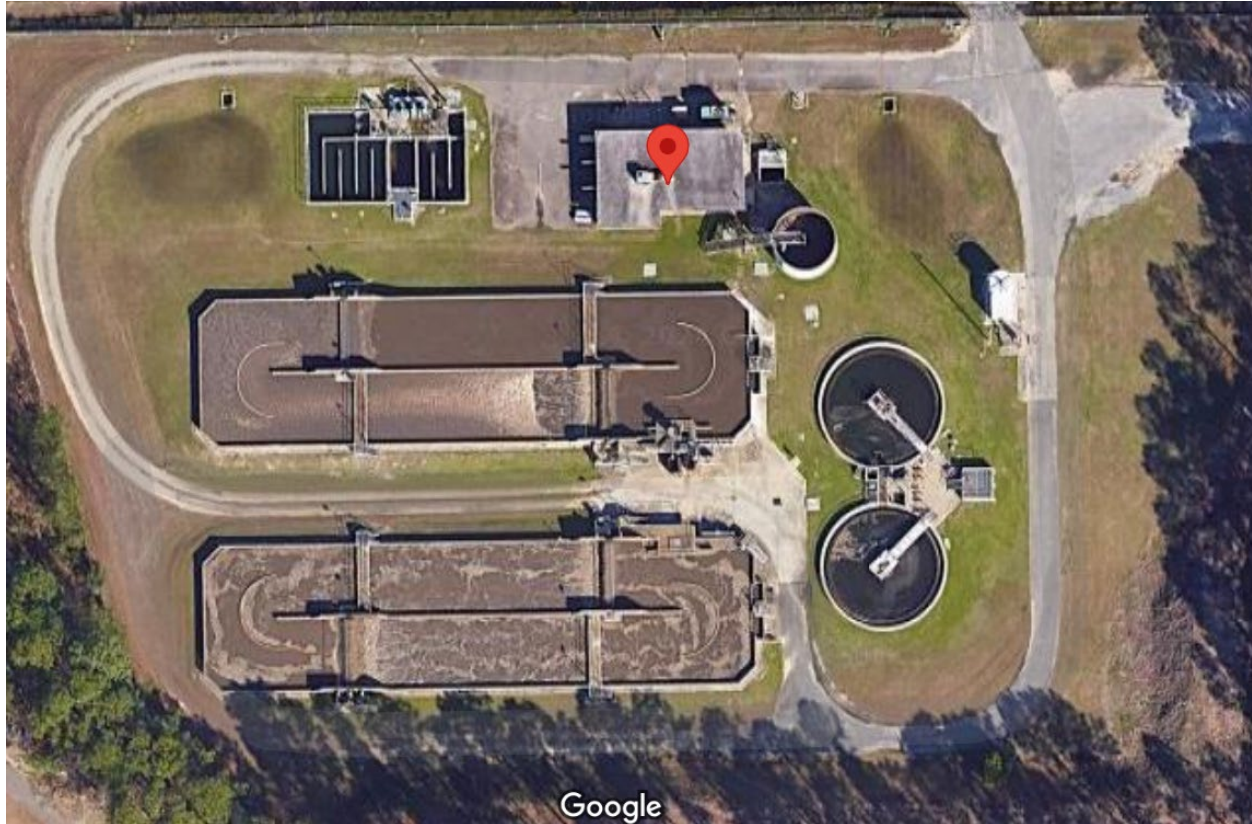
Murrells Inlet WWTP treatment system includes two identical systems of mechanical bar screens, oxidation ditches, secondary clarifiers, and chlorine contact chambers with four feet wide rectangular weirs to measure effluent flow (see Figure 1). Waste sludge is sent via tanker truck to Pawley's Island WWTP for disposal.

Figure 1 – Facility Aerial View

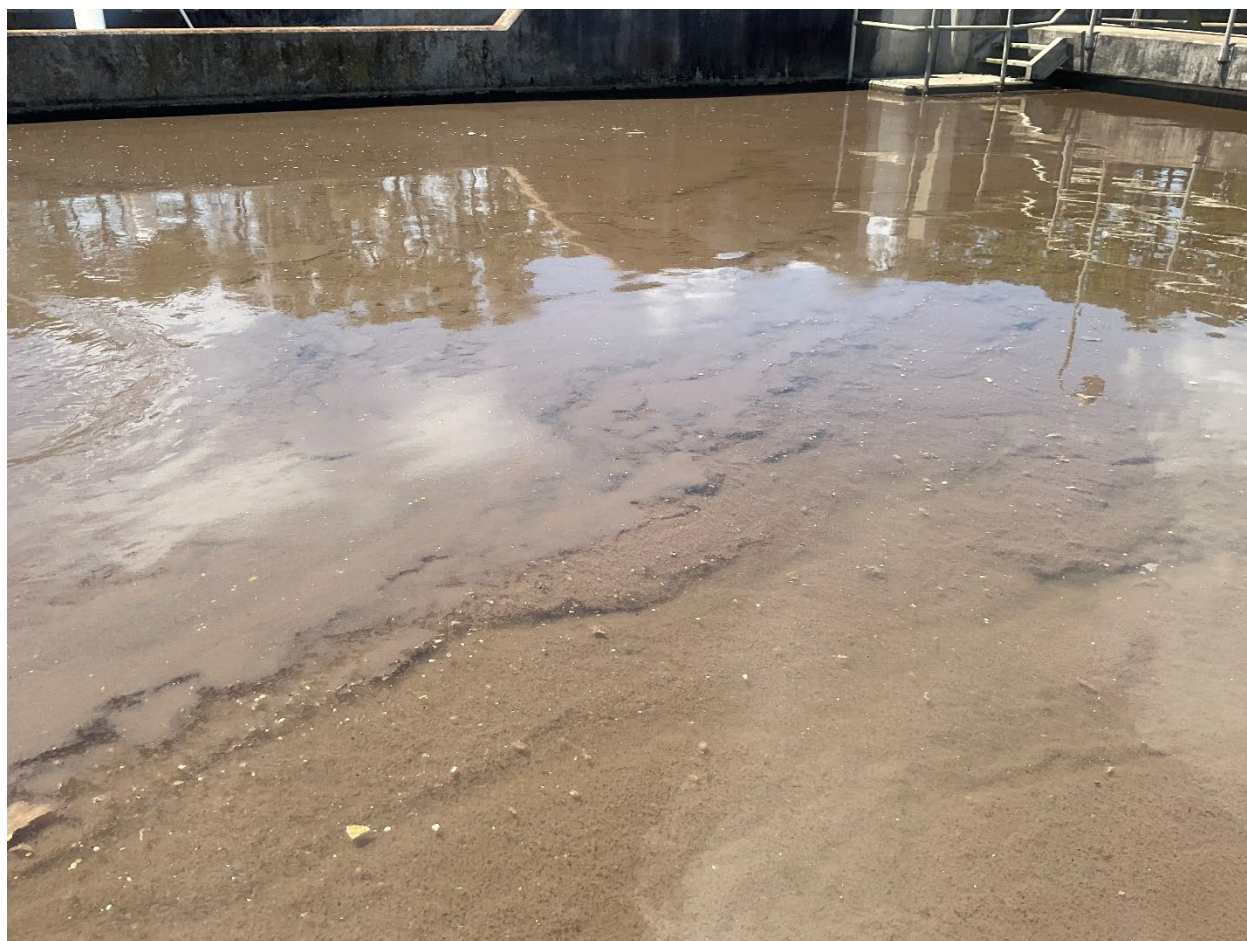
The facility is operating and working to maintain its treatment units to meet its NPDES permit requirements. At the time of the inspection, the grit chamber was not operational, and the facility stated that it is waiting for a new pump to repair the unit. There was some amount of grit seen in both oxidation ditches (Figure 2) and secondary clarifiers (Figure 3). Additionally, the secondary clarifiers had a lot of algae growth on the weir plates (Figure 3).

*Figure 2 – Grit presence in Oxidation Ditch*

- Facility should immediately repair the grit system to avoid grit impacts in their treatment processes, including but not limited to, accumulation of grit in tanks that

reduce treatment capacity, clogs in pipes and channels, and wear and tear on pumps, valves, and other equipment.

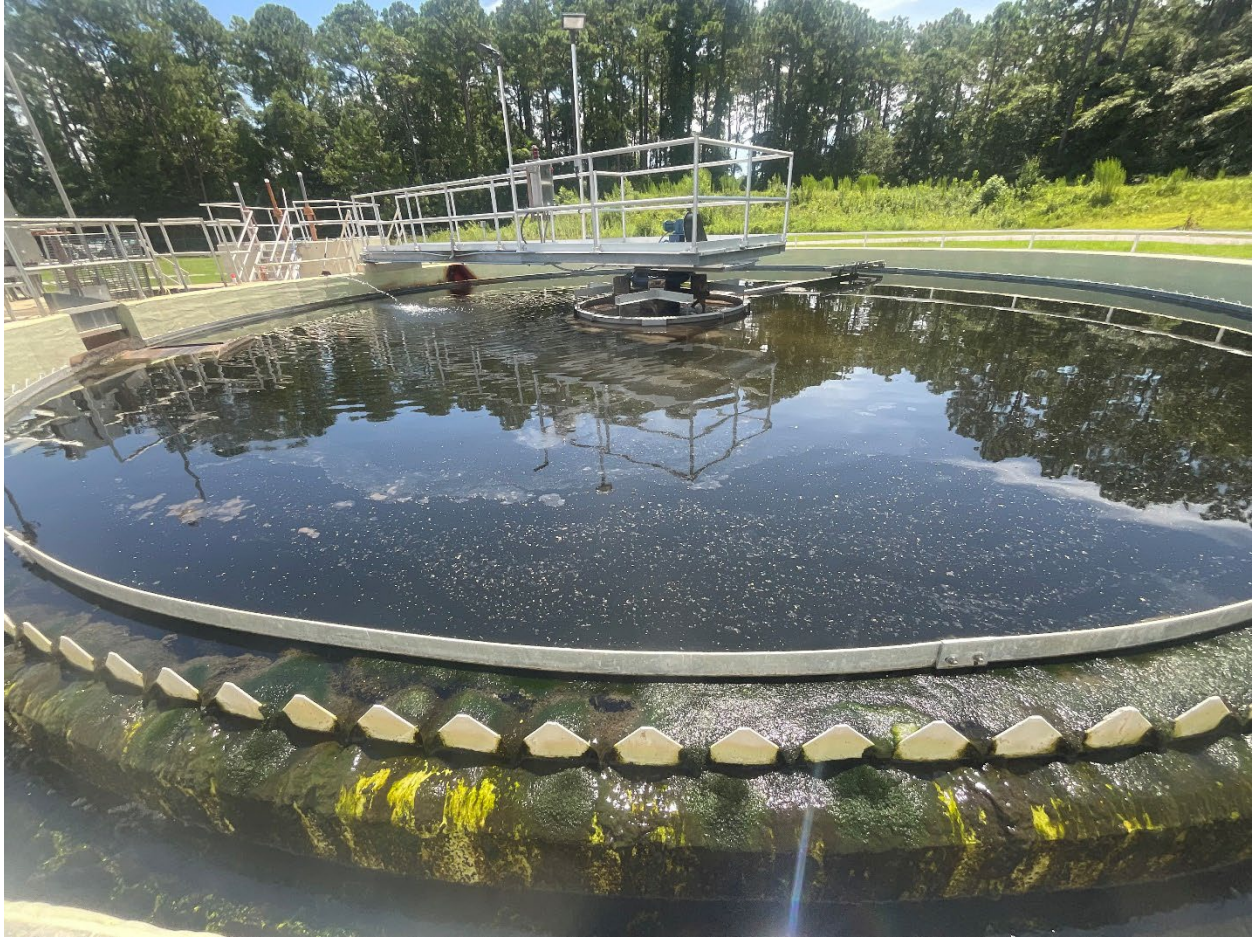
Figure 3 – Presence of Grit in Clarifier and Algae Growth on Weir Plates

- Facility should upload the missing DMR data to the SC Department of Environmental Services (SCDES) electronic DMR system and/or consult with the SCDES to identify any potential data transfer issues.
- Facility should perform more routine cleaning to prevent excessive algae growth on secondary clarifier weir plates, which can lead to poor effluent water quality.
