**Region 6 - Enforcement & Compliance Assurance Division**  
**INSPECTION REPORT**

| Company Name: | Los Alamos County | |
| Facility Name: | White Rock WWTF | |
| Identification/Permit Number: | NM0020133 | |

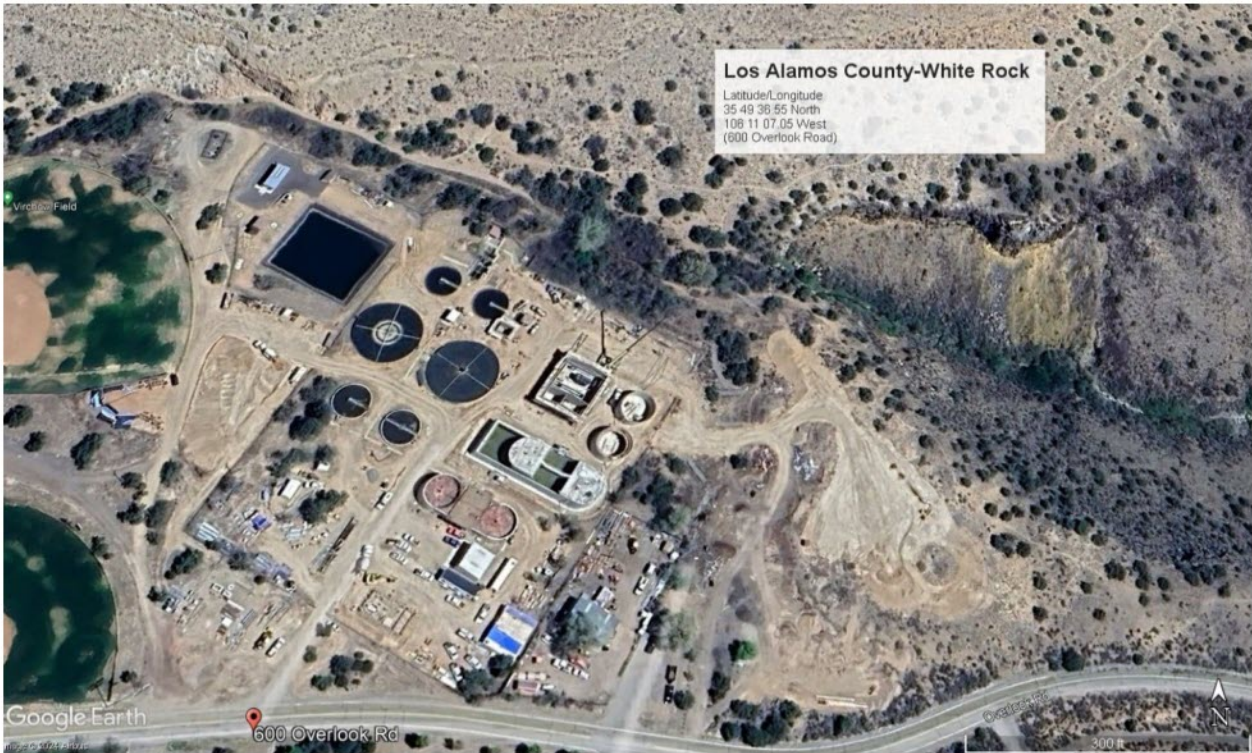
**Aerial Image #1:** Overall view of the Los Alamos-White Rock Wastewater Treatment Facility. Note: this Aerial Image is dated May 7, 2023, and illustrates the existing WWTF. Aerial from Google Earth maps.

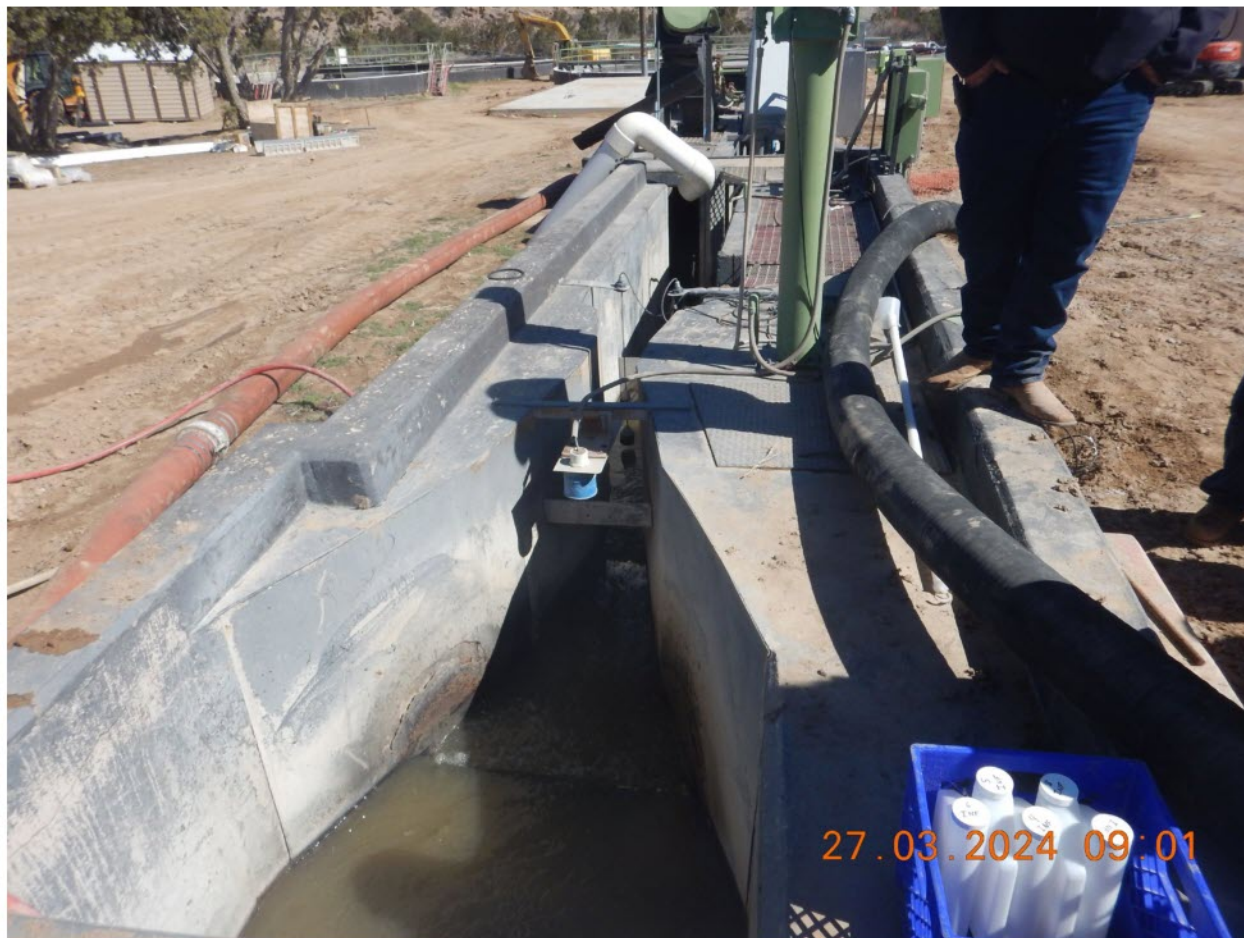
Photo No. 1

View of existing headworks looking approximately North. Note: this structure is identified in Appendix 2 Current White Rock Site Plan to be demolished or abandoned. (DSCN2688). Photographed by D. Esparza

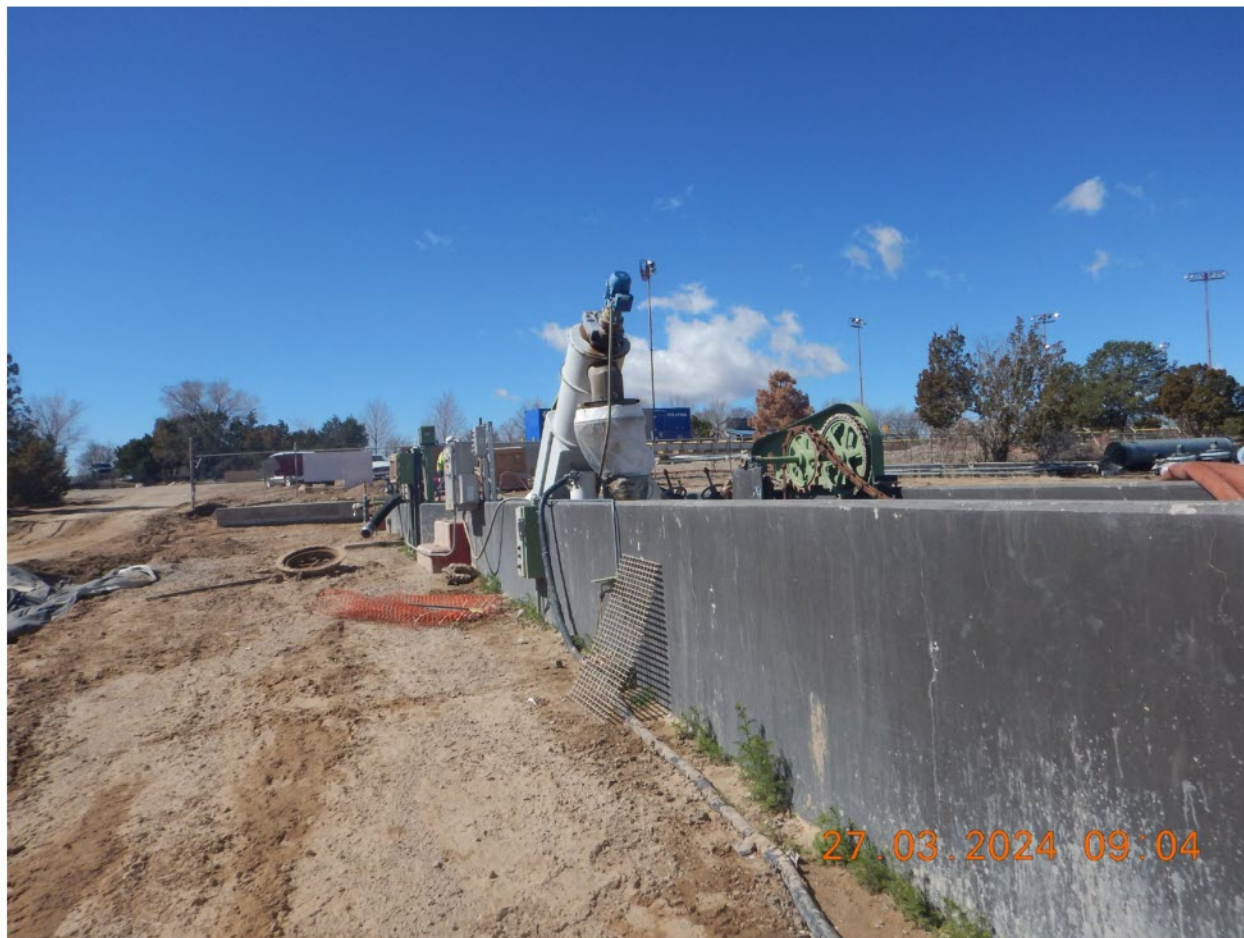
Photo No. 2

View of existing grit removal located adjacent to the existing headworks looking approximately South. **Note<sub>1</sub>**: the concrete degradation and spalling. **Note<sub>2</sub>**: this structure is identified in Appendix 2 Current White Rock Site Plan to be demolished or abandoned. (DSCN2689). Photographed by D. Esparza

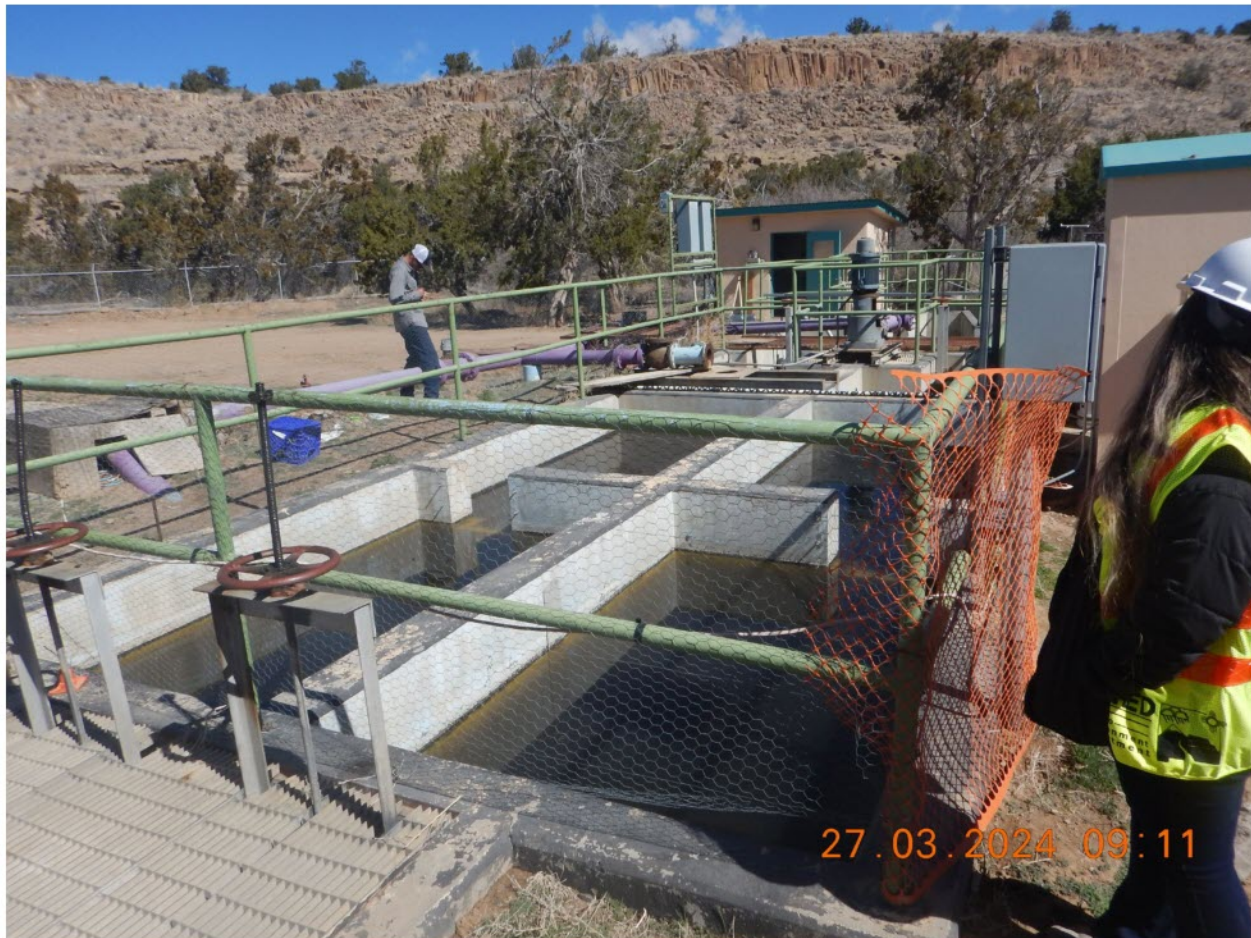
Photo No. 3

View of the existing chlorine contact chamber. **Note<sub>1</sub>**: this structure is identified in Appendix 2 Current White Rock Site Plan to be demolished or abandoned. This disinfection process will be replaced by two (2) channels of two (2) banks each of ultraviolet (UV) modules for disinfection, prior to being discharged to Cañada Del Buey, thence to the Rio Grande via an outfall (Outfall 001). (DSCN2691). Photographed by D. Esparza

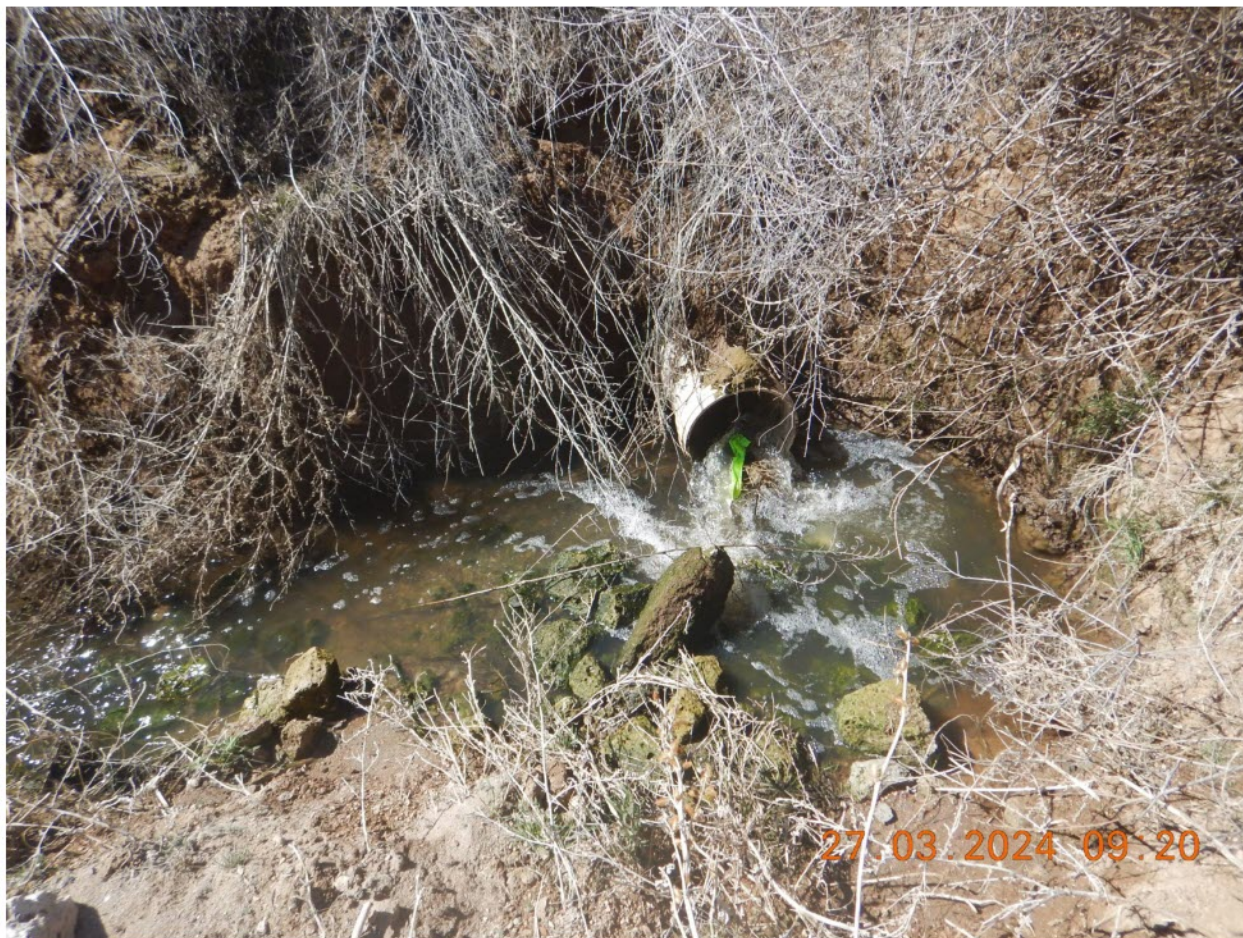
Photo No. 4

View of the White Rock WWTP Outfall 001. Note: it was suggested debris be cleared from the discharge conduit and "riprap" or similar be placed to minimize/prevent back flow or conduit undermining. (DSCN2692). Photographed by D. Esparza
