INSPECTION REPORT

| Type of Inspection | Focused Compliance Inspection (FCI) | | | |
| Facility or Site Name | Action Oil Services, Inc. | | | |
| Type of Operation | Action Oil Services, Inc.is a used oil transporter and transfer facility that picks up used oil waste from other facilities. | | | |

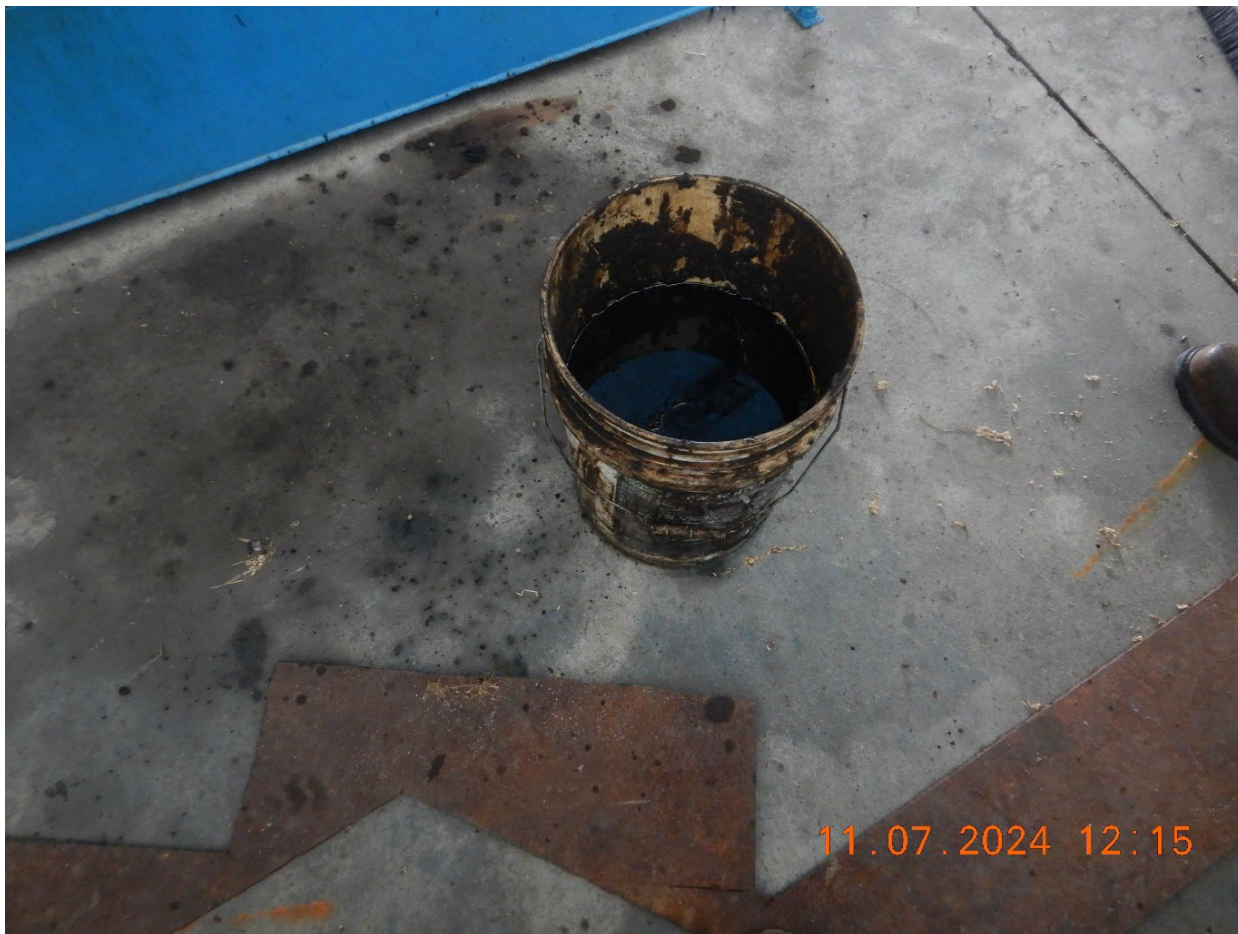
Photo No. 1

Description: View of a half-full 5-gallon container storing used oil that was unlabeled observed on the process pad.

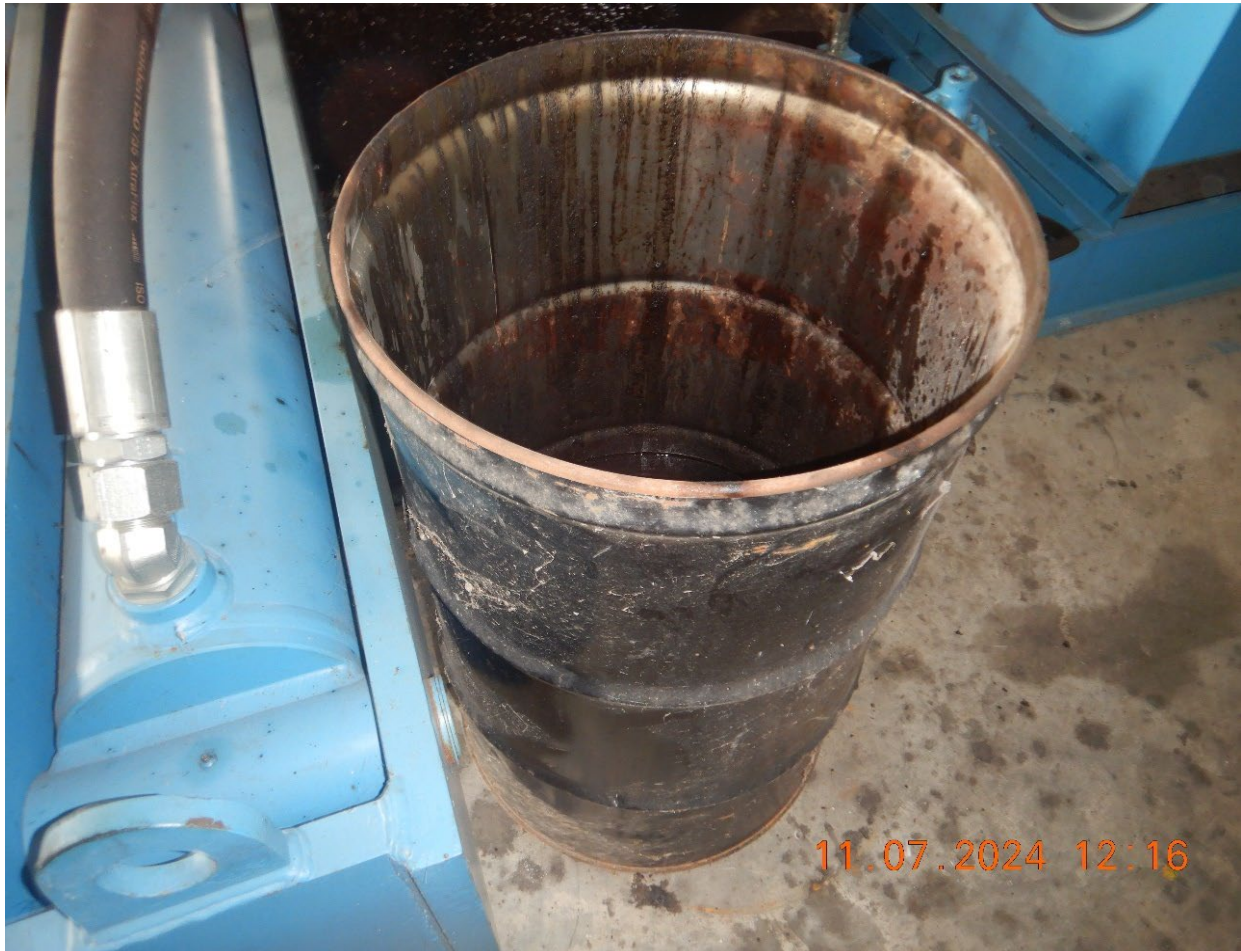
**Photo No. 2**

Description: View of a quarter-full 55-gallon container storing used oil that was unlabeled observed on the process pad.

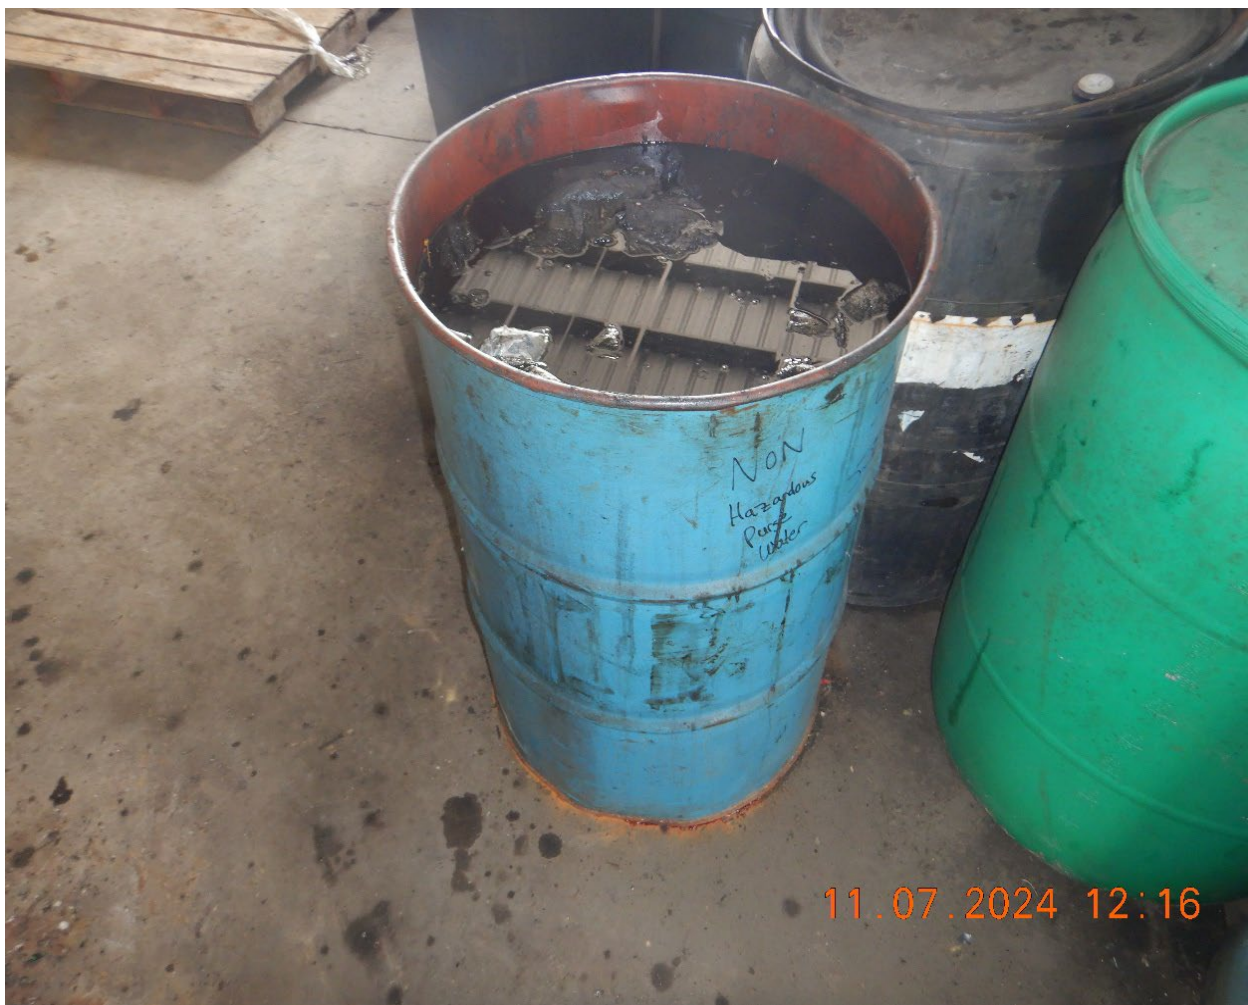
Photo No. 3

Description: View of a full 55-gallon container storing used oil that was unlabeled observed on the process pad.

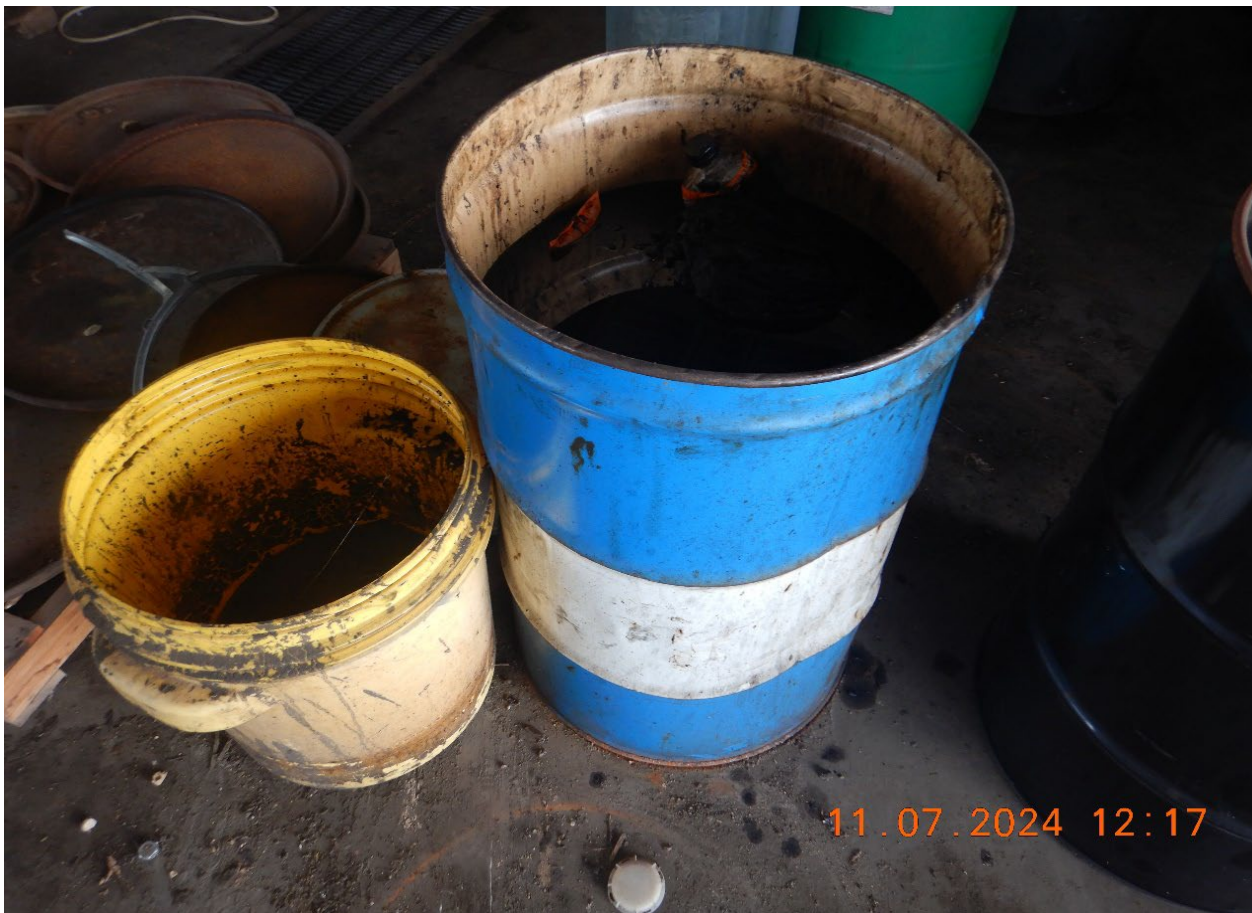
**Photo No. 4**

Description: View of a half-full 55-gallon container storing used oil that was unlabeled observed on the process pad.

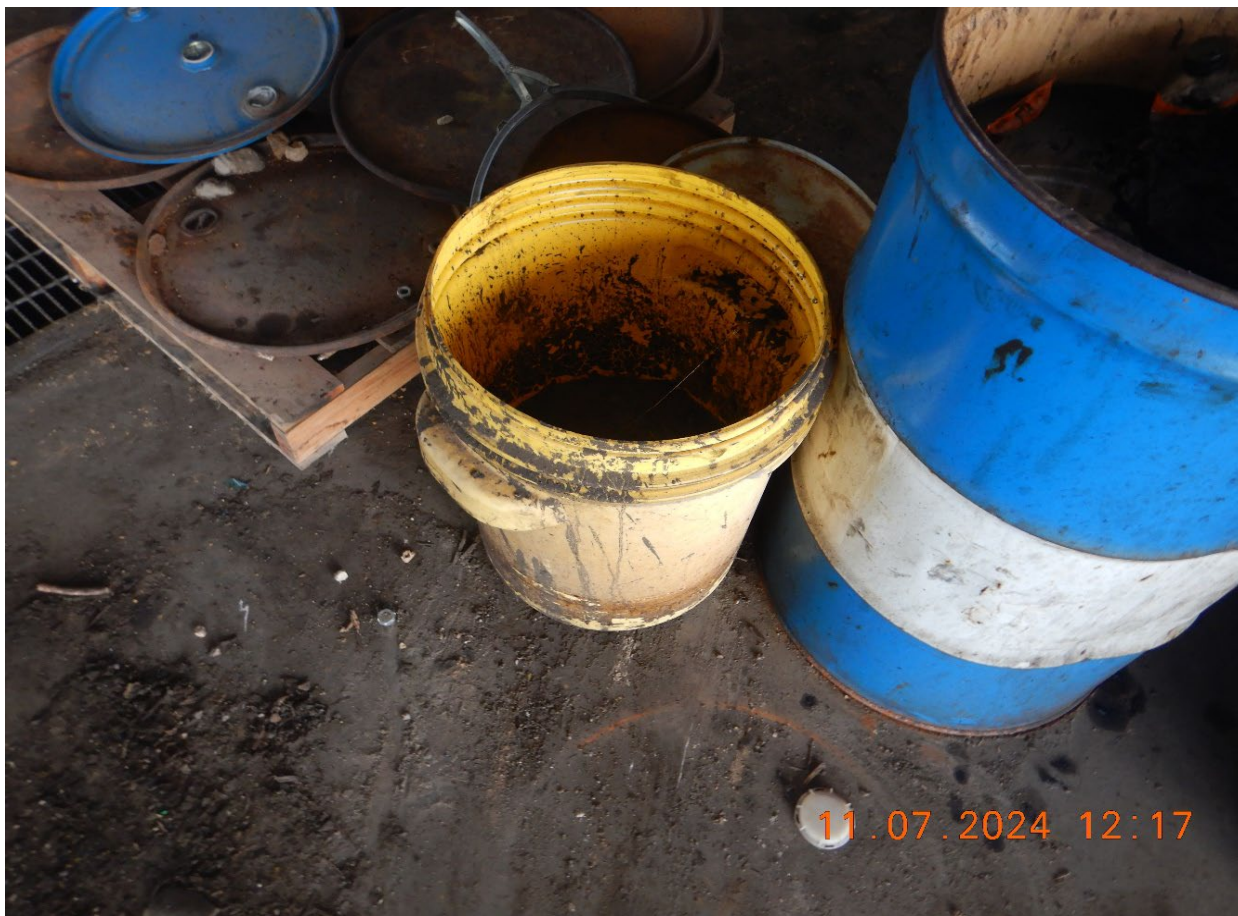
Photo No. 5

Description: View of a quarter-full 5-gallon container storing used oil that was unlabeled observed on the process pad.

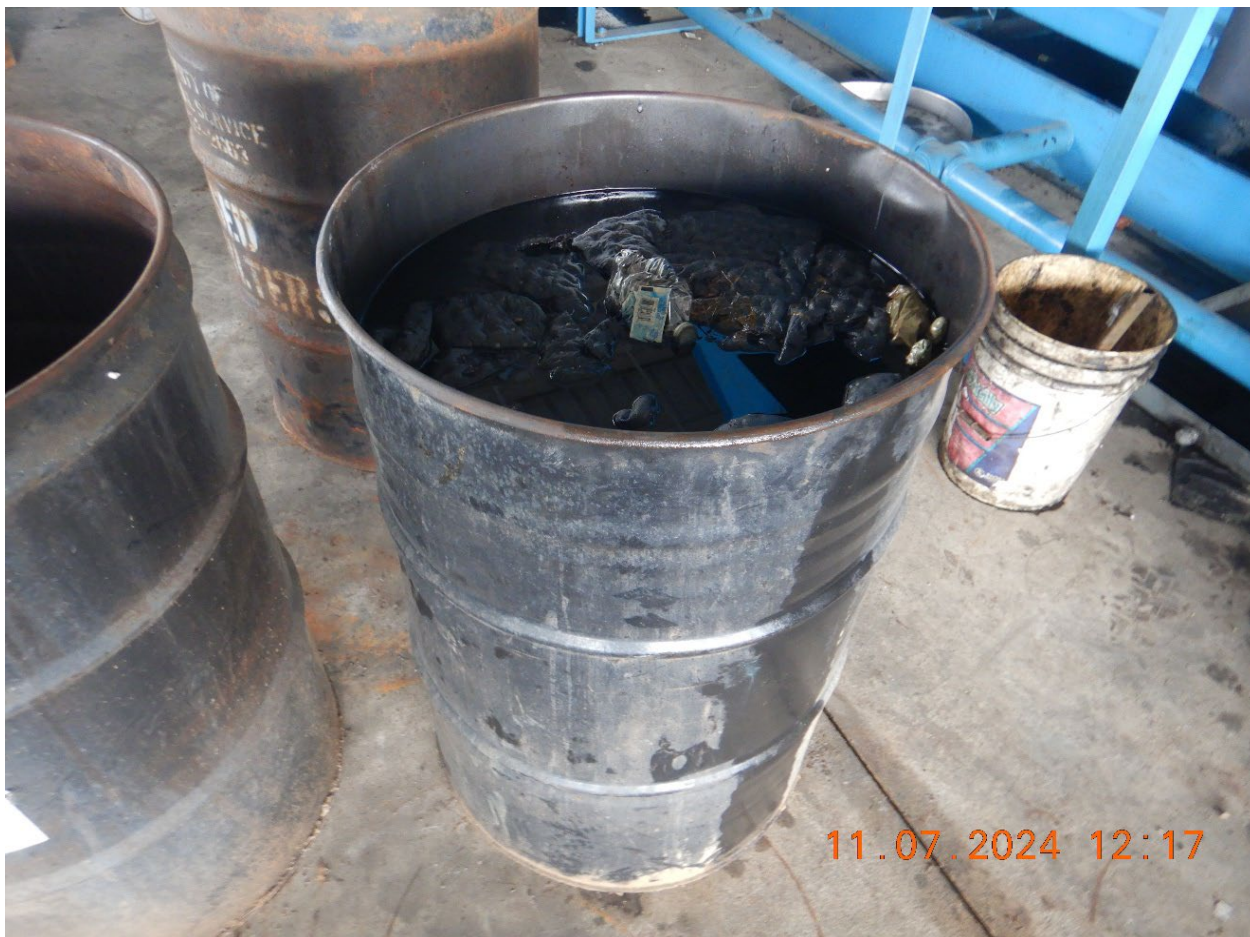
Photo No. 6

Description: View of a full 55-gallon container storing used oil that was unlabeled observed on the process pad.

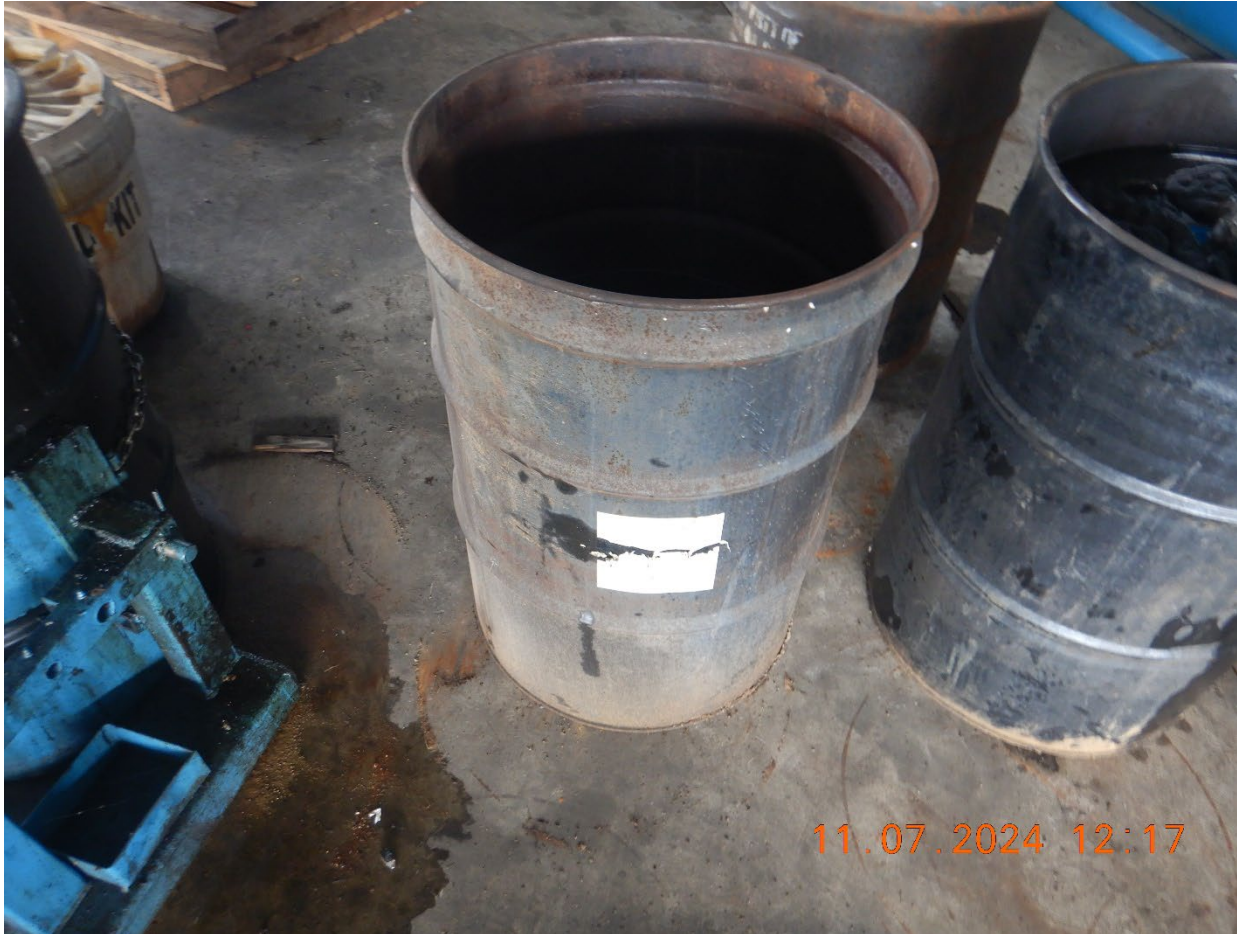
Photo No. 7

Description: View of a quarter-full 55-gallon container storing used oil that was unlabeled observed on the process pad.

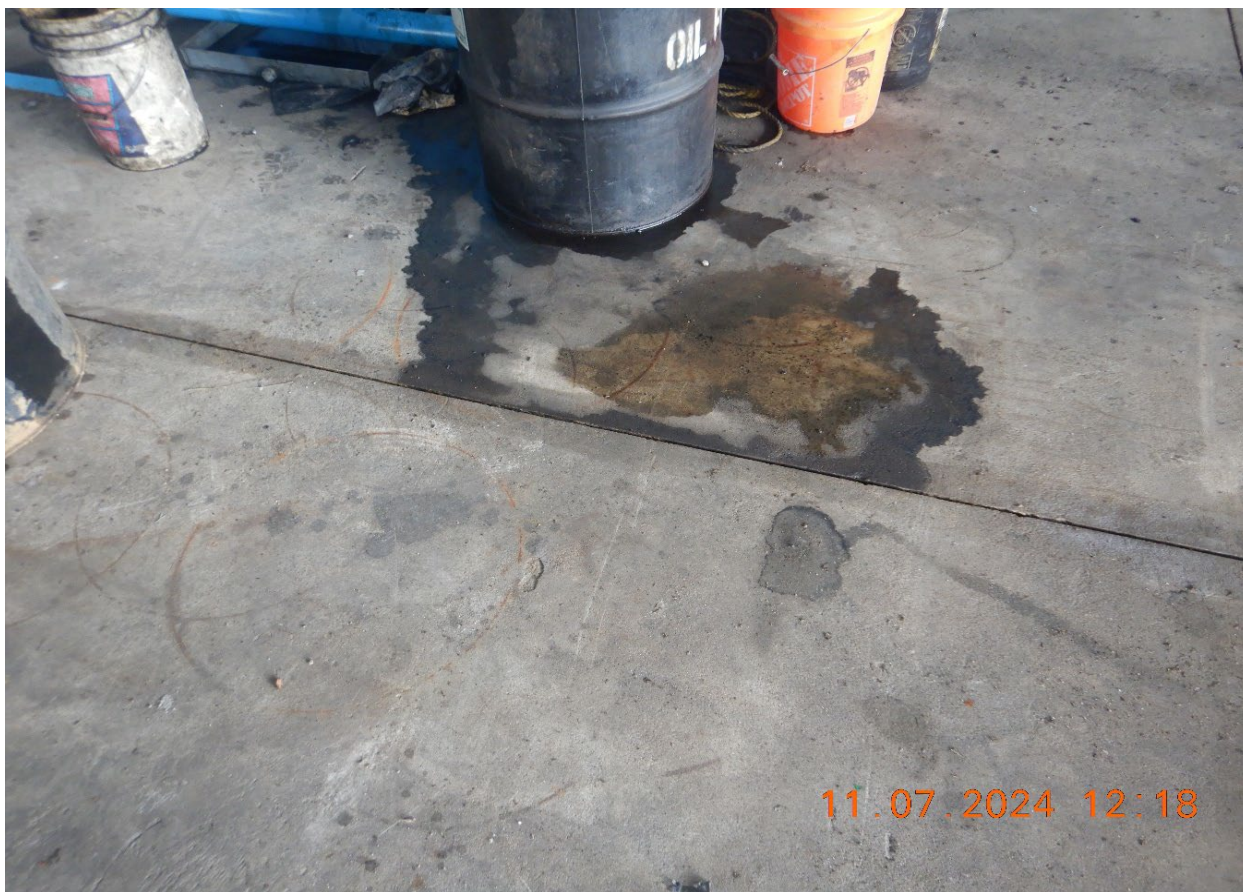
Photo No. 8

| Tenant: Action Oil Services | | |
|---|---|---|
| <b>AOC #2</b> – Action Oil did not clean up and manage properly the released used oil and other materials. | <b>Citation:</b> 40 CFR 279.45(h) | Section: 2.1 |

Description: A view of spilled oil that was not cleaned up was found on the concrete pad in the processing area next to the hopper.

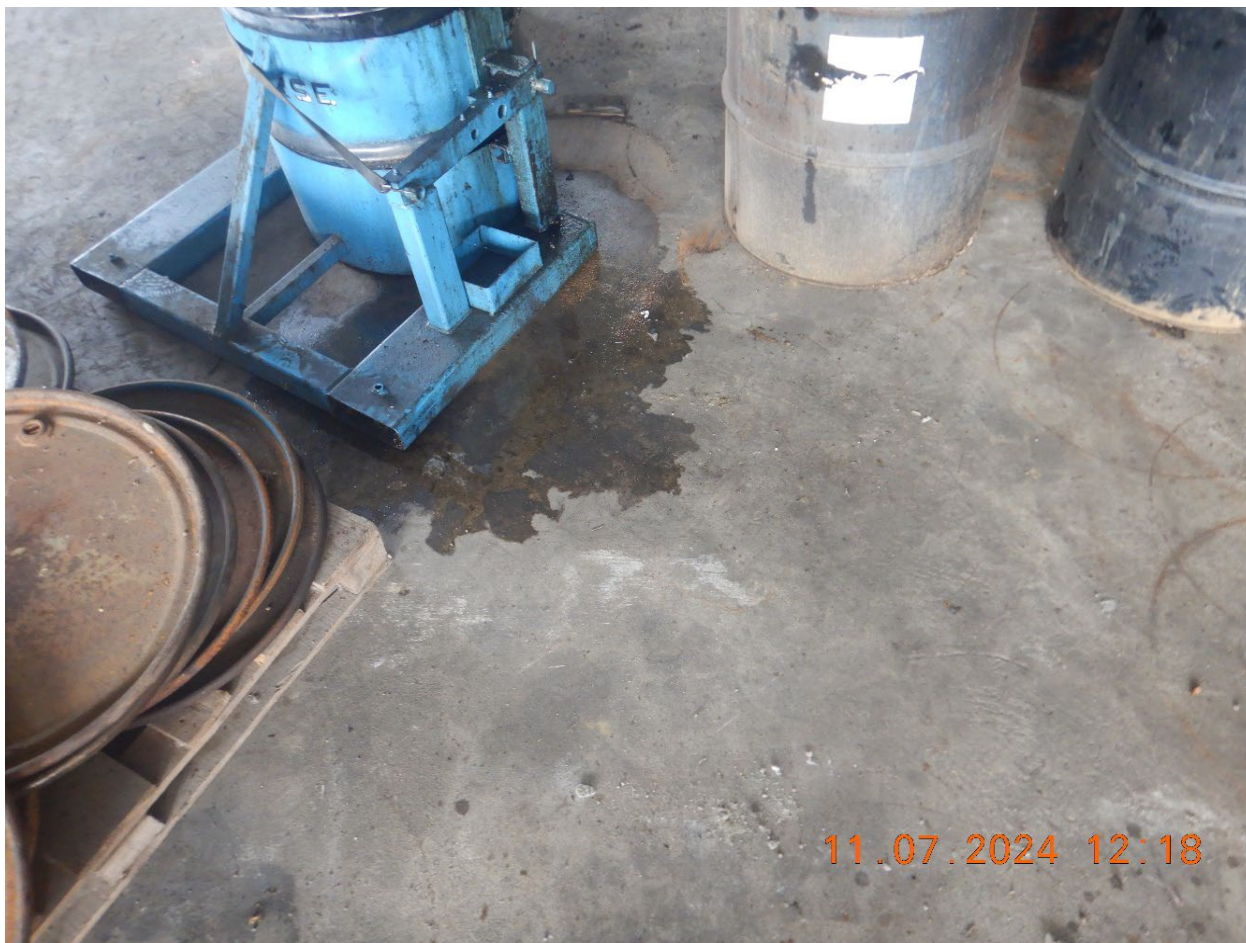
Photo No. 9

Description: A view of another spill of oil that was not cleaned up was found on the concrete pad in the processing area next to the hopper.

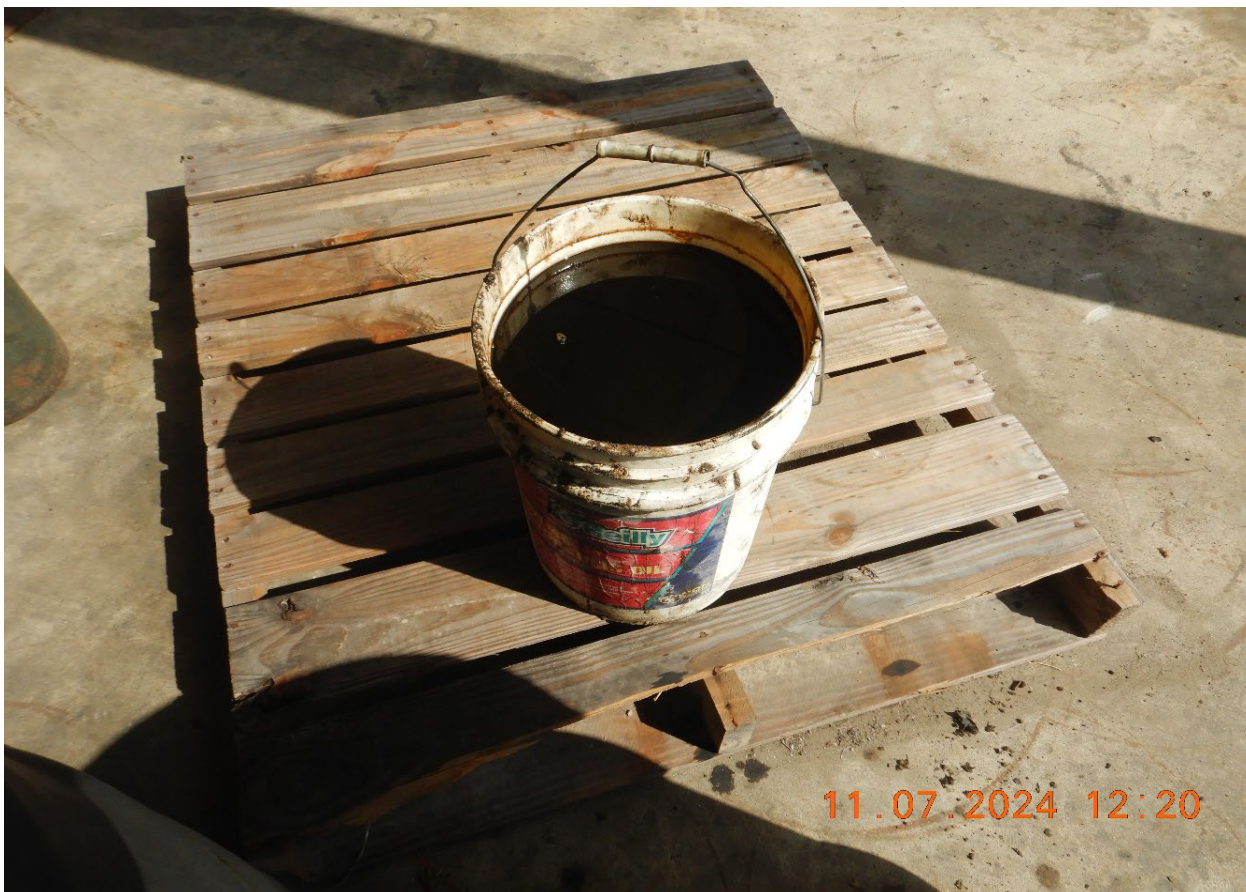
Photo No. 10

Description: View of a full 5-gallon container storing used oil that was unlabeled observed on the process pad.

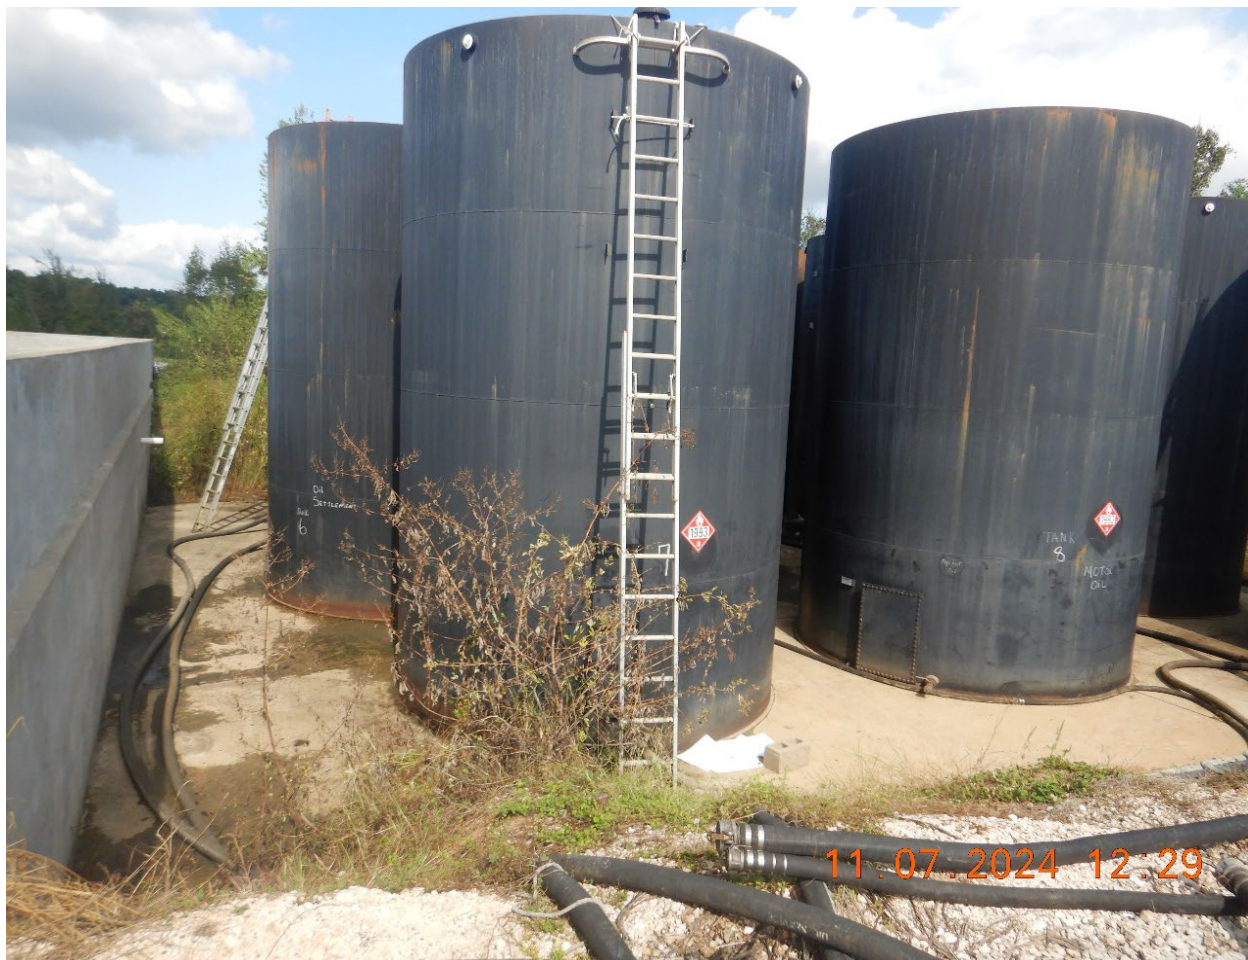
Photo No. 11

| <b>AOC #3</b> – Action Oil did have a secondary containment system for an aboveground storage tank used to store used oil at a transfer facility. | <b>Citation:</b> 40 CFR 279.45(f) | Section: 2.1 |

Description: Overview of the older tank farm found in the back of the facility in which there was no secondary containment system.

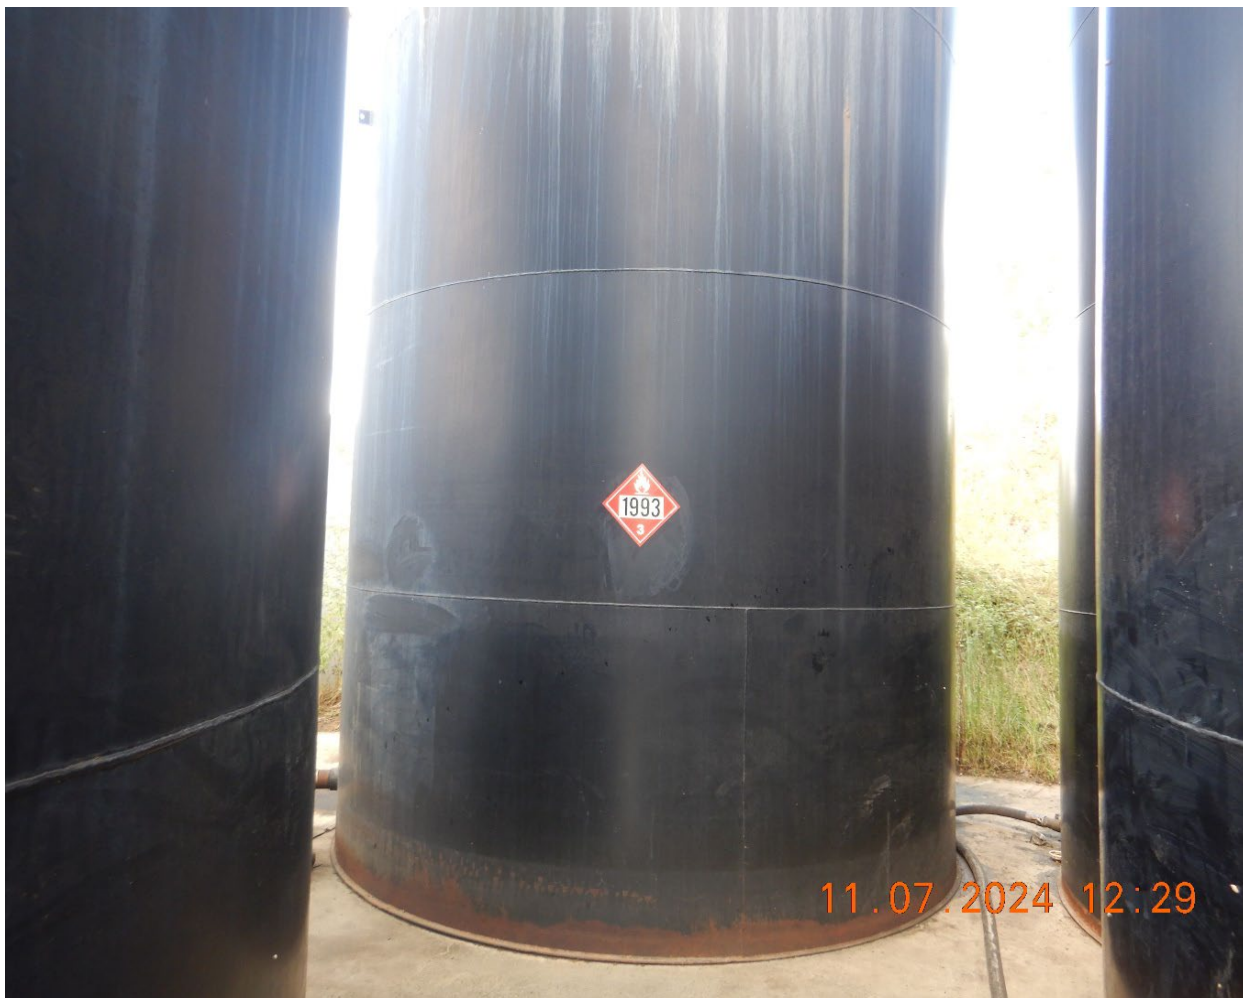
Photo No. 12

currently storing used oil and it is used as an oil/water separator (see Appendix 1 – Photo 12). The tank was not labeled as used oil at the time of the inspection (see **AOC#1**). The inspection team noted the concrete pad where the oil/water separator was sitting did not have a secondary containment system (see Appendix 1 – Photo 11) [**AOC#3** – *Action Oil did have a secondary containment system for an aboveground tank used to store oil at a transfer facility - 40 CFR 279.45(f)*]. Mr. Tannehill informed the inspection team that the water from the bottom of the oil/water separator is discharged into the county drainage canal located at the back of the property behind the tank farm (see Appendix 1 – Photos 13 to 15). Mr. Tannehill said they do not have an NPDES permit and they occasionally sample the water in the oil/water separator. Adjacent to the older ten tanks was a set of ten new used oil tanks that were actively storing used oil at the time of the inspection. However, the tanks did not contain a label or marking indicating they were storing used oil (see Appendix 1 – Photos 16 and 17, **AOC#1**).

Description: View of the tank used as an oil/water separator which was storing used oil and was not labeled "Used Oil."

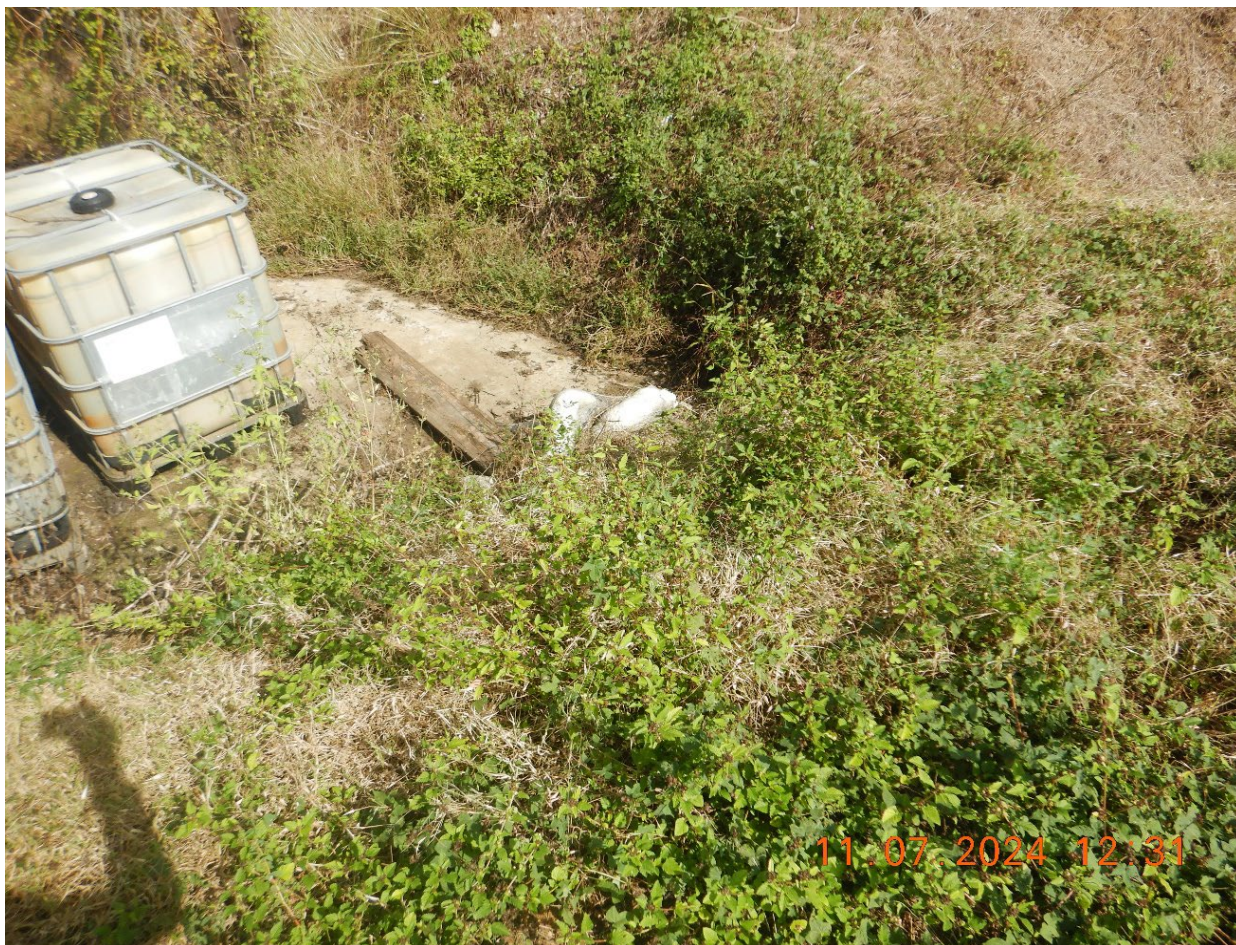
**Photo No. 13**

Description: View of the drain in which water from the oil/water separator is discharged behind the facility. Note the two totes seen to the left were empty.

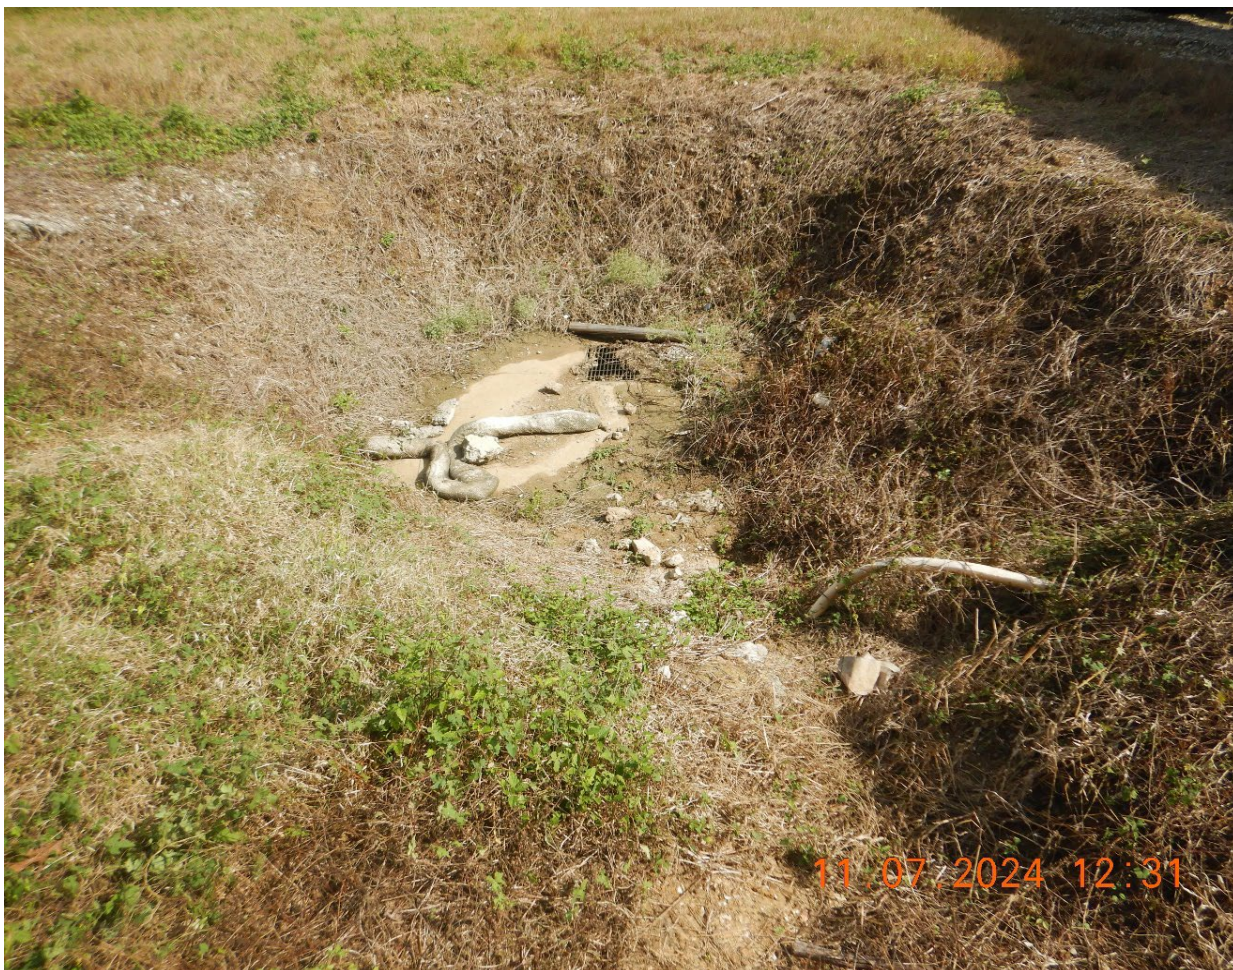
**Photo No. 14**

Description: View of the drain in which water from the oil/water separator is discharged behind the facility.

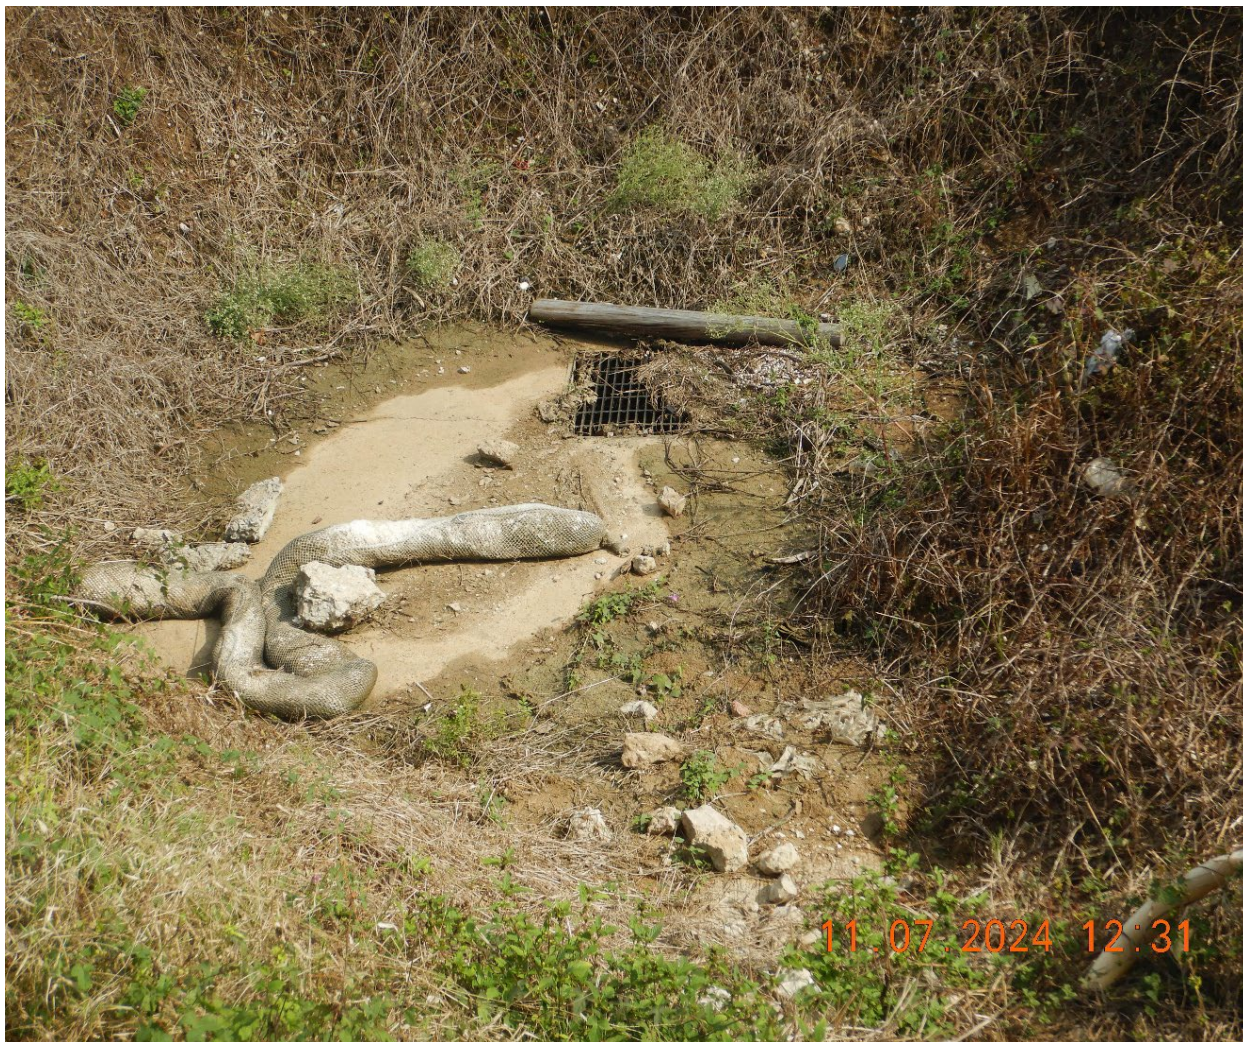
Photo No. 15

Description: View of the drain in which water from the oil/water separator is discharged behind the facility.

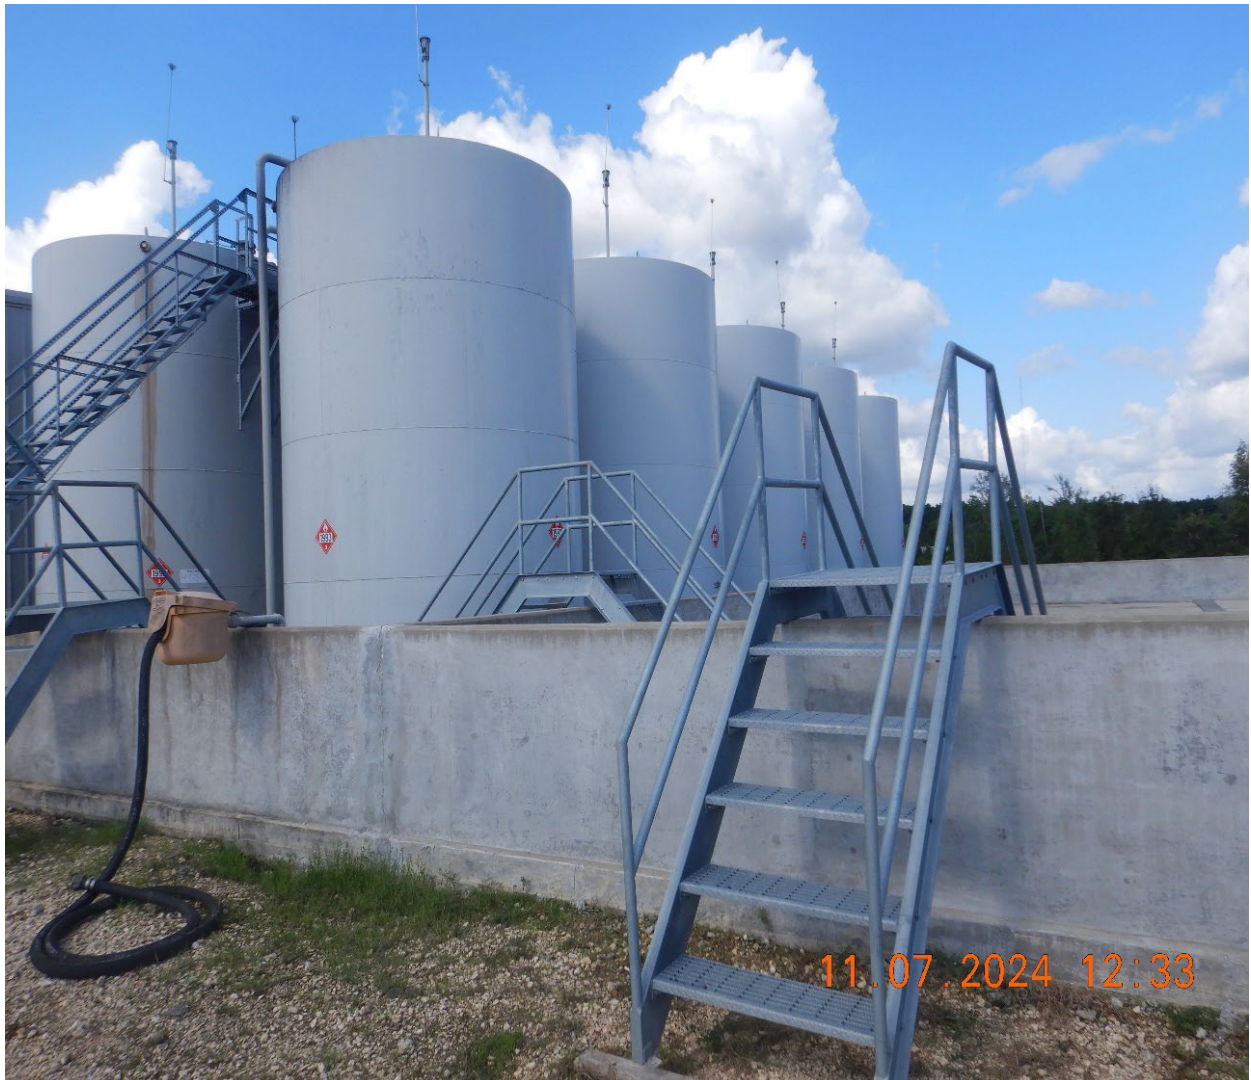
Photo No. 16

| Tenant: Action Oil Services | | |
|---|---|---|
| <b>AOC #1</b> – Action Oil did not clearly label containers used to store used oil with the words “Used Oil.” | <b>Citation:</b> 40 CFR 279.45(g)(1) | Section: 2.1 |

Description: Overview of the newly built tank farm containing ten used oil tanks that were actively storing used oil. None of the tanks were labeled "Used Oil."

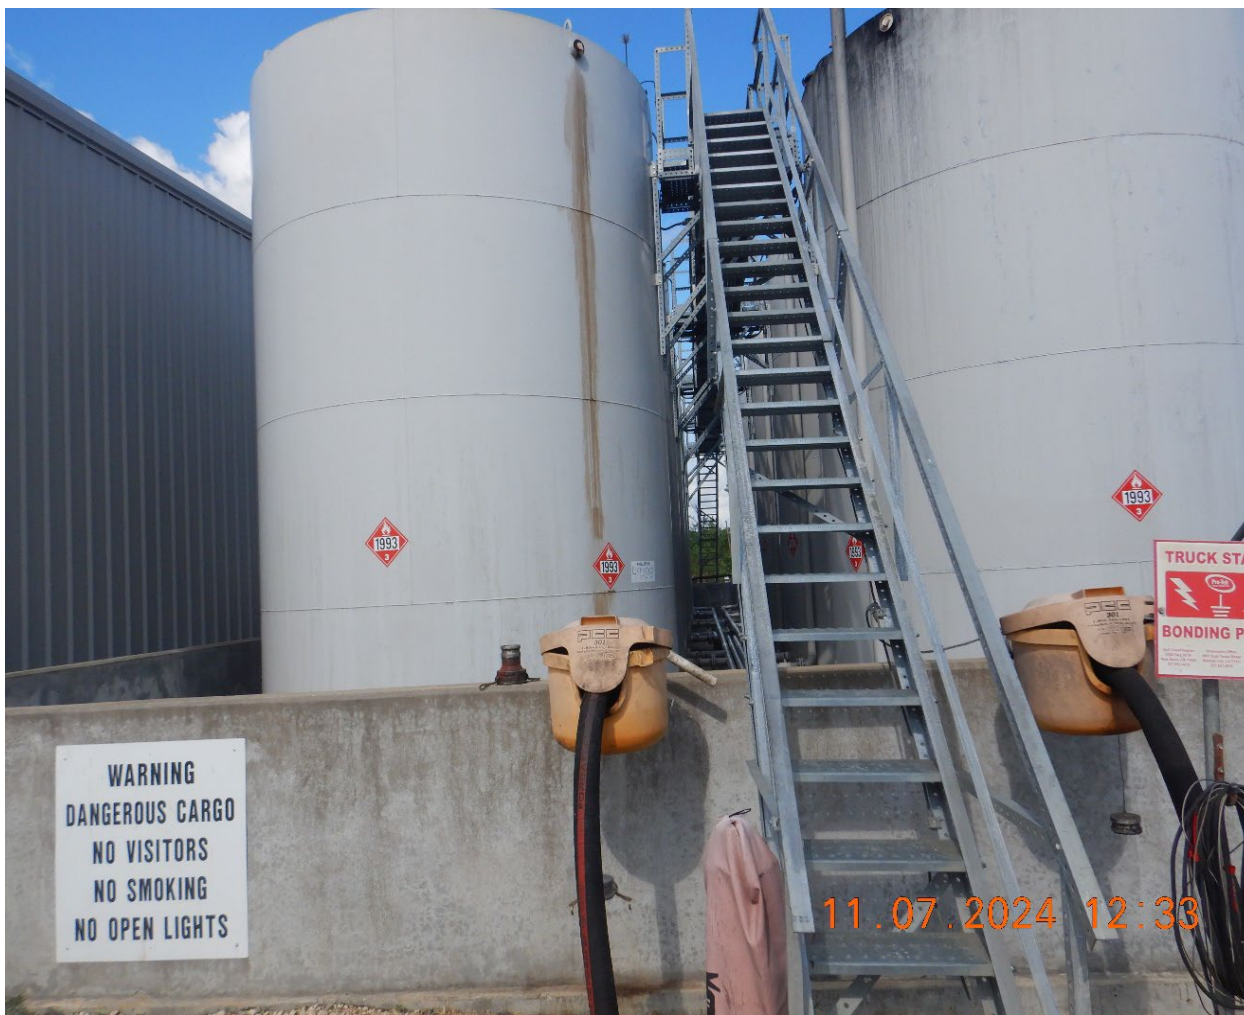
Photo No. 17

Description: Overview of the newly built tank farm containing ten used oil tanks that were actively storing used oil; none of the tanks were labeled.

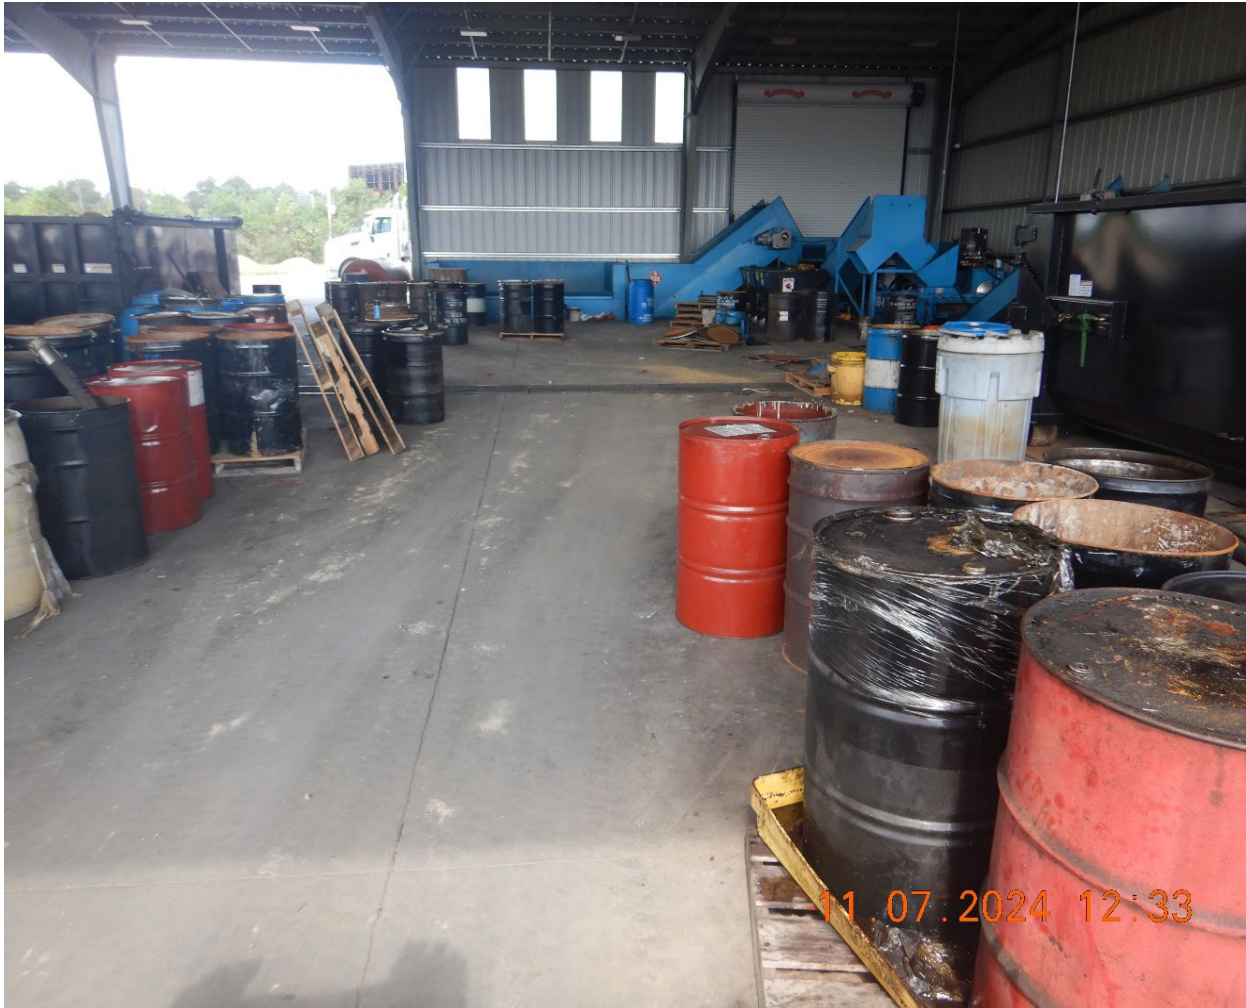
Photo No. 18

Description: Overview of the process pad. A mixture of empty and non-empty 55-gallon drums with the filter press and hopper is seen in the top right corner. The blind sump runs horizontal across the middle of the process pad.
