INSPECTION REPORT

| Type of Inspection | Focused Compliance Inspection (FCI) | | | |
| Facility or Site Name | Action Oil Services, Inc. | | | |
| Type of Operation | Action Oil Services, Inc.is a used oil transporter and transfer facility that picks up used oil waste from other facilities. | | | |

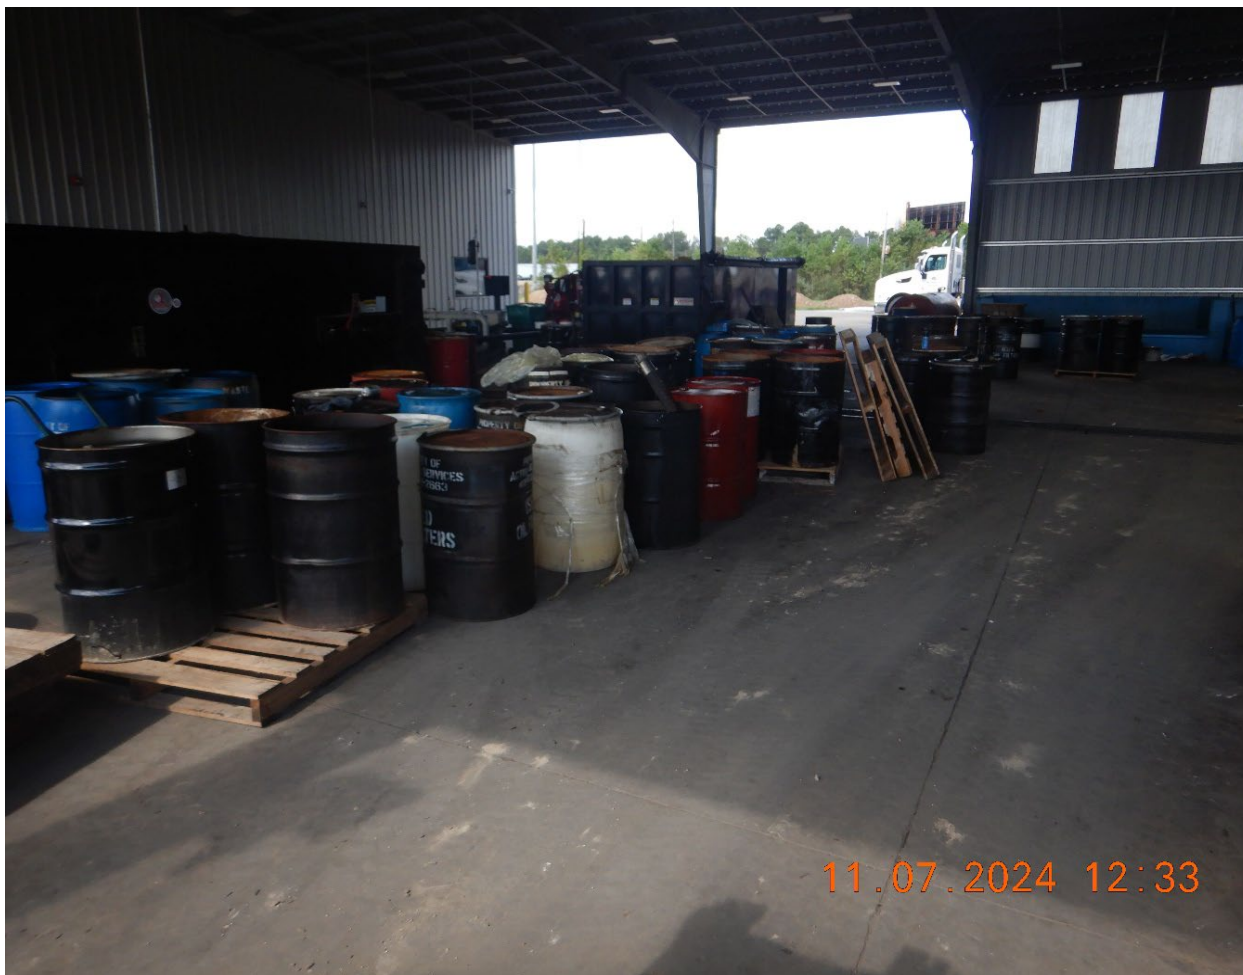
Photo No. 19

Description: Overview of the process pad, the roll-off boxes are used to store non-hazardous debris.

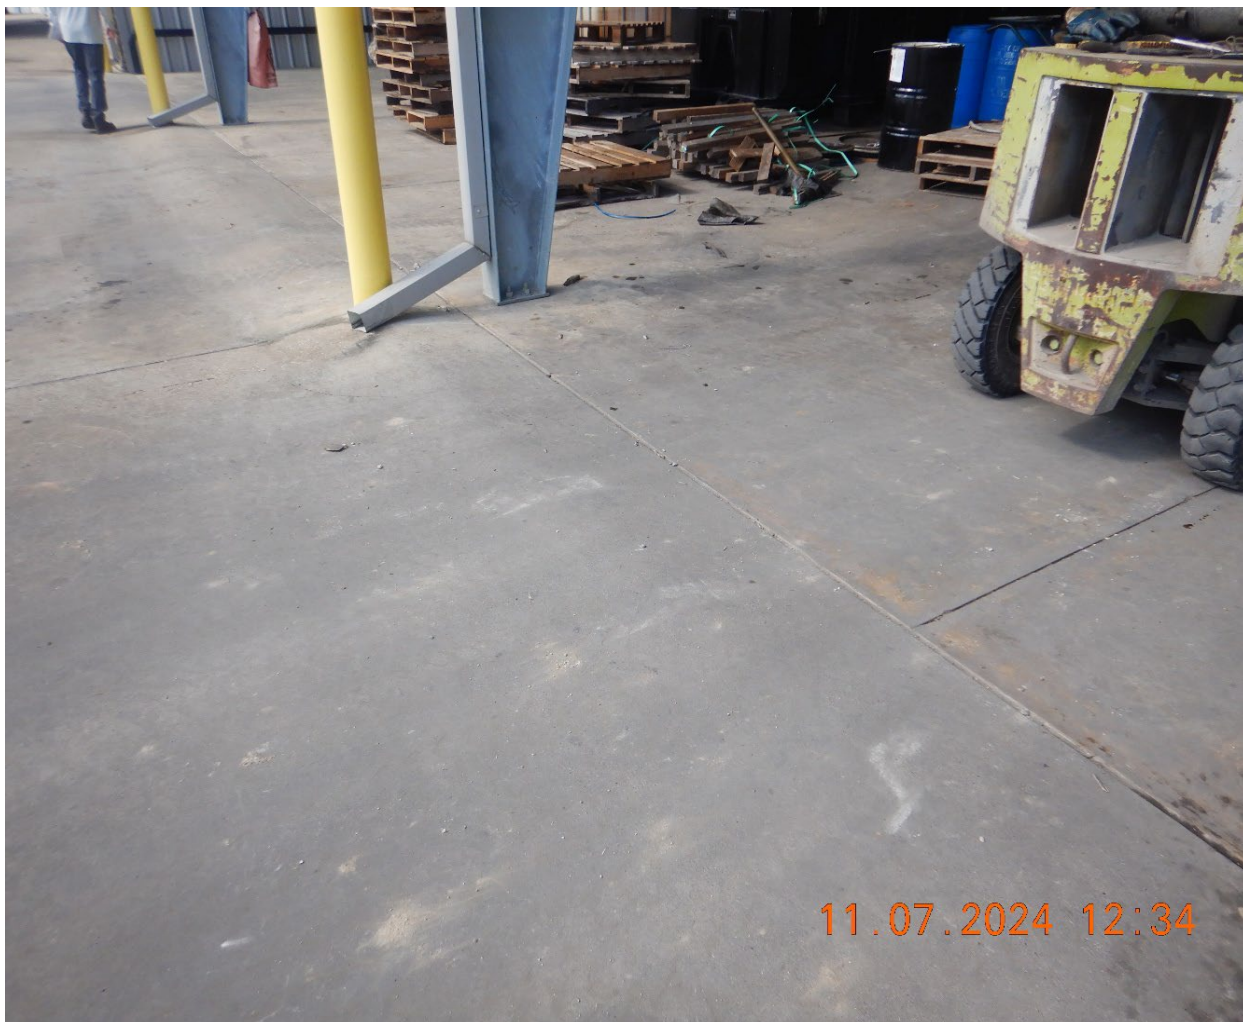
**Photo No. 20**

Description: View of the concrete berm surrounding the perimeter of the process pad.

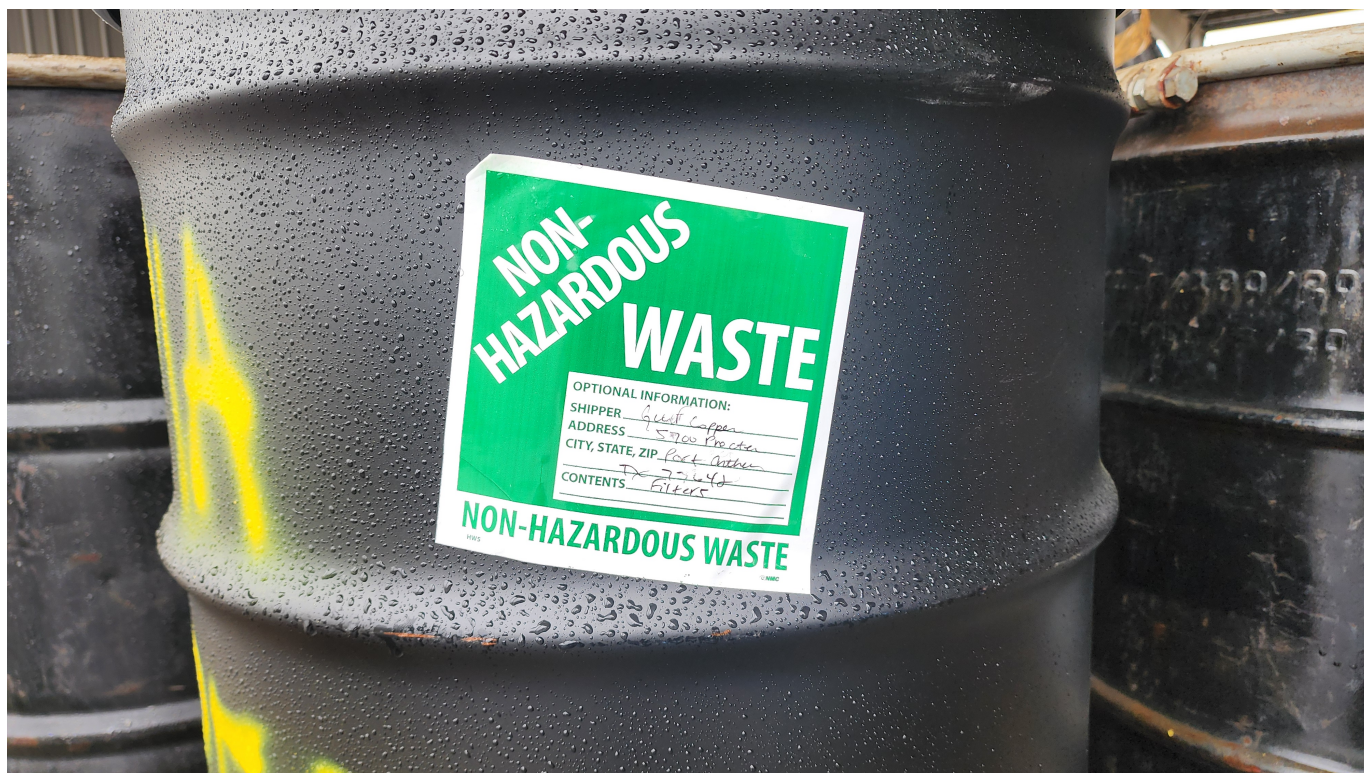
Photograph provided by Action Oil on 11/18/2024 in response to AOCs

- Photos of labels placed on non-hazardous drums in the process pad and the spills next to the hopper cleaned up (Appendix 2).
- Statement that labels have been ordered for the used oil tanks.
- Sample test results for the water discharge from the oil/water separator were analyzed on 11/18/2024 (Appendix 3).
- An example of a used oil shipment ticket to Blue Tide with pre-shipment test results (Appendix 4).
- The cover page of their current SPCC plan which was last revised in 2005 (Appendix 5).
- Drawing of the facility and containment area (Appendix 5).
- Pictures of a secondary containment system installed on the concrete pad for the older ten tanks; sent on 11/25/2024 (Appendix 6).

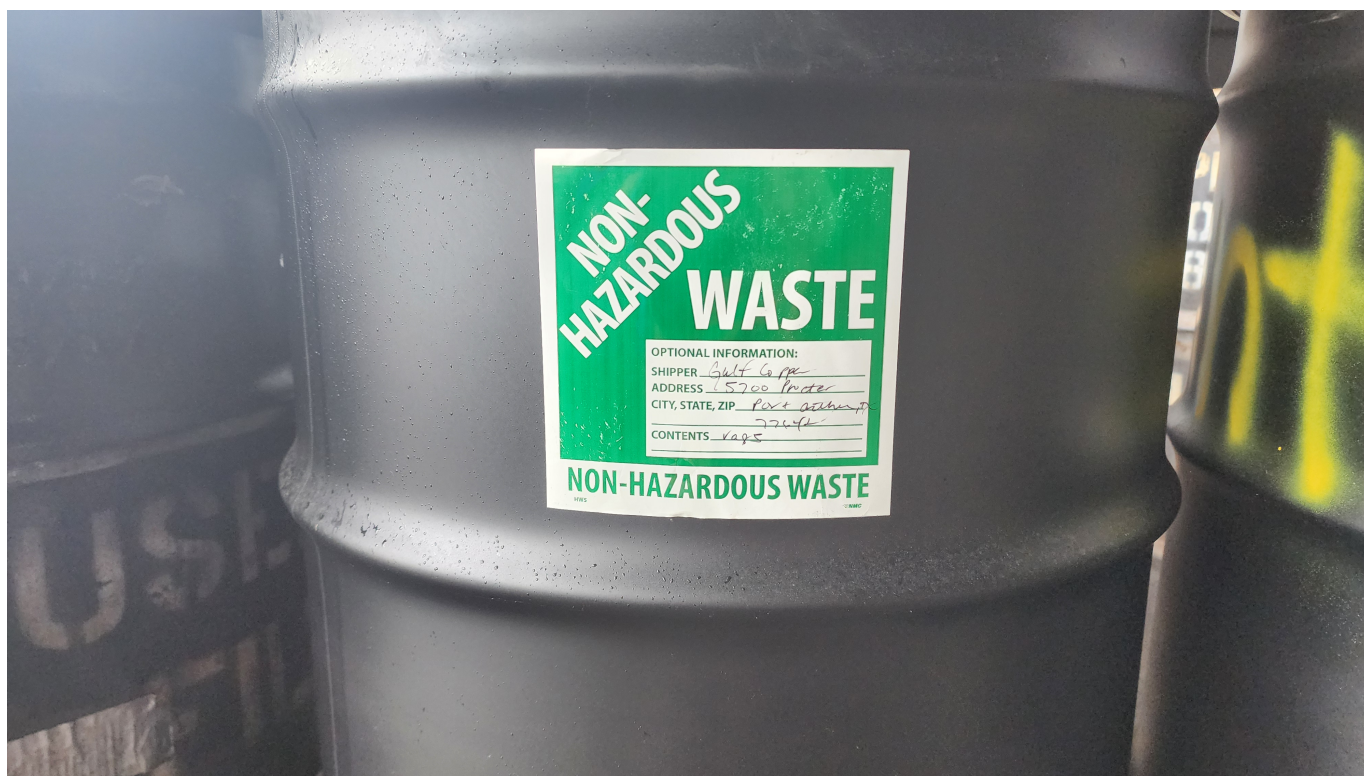
Photograph provided by Action Oil on 11/18/2024 in response to AOCs

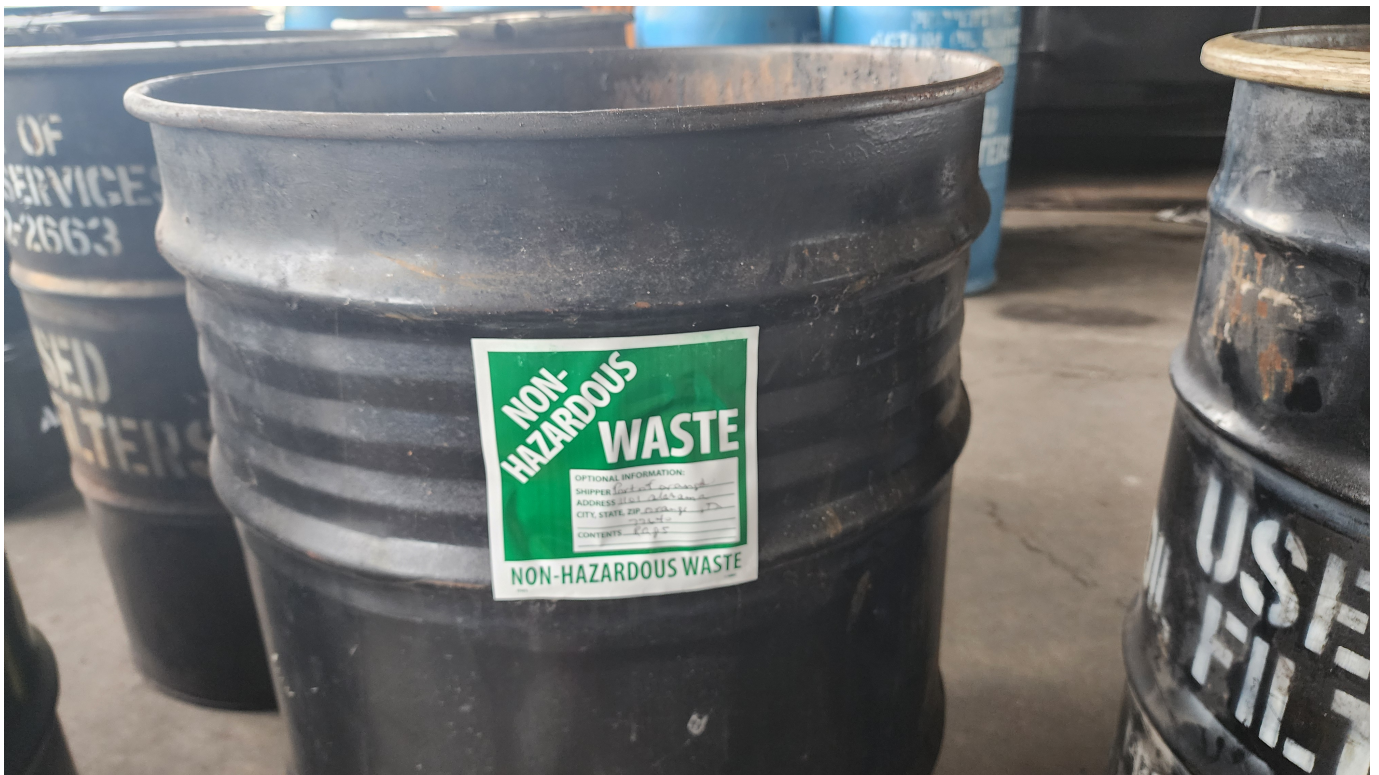
Photograph provided by Action Oil on 11/18/2024 in response to AOCs

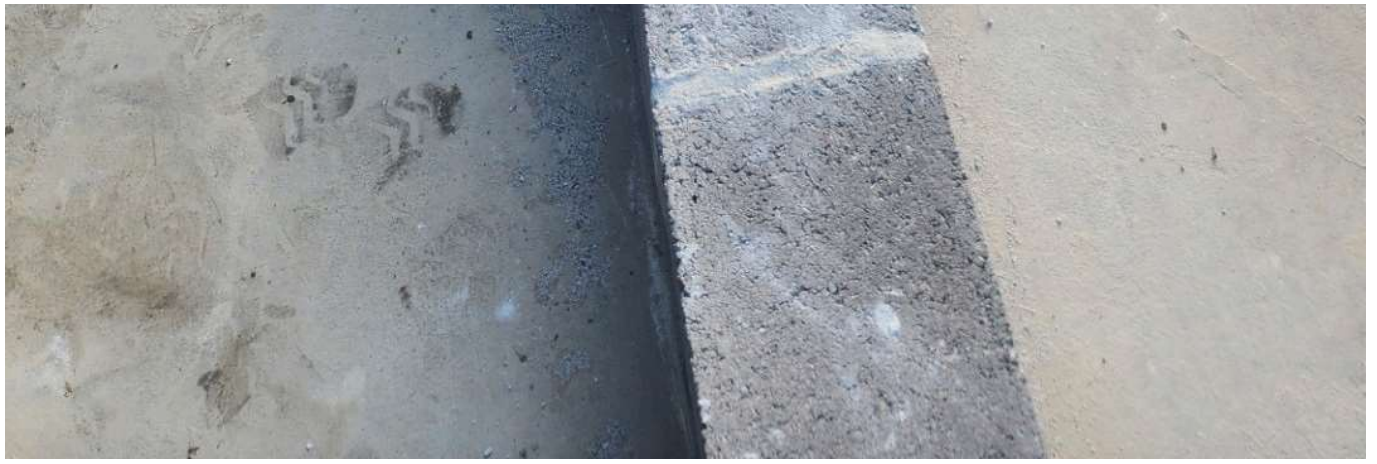
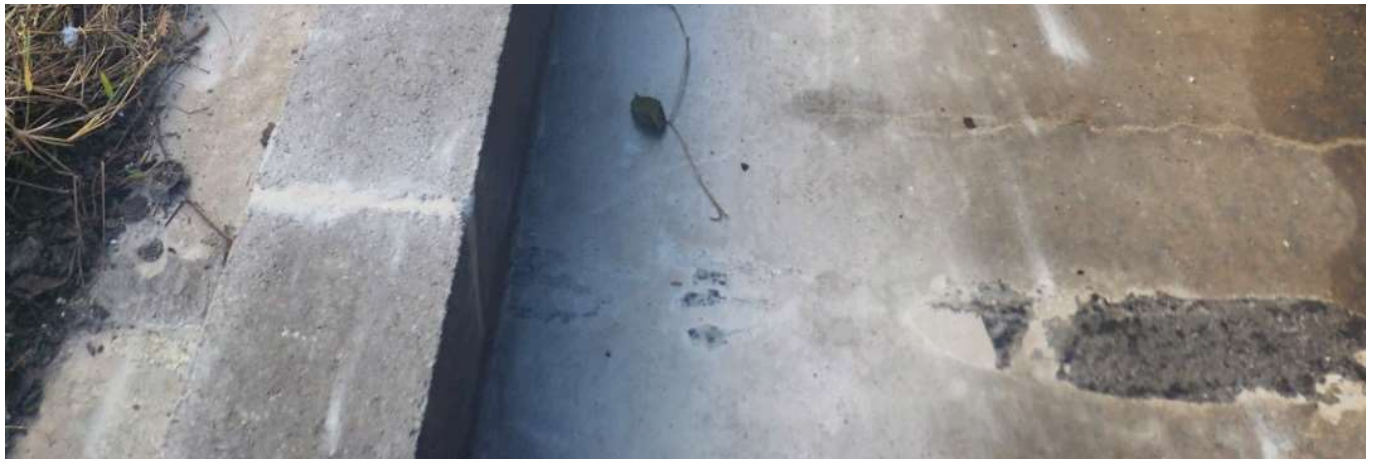
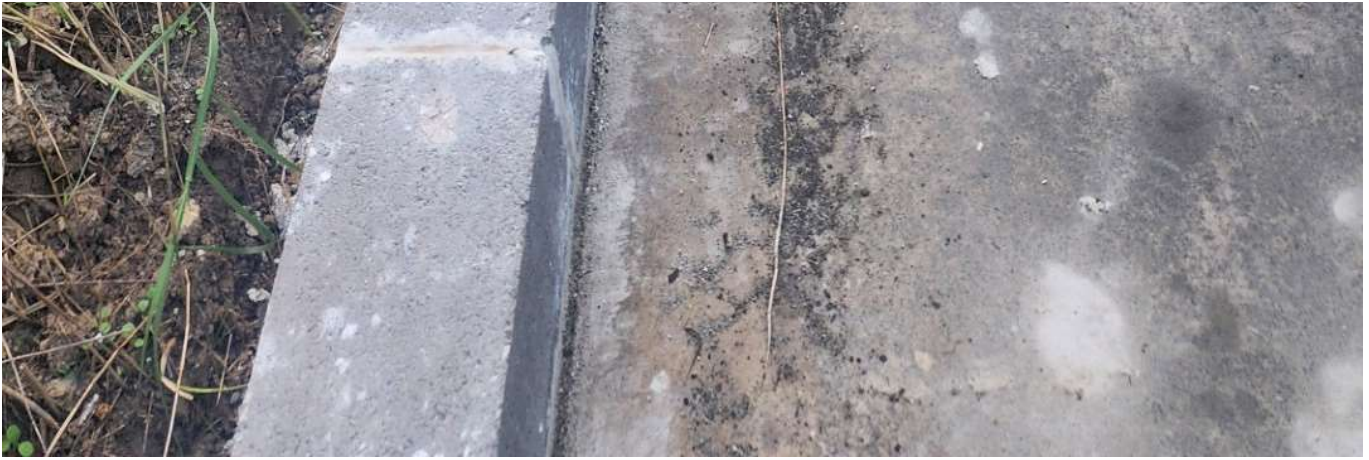
Vince, please see attached photos of the newly installed secondary containment here at Action Oil. These are solid cinder blocks and are mortared beneath and in between to create an impenetrable barrier. Any questions please reach out.

1. 11/18/24 Action Oil email – Landon Tannehill provided the inspection team with photos of attempted corrections made towards AOCs observed and requested documentation from the inspection team.
2. 11/25/24 Action Oil email – Landon Tannehill provided the inspection team with photos of the secondary containment system installed on the tank farm.
