Re: Inspection Report for Fort Belknap Old Hays Wastewater Lagoons, MTU000032

## NPDES Wastewater Lagoon Inspection Report

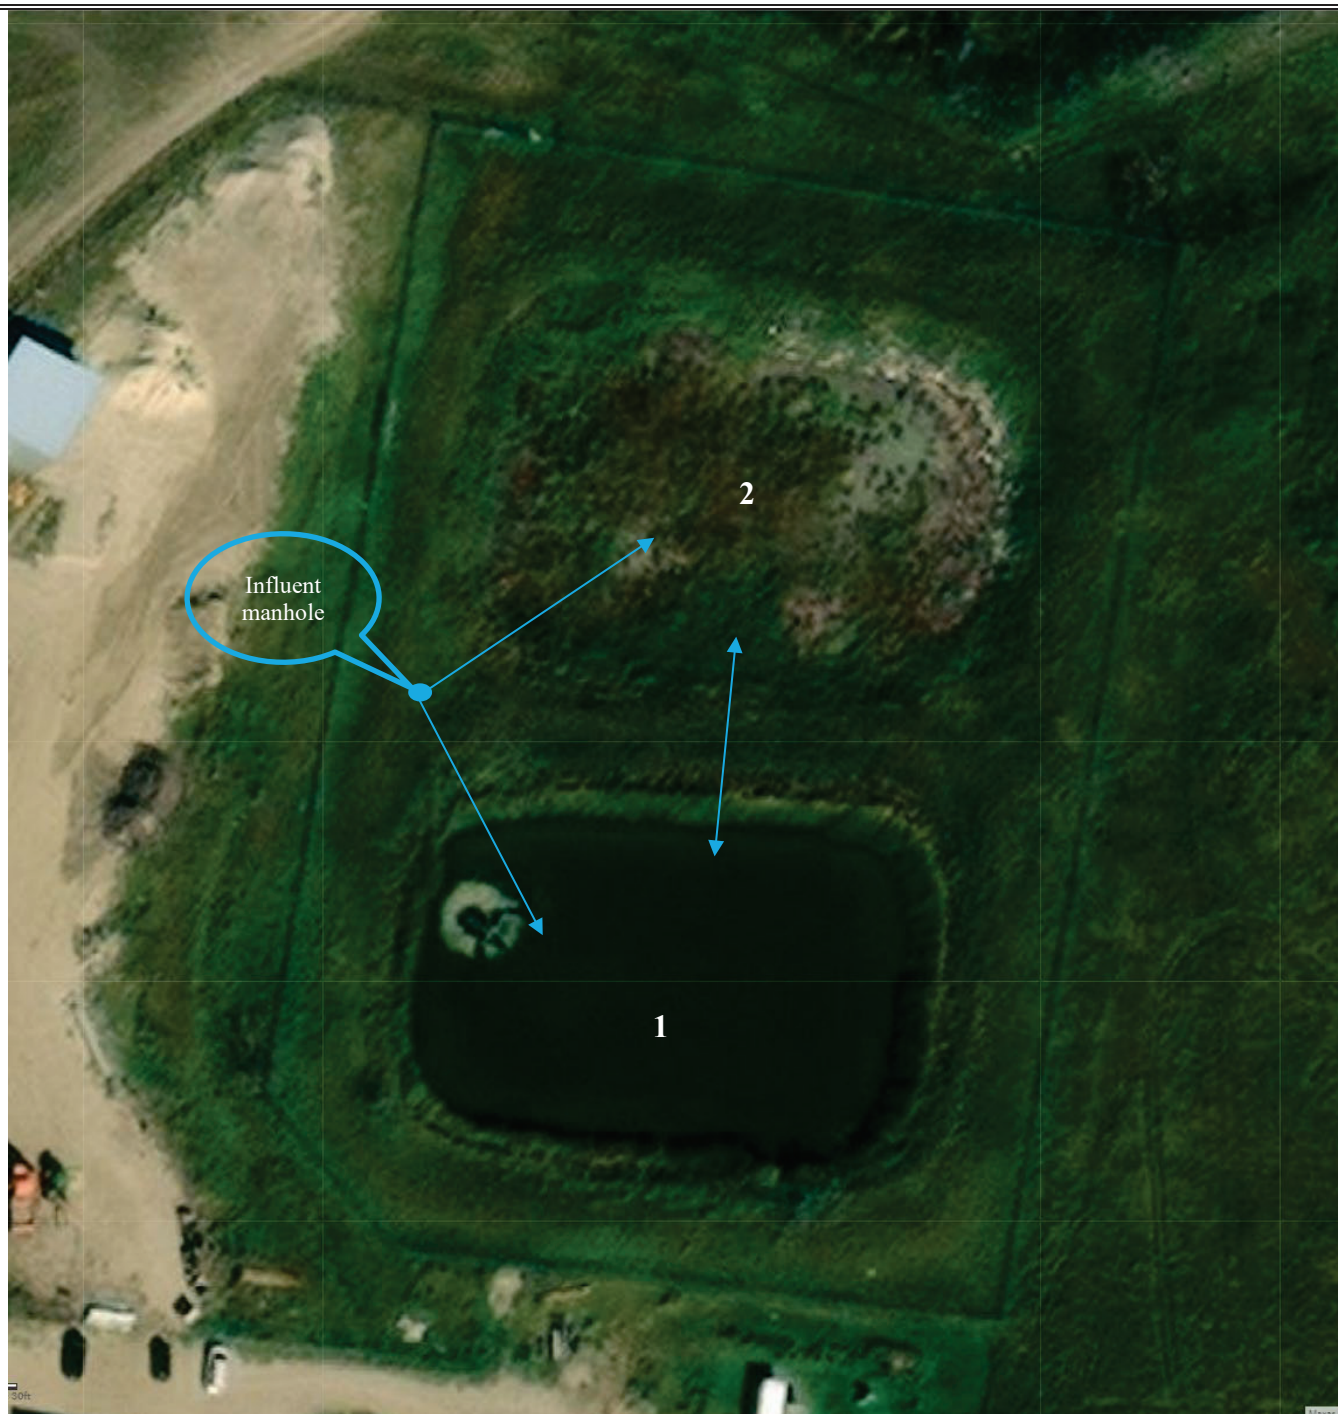
Old Hays Lagoons wastewater treatment facility was originally constructed in 1994 as a 2-cell lagoon system. The facility serves a population of approximately 25 homes and processes domestic waste only. The facility consists of a collection system and two bentonite floor-lined cells. The cells operate in series by gravity with no pumps for aeration or flow. The facility has the option of discharging to either lagoon cell as the primary cell, and periodically rotates the lead cell. Lagoon cell 1 is the south cell and is approximately 0.65-acres in size. Lagoon cell 2 is the north cell and is approximately 0.65-acres in size. Wastewater from collection system enters a manhole located west of lagoon cells and directs flow to either cell using a valve. When cell 1 is the primary cell, wastewater enters the cell in the northwest corner and into the center of the cell. When cell 2 is the primary cell, wastewater enters the cell in the southwest corner and into the center of the cell. Wastewater would then flow to the other cell in the center of the adjoining dike walls. There is not a constructed discharge pipe. Sludge removal has not occurred in this lagoon system.

The site visit included walking around lagoon cell 1 (photos 752, 755 and 756), and cell 2 (photos 753 and 754). At the time of the inspection, cell 1 was being operated as the primary cell. I observed cattail and vegetated shrub growth within cell 1. I observed grasses in excess of 6-inches tall surrounding the cells and within each cell. North (approximately 100-feet) and east (approximately 153-feet) of the lagoon system Little Peoples Creek; however, no discharge pipe was observed.
