**Region 6 - Enforcement & Compliance Assurance Division**  
**INSPECTION REPORT**

| Inspection Date(s): | 12/02/2025 and 12/03/2025 | |
| Company Name: | <b>LBOC, LLC</b> | |
| Facility Name: | <b>Baker Sand Unit Tank Battery</b> | |

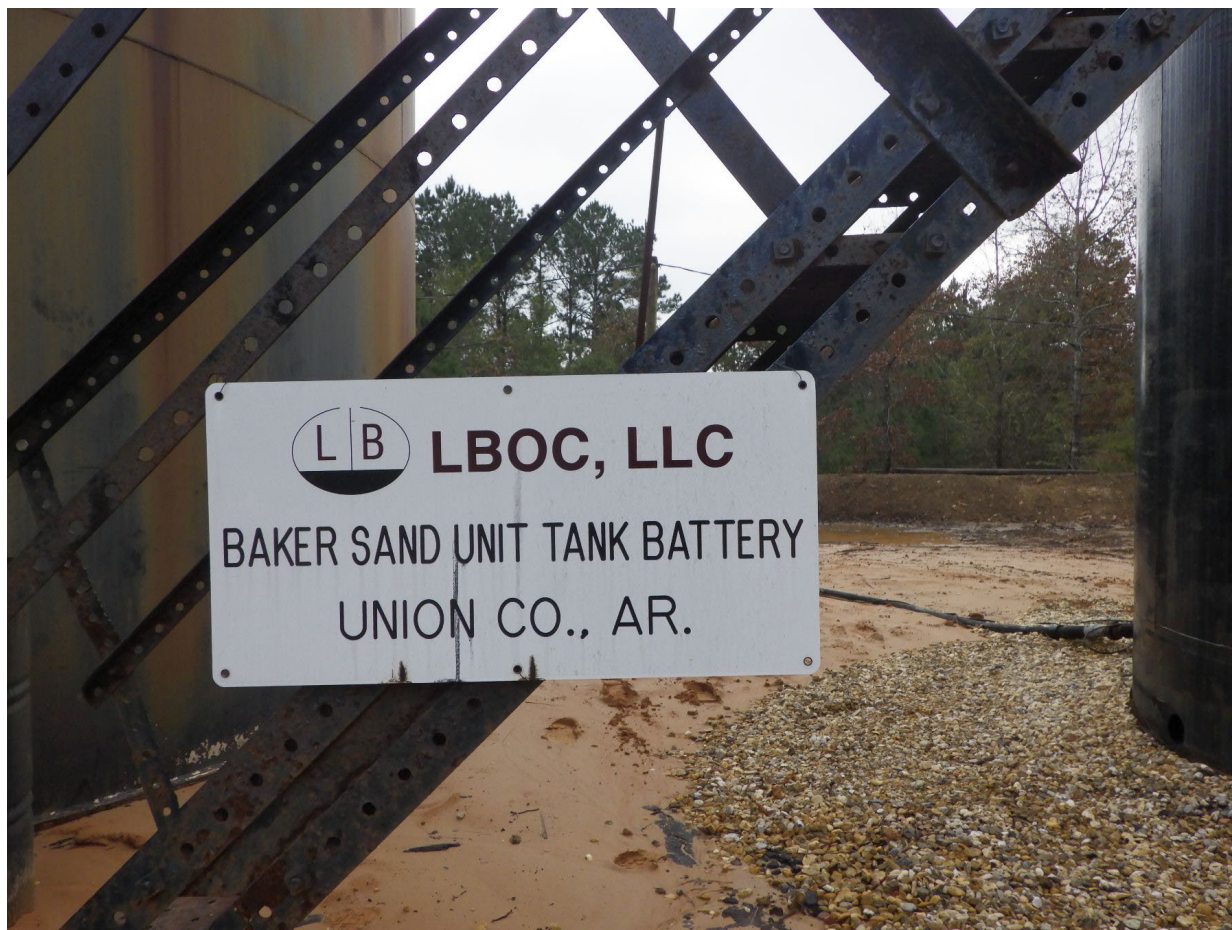
Photo No. 1

I observed the LBOC, LLC / Baker Sand Unit Tank Battery, signage, and storage tanks; see Appendix 1 (Photographs Log), Photos No. 1 and No. 2. For additional GPS location and photo metadata, see Appendix 1.

| Description: | Looking SSW, this photo shows the signage identifying the company and lease names for the Baker Sand Unit Tank Battery (Facility). | | |

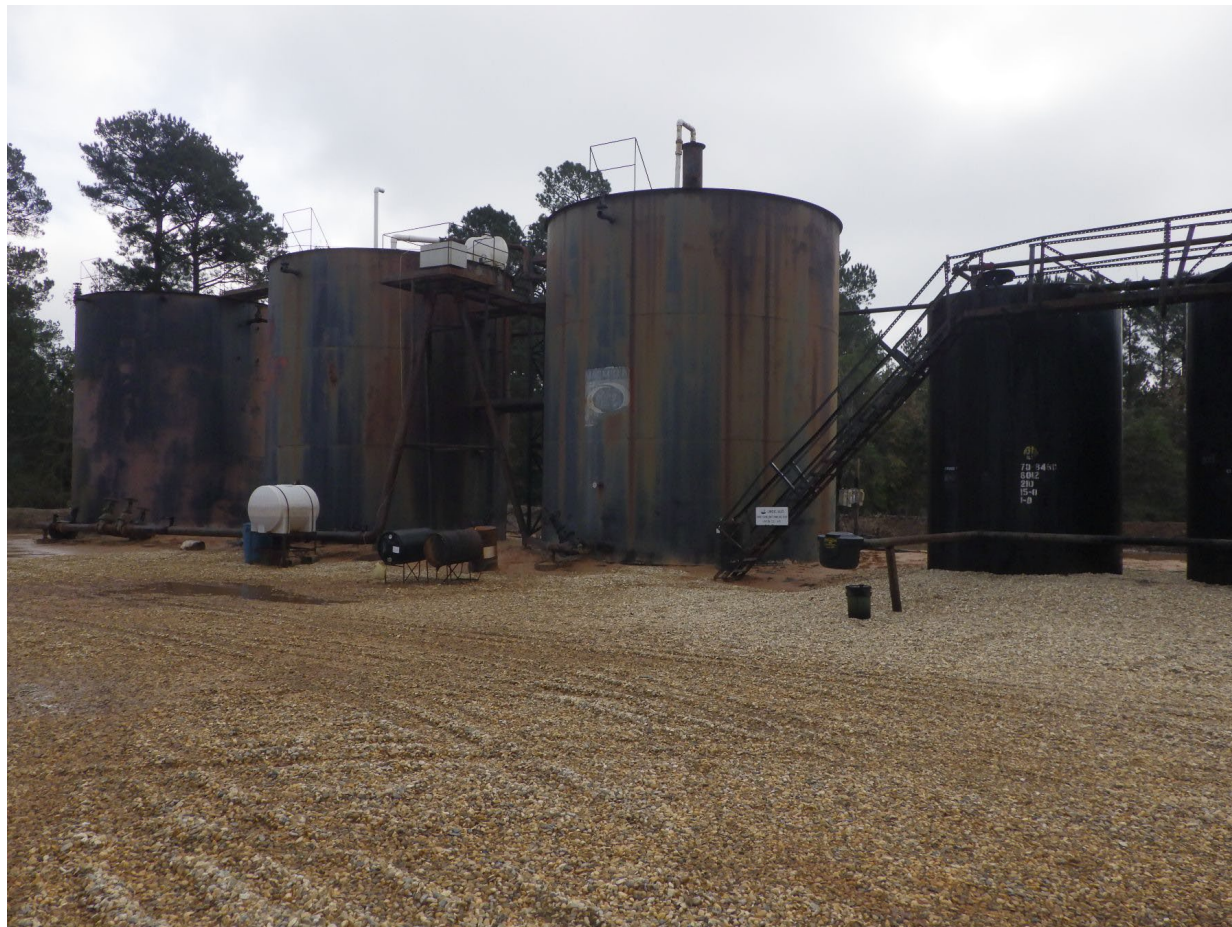
Photo No. 2

EPA conducted a follow-up inspection on the LBOC, LLC / Baker Sand Unit Tank Battery, which contains five (5) storage tanks in operation and four (4) storage tanks not in operation.

| Description: | Looking ESE, this photo shows an overview of the storage tanks located inside containment. | | |

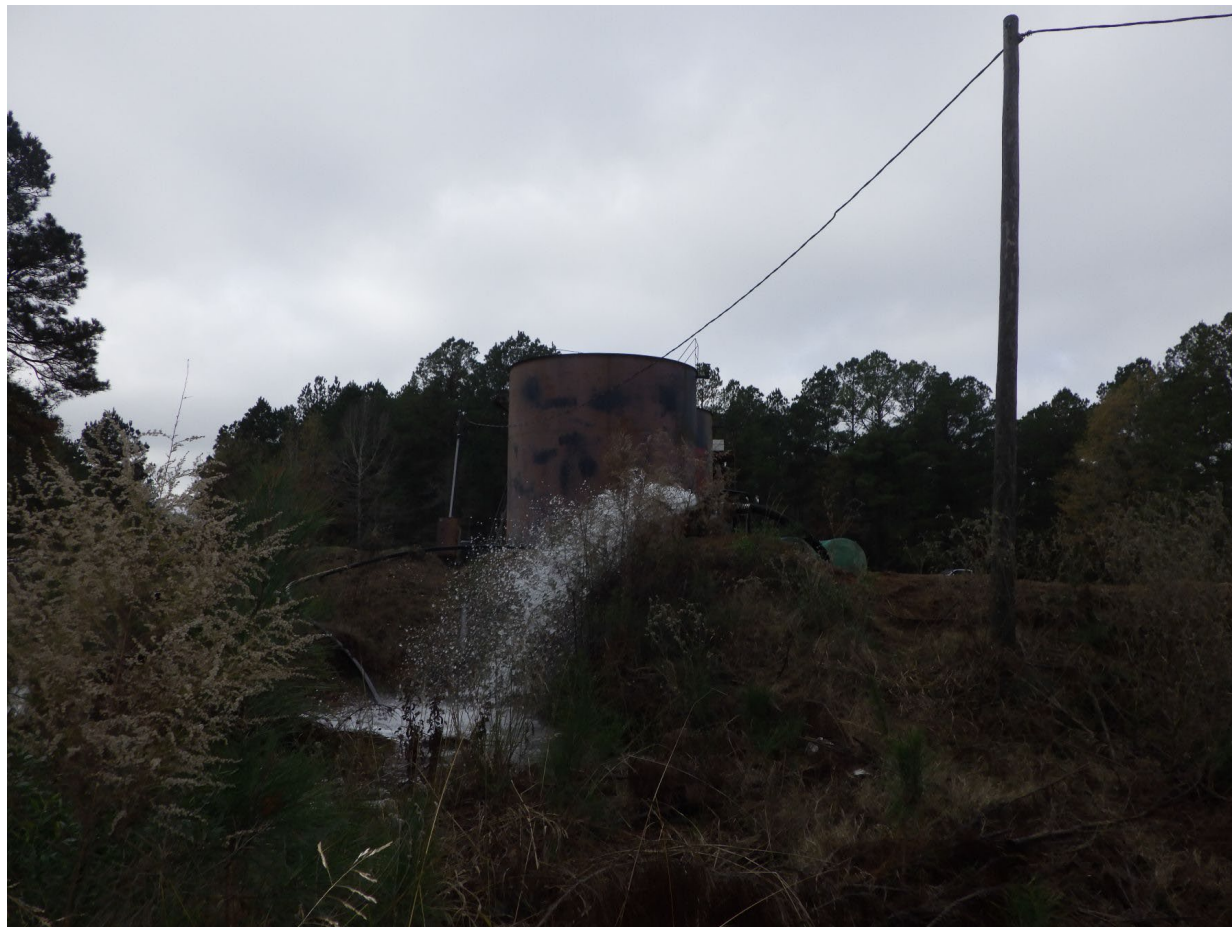
Photo No. 3

I observed a crew of three people actively pumping water over the berm for the secondary containment, see Photo No. 3.

I spoke with the personnel actively pumping accumulated stormwater from inside the secondary containment berm, and I provided them feedback regarding the TDS readings analyzed during the inspection. Additionally, I spoke with Mr. Scott Carter via cellphone during the inspection. In August 2025, EPA issued an Administrative Order to LBOC, LLC for this facility. There were no areas of concern at the time of the inspection.

| Description: | Looking W, this photo shows personnel pumping accumulated stormwater over the levee from containment. | | |

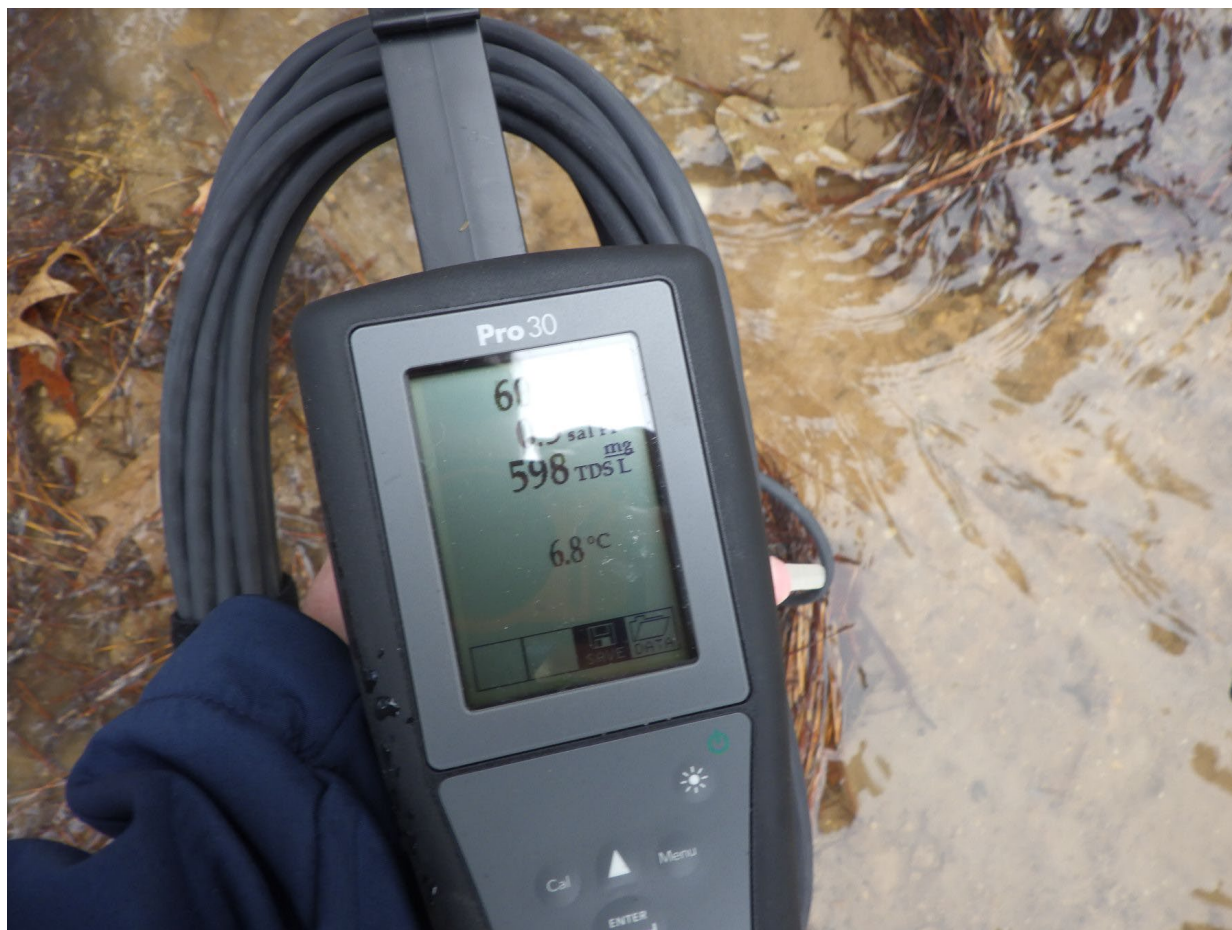
Photo No. 4

I observed Total Dissolved Solids (TDS) readings of 598 and 601 mg/L of the discharge, see Photos No. 4 and No. 5.

| Description: | Looking NNE, this photo shows the TDS reading (598 mg/L) of the water pumped over the side of the containment levee shown in Photo No. 3. | | |

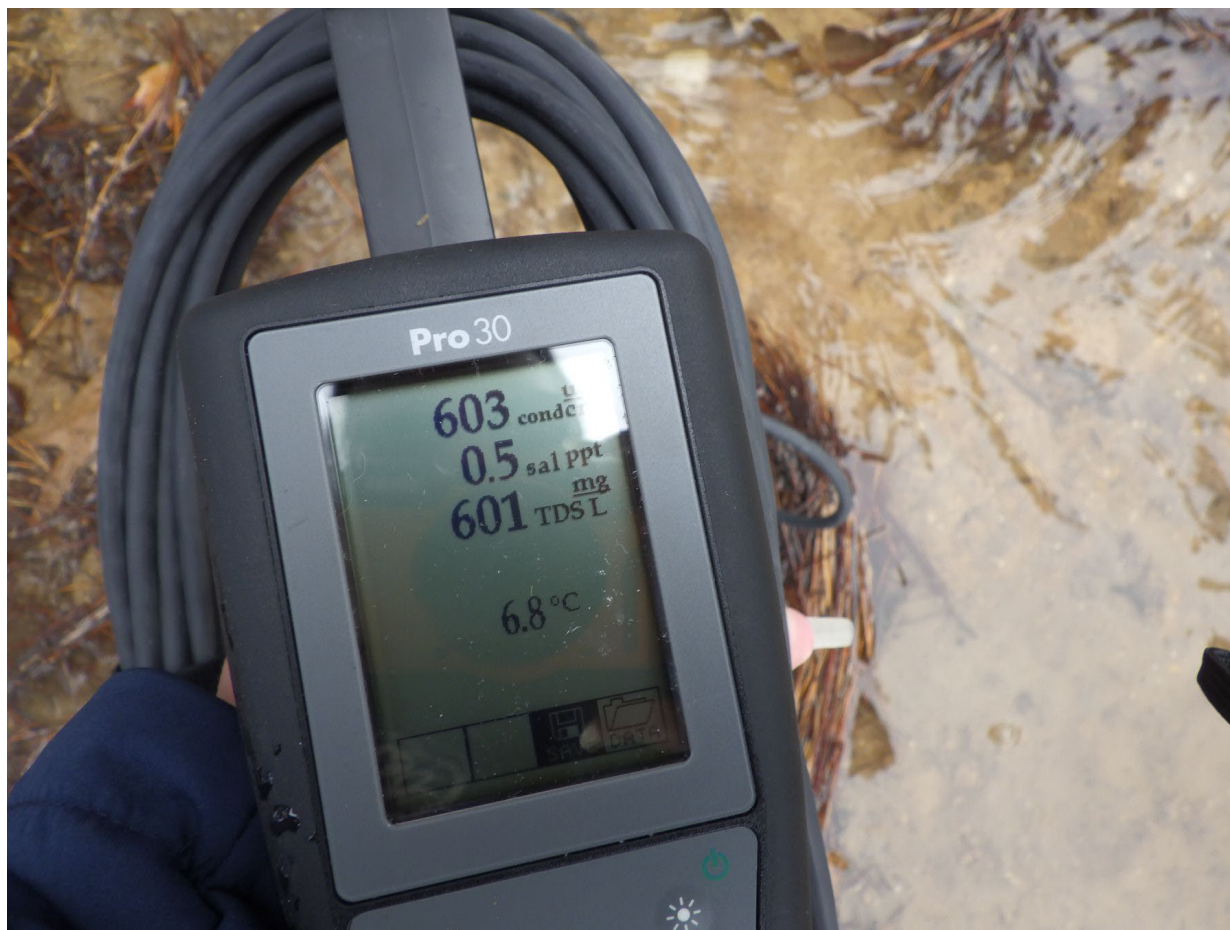
Photo No. 5

| Description: | Looking NNE, this photo shows an additional TDS reading (601 mg/L) of the water pumped over the side of the containment levee shown in Photo No. 3. | | |
