**Region 6 - Enforcement & Compliance Assurance Division**  
**INSPECTION REPORT**

| Regulatory Program: | Water (CWA) Brine Program (Oil & Gas inspection) | |
| Company Name: | <b>Williamson Pumping Service, Inc.</b> | |
| Facility Name: | <b>Featherstone SWD Tank Battery</b> | |

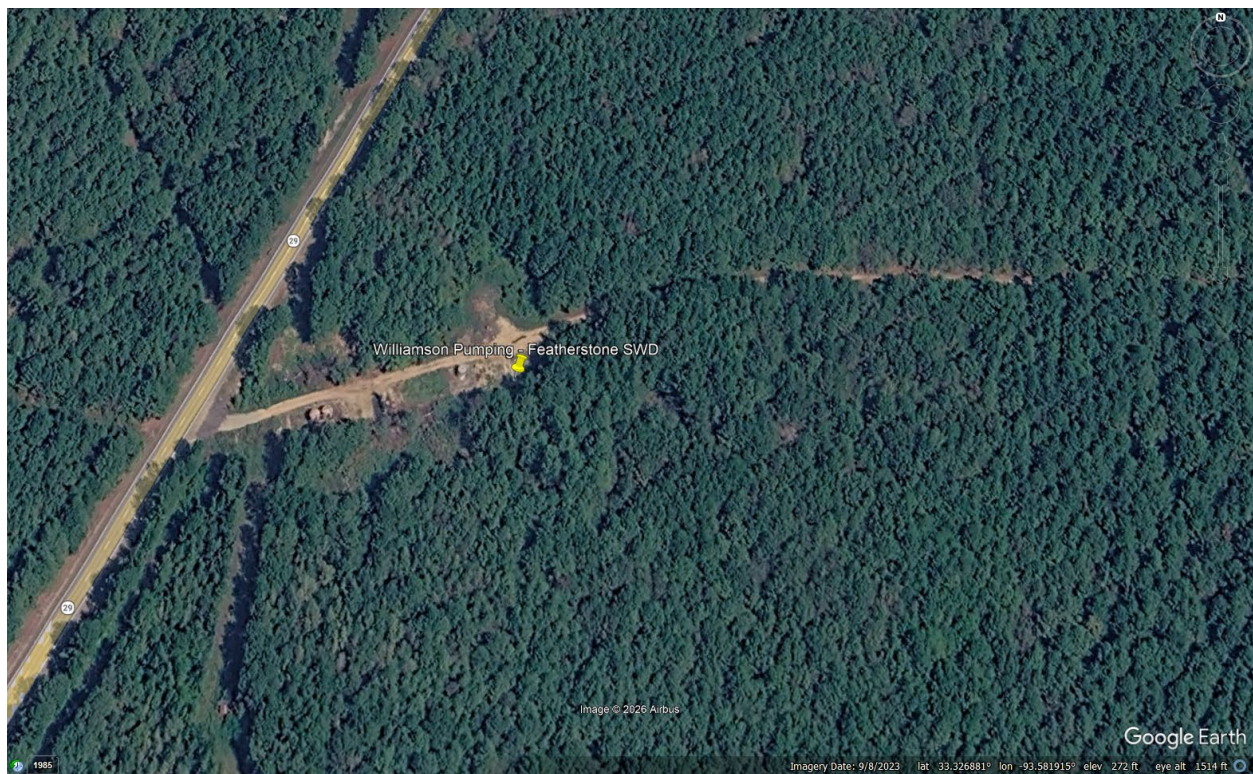
**Map 1.** Aerial imagery (Google Earth dated 09/08/2023) of the Williamson Pumping Service, Inc. / Featherstone SWD Tank Battery facility.

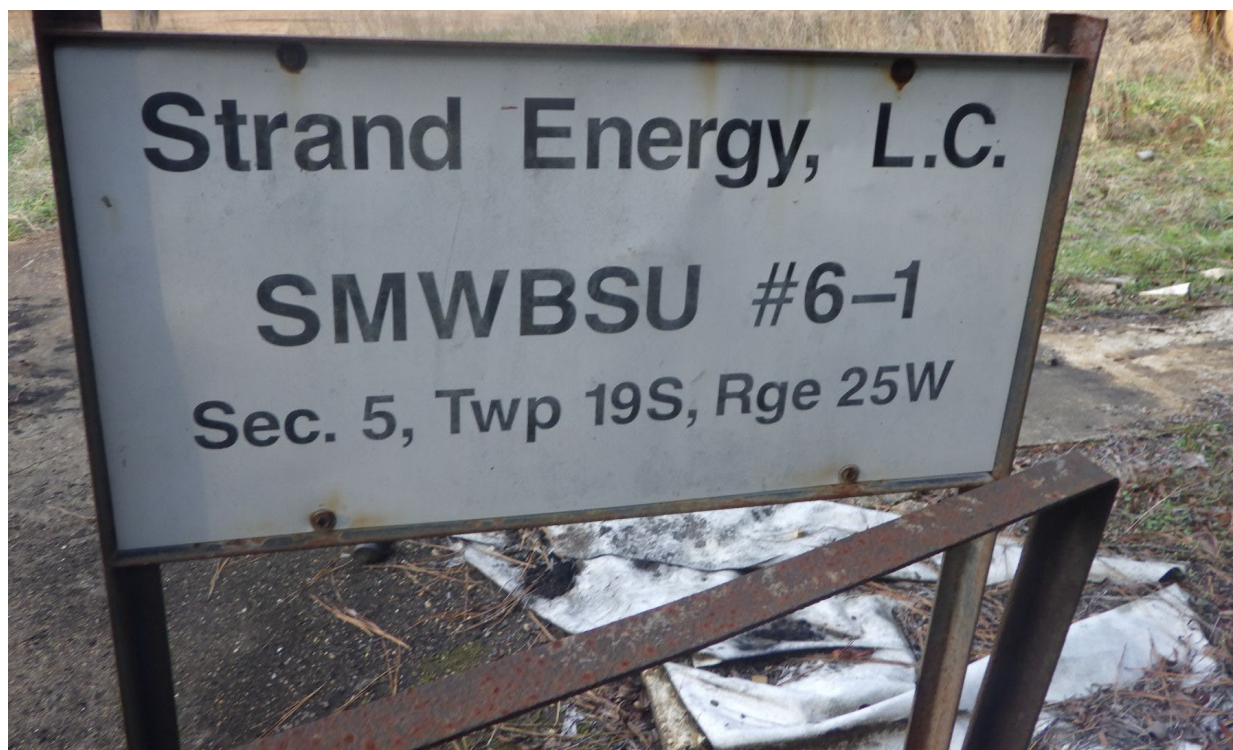
Photo No. 1

I observed the facility signage and an overview of the facility; see Appendix 1 (Photographs Log), Photos No. 1 and No. 2. For additional GPS location and photo metadata, see Appendix 1.

| Description: | Looking N, this photo shows a sign located at the site; company on the signage no longer operates in the state.<br><br>Note: photo edited to remove coworker. | | |

- Incorrect/outdated signage at the facility (required by AOGC) (Photo No. 1),
- Accumulated salt inside the saltwater storage tank battery, 40 CFR 112.9(d)(3) (Photos No. 4 and No. 5); and
- Possible historic saltwater release from the facility, 40 CFR 112.9(d)(3) (Photo No. 7)

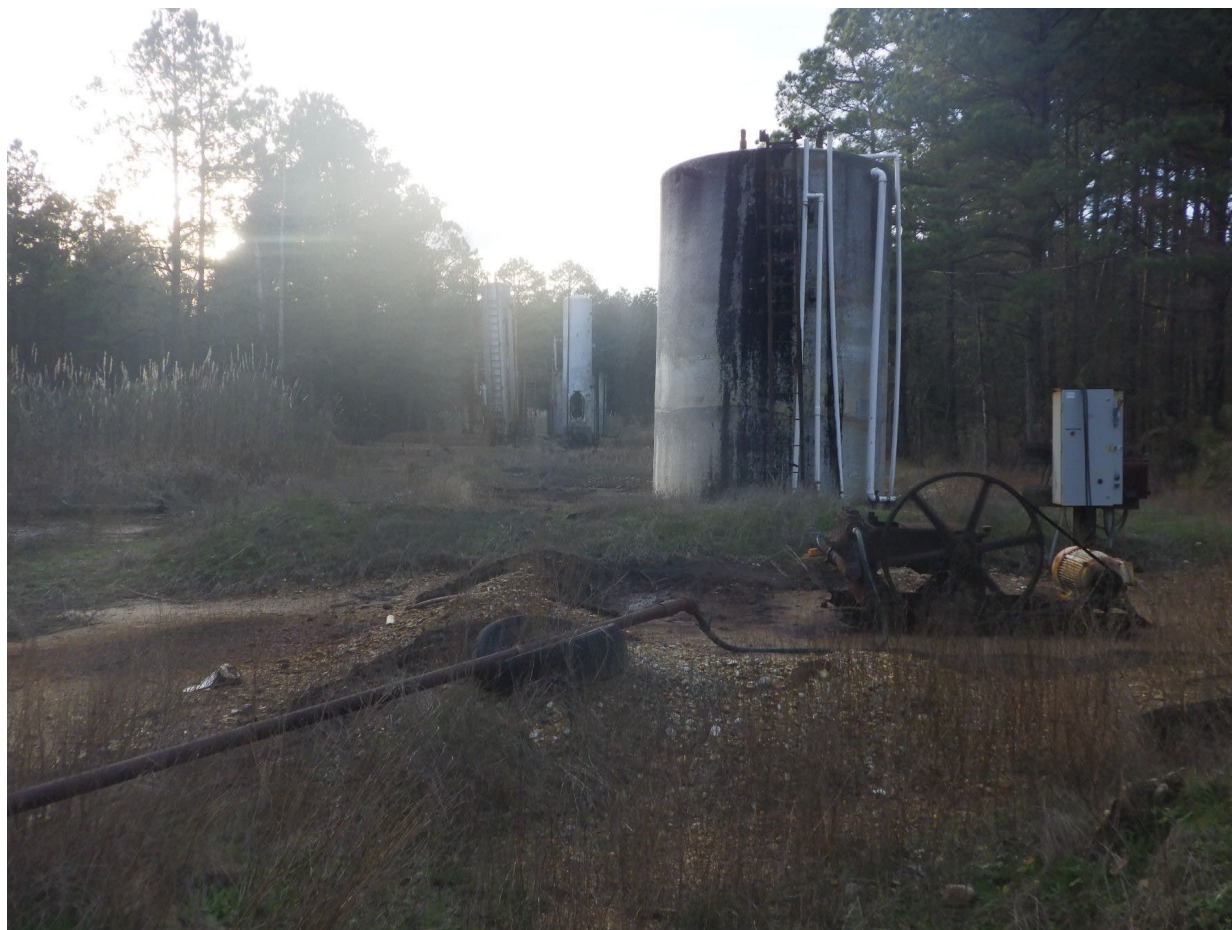
Photo No. 2

| Description: | Looking WNW, this photo shows an overview of the SWD tank batteries with separate batteries for the separators, saltwater storage tank, and SWD pump. | | |

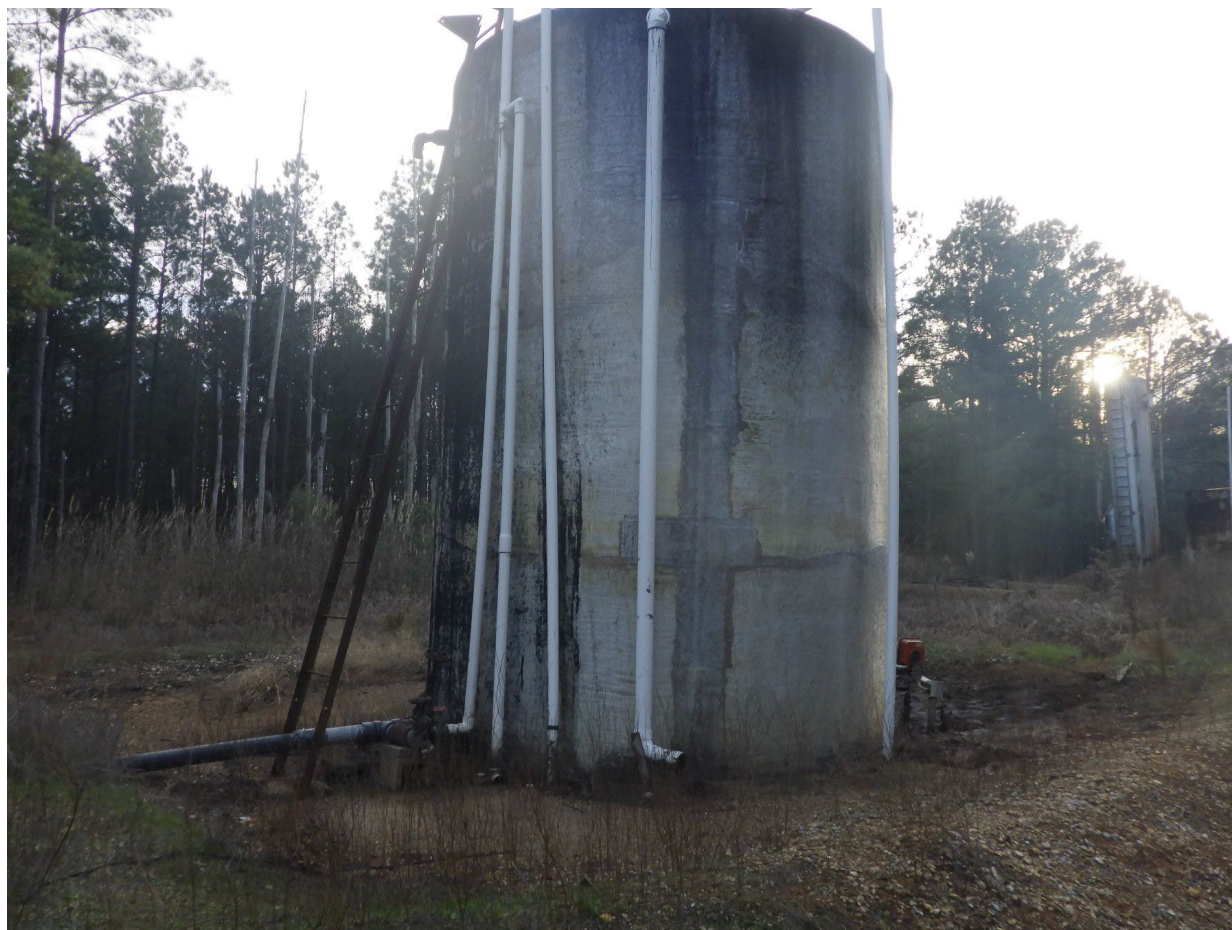
Photo No. 3

I observed the saltwater storage tank and the associated tank battery, see Photo No. 3.

| Description: | Looking SW, this photo shows the saltwater storage tank that would be utilized after separation. | | |

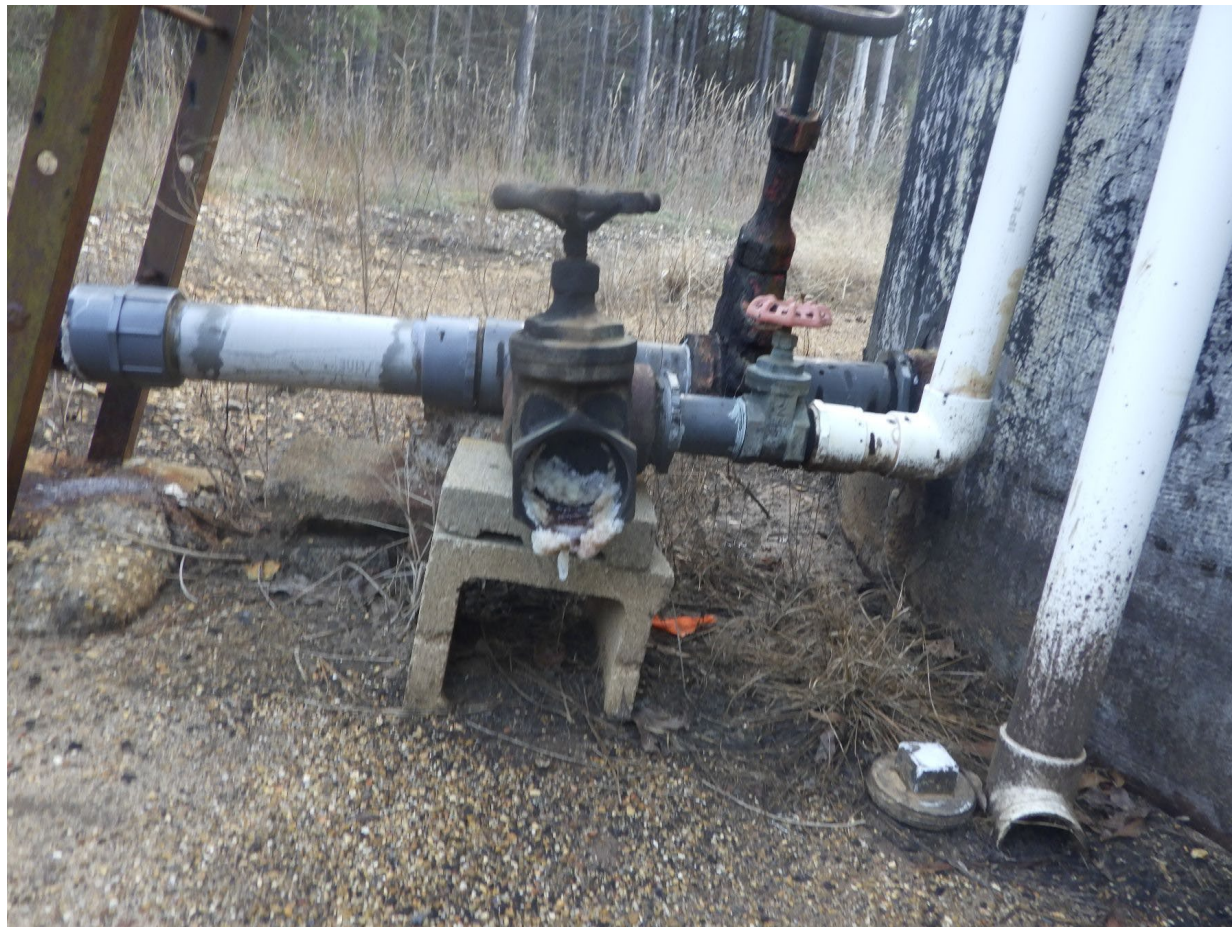
Photo No. 4

I observed an uncapped pipe with salt crystal accumulation inside the tank battery, see Photo No. 4.

| Description: | Looking SSW, this photo shows piping and a valve at the saltwater storage tank with salt crystals present. | | |

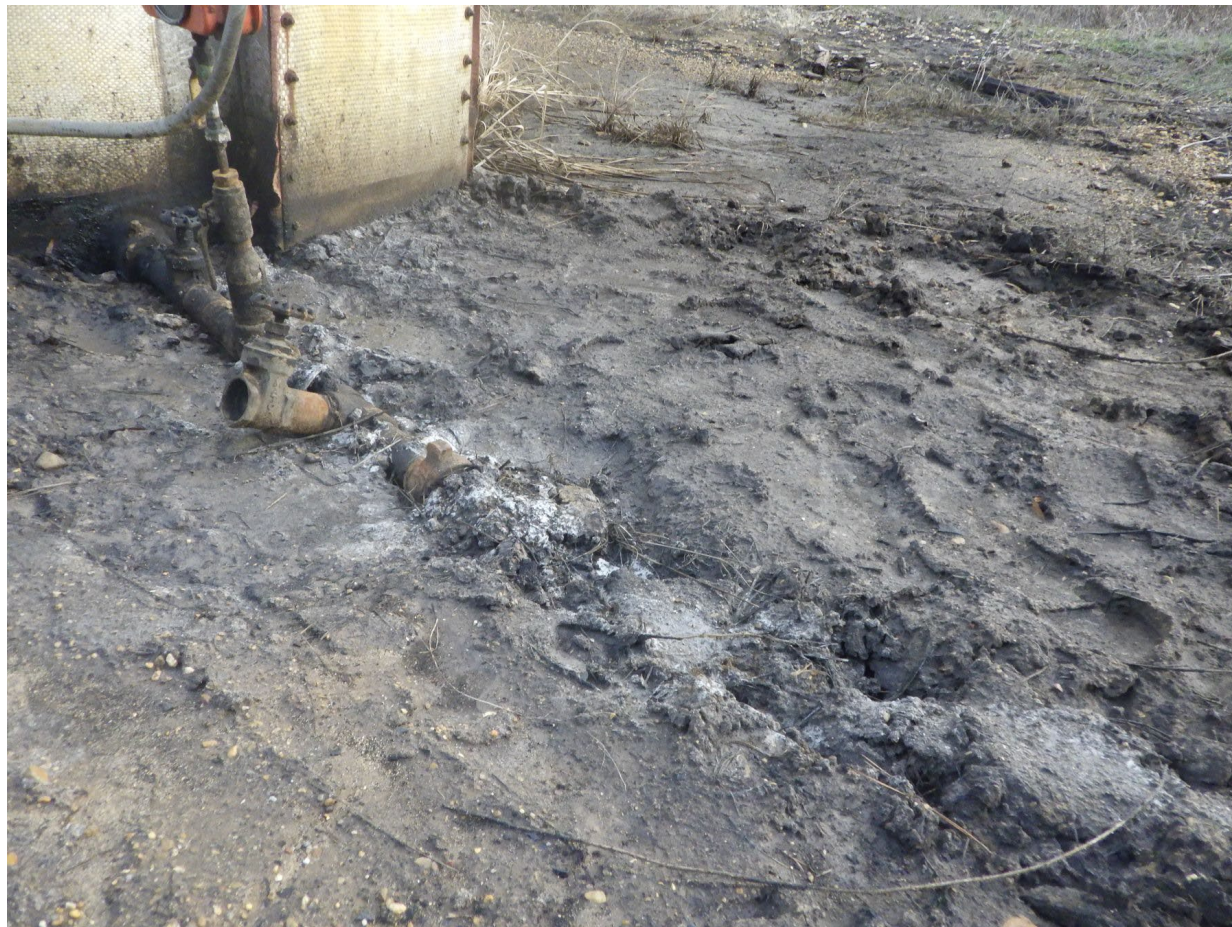
Photo No. 5

I observed a disturbed area and excavated piping with salt crystal accumulation inside the tank battery, see Photo No. 5.

| Description: | Looking NE, this photo shows a disturbed area from recent repairs with salt crystals on the soil surface. | | |

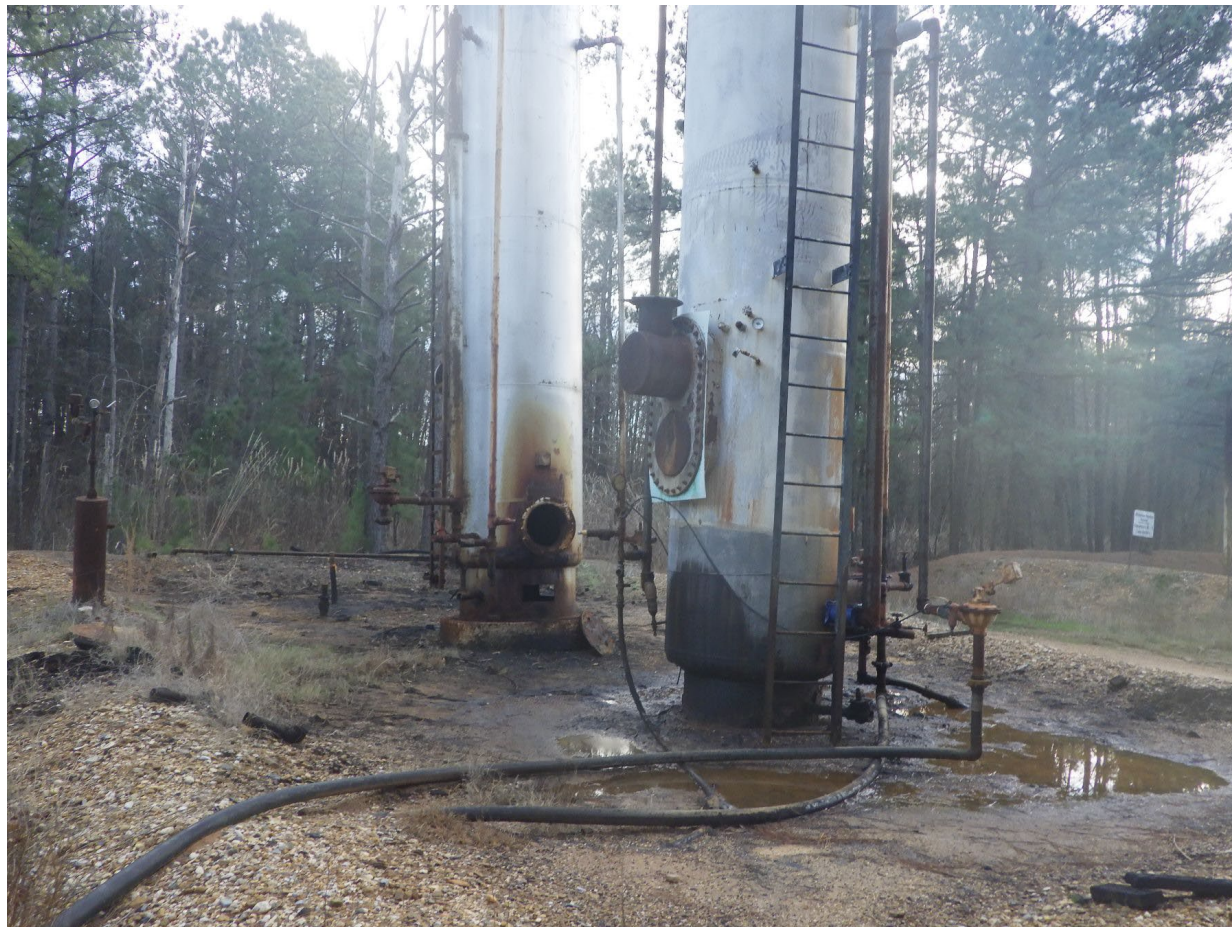
Photo No. 6

I observed two (2) separators inside a tank battery, see Photo No. 6,

| Description: | Looking SW, this photo shows two separators inside secondary containment. | | |

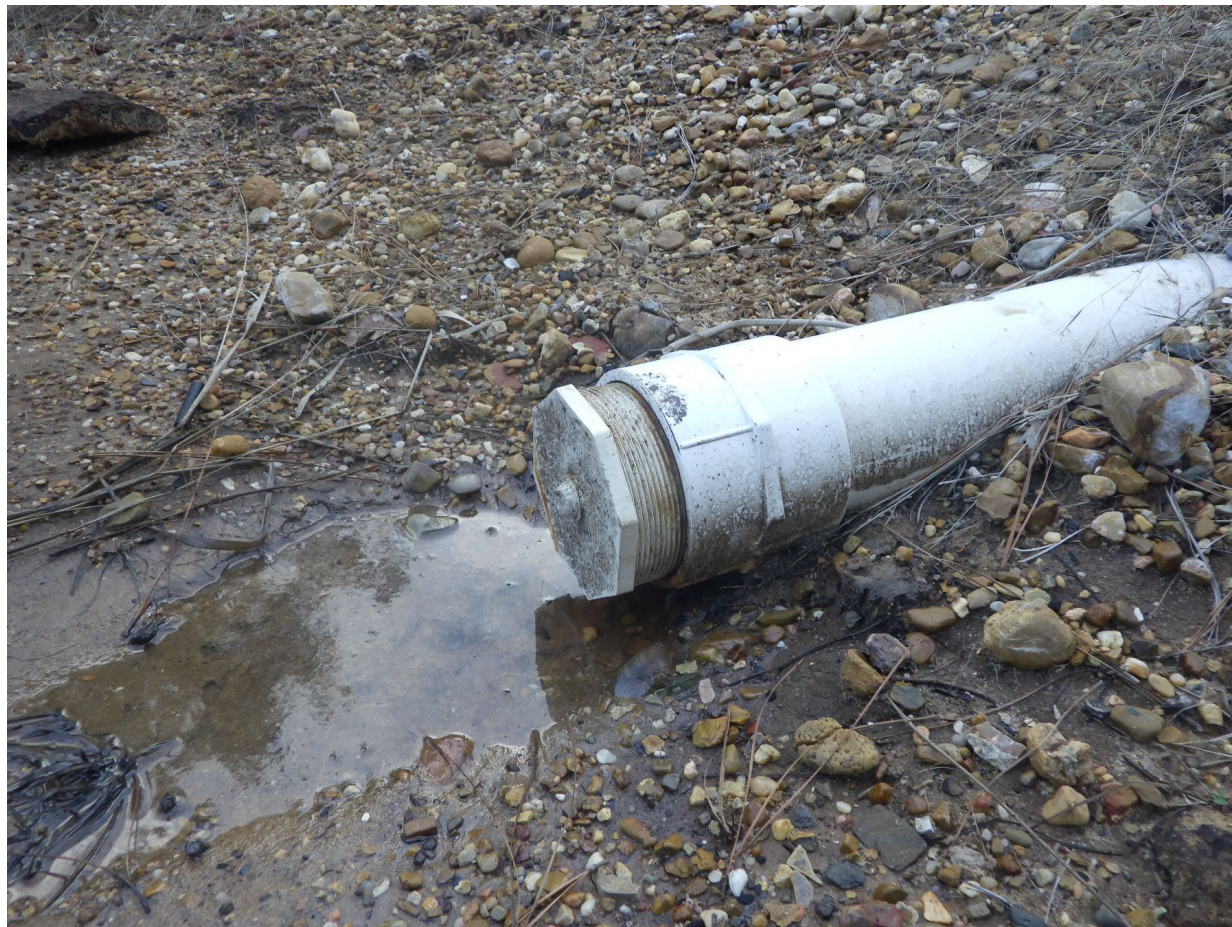
Photo No. 7

| Description: | Looking NW, this photo shows the drainpipe for the separator tank battery; the cap is in place but not fully closed. | | |

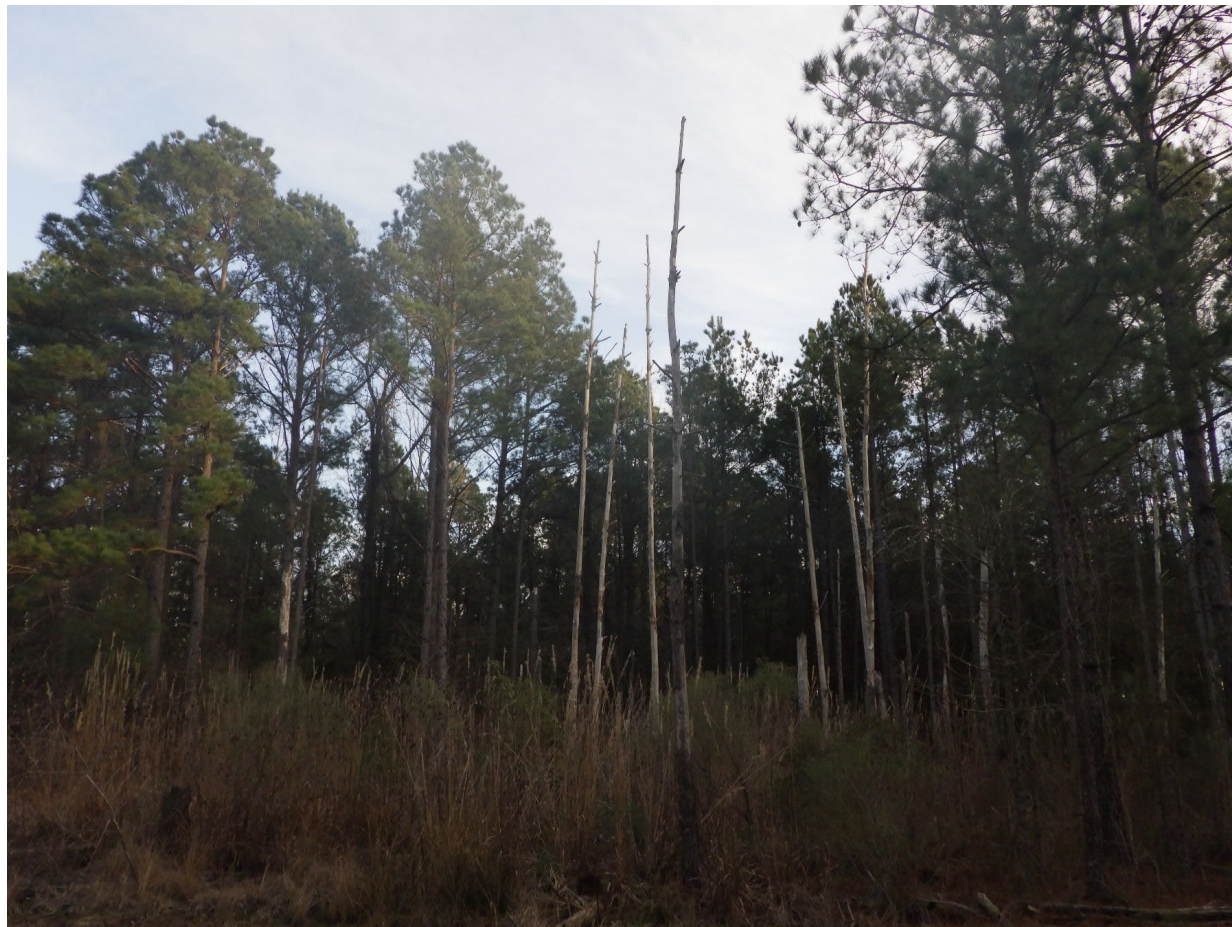
Photo No. 8

I observed dead vegetation and trees in an adjacent wetland from a possible historic release of saltwater, see Photo No. 7.

| Description: | Looking SSE, this photo shows an area adjacent to the facility with dead vegetation. | | |
