**Compliance Evaluation Inspection Report**

Falcon POTW  
125 Nevils Road,  
Falcon, MS 38628  
NPDES Permit Number: MS0036731

**Project No. CV-MS0036731-08132024**

**COMPLIANCE EVALUATION INSPECTION REPORT**  
Falcon MS POTW, Project # CV-MS0036731-08132024

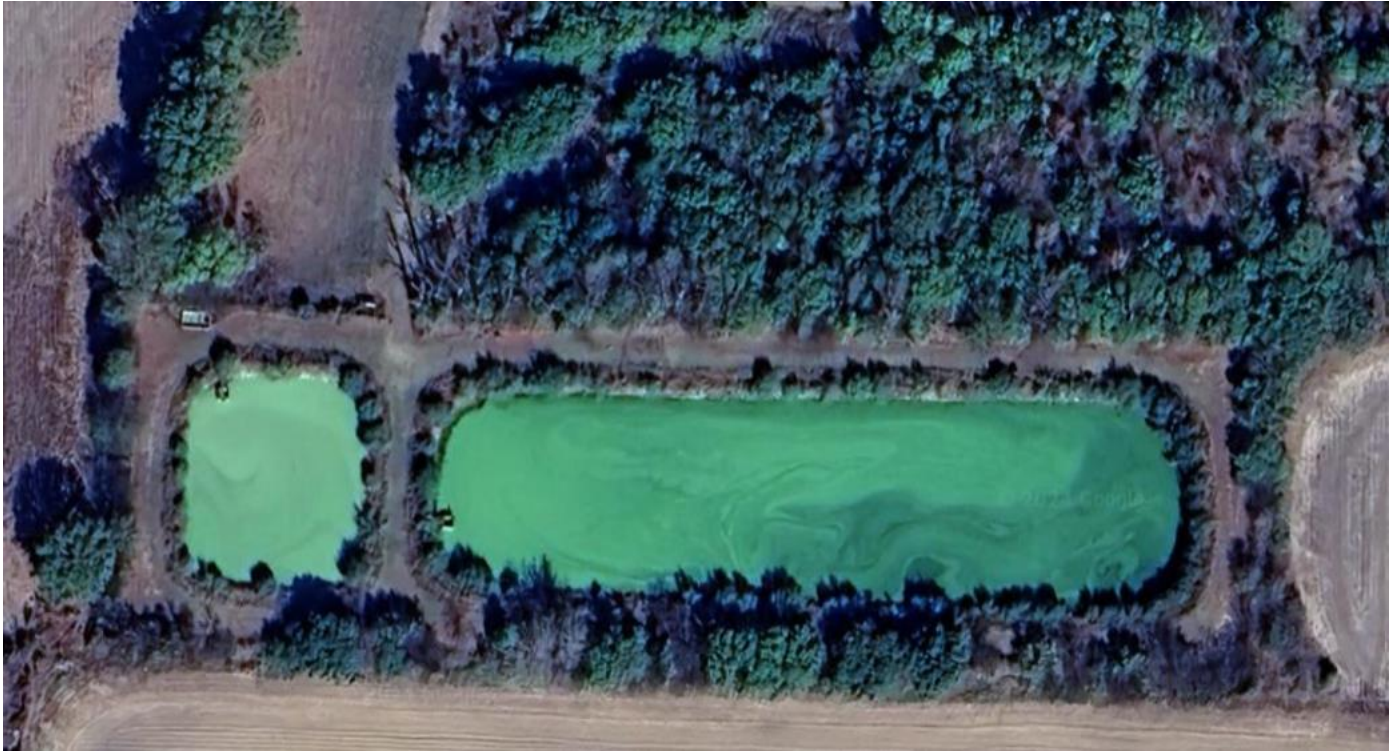
Figure 1. Aerial View of Facility

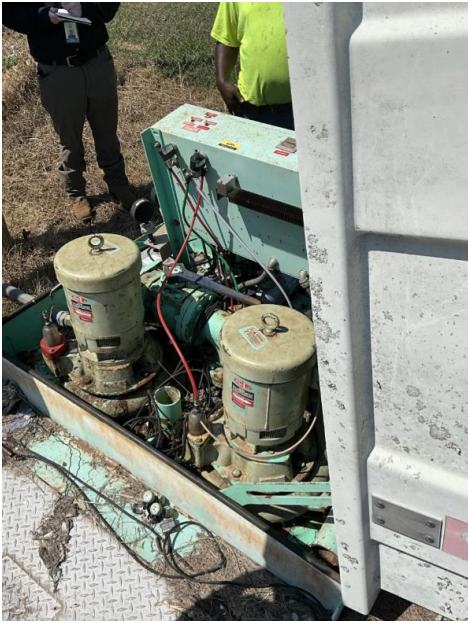
- The Charley Pride lift station was inoperable (Photo 1).
- The Charley Pride lift station pump seal was not working, and the Town is waiting for Luckett pumping to come out and provide service (Photo 2).
- The Third Street lift station is manually being pumped down. Both pumps seem to be operational, but the maintenance worker says they'll burn out if left on automatic. The floats may be inoperable. (Photo 3).
- The v-notch weir and chlorine contact chamber have not been maintained. No feed control. Excessive algae and duckweed (Photo 4).
- Chlorine disinfection tablets were empty. No knowledge of the type of tablets, percentage of tablets used, or if there were any tablets on hand (photo 5).

Photo 1: Inoperable pump at lift station no.1.

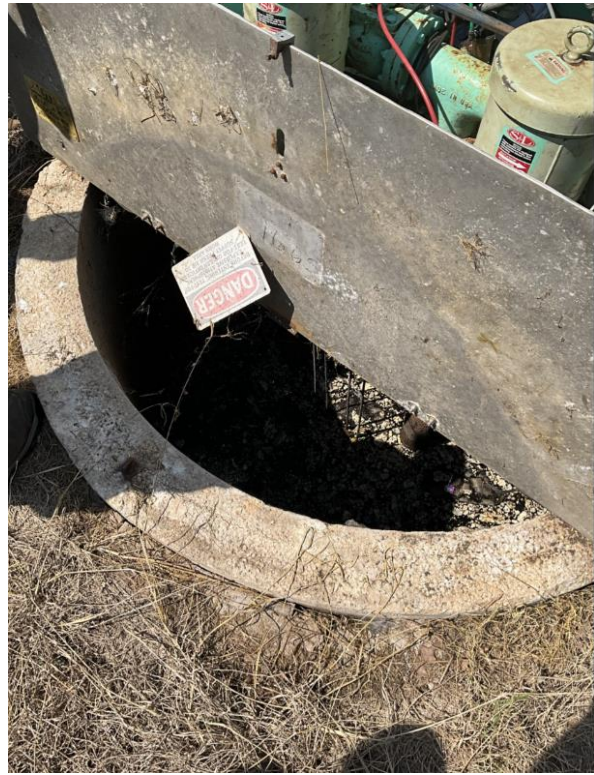
Photo 2: Lift station no.1 well full.

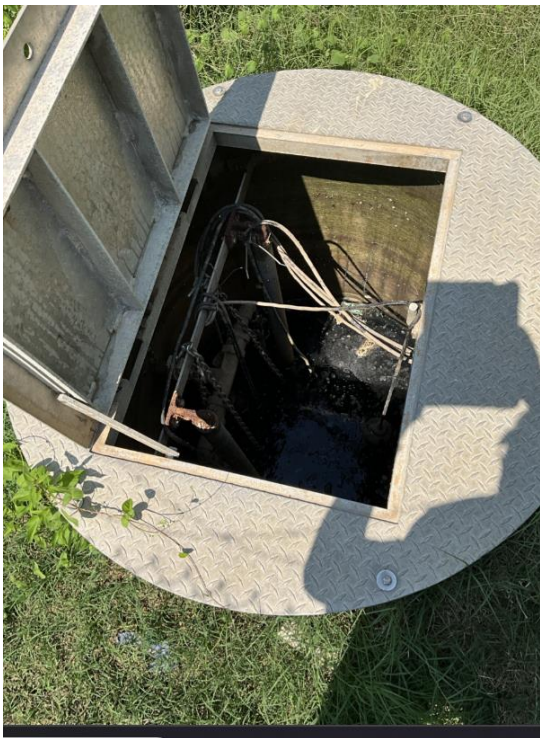
Photo 3: Lift station no. 2

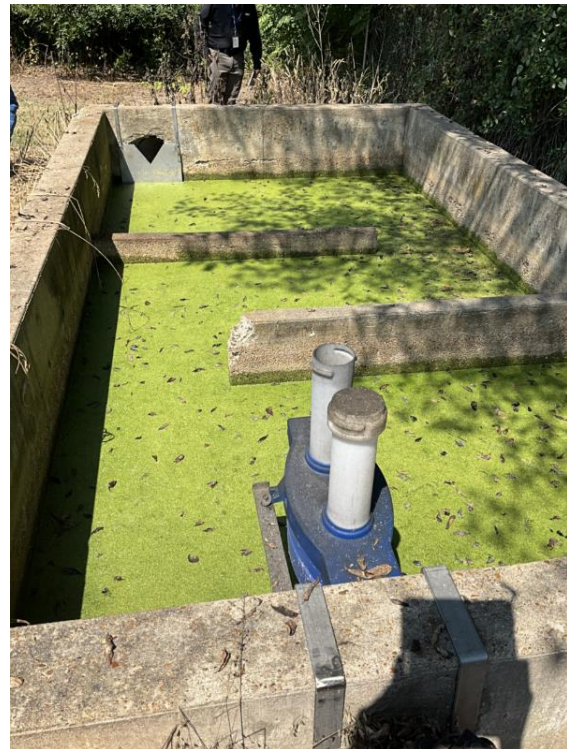
The effluent flow meter was not evaluated during this inspection as it was non-operational, but Mr. West said he would start using a yardstick at the v-notch weir to determine flow.

Photo 4: V-notch weir & Chlorine contact chamber

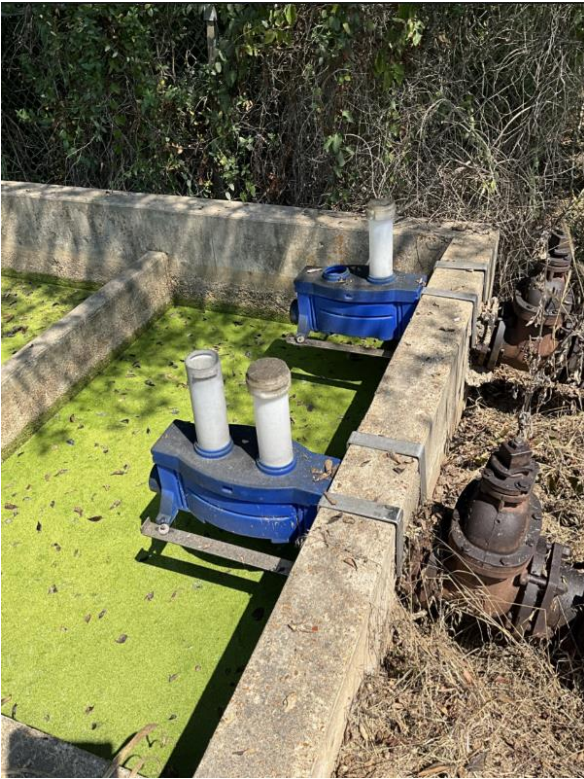
Two lift stations feed into the plant. The POTW consists of two facultative lagoons with chlorine tablet disinfection which at the time of the inspection was out of service. No chlorine tablets were on site for effluent disinfection. Neither the operator nor service worker were sure of the last time chlorine tablets were available for disinfection. The first cell of the facility is approximately 400'x 100' and feeds to the second cell which is approximately 125'x 100'. The following components were observed:

Photo 5: No chlorine tablets present.

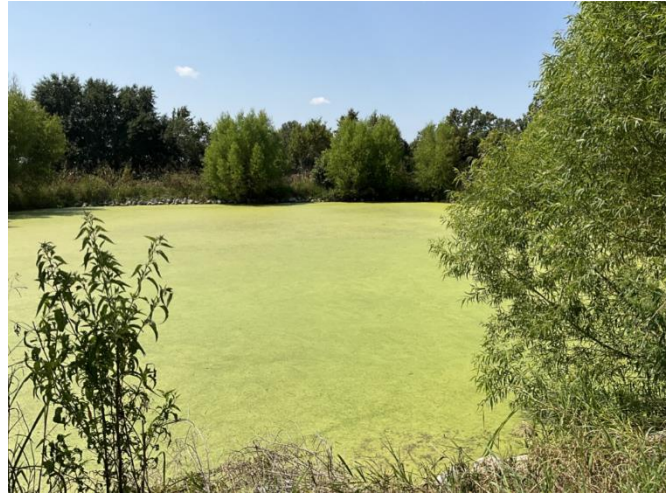
- Cells 1 and 2 have not been maintained. Vegetation and woody plants/trees have accumulated along both dikes, pond edge and in the pond. Excessive algae and duckweed. (Photos 6 & 7).

Photo 6: Lagoon- Cell 2, full of duckweed.

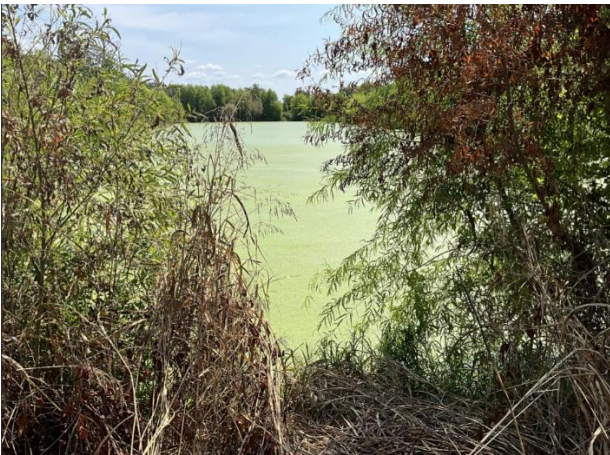
Photo 7: Lagoon- Cell 1, full of duckweed.
