**Region 6 - Enforcement & Compliance Assurance Division**  
**INSPECTION REPORT**

| Inspection Date(s): | 09/13/2022 | |
| Facility Name: | <b>Rio Puerco Wastewater Treatment Plant (WWTP)/Route 66 Casino</b> | |
| Identification/Permit Number: | NM0030686 | |

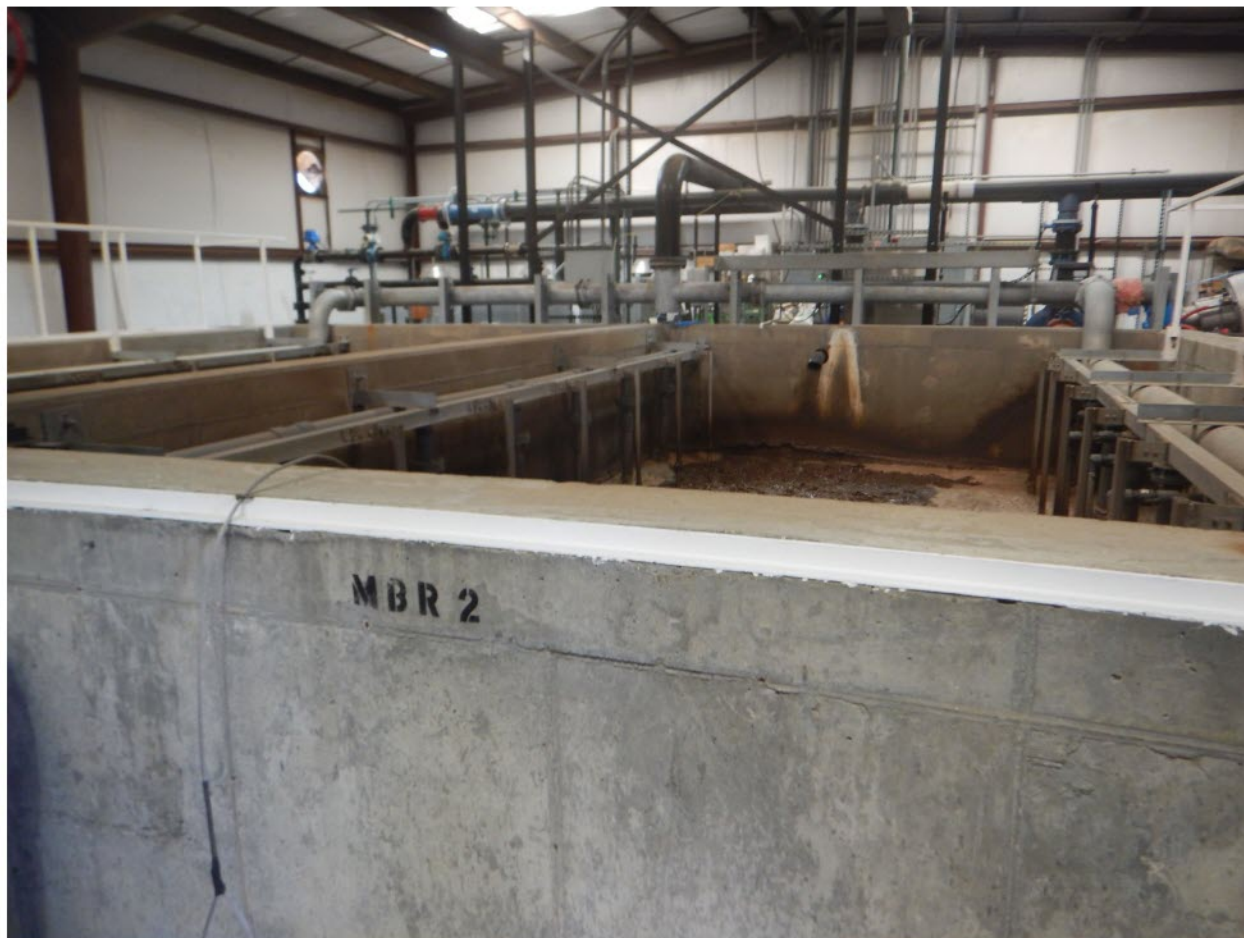
Photo No. 1

Overall view of the Casa Blanca membrane bioreactor (MBR) basin #2. (DSCN1662). September 13, 2022.  
Photographed by D. Esparza

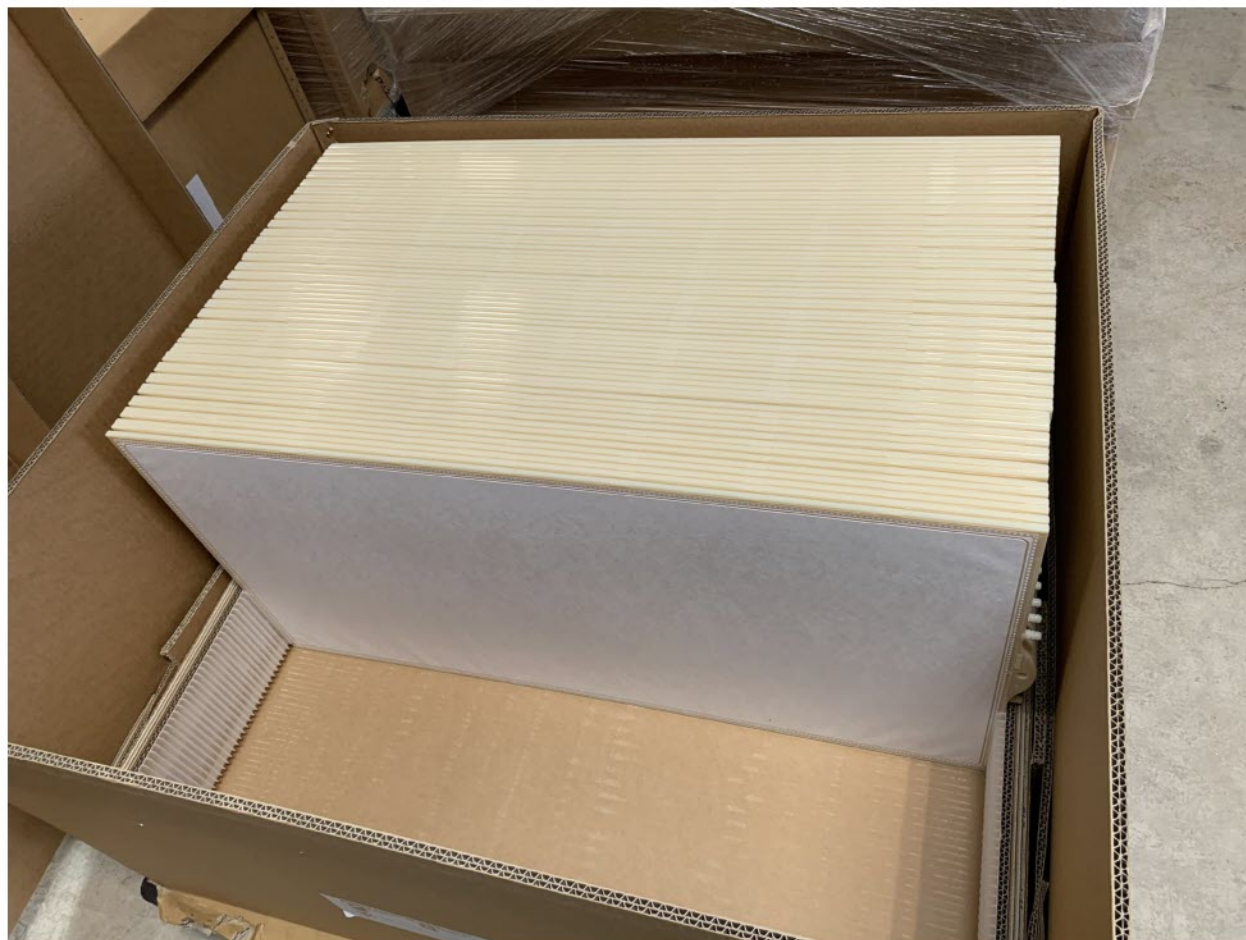
Photo No. 2

Replacement membrane cartridges awaiting installation. (IMG0143). September 13, 2022.  
Photographed by D. Esparza

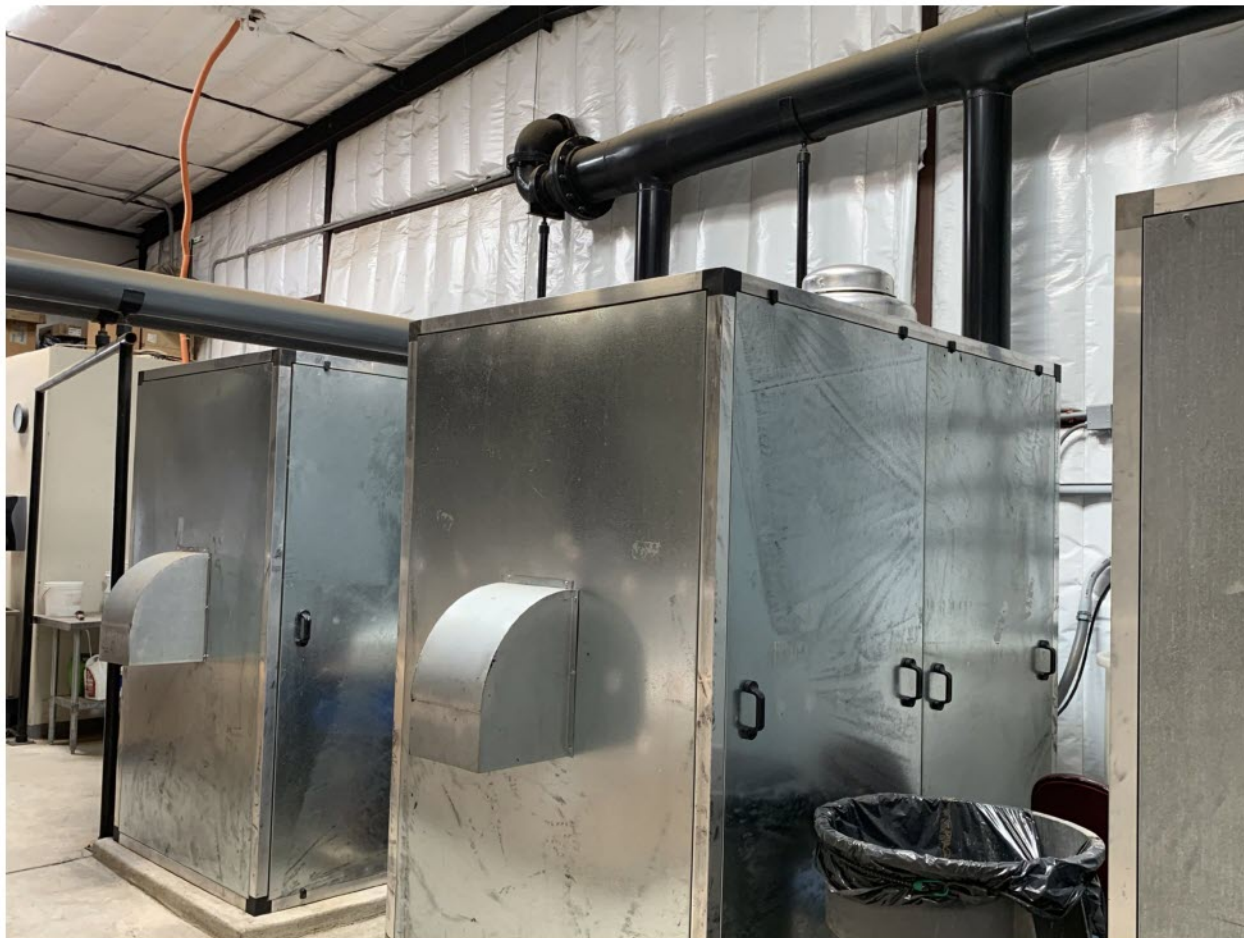
Photo No. 3

View of two (2) of the three (3) WWTP blowers. Note: one (1) blower required extensive repair after catching fire. (IMG0147). September 13, 2022. Photographed by D. Esparza

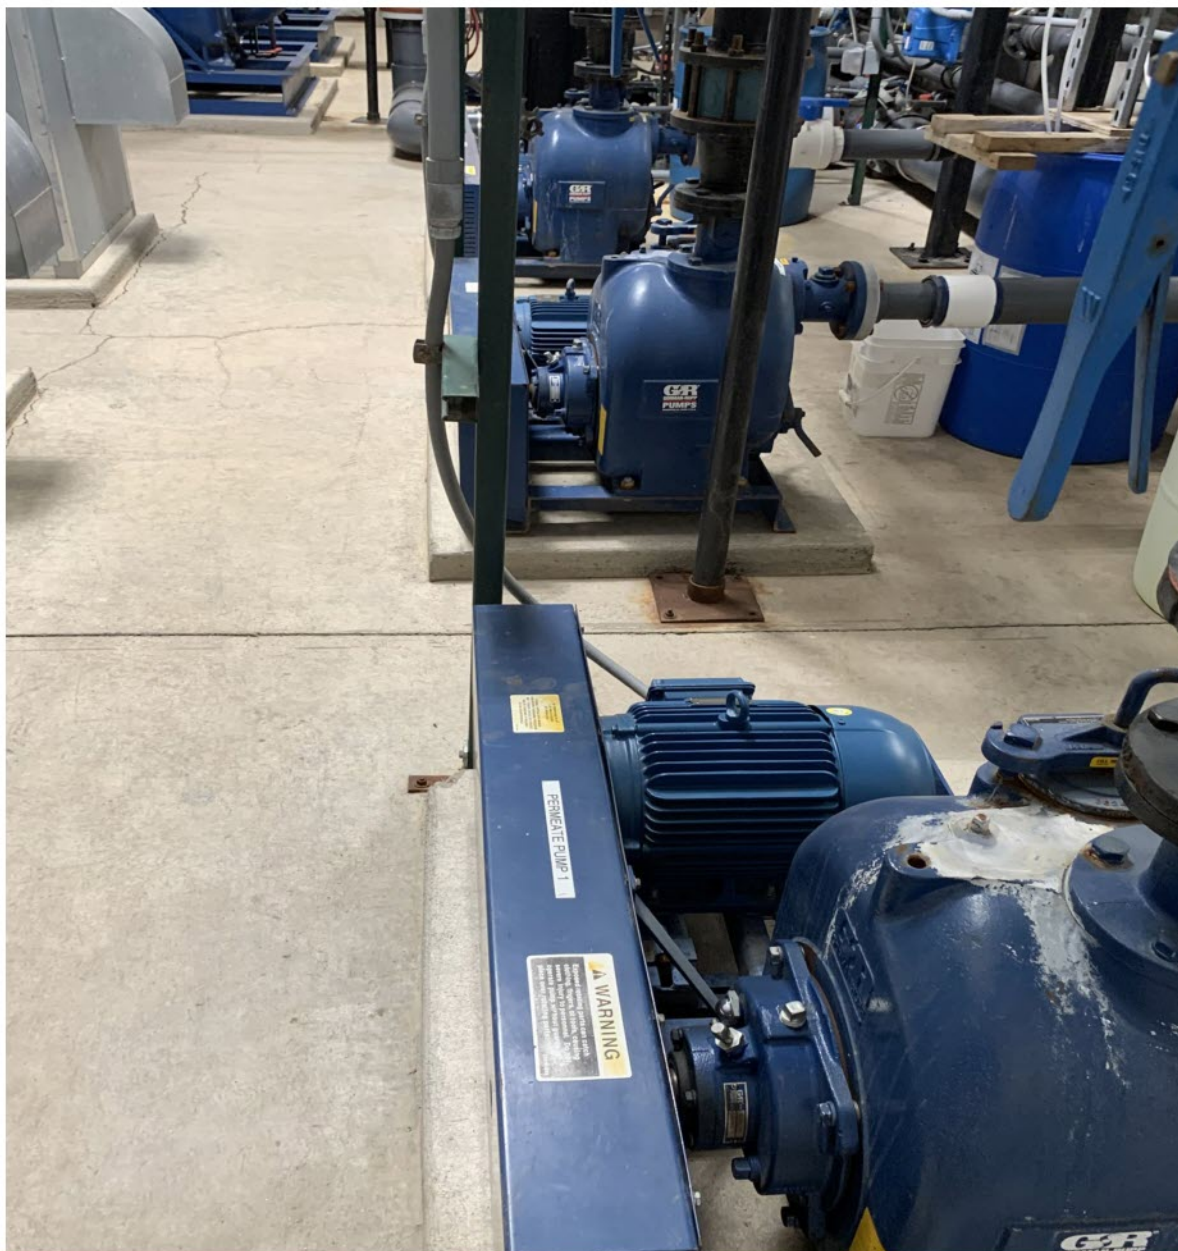
Photo No. 4

Overall view of the WWTPs permeate pumps. (IMG0148). September 13, 2022. Photographed by D. Esparza

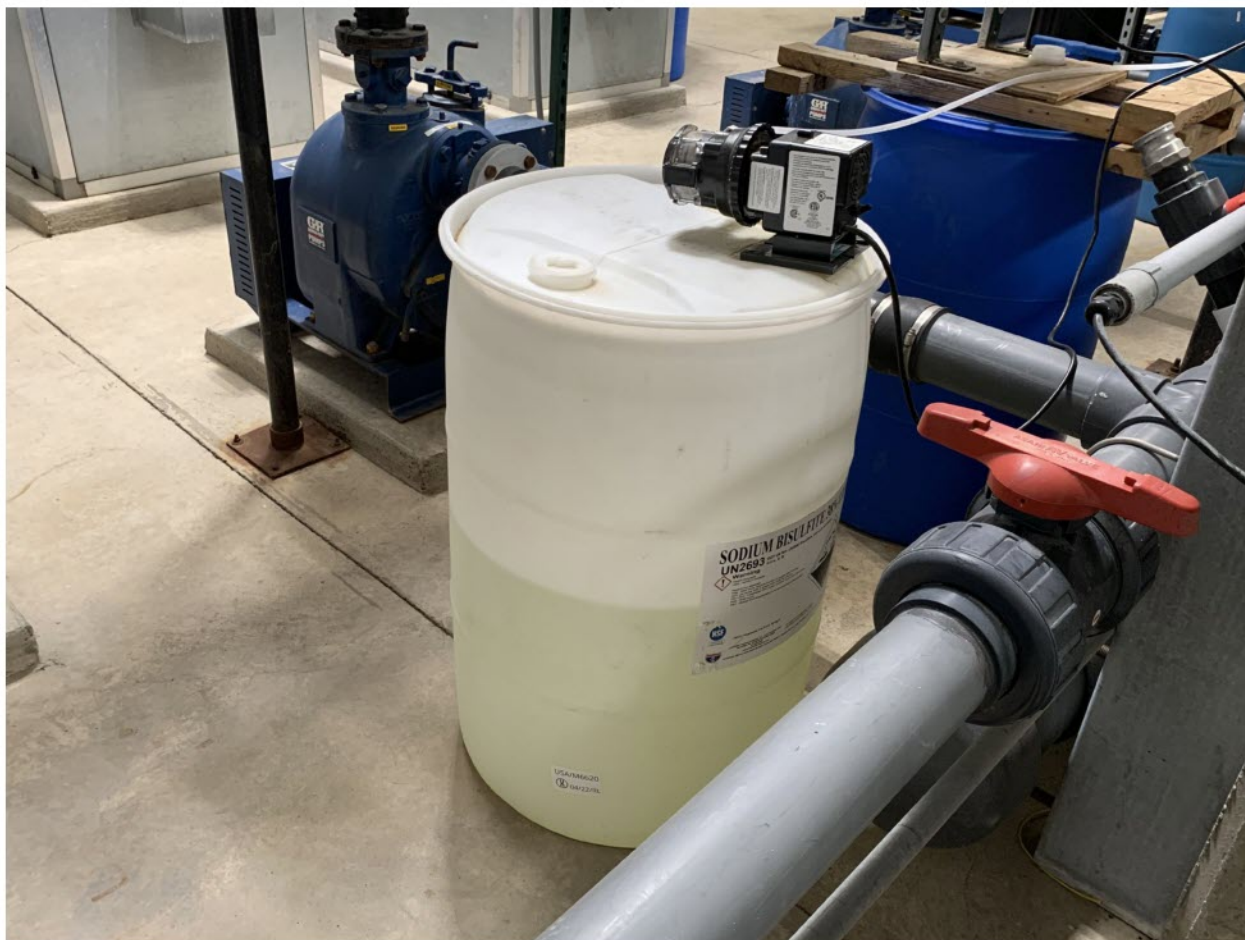
Photo No. 5

View of the bulk Sodium Bisulfite solution and peristaltic pump used in the treatment process. (IMG0149). September 13, 2022. Photographed by D. Esparza

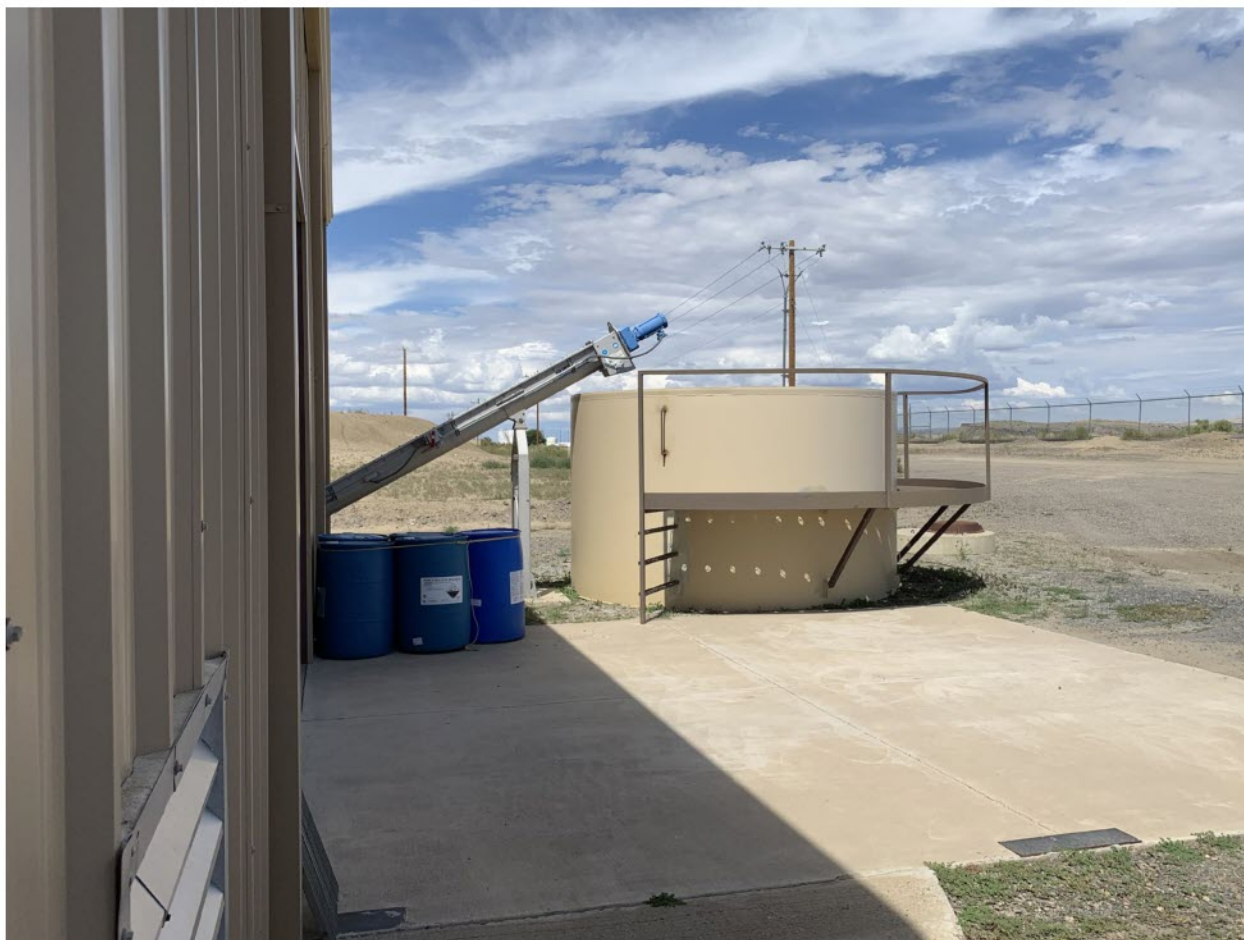
Photo No. 6

View of the onsite 8k gallon sludge tank currently not in use. Atlas Pumping extracts approximately 3.5k gallons per week from the WWTP MBRs and transports to a disposal facility. (IMG0153). September 13, 2022. Photographed by D. Esparza

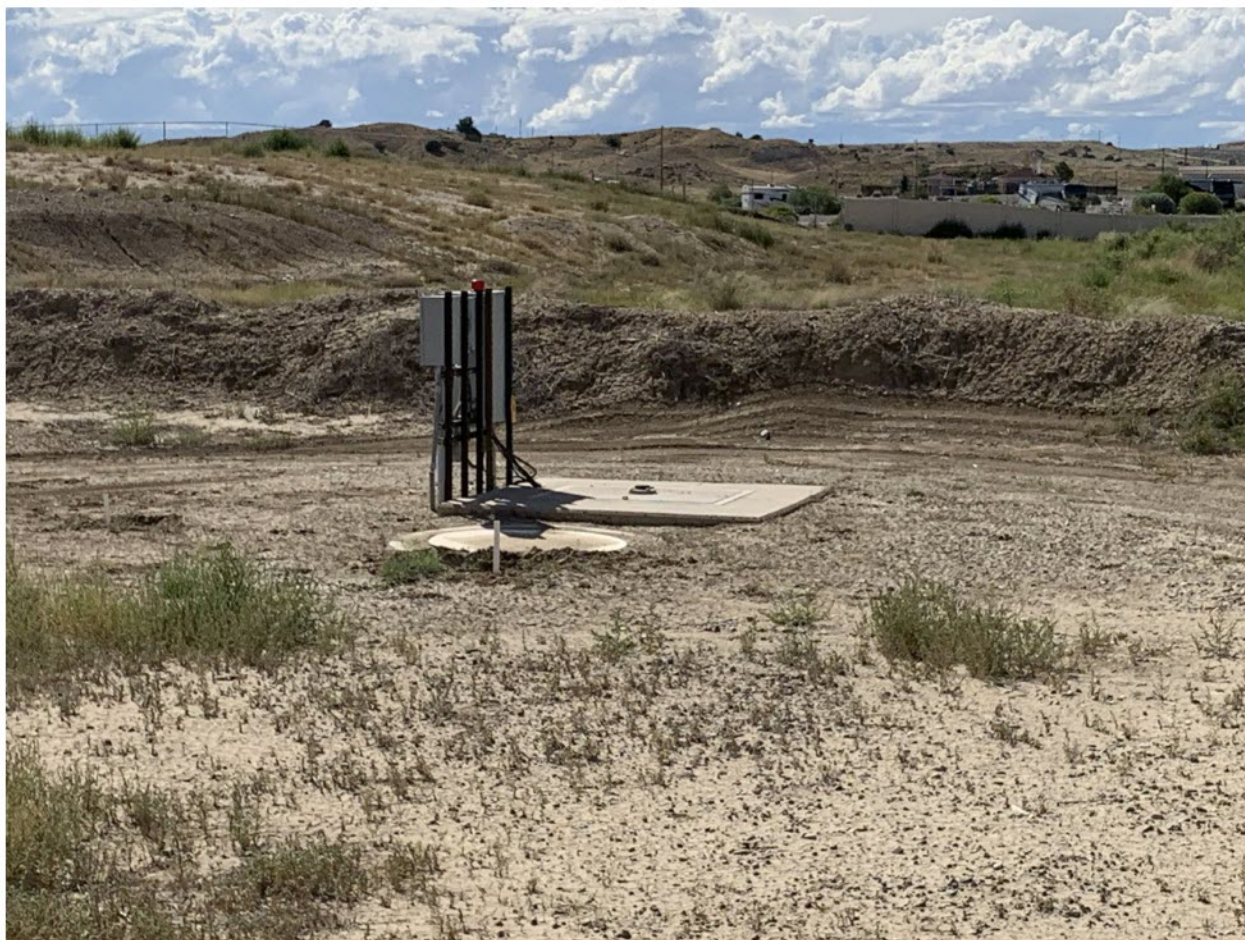
Photo No. 7

- The operator (Mr. Trotter) oversees this facility (Rio Puerco) and Casa Blanca WWTP (NM0030678) on an individual employee basis full-time. Additionally, he (Trotter) is responsible for sample collection and operation and maintenance (O&M) associated with both facilities.
- The one (1) lift station located approximately Northwest of the WWTP lacks secure perimeter fencing, a safety gate (beneath the hatchway opening), alarms (either audible or flashing light) or signage.
- The WWTP currently does not de-chlorinate the effluent prior to discharge at Outfall 001.

View of the one (1) lift station (LS) located approximately Northwest of the WWTP. Note: The LS lacks secure perimeter fencing, a safety gate (beneath the hatchway opening), alarms (either audible or flashing light) or signage (IMG0154). September 13, 2022. Photographed by D. Esparza

- Additional certified facility staff to assist in the day-to-day operations of both facilities and to address potential absence due to illness or personal time off (PTO) issues.
- Pursuant to the discussion with Mr. Trotter regarding types of disinfection, sampling equipment and given his time constraints operating both systems. It might be beneficial for LDC to research acquisition and installation of an ultraviolet (UV) disinfection system in conjunction with an automatic sampling unit.
- Installation of secure perimeter fencing, a safety gate (beneath the hatchway opening), alarms (either audible or flashing light) or signage at the lift station.
