United States Environmental Protection Agency  
Region 4  
CV-NC0037737-4262023  
**Reconnaissance Inspection Report**

| Name and Location of Facility Inspected (For industrial users discharging to POTW, also include POTW name and NPDES permit number)<br>Nantahala Village WWTP<br>9400 U.S. Hwy 19W / Bryson City, NC, 28713 | Entry Date/Time<br>4/26/2023 10:00 AM<br>Exit Date/Time<br>4/26/2023 11:30 AM | Permit Effective Date<br>6/1/2018<br>Permit Expiration Date<br>10/31/2022 |

On April 26, 2023, the U.S. Environmental Protection Agency, Region 4, conducted a Reconnaissance Inspection (RI) of the Nantahala Village wastewater treatment plant (the "Facility") located at 9400 Hwy 19 W in Bryson City, North Carolina. The Facility is owned by Roumelco Properties and operated by Earth Environmental Services as well as Nantahala Village resort staff. The Wastewater Treatment Plant (WWTP) is operated by a contract operator Mr. Mark Bentley, who is employed by Earth Environmental Services, and who is the operator of record. The inspection was conducted under the authority of Section 308 of the Clean Water Act (CWA), as amended. This report and attachments present the results of the inspect

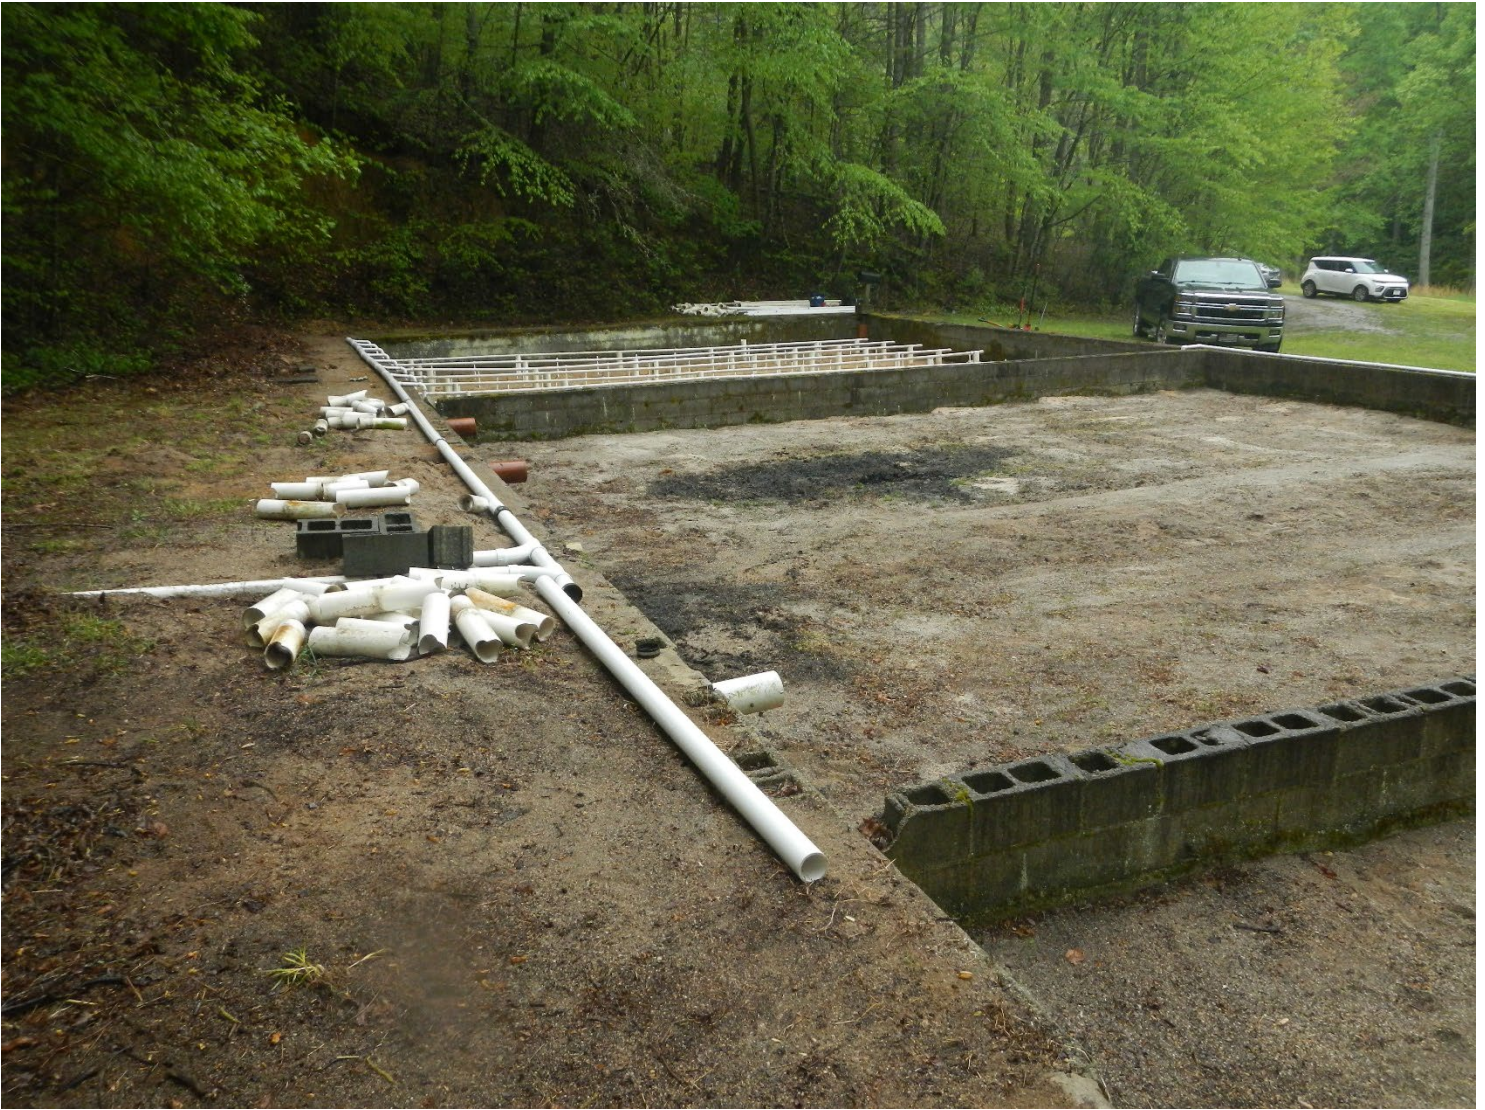
The sand filter system was disassembled to put pipes in a more effective location to avoid short circuiting and make maintenance easier (Figure 1 of Attachment 2). The recirculation tank had significant buildup of vegetative debris from surrounding woods causing issues with clogging. (Figure 2 of Attachment 2).

Figure 1 Sand filter system disassembled for repairs.

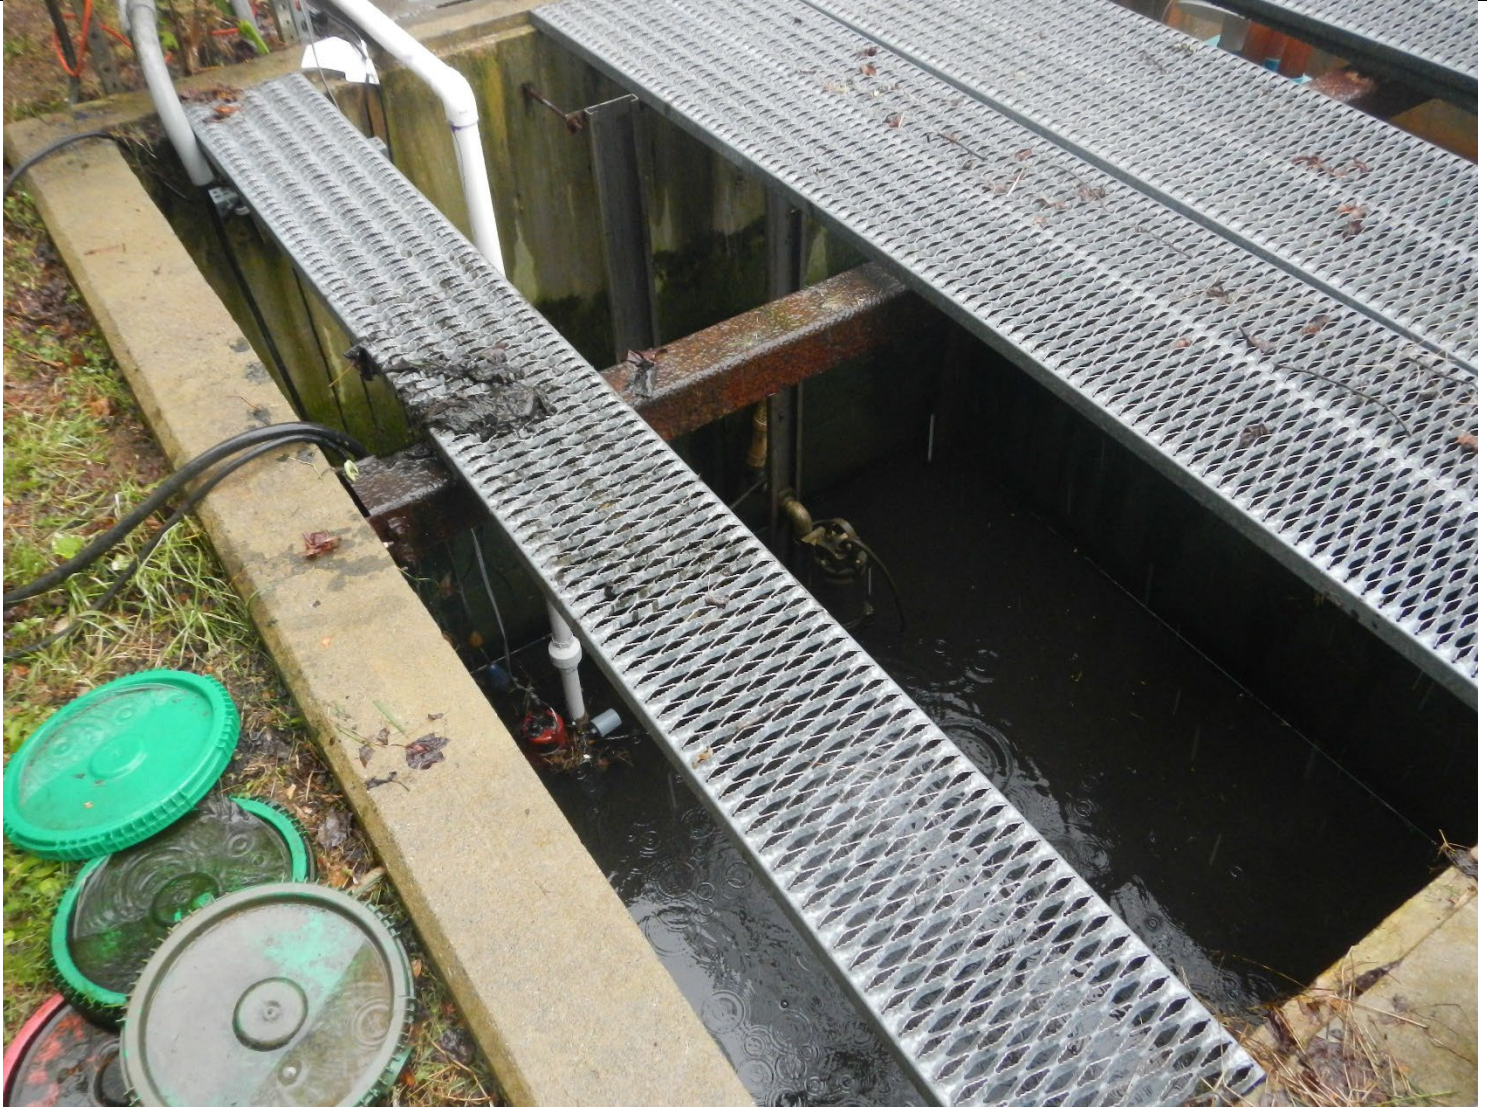
Figure 2 Recirculation system with example of debris buildup.
