## **RCRA Inspection Report**

Adornus Manufacturing USA, LLC EPA ID# SCD000648493  
1551 Highway 9 Bypass West  
Lancaster, South Carolina 29720

February 26, 2021

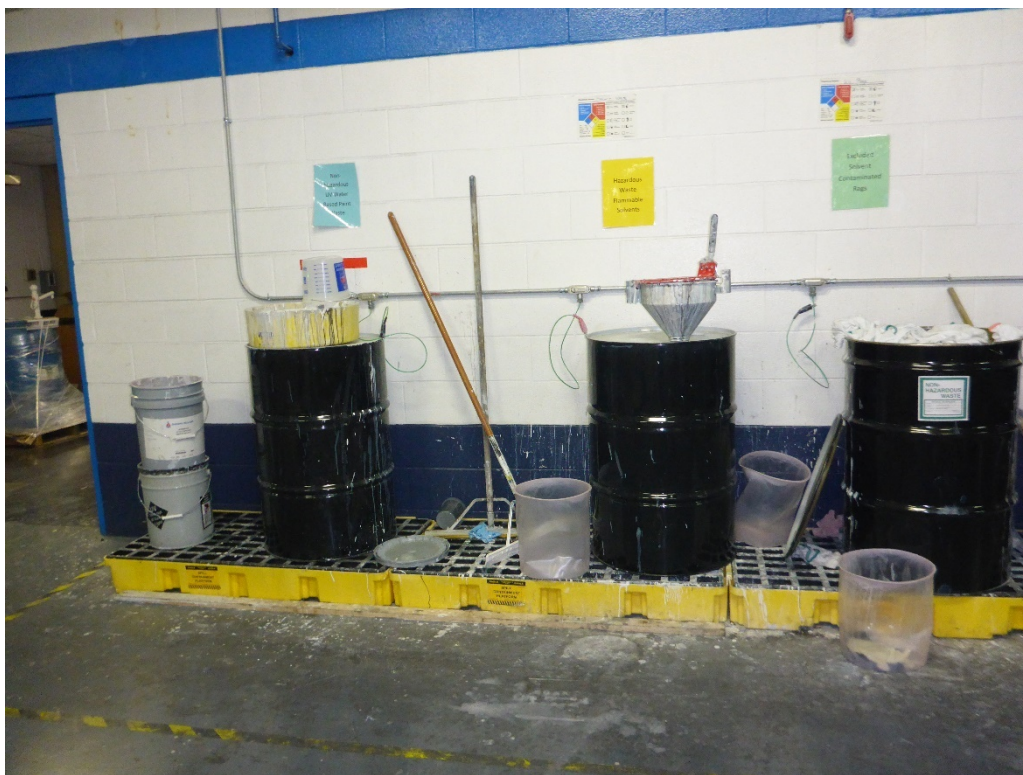
**Paint Mixing Room Area:** The facility tour began just outside of the paint mixing room, where the inspectors observed five 55-gallon drums sitting on portable secondary containment pallets along the wall (Photos 1 and 2). The first drum was identified as nonhazardous UV water based paint, the second was identified as hazardous waste flammable solvents, the third was identified as excluded solvent contaminated disposable wipes, the fourth was identified as denatured alcohol product, and the fifth was identified as acetone product. Although the sign on the wall behind the second 55-gallon drum indicated that this drum contained hazardous waste flammable solvents, no hazardous waste label was visible on the drum. The drum was equipped with a funnel, which was open when the inspectors arrived in this area. The inspectors also observed a flammable liquid DOT hazard placard on the drum. The drum of excluded solvent contaminated disposable wipes was labeled as nonhazardous waste excluded solvent contaminated wipes. This drum was completely open and was not equipped with a lid.

**Photo 1:** Three of five 55-gallon drums staged on portable secondary containment pallets in the UV Paint Coating Area along the wall just outside of the Paint Mixing Room. The drum on the left was identified for accumulating nonhazardous UV water based paint; the drum in the middle was identified for accumulating hazardous waste flammable solvents; and the drum on the right was identified for accumulating excluded solvent contaminated disposable wipes.

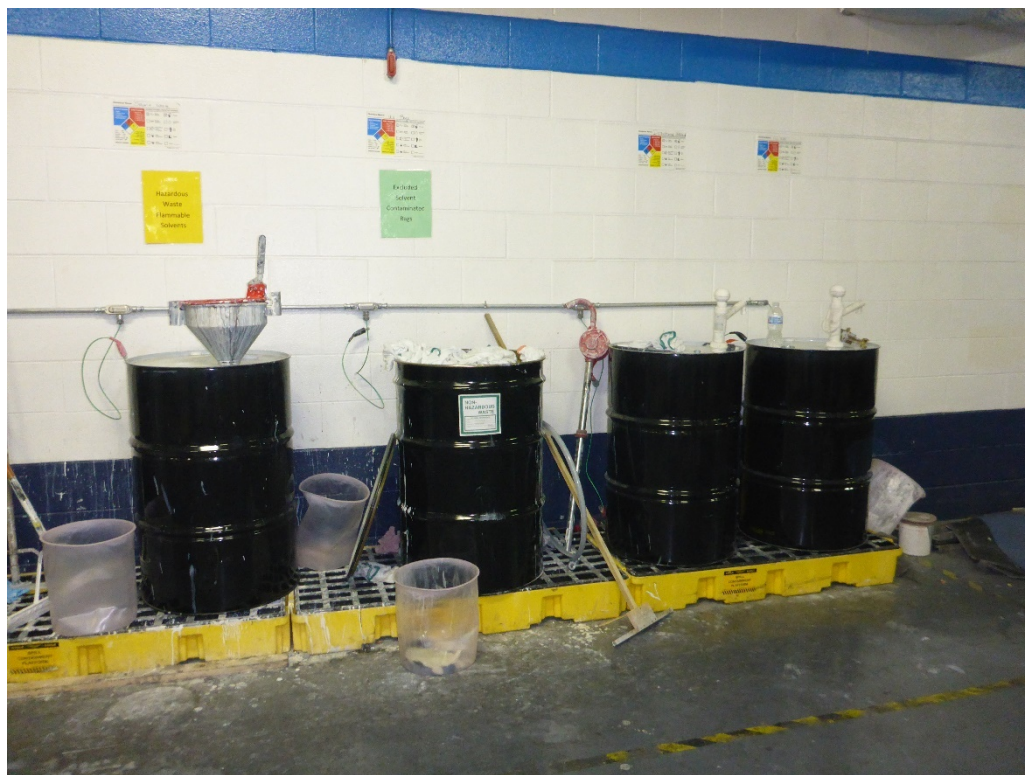
**Photo 2:** Four of five 55-gallon drums staged on portable secondary containment pallets in the UV Paint Coating Area along the wall just outside of the Paint Mixing Room. The drum on the left was identified for accumulating hazardous waste flammable solvents; second drum from the left was identified for accumulating excluded solvent contaminated disposable wipes; the second drum from the right was identified as denatured alcohol; and the drum on the right was identified as acetone.

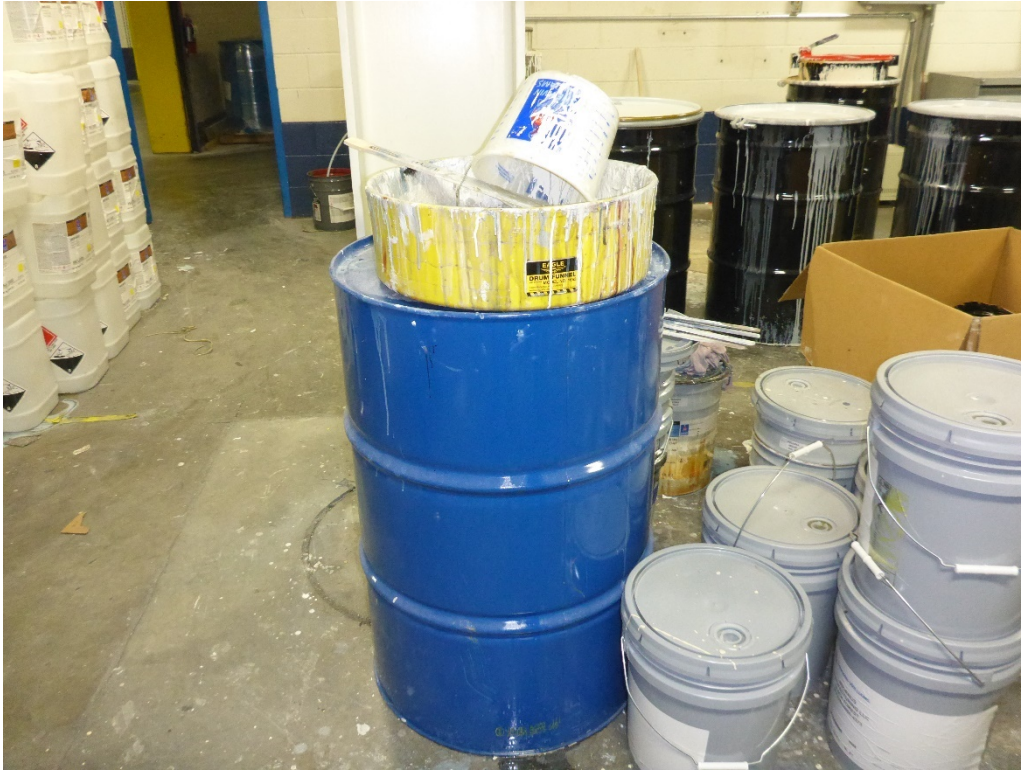
explained that this room is used to manage solvent-based paints and waste, and UV waste should not be brought to this area. However, the inspection participants observed one blue 55-gallon drum with an open-top funnel in the open container bung (Photo 3). Mr. Casey explained that this drum is kept in this area as a courtesy to accumulate the contents of any 5-gallon buckets of UV paint waste that are brought here by mistake. The drum was still labeled as acetone product and identified with a flammable liquid DOT hazard placard.

**Photo 3:** One 55-gallon drum observed near a post in the Reclaim Room. According to facility personnel, this drum, which is equipped with an open funnel, is used to accumulate waste UV paints that are brought into this room. Personnel stated that the standard operating procedure is to pour the contents of waste UV paint buckets into the designated 55-gallon accumulation drum located on portable secondary containment pallet in the UV Paint Coating Area along the wall just outside of the Paint Mixing Room shown in Photo #1. However, personnel working in this room maintain the accumulation drum shown in this photograph as a courtesy when employees mistakenly bring the 5-gallon containers of UV paint waste to this room.

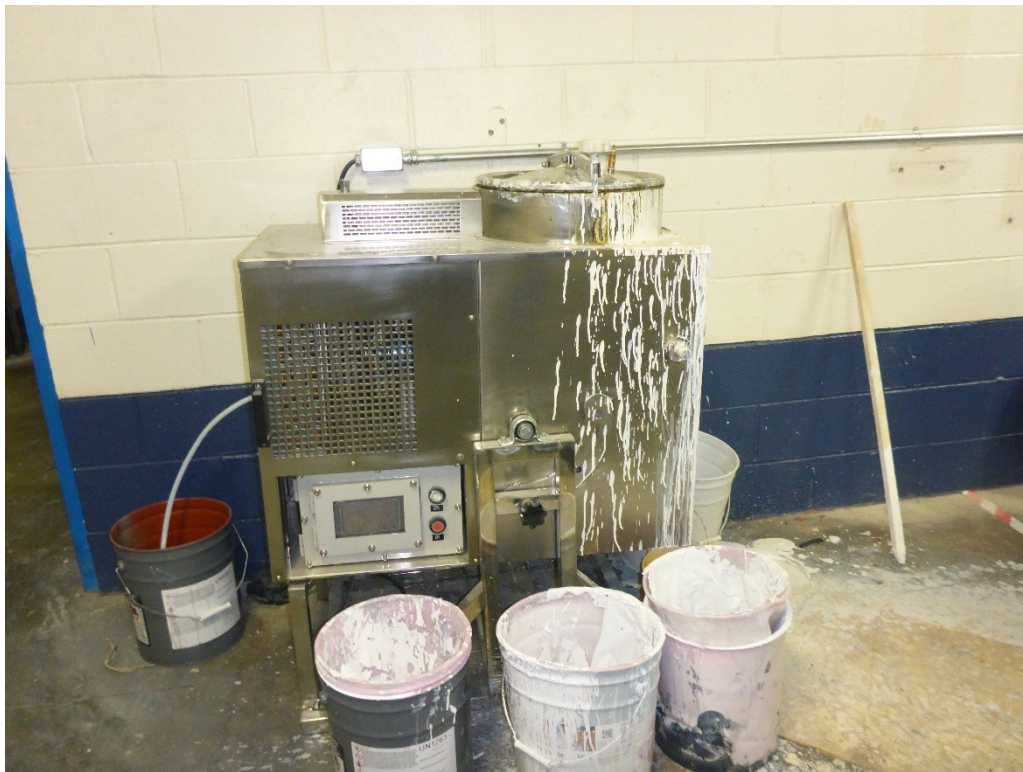
The inspection participants observed a small solvent distillation unit inside the Reclaim Room (Photo 4). Mr. Casey explained that the conveyor belts used in the UV paint coating line system are cleaned using a solvent-based Cefla Belt Cleaner. The cleaner is fed through the system once to clean the belts before it is accumulated in a 55-gallon drum for reclamation and reuse on-site. The spent Cefla Belt Cleaner solvent is reclaimed using the small solvent distillation unit observed in this area. Mr. Casey explained that the three 55-gallon drums observed next to the solvent distillation unit (Photo 5) contain spent Cefla Belt Cleaner solvent that will be reclaimed in the distillation unit. None of these drums were labeled, and one was open without a ring to secure the lid to the drum. The inspectors observed a milky liquid with a solvent odor inside the open drum.

**Photo 4:** Solvent distillation unit found in the reclaim room. The bucket on the left is used to accumulate recovered solvent for reuse on-site. The three 5-gallon buckets in front of the machine contain an unknown material and may be used to load spent solvents into the machine and/or unload solvent sludge from the machine.

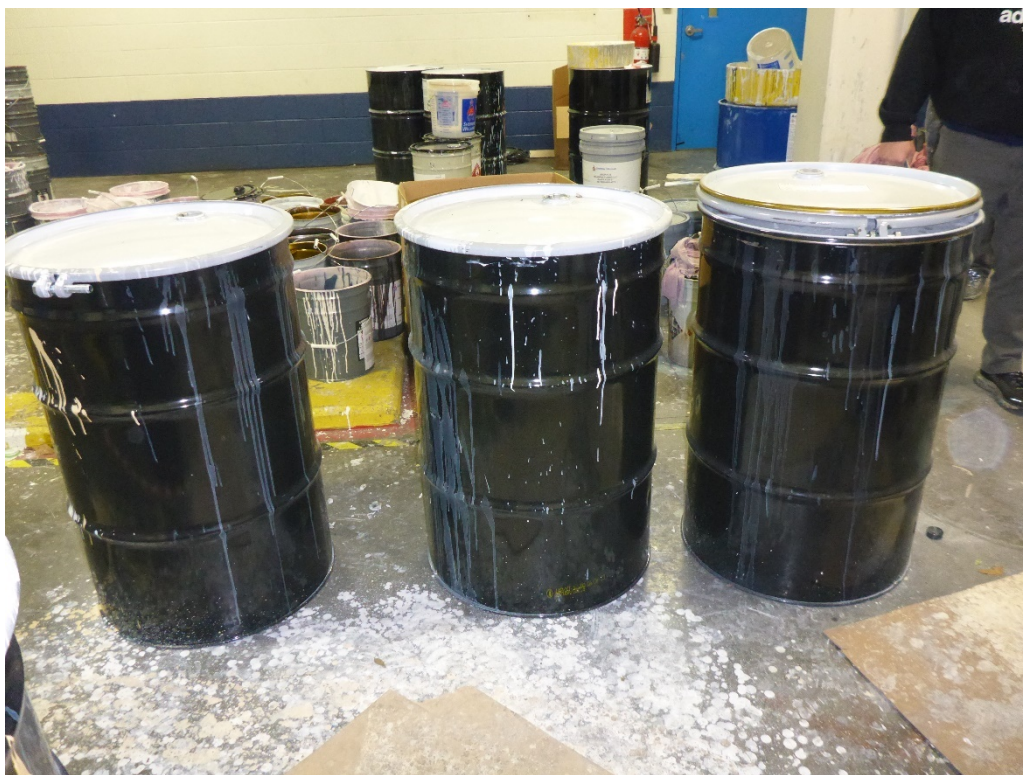
**Photo 5:** Three unlabeled 55-gallon drums observed near the solvent distillation unit in the Reclaim Room. Two of the drums are closed, but the drum on the right is open with no ring to secure the lid to the container. According to facility personnel, these drums contain spent Cefla Belt Cleaner solvent that is generated in the UV paint line. These solvents are staged here to be reclaimed in the solvent distillation unit, and the reclaimed solvent will be reused in the UV paint line.

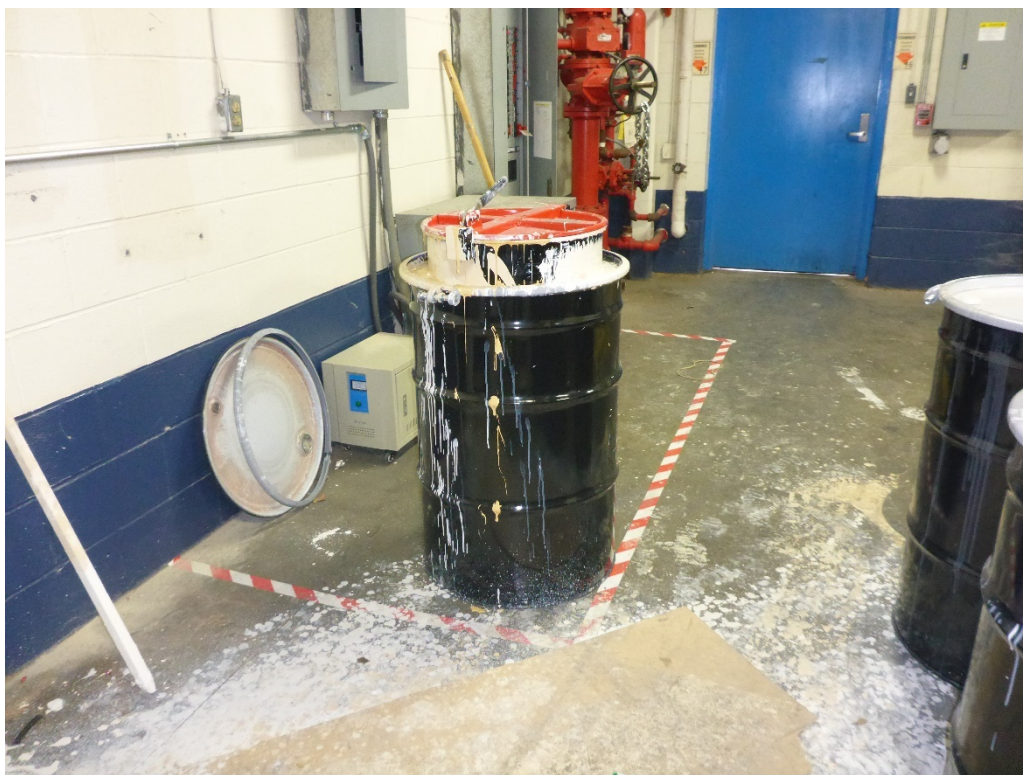
**Photo 6:** One 55-gallon drum observed near the wall near the solvent distillation unit in the Reclaim Room. According to facility personnel, solvent sludge generated in the distillation unit is manually transferred into this drum using a 5-gallon bucket. The drum is fitted with an elevated lid, which was latched closed. The drum was not labeled as “hazardous waste,” it was not marked with an accumulation start date, and it was not marked with an indication of the hazards of its contents.

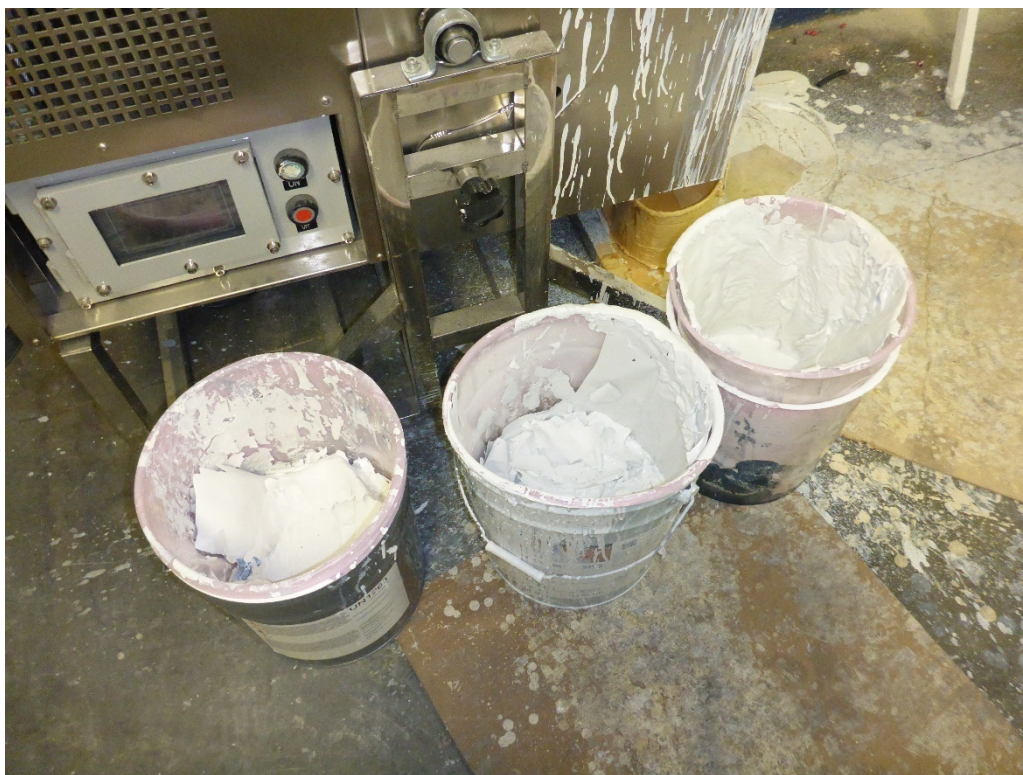
The inspectors observed three 5-gallon buckets staged next to the distillation unit (Photo 7). It appears that these buckets may be used to transfer spent solvents into the distillation unit and/or transfer solvent sludge out of the unit. The buckets were completely open, and none of them were labeled.

**Photo 7:** Three 5-gallon buckets in front of the solvent distillation machine that contain an unknown material and may be used to load spent solvents into the machine and/or unload solvent sludge from the machine.

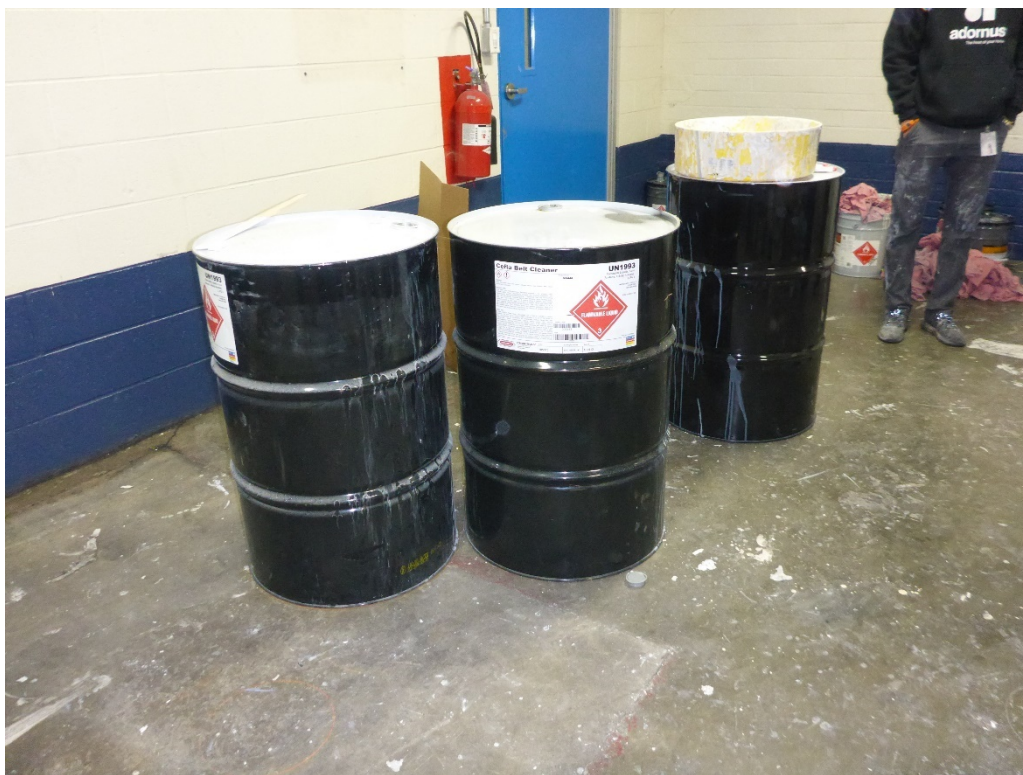
The inspection participants observed three 55-gallon drums in the Reclaim Room near the wall opposite the solvent distillation unit (Photo 8). Mr. Casey explained that these drums contain recycled Cefla Belt Cleaner, which will be used again in the UV paint line. Two of the drums were labeled with the original Cefla Belt Cleaner label, which included a flammable liquid DOT hazard placard. The original label on the third drum had been spray painted over, leaving the drum with a flammable liquid DOT hazard placard but without a label (Photo 9). This drum was equipped with an open-top yellow funnel in the open container bung.

**Photo 8:** Three 55-gallon drums observed in the Reclaim Room near the wall opposite the solvent distillation unit. According to facility personnel, two of the drums contain new or recovered Cefla Belt Cleaner solvents, and the third drum, which is equipped with an open funnel, is used to accumulate reclaimed Cefla Belt Cleaner solvent that is generated in the solvent distillation unit in this room.

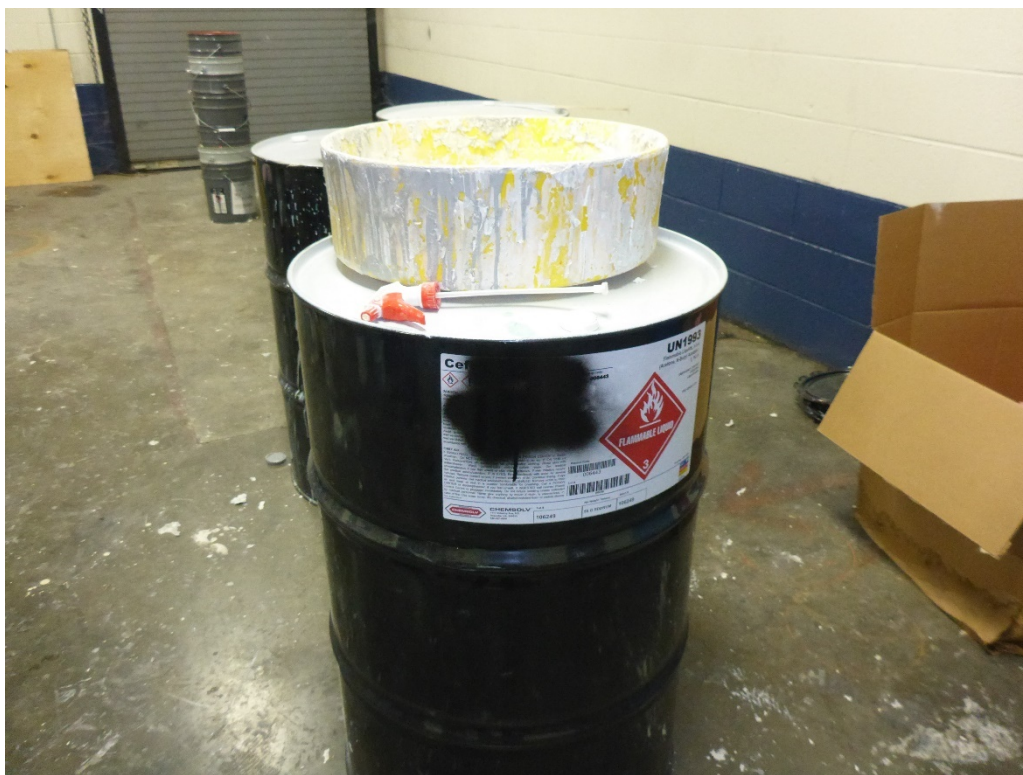
**Photo 9:** Another view of the 55-gallon drum observed near the wall opposite the solvent distillation unit in the Reclaim Room. According to facility personnel, this drum, which is equipped with an open funnel, is used to accumulate reclaimed Cefla Belt Cleaner solvent that is generated in the solvent distillation unit in this room.

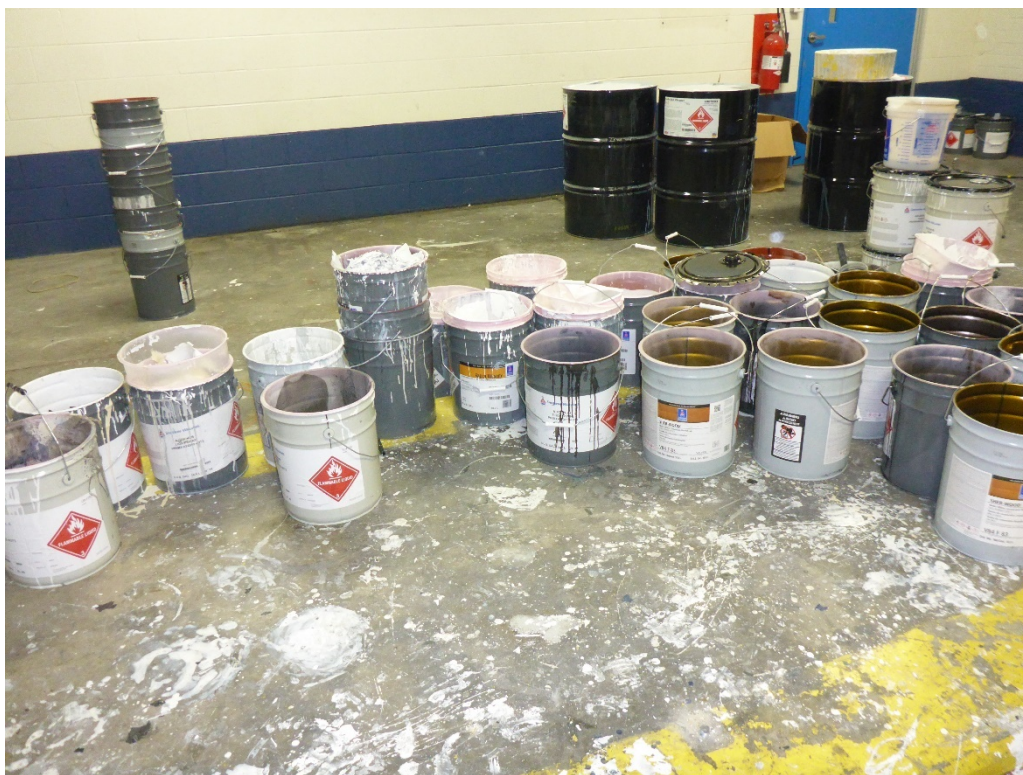
The inspection participants observed several 5-gallon buckets and bucket liners containing varying amounts of waste paint in the Reclaim Room (Photos 10, 11 and 12). Personnel explained that these buckets are staged in this area to dry before the contents are disposed of as solid waste. Personnel estimated that buckets used at the first and second solvent paint spray lines to accumulate solvent paint waste are brought here at the end of the day and staged in this

area to dry. Although Mr. Casey stated that this room is only used to manage solvent paint waste, other facility personnel stated that buckets and bucket liners of UV paint waste are also brought to this area to dry. It appeared that some 5-gallon buckets and bucket liners observed in this area contained UV paint waste and others contained spent solvents or solvent paint waste.

**Photo 10:** Several 5-gallon buckets with and without liners in the Reclaim Room. Buckets and liners appear to contain spent solvents, solvent paint waste and/or UV paint waste. The buckets are open and not labeled.

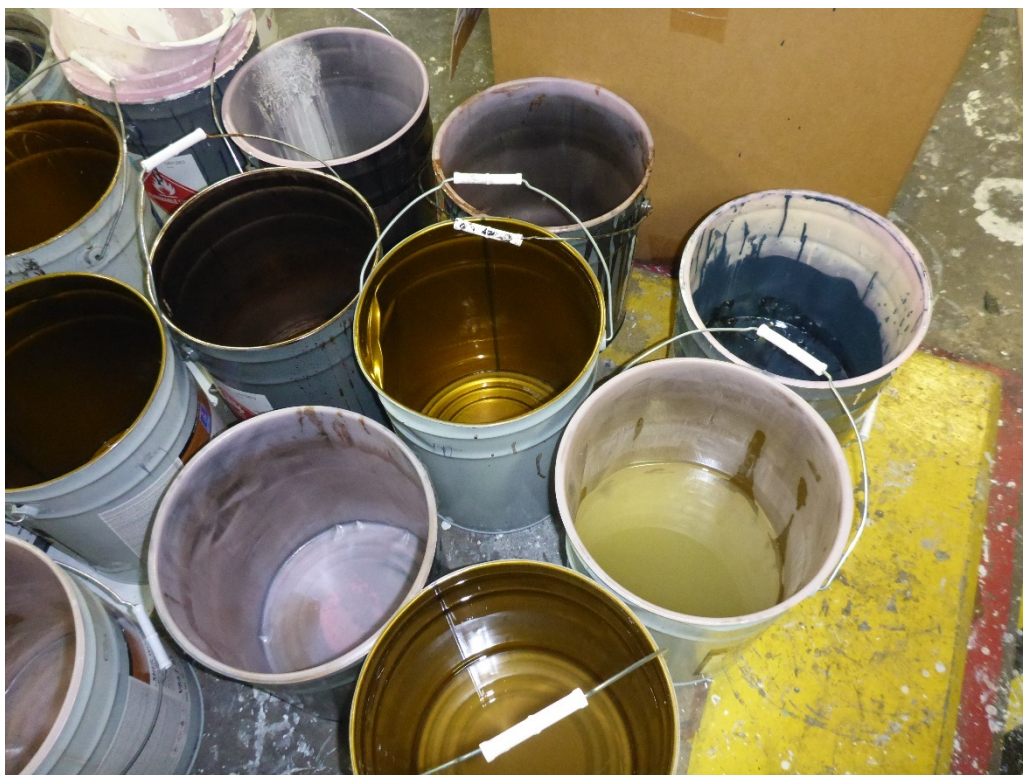
**Photo 11:** Several of the 5-gallon buckets in the Reclaim Room. Buckets appear to contain spent solvents and/or solvent paint waste. The buckets are open and not labeled.

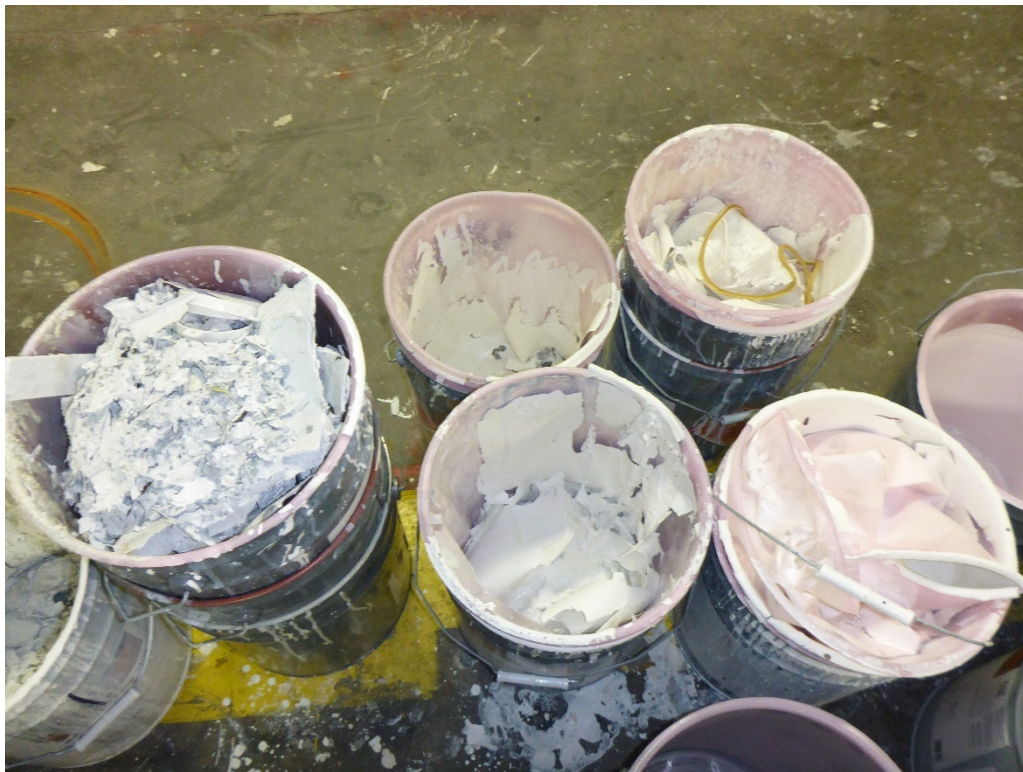
**Photo 12:** Several of the 5-gallon buckets with and without liners in the Reclaim Room. Buckets and liners appear to contain UV paint waste. The buckets are open and not labeled.

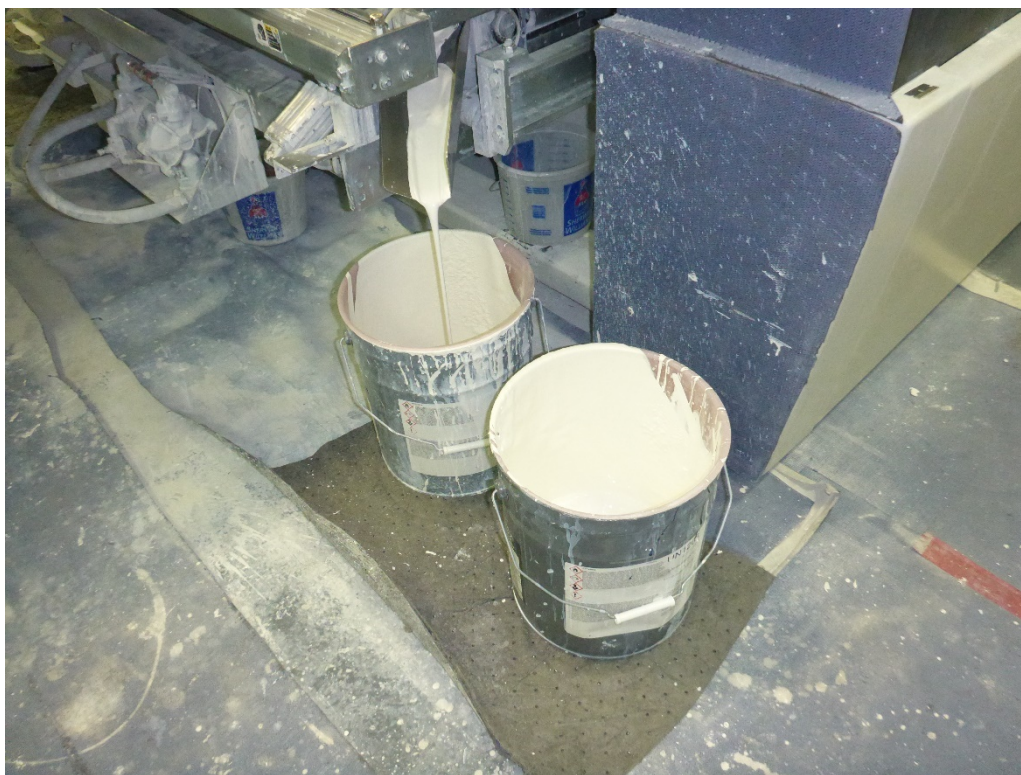
First Solvent Paint Spray Line: Adornus manages a SAA at the first solvent paint spray line for managing D001 / F003 / F005 hazardous waste flammable liquid (toluene / acetone) that is generated as excess paint and overspray in this line. The facility maintains a fire extinguisher and a spill kit near this area. The inspectors observed two 5-gallon buckets and three 55-gallon drums in this SAA. The buckets were staged next to the excess paint outfall (Photo 13), two drums were located at the end of the process line (Photo 14), and one drum was located on a portable secondary containment unit next to the wall (Photo 15). The buckets were completely open and not labeled with the words “hazardous waste” or an indication of the hazards of the contents. The two drums at the end of the process line were both closed, labeled D001 / F003 / F005 hazardous waste flammable liquid (toluene / acetone), and identified with a flammable liquid DOT hazard placard. One drum was dated 02/24/2021 and the other was dated 02/25/2021. The product labels for the raw materials originally contained in these drums were still visible, and the flammable liquid hazard placard on the drum dated 02/25/2021 was the placard found on this raw material label. The third drum was equipped with an open-top funnel in the open bung. It was labeled as hazardous waste and identified with a flammable liquid DOT hazard placard.

**Photo 13:** Two 5-gallon buckets staged at the first solvent paint spray line SAA. These buckets are used to accumulate D001 / F003 / F005 hazardous waste flammable liquid (toluene / acetone) that is generated as excess paint and overspray in this solvent paint spray line unit. Neither bucket is labeled with the words “hazardous waste.” Neither bucket is closed, but only one has waste being added into the container.

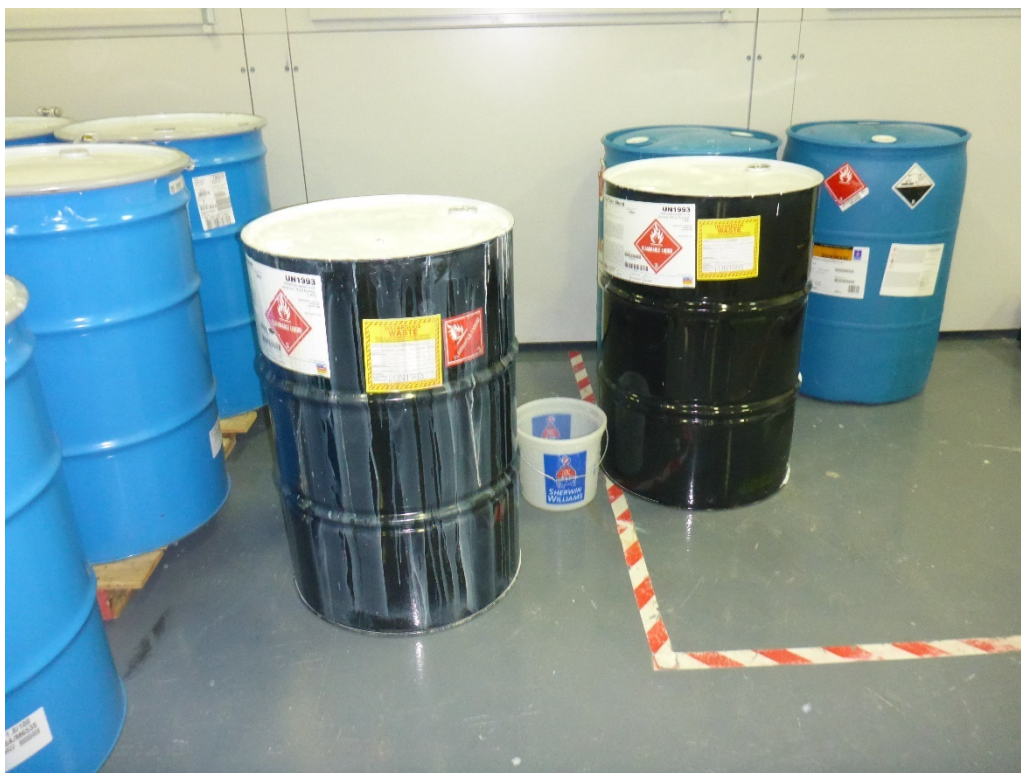
The total volume of waste in the two 5-gallon buckets and the 55-gallon drum next to the wall appeared to be less than 55 gallons. However, the volume of waste contained in the two full 55-gallon drums located at the end of the process line caused this SAA to exceed the 55-gallon limit. The drums of excess waste observed in this SAA were dated 02/24/2021 and 02/25/2021, so it appears that, at the time of the inspection, fewer than three consecutive calendar days had passed since the excess waste had begun accumulating.

**Photo 14:** Two 55-gallon drums of hazardous waste observed with other 55-gallon drums at the end of the first solvent paint spray line. The drums were both labeled as D001 / F003 / F005 hazardous waste flammable liquid (acetone / toluene) and identified with a flammable liquid DOT hazard placard. One drum was dated 02/24/2021 and the other was dated 02/25/2021. Both drums also had product labels clearly visible for the original contents of the containers.

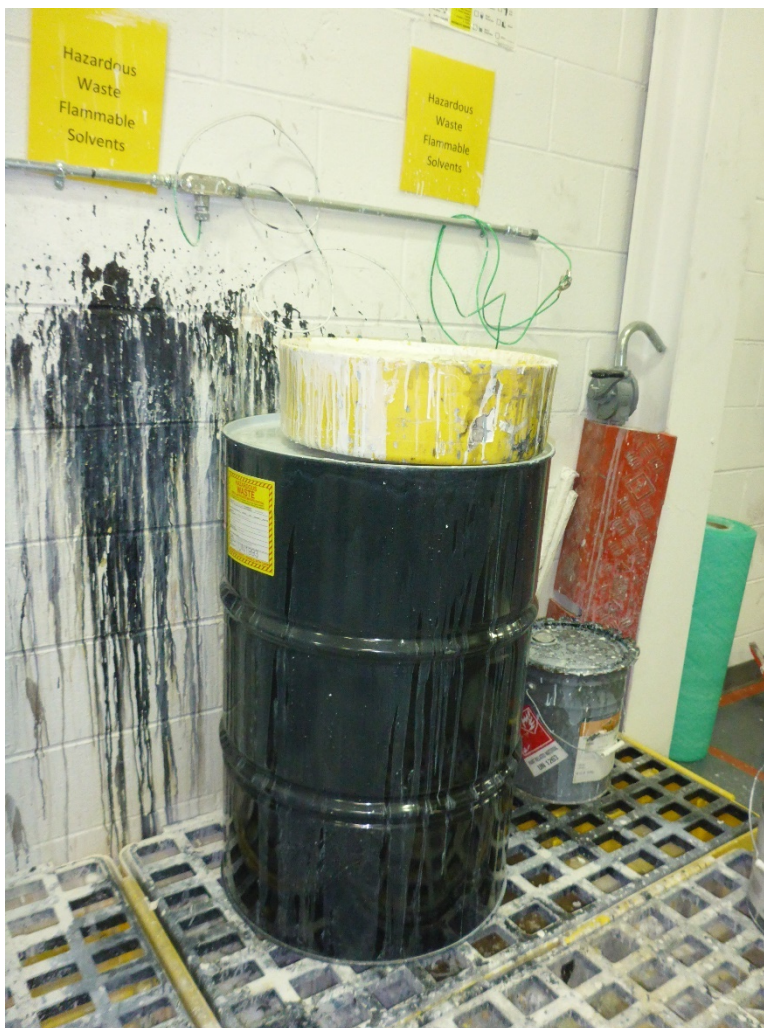
**Photo 15:** One 55-gallon drum located in the first solvent paint spray line SAA. The drum is located on a secondary containment pallet next to the process line. D001 / F003 / F005 hazardous waste flammable liquid (toluene / acetone) that is generated as excess paint and overspray in the solvent paint spray line is poured from the 5-gallon buckets staged at the spray line into this 55-gallon drum. The drum is equipped with an open funnel. It is labeled as D001 / F003 / F005 hazardous waste flammable liquid (toluene / acetone) and it is identified with a flammable liquid DOT hazard placard.

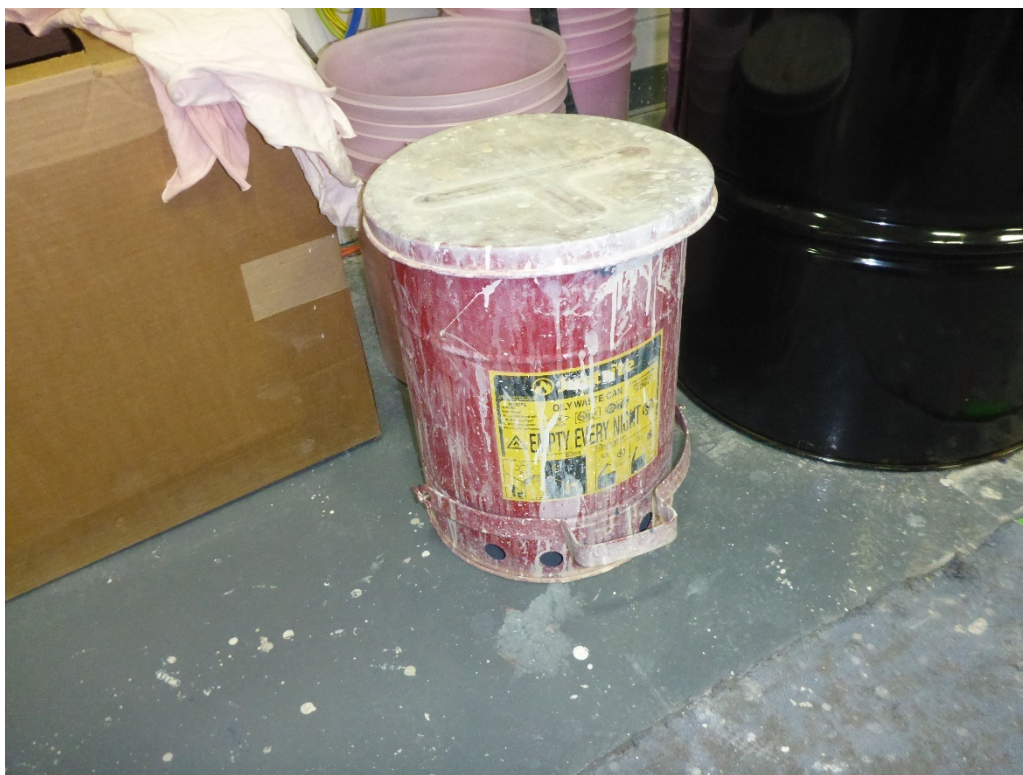
The inspectors observed one 5-gallon flip-top flammable can next to the first solvent paint spray line (Photo 16). The can is used to accumulate excluded solvent contaminated disposable wipes, but it was labeled “oily waste, empty every night.” The can was not labeled as excluded solvent contaminated wipes.

**Photo 16:** One 5-gallon step-open flammable can for accumulating excluded solvent contaminated disposable wipes at the first solvent paint spray line. The container is labeled as “oily waste” and “empty every night.” It is not labeled as excluded solvent contaminated wipes.

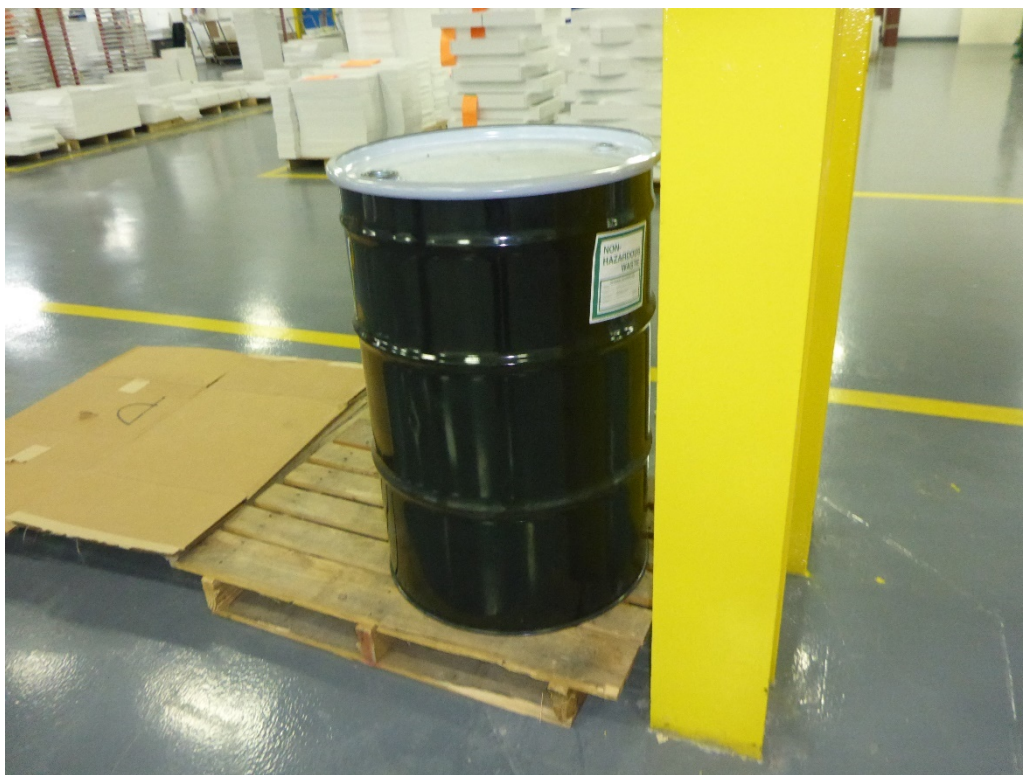
The inspectors observed one 55-gallon drum next to a support beam near the first solvent paint spray line (Photo 17). This drum is used to accumulate excluded solvent contaminated disposable wipes. The drum was closed, and it was labeled as nonhazardous waste excluded solvent contaminated rags.

**Photo 17:** One 55-gallon drum of excluded solvent contaminated disposable wipes observed near the end of the first solvent paint spray line. The drum was closed and labeled non-hazardous solvent excluded rags.

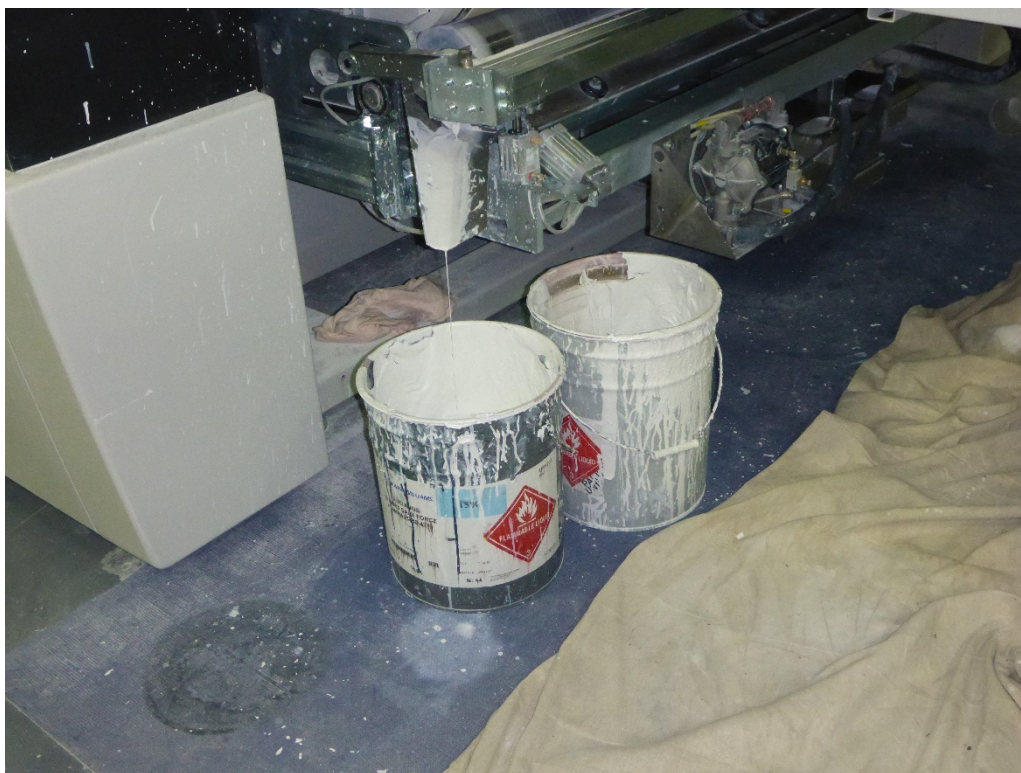
Second Solvent Paint Spray Line: Adornus manages a SAA at the second solvent paint spray line for managing D001 / F003 / F005 hazardous waste flammable liquid (toluene / acetone) that is generated as excess paint and overspray in this line. The facility maintains a fire extinguisher near this area. The inspectors observed a fire extinguisher, two 5-gallon buckets (Photo 18) and one 55-gallon drum (Photo 19) in this SAA. The buckets were staged next to the excess paint outfall, and the drum was located on a portable secondary containment unit next to the wall. The buckets were completely open and not labeled with the words “hazardous waste” or an indication of the hazards of the contents. The drum was equipped with a latched funnel lid. It was labeled as

**Photo 18:** Two 5-gallon buckets staged at the second solvent paint spray line SAA. These buckets are used to accumulate D001 / F003 / F005 hazardous waste flammable liquid (toluene / acetone) that is generated as excess paint and overspray in this solvent paint spray line. Neither bucket is labeled with the words “hazardous waste.” Neither bucket is closed, but only one has waste being added into the container.

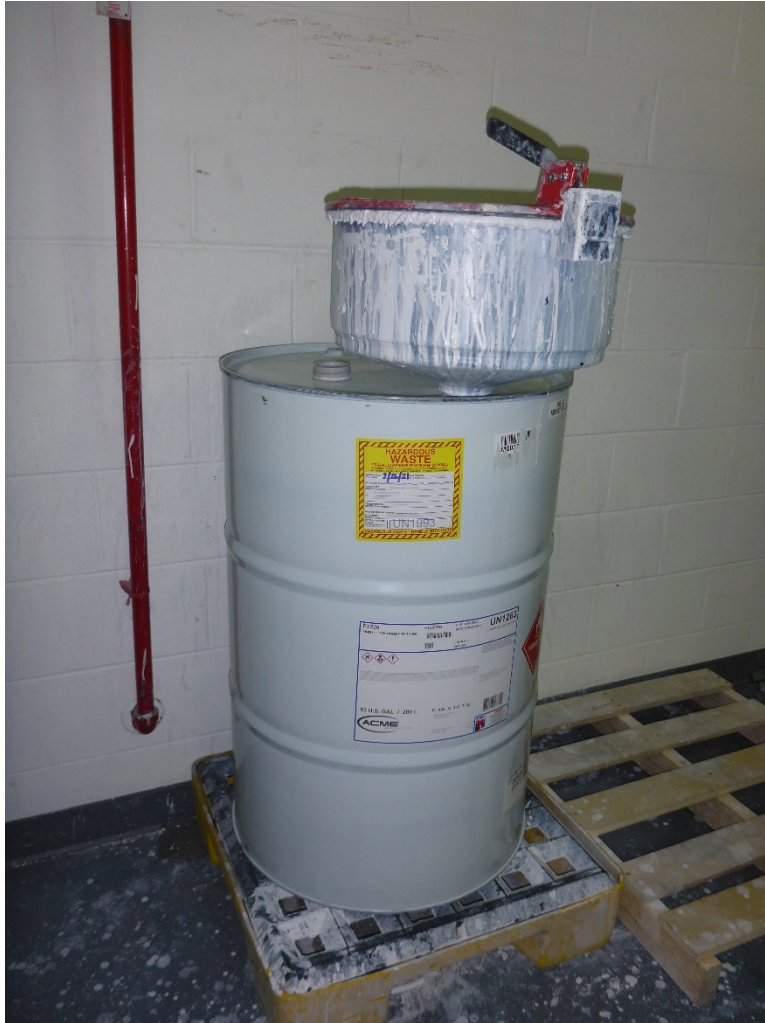
**Photo 19:** One 55-gallon drum located in the second solvent paint spray line SAA. The drum is located on a secondary containment pallet next to the process line. D001 / F003 / F005 hazardous waste flammable liquid (toluene / acetone) that is generated as excess paint and overspray in the solvent paint spray line is poured from the 5-gallon buckets staged at the spray line into this 55-gallon drum. The drum is closed with a latched funnel in the bung. It is labeled as D001 / F003 / F005 hazardous waste flammable liquid (toluene / acetone) and it is identified with a flammable liquid DOT hazard placard.

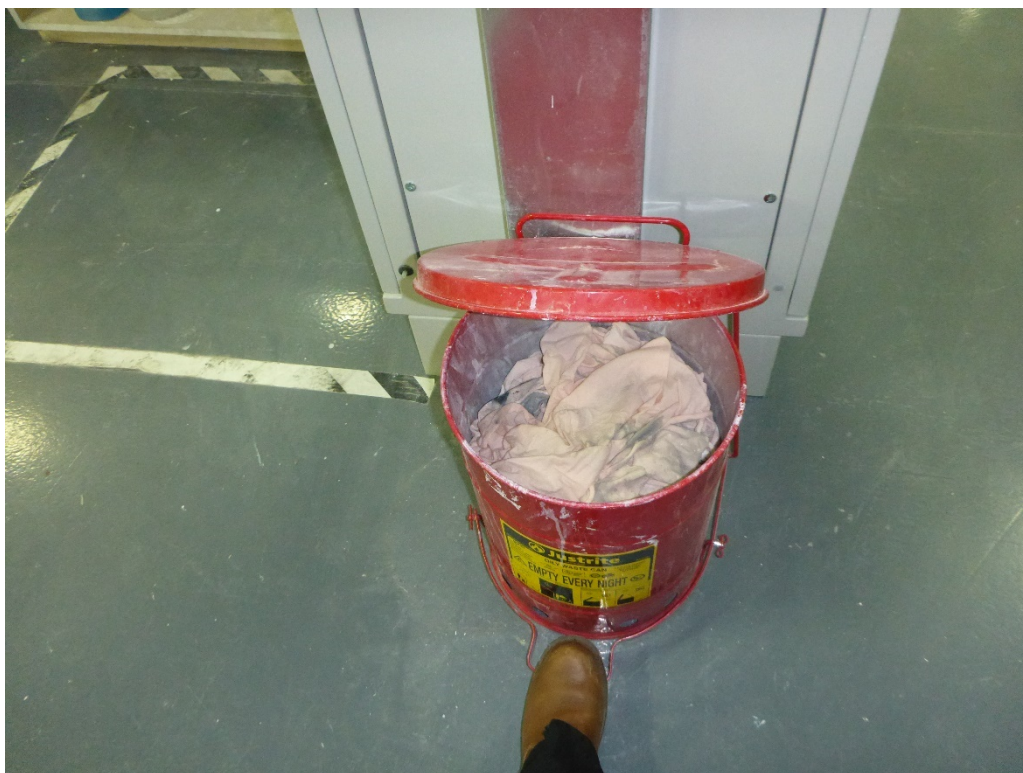
The inspectors observed one 5-gallon flip-top flammable can next to the second solvent paint spray line (Photo 20). The can is used to accumulate excluded solvent contaminated disposable wipes, but it was labeled “oily waste, empty every night.” The can was not labeled as excluded solvent contaminated wipes.

**Photo 20:** One 5-gallon step-open flammable can for accumulating excluded solvent contaminated disposable wipes at the second solvent paint spray line. The container is labeled as “oily waste” and “empty every night.” It is not labeled as excluded solvent contaminated wipes.

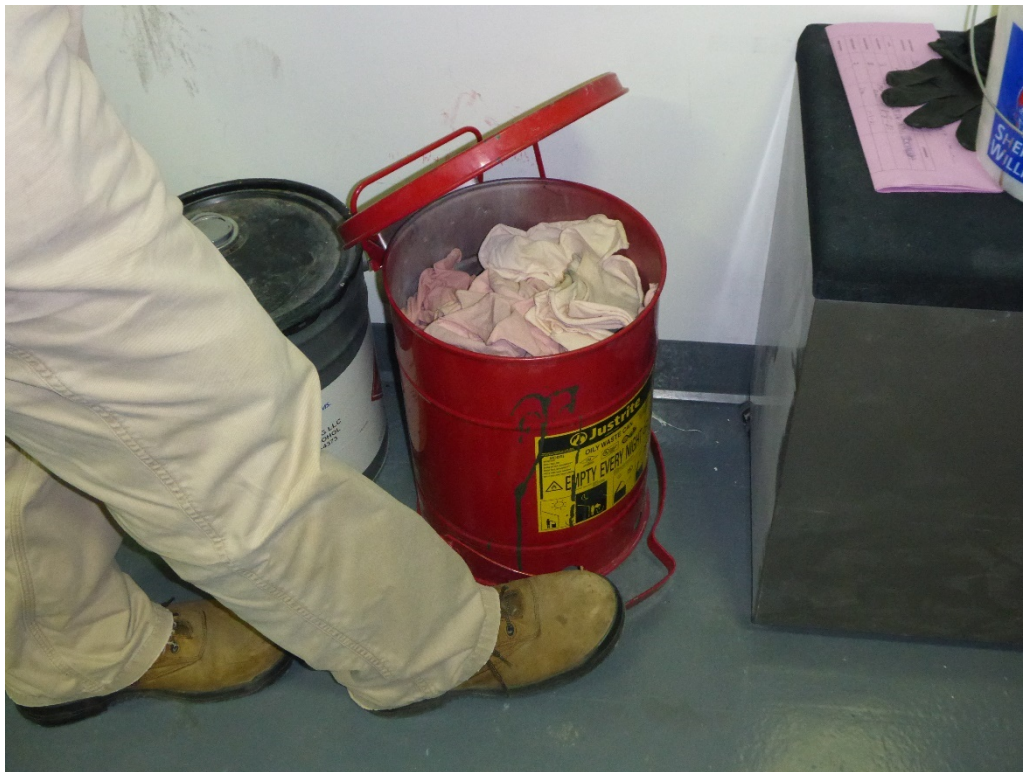
The inspectors observed one 5-gallon flip-top flammable can next to the paint / stain mixing station (Photo 21). The can is used to accumulate excluded solvent contaminated disposable wipes, but it was labeled “oily waste, empty every night.” The can was not labeled as excluded solvent contaminated wipes.

**Photo 21:** One 5-gallon step-open flammable can for accumulating excluded solvent contaminated disposable wipes at the laquer spray line. The container is labeled as "oily waste" and "empty every night." It is not labeled as excluded solvent contaminated wipes.

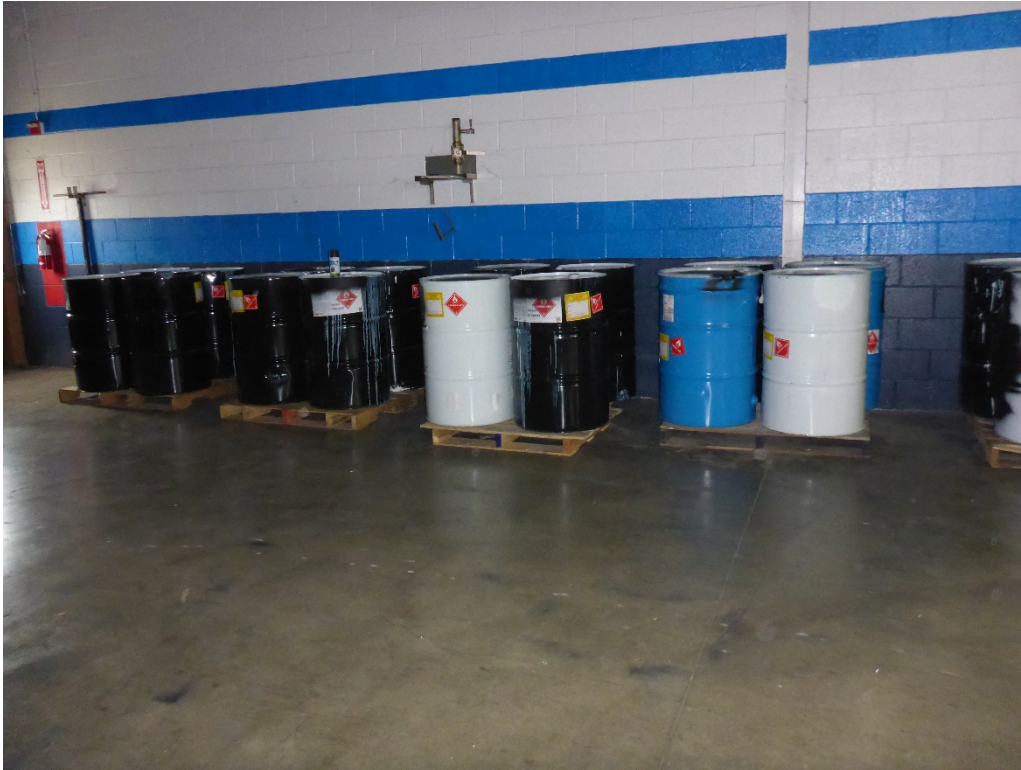
**Photo 22:** Twenty 55-gallon drums of hazardous waste observed in the hazardous waste CAA. The drums were staged on six wooden pallets. Hazardous waste labels were observed on seventeen of the drums, indicating that the containers held D001 / F003 / F005 hazardous waste flammable liquids (acetone / toluene). Hazardous waste labels were observed on the remaining three drums, but the labels were obscured by other drums or the wall and could not be read. No accumulation start dates were observed on three drums. The oldest drum with an accumulation start date was dated 02/05/2021. Although all of the drums were identified with a flammable liquid DOT hazard placard, that placard had been partially covered with black spray paint on two of the drums.
