## **RCRA Inspection Report**

Adornus Manufacturing USA, LLC EPA ID# SCD000648493  
1551 Highway 9 Bypass West  
Lancaster, South Carolina 29720

February 26, 2021

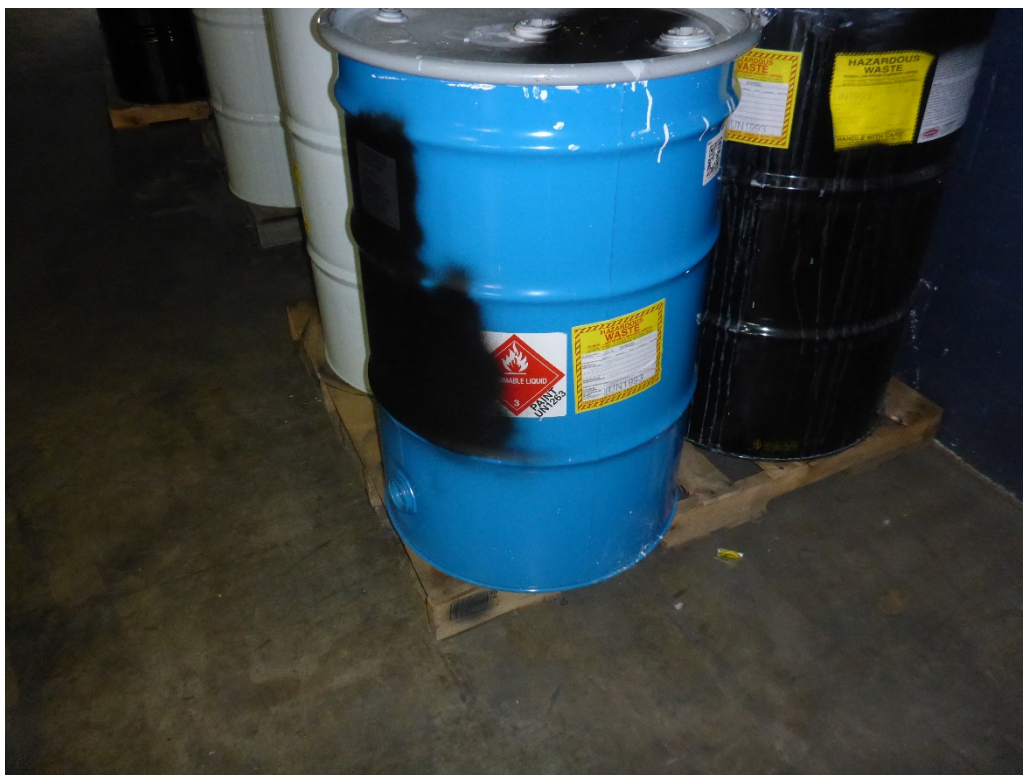
**Photo 23:** Partially covered flammable liquid DOT hazard placard on one drum in the hazardous waste CAA.

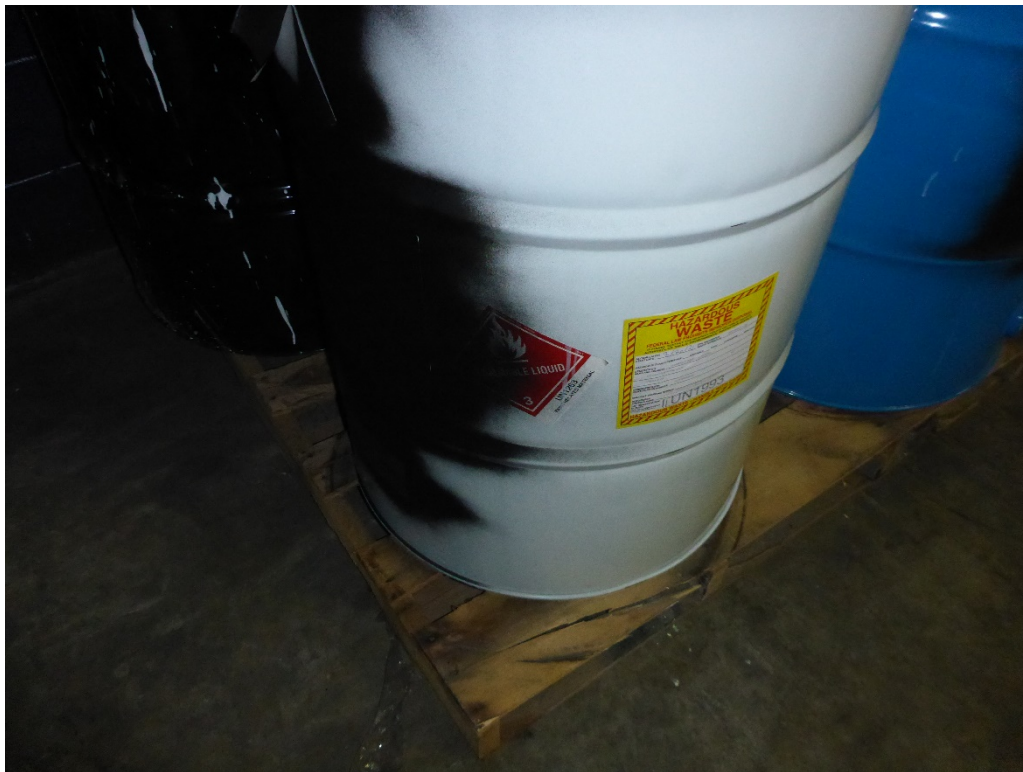
**Photo 24:** Partially covered flammable liquid DOT hazard placard on one drum in the hazardous waste CAA.

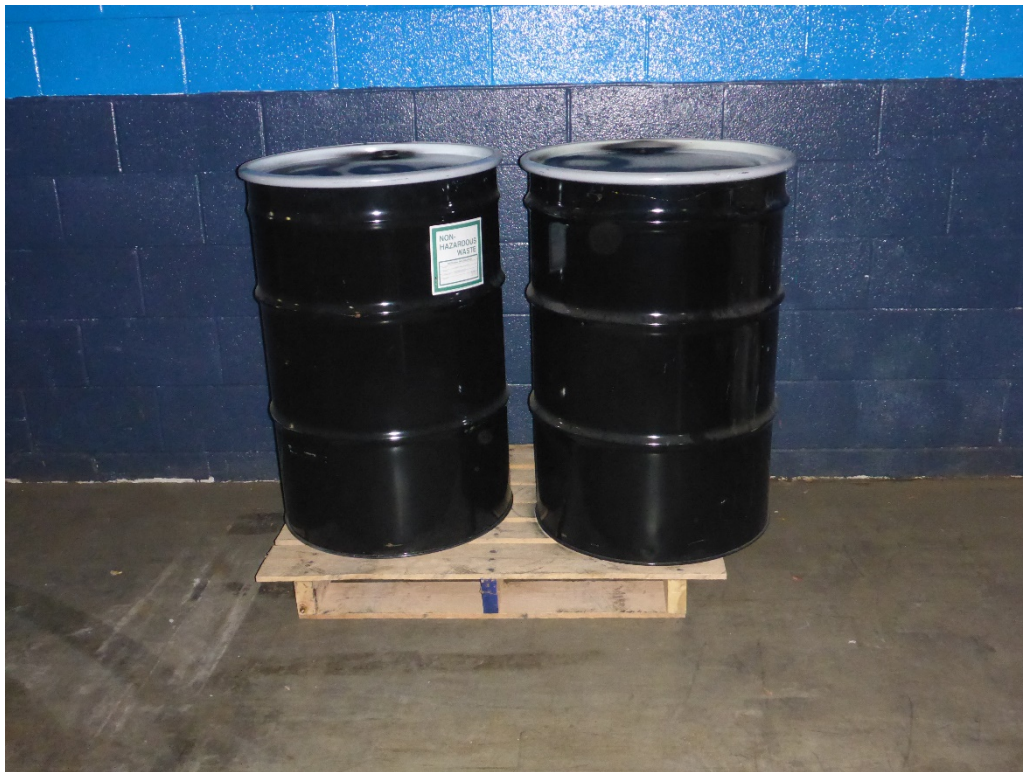
**Photo 25:** Two 55-gallon drums of excluded solvent contaminated disposable wipes observed in the hazardous waste CAA. The drums were both closed and labeled nonhazardous excluded solvent contaminated rags.

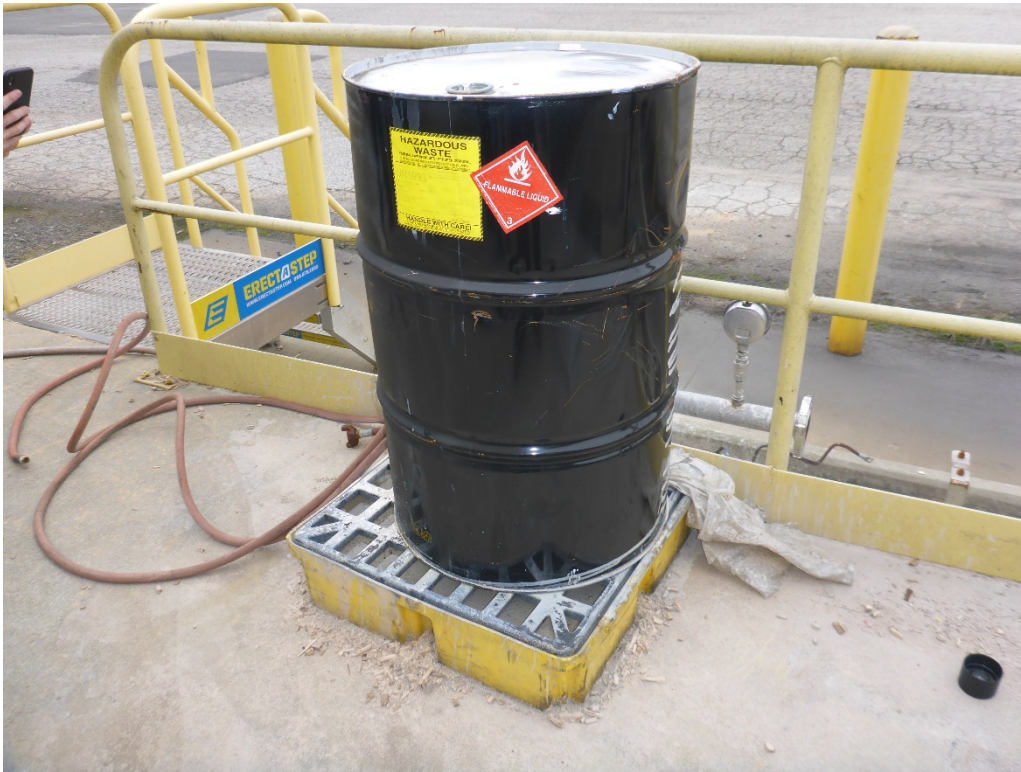
**Photo 26:** One drum of hazardous waste observed on a secondary containment pallet on the loading dock outside of the hazardous waste CAA. The drum was labeled D001 / F003 / F005 hazardous waste flammable liquid (acetone / toluene) and identified with a flammable liquid DOT hazard placard. The drum was dated 10/07/2020, and the secondary containment unit was full of liquid. Mr. Lucas explained that the drum was hit with a forklift during loading activities, which caused it to leak. Because the leaking drum could not be loaded onto the truck for transport off-site, it was moved out to this portable secondary containment unit

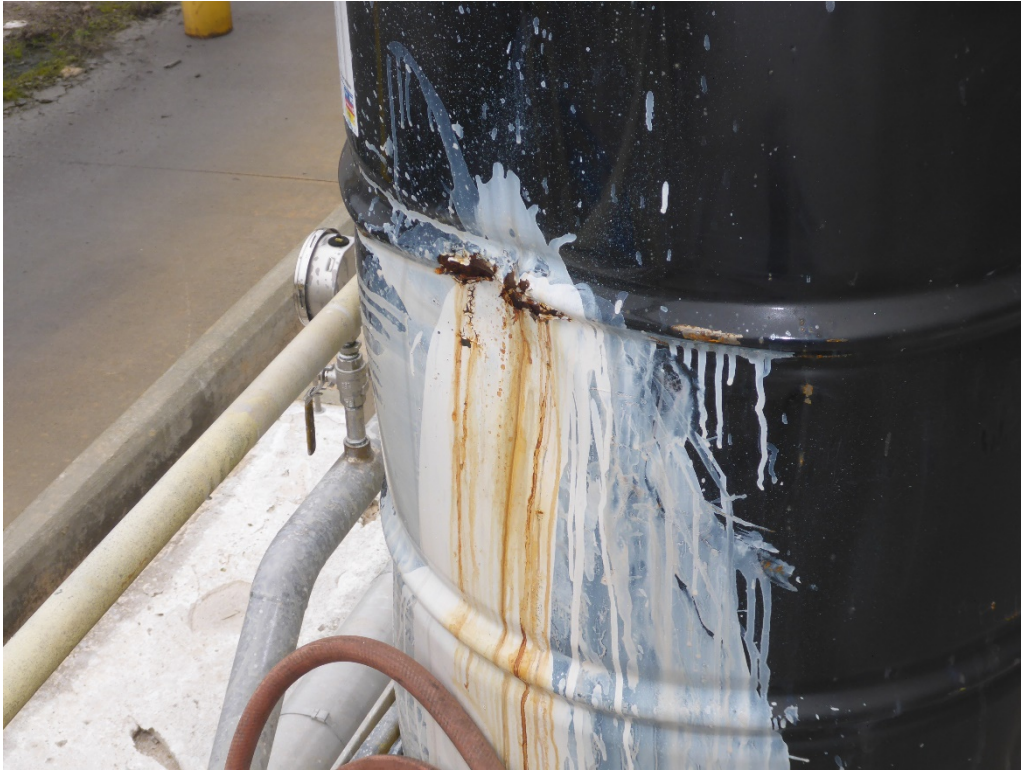
**Photo 27:** Damage to the 55-gallon drum observed on a secondary containment pallet on the loading dock outside of the hazardous waste CAA. The drum was labeled D001 / F003 / F005 hazardous waste flammable liquid (acetone / toluene) and identified with a flammable liquid DOT hazard placard. The drum was dated 10/07/2020, and the secondary containment unit was full of liquid. Mr. Lucas explained that the drum was hit with a forklift during loading activities, which caused it to leak. Because the leaking drum could not be loaded onto the truck for transport off-site, it was moved out to this portable secondary containment unit.

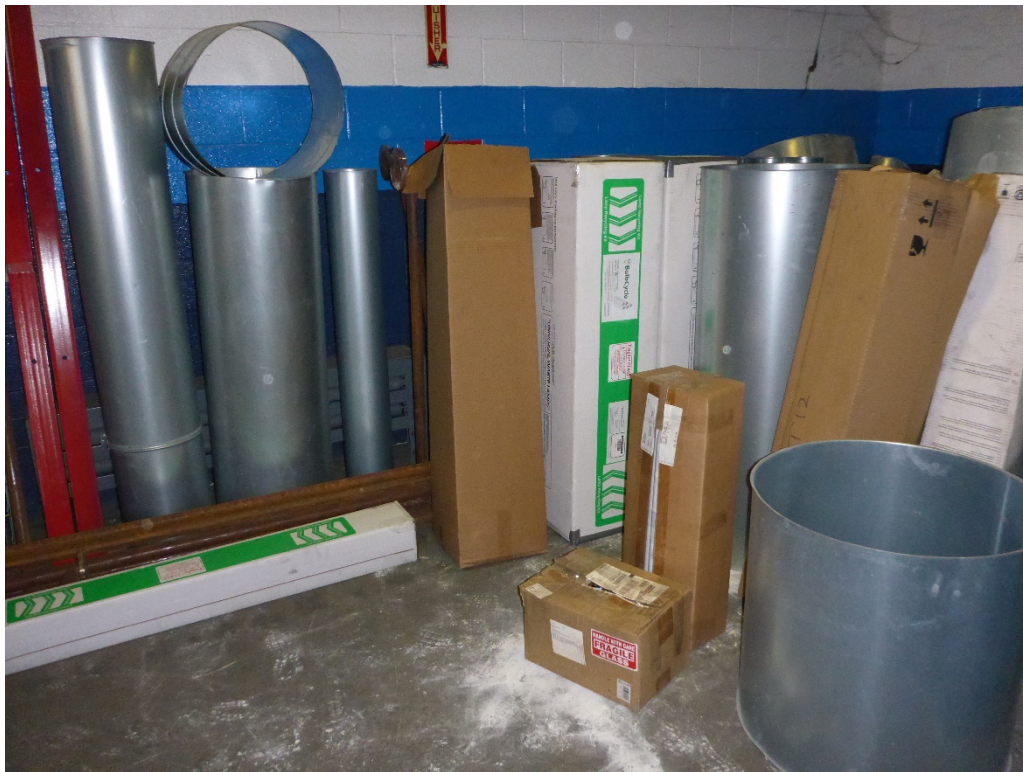
**Photo 28:** Boxes of used lamps observed in the universal waste storage area within the hazardous waste CAA outbuilding: one box of 8-foot used fluorescent lamps, six boxes of 4-foot used fluorescent lamps, one box of 2.5-foot used fluorescent lamps and one box of used metal halide lamps. Four boxes of 4-foot lamps, the box of 2.5-foot lamps, and the box of metal halide lamps were not labeled. Two boxes of 4-foot lamps were not closed. None of the boxes were marked with an accumulation start date.

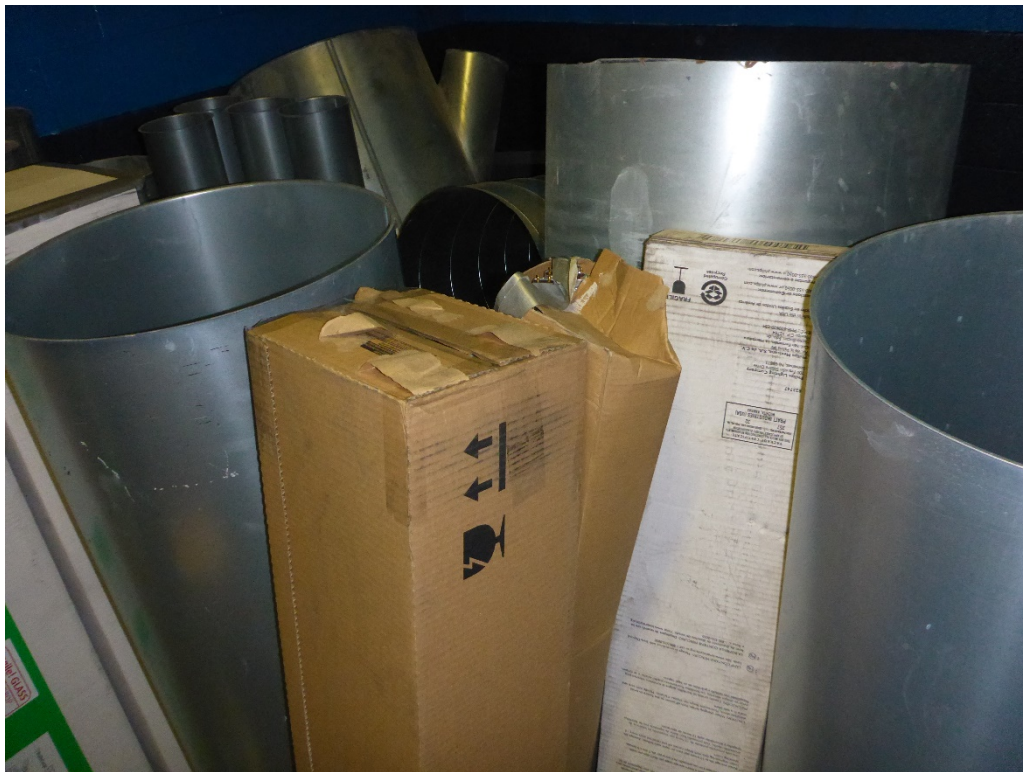
**Photo 29:** Three boxes of 4-foot used fluorescent lamps observed in the universal waste storage area within the hazardous waste CAA outbuilding. The boxes are not labeled as universal waste lamps, and one of the boxes is open.

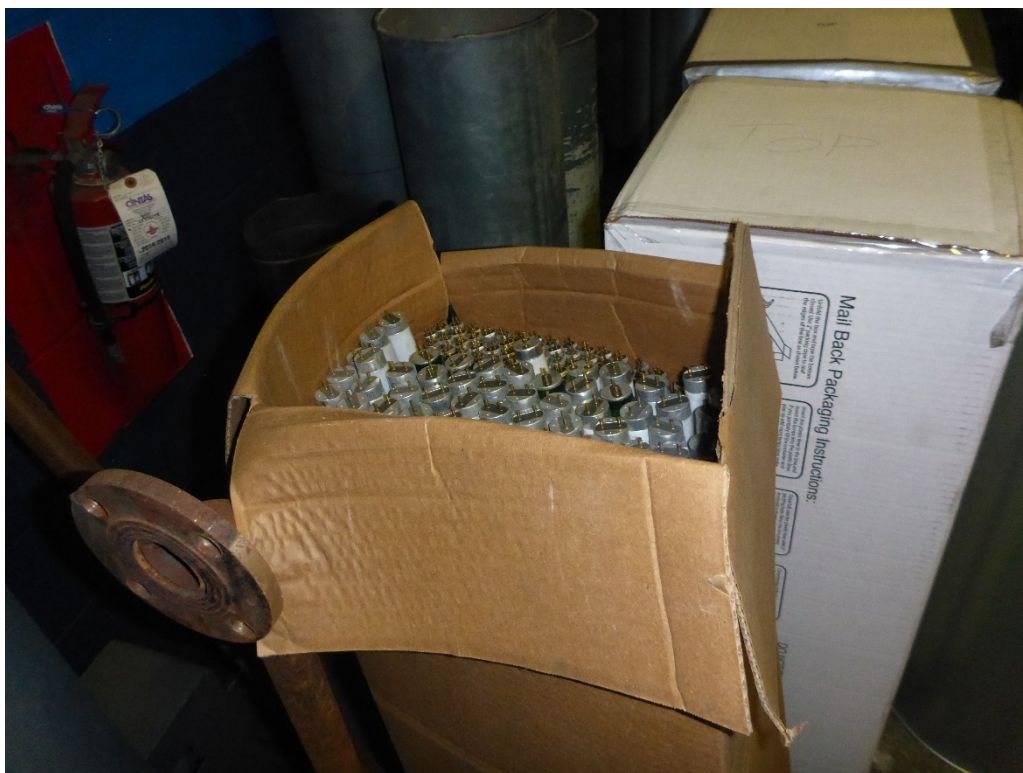
**Photo 30:** Three boxes of 4-foot used fluorescent lamps observed in the universal waste storage area within the hazardous waste CAA outbuilding. The brown cardboard box is not labeled as universal waste lamps, and it is open. The white boxes are labeled as universal waste lamps, and they are closed.
