**Alco High Tech Plastics, Corozal , Puerto Rico**

**PRR000027003**

**CEPD-RCRA-23-0441**

**Eduardo Gonzalez  
March 27, 2024**

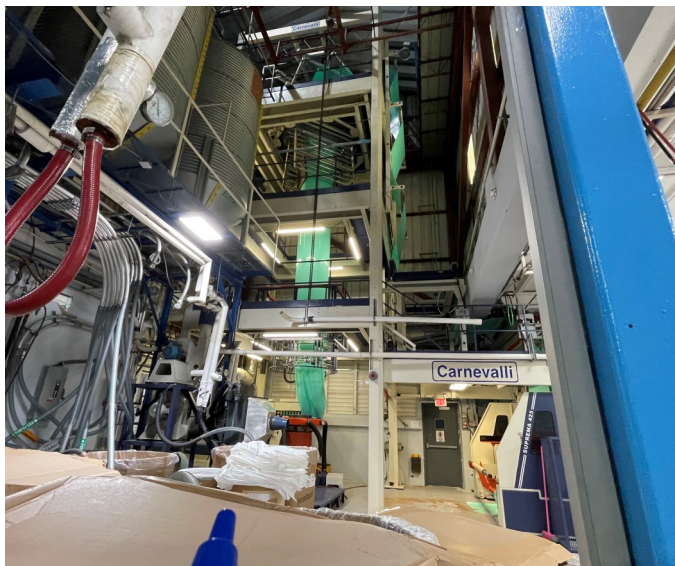
**Picture 1 - ALCO HIGH TECH PLASTICS** - At the Plastic Extrusion area, a high-volume manufacturing process is undertaken where raw plastic (pellets) is melted and formed into a continuous plastic layer.

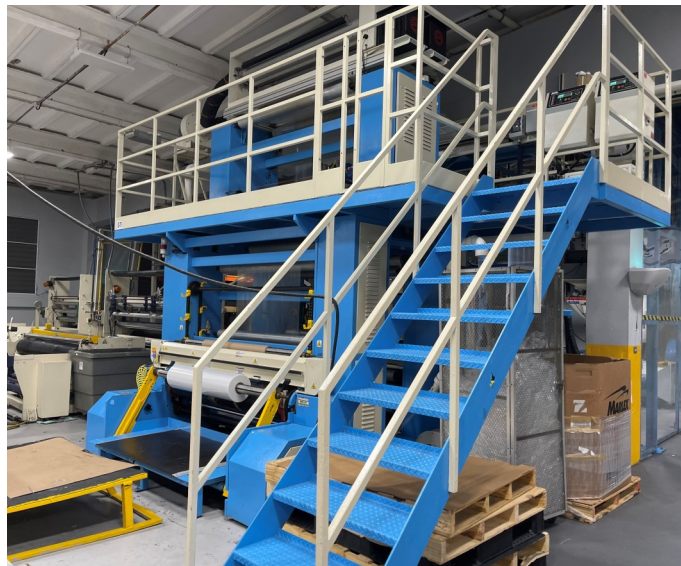
**Picture 2 - ALCO HIGH TECH PLASTICS** - At the Plastic Extrusion area, the material is gradually melted by the mechanical energy generated by turning screws and by heaters arranged along the barrel of the extruder.

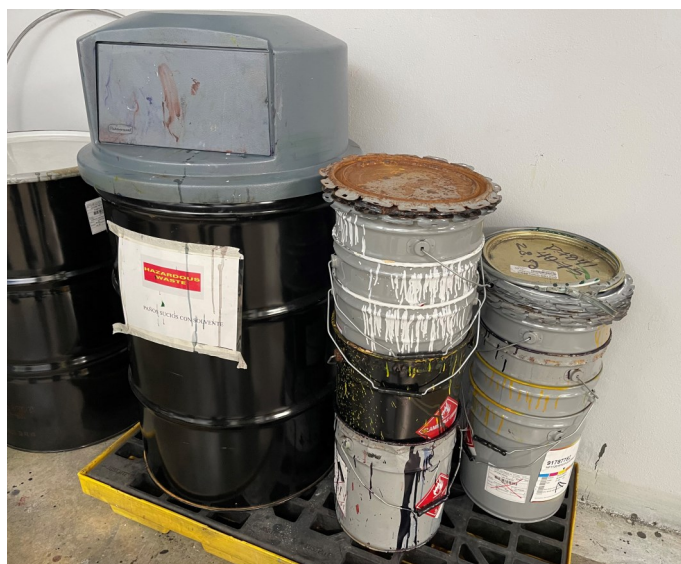
**Picture 3 - ALCO HIGH TECH PLASTICS** - At the Plastic Extrusion area (SOMA), there was a SSA with (1) 55-gallon black drum with impacted rags with spent liquid solvent waste containing a mixture of propanol and ink, labeled as “Hazardous Waste,” and not identified with its hazard communication pictogram as “Flammable Solids.”

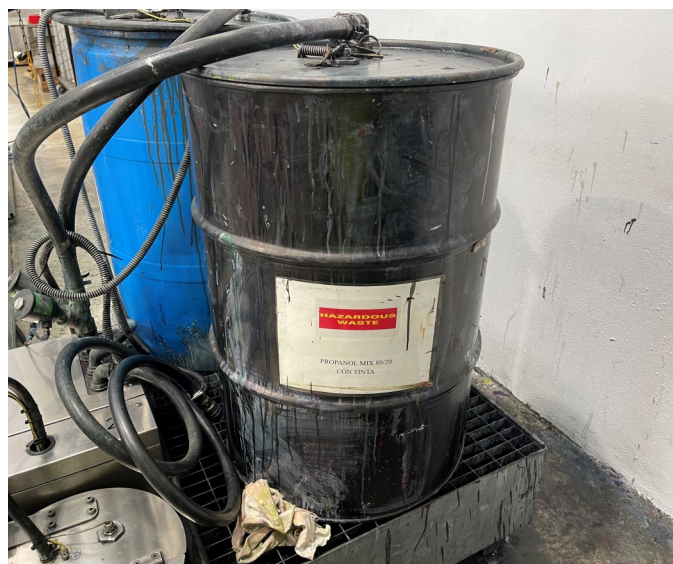
**Picture 4 - ALCO HIGH TECH PLASTICS** - At the Plastic Extrusion area (SOMA), there was a second SSA with one (1) 55-gallon black drum with with spent liquid solvent waste containing a mixture of propanol and ink, labeled as “Hazardous Waste,” and not identified with its hazard communication pictogram as “Flammable Liquids.”

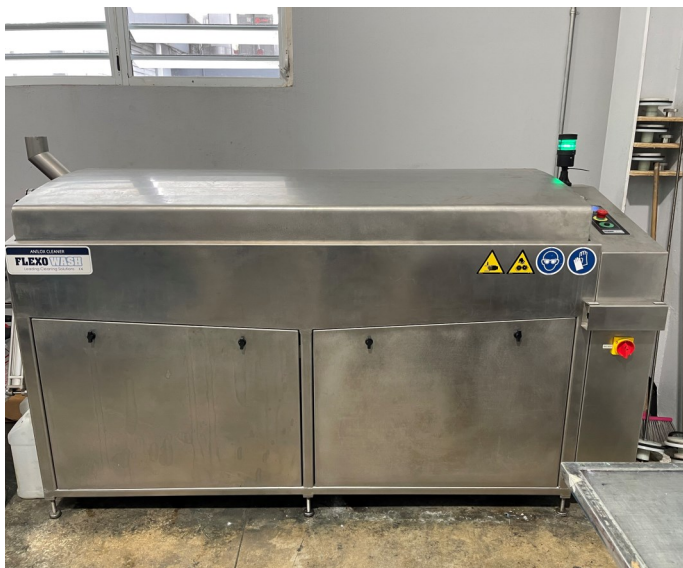
**Picture 5 - ALCO HIGH TECH PLASTICS** - At the Plastic Extrusion area (SOMA), there was a third SSA with one (1) 300-gallon stainless steel tank used to clean anilox rollers not labeled with the words, “Hazardous Waste,” nor identified with its hazard communication pictogram as “Corrosive Liquids.”

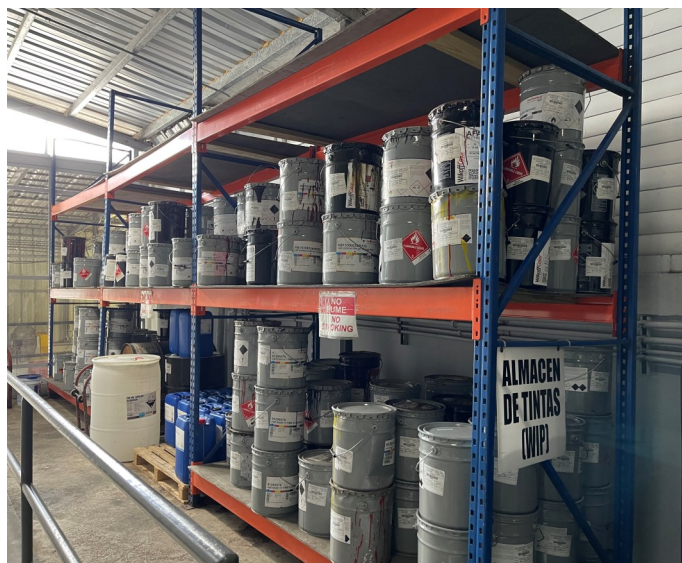
**Picture 6 - ALCO HIGH TECH PLASTICS** - At the Ink Warehouse area EPA Inspector observed that all new ink products are stored in 5-gallon pails (i.e., Cyan, Magenta, Yellow and Black) for immediate use in plastic printing machines.

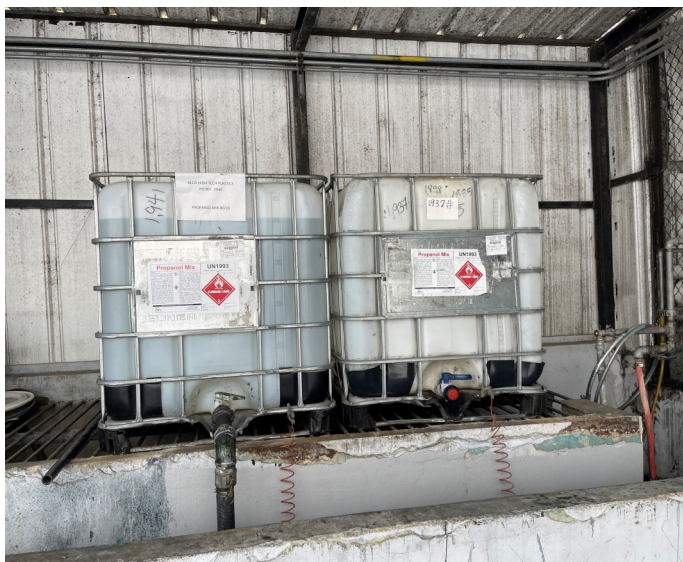
**Picture 7 - ALCO HIGH TECH PLASTICS** - At the the Alcohol Warehouse area, it was observed that all Propanol Mix 80/20 solvent products (i.e., UN 1993 – Flammable Liquids) are stored in two (2) 275-gallon totes for future use in plastic printing machines.

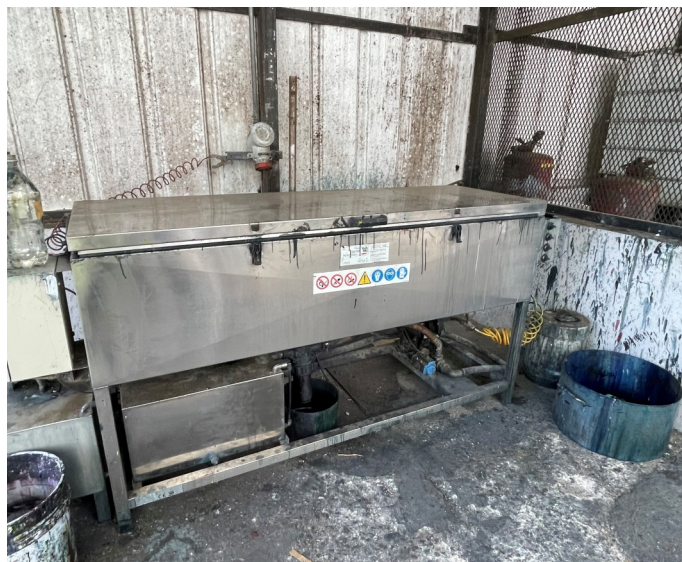
**Picture 8 - ALCO HIGH TECH PLASTICS**— At the Alcohol Warehouse, I observed a part-washer machine that was used to clean anilox and/or plaster rollers until the new SAA Washing Machine unit was installed nearby the plastic printing machines. This part-washer has been discontinued and emptied over a year ago and is not currently in use.

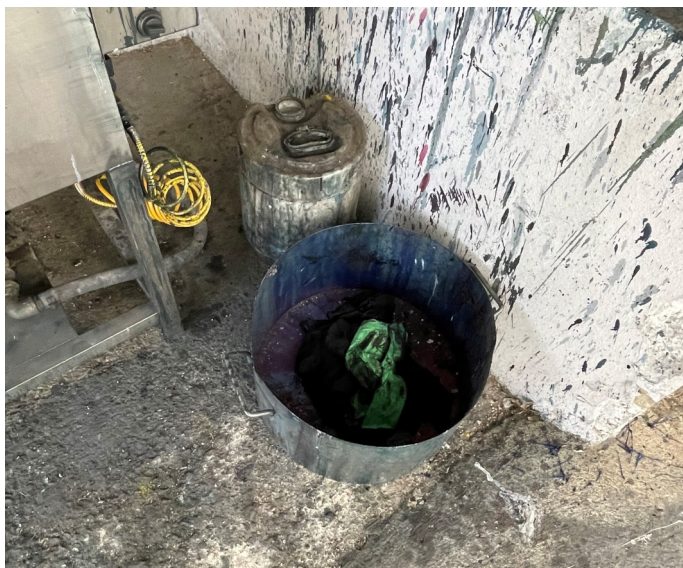
**Picture 9 - ALCO HIGH TECH PLASTICS** - At the Alcohol Warehouse, I observed one (1) ½-cut 55-gallon blue plastic drum “open” with impacted rags contaminated with spent liquid solvent waste of a mixture of propanol and ink, not labeled as “Hazardous Waste,” nor identified with its hazard communication pictogram as “Flammable Solids.”

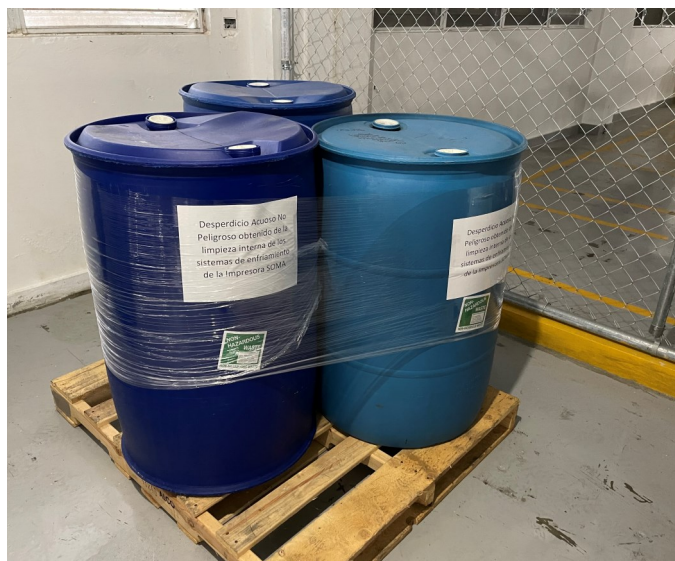
**Picture 10 - ALCO HIGH TECH PLASTICS** - At the 90-day Hazardous Waste Accumulation area, I observed three (3) 55-gallon blue plastic drums containing aqueous wastes generated from the cleaning activities of the cooling system of the SOMA Printing Machine, all clearly labeled with the words, “Non-Hazardous Waste.”

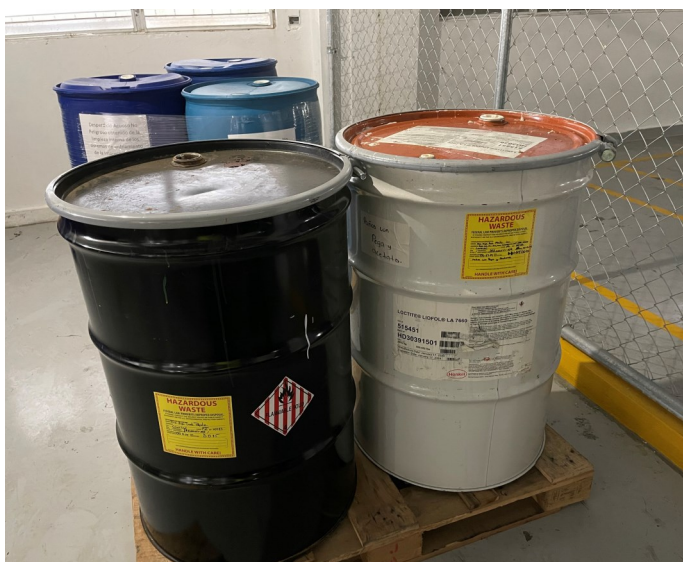
**Picture 11 - ALCO HIGH TECH PLASTICS** - At the 90-day Hazardous Waste Accumulation area, I observed two (2) 55-gallon drums containing rags impacted with glue and spent acetone, clearly labeled with the words, “Hazardous Waste,” and dated on March 7, 2024, and March 11, 2024, respectively.

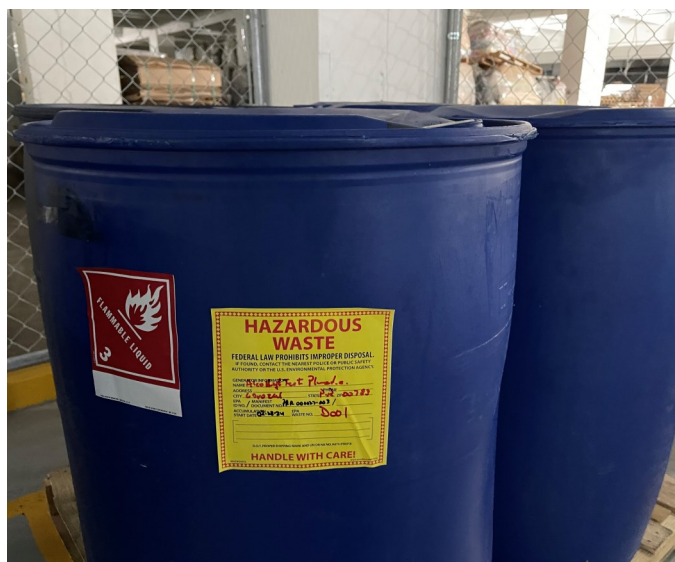
**Picture 12 - ALCO HIGH TECH PLASTICS**- At the 90-day Hazardous Waste Accumulation area, I observed seven (7) 55-gallon blue plastic drums containing with spent liquid solvent waste containing a mixture of propanol mix 80/20 and ink waste and coded as “D001” (Ignitable). All drums were clearly labeled with the words, “Hazardous Waste,” and dated Feb-Mar 2024.

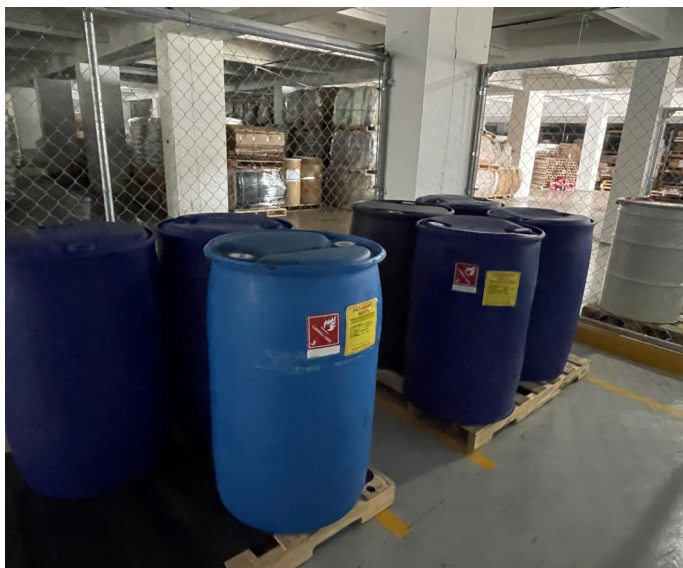
**Picture 13– ALCO HIGH TECH PLASTICS—** At the 90-day Hazardous Waste Accumulation area, I observed two (2) 55-gallon drums, one steel black and the other plastic white, containing unknown water paints identified with its hazard communication pictograms as, “Flammable Liquids,” without proper hazardous waste determination as “Hazardous Waste.”

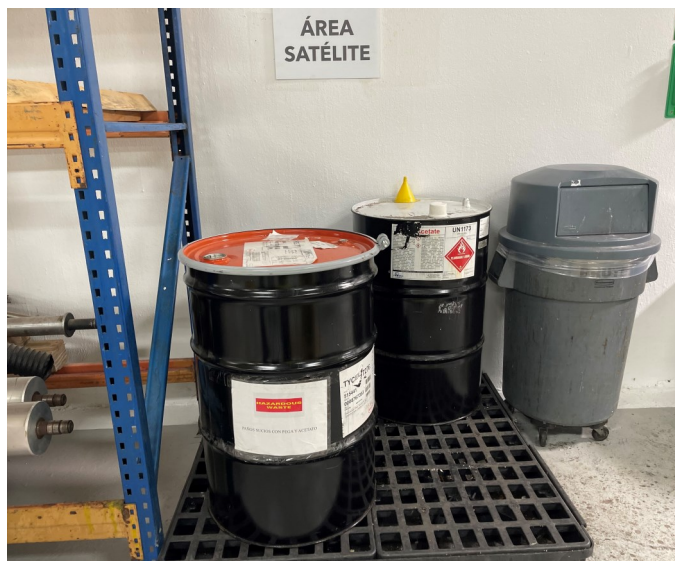
**Picture 14 - ALCO HIGH TECH PLASTICS-** At the Plastic Lamination one (1) 55-gallon black steel drum with impacted rags contaminated with glue and spent ethyl acetate, labeled as “Hazardous Waste,” and “Paños Sucios con Pega y Acetato,” and was not identified with its hazard communication pictogram as “Flammable Solids”

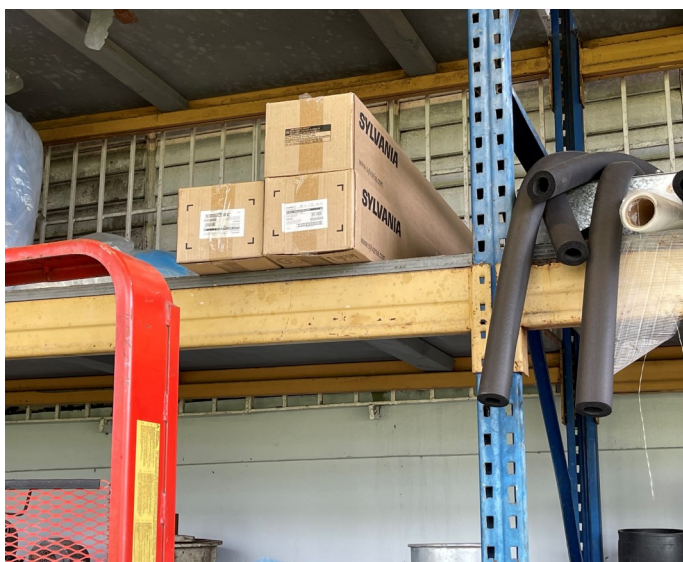
**Picture 15-ALCO HIGH TECH PLASTICS-** At the Universal Waste Storage area, I observed five (5) square cardboard boxes (1’x1’x 4’) packing over forty (40) 4-foot spent fluorescent lamps, some open and not labeled with the words, “Universal Waste.”

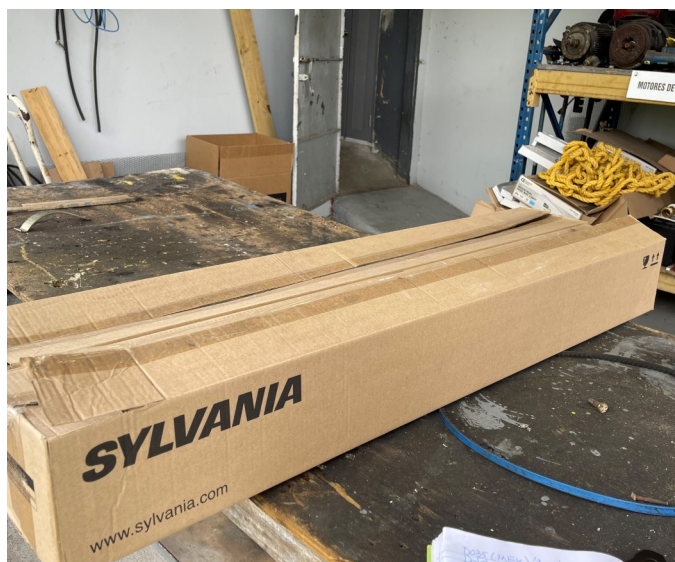
**Picture 16 - ALCO HIGH TECH PLASTICS-** At the Universal Waste Storage area, I also observed five (5) square cardboard boxes (1’x1’x 4’) packing over forty (40) 4-foot spent fluorescent lamps, not labeled with their accumulation start dates.

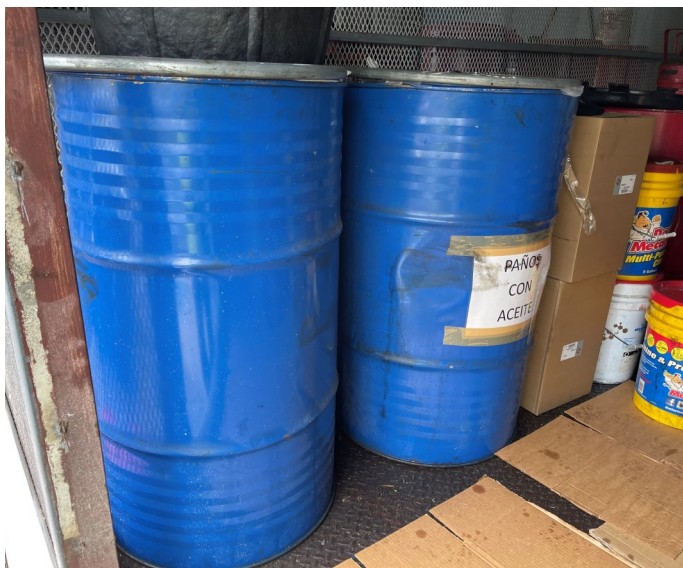
**Picture 17- ALCO HIGH TECH PLASTICS**— At the Used Oil Storage area, I observed one (1) 55-gallon blue steel drums with impacted rags with used oil not marked with the words, "Used Oil."

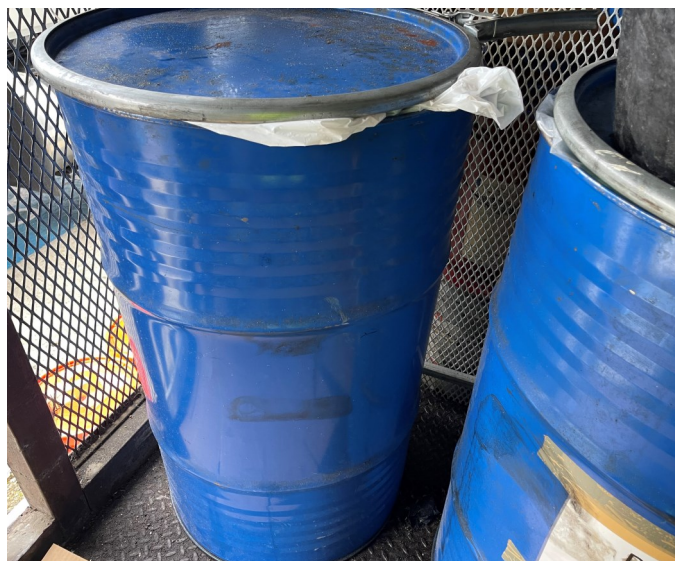
**Picture 18 - ALCO HIGH TECH PLASTICS-** At the Used Oil Storage area, I observed one (1) 55-gallon blue steel drums with impacted used oil filters not marked with the words, "Used Oil."

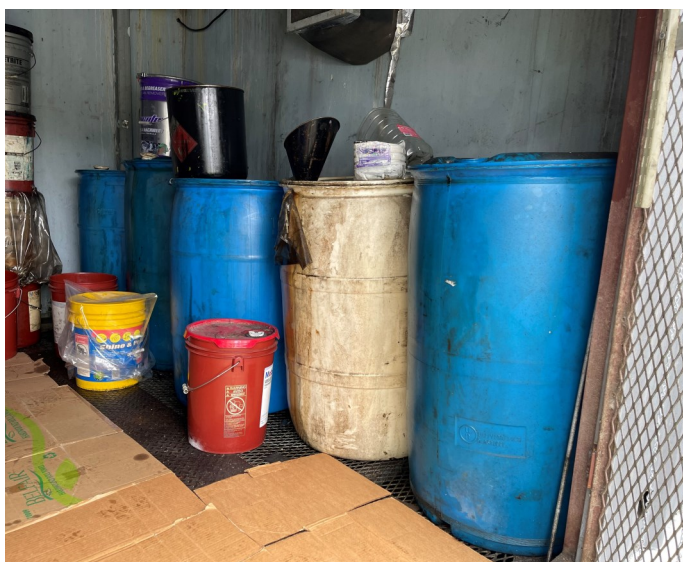
**Picture 19-ALCO HIGH TECH PLASTICS-** At the Used Oil Storage area, I observed five (5) 55-gallon blue/white plastic drums with used oil not marked with the words, "Used Oil."

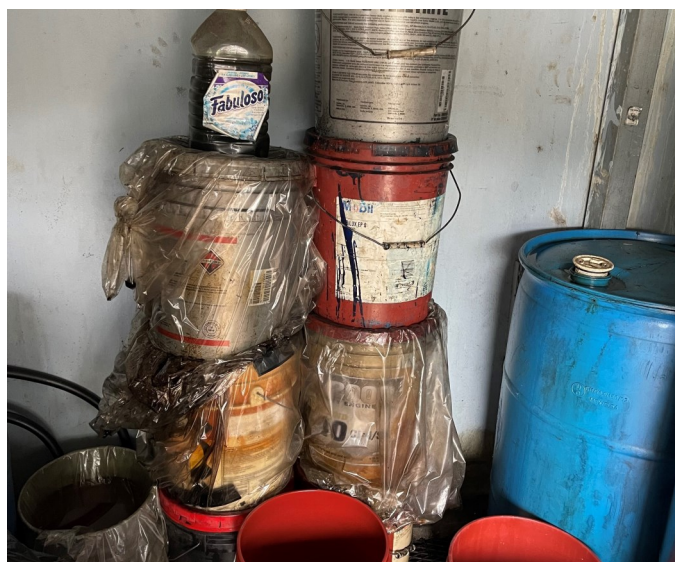
**Picture 20 - ALCO HIGH TECH PLASTICS-** At the Oil Storage area, I observed seven (7) 5-gallon orange/gray plastic containers with used oil not marked with the words, "Used Oil"
