## Annex II - Hydrocarbon Refrigerants in RHVAC Systems Casualties (selected incidents)

### Hydrocarbon Refrigerant Casualties

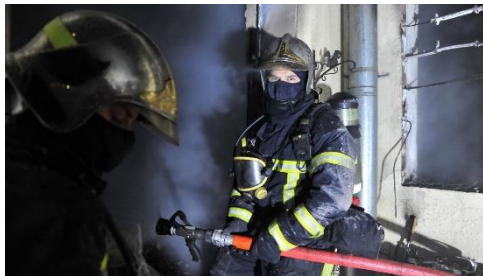
[www.francebleu.fr](http://www.francebleu.fr)

2. - Explosion of an air conditioner in Montpellier France followed by building fire.

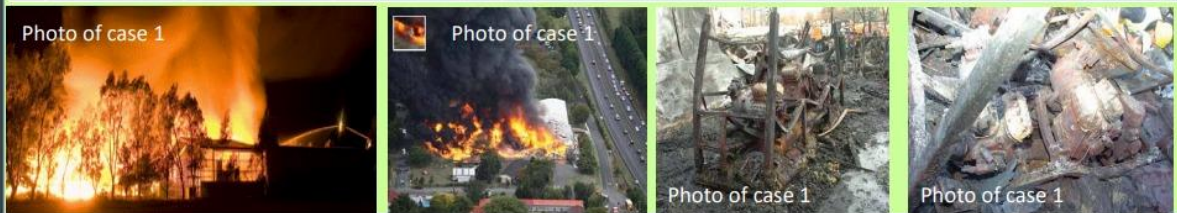
IMG 20230407

16. 1 fireman killed and 7 injured in New Zealand 4. May 2008, from a massive explosion on a refrigeration system with leakage, charged with hydrocarbon natural refrigerant (propane) (see picture attached IMG 20230407)

| | Type | Refrigerant | Place/Date | Detail of accident |
|---|---|---|---|---|
| 1 | Refrigeration | Propane | New Zealand<br>2008/4/5 | <b>Propane Refrigerant leaked and massive explosion occurred</b> in cold storage, <b>killed one fireman and injured seven</b> . Refrigeration units originally charged with HCFC-22 was replaced with propane. |
| 2 | Refrigeration | Propane | New Zealand<br>2010/5 | <b>Propane was exploded during welding work.</b> Markings on the valve he was repairing and other parts of system indicated it contained non-flammable R22 or Freon. |
| 3 | AC | HR429 or neat Propane | Hong Kong<br>2013/1/9 | <b>During maintenance, AC was exploded.</b> Witnesses at the time said they heard two explosions which smashed all the windows in the second floor restaurant. <b>More than 20 people were injured.</b> |

17. In New Zealand, May 2010, while repairing a refrigeration system, welding and replacing a defective valve, the unit charged with hydrocarbon natural refrigerant (propane) exploded. (see picture attached IMG 20230407)

18. 9.Jan 2013 in Hong Kong, during maintenance of an air conditioner in a restaurant, charged with hydrocarbon natural refrigerant (propane) exploded. More than 20 people seriously injured. (see picture attached IMG 20230407)
