**CLEAN WATER ACT INSPECTION REPORT  
U.S. ENVIRONMENTAL PROTECTION AGENCY  
REGION 5**

**Purpose:** Clean Water Act – Industrial User Inspection

**Facility:** Tuf-Tile Inc.  
905 Tesler Road  
Lake Zurich, Illinois

**Date of Inspection:** April 24, 2025

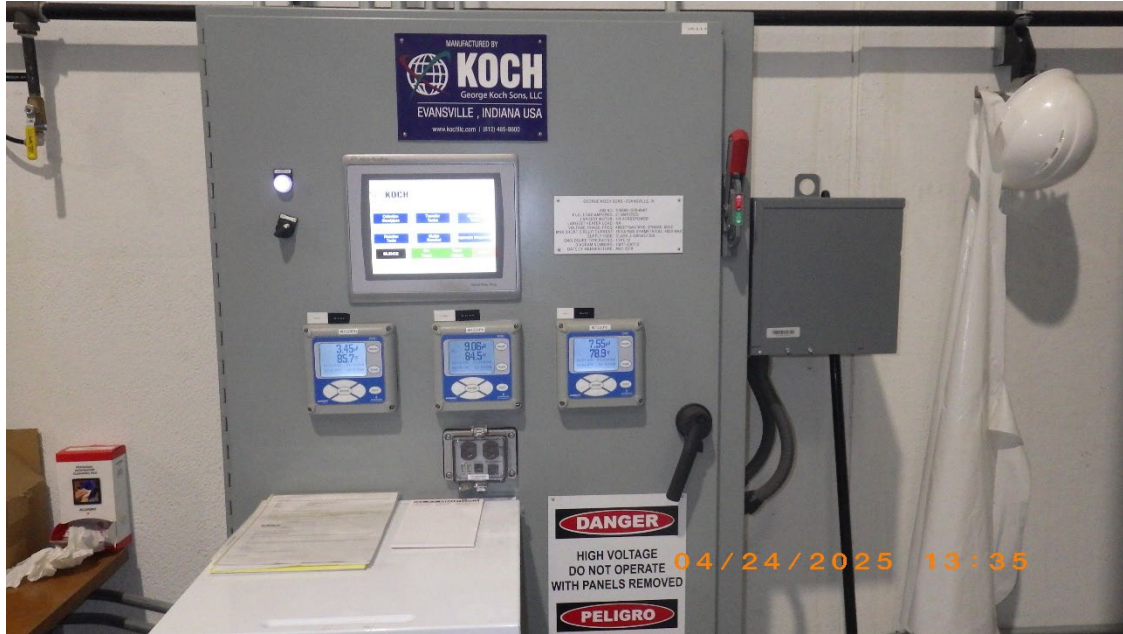
1: RIMG0289

Description: Overview of control system for Onsite Waste Treatment System

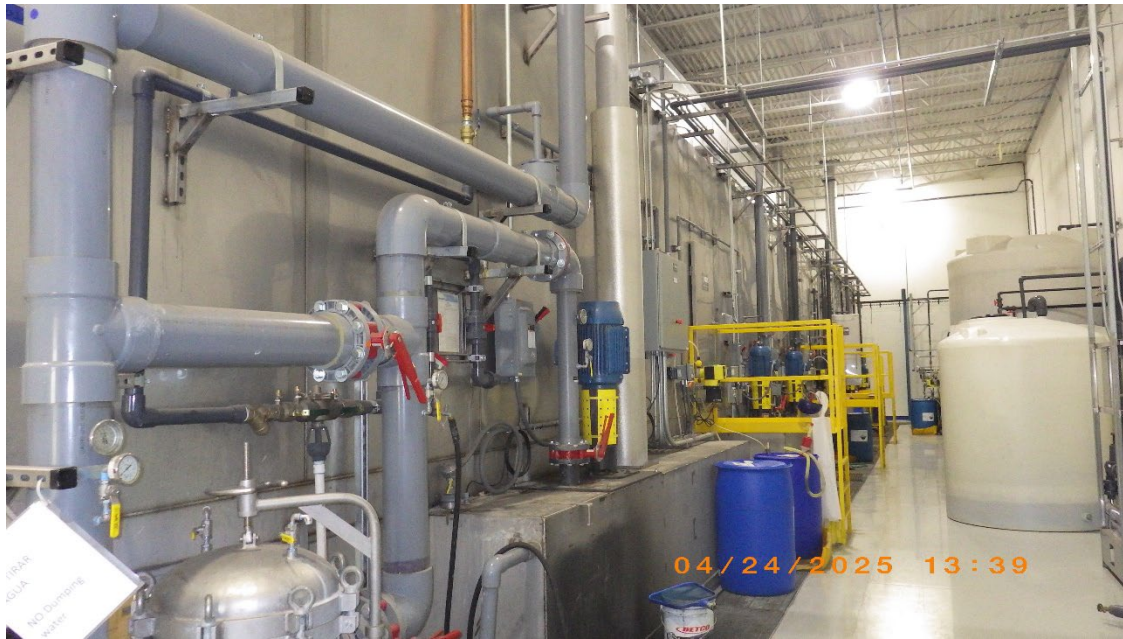
2: RIMG0290

Description: Overview of Paint Line Rinse Series with Stage 1 in foreground and Rinse Holding Tank/Concentrate on right side.

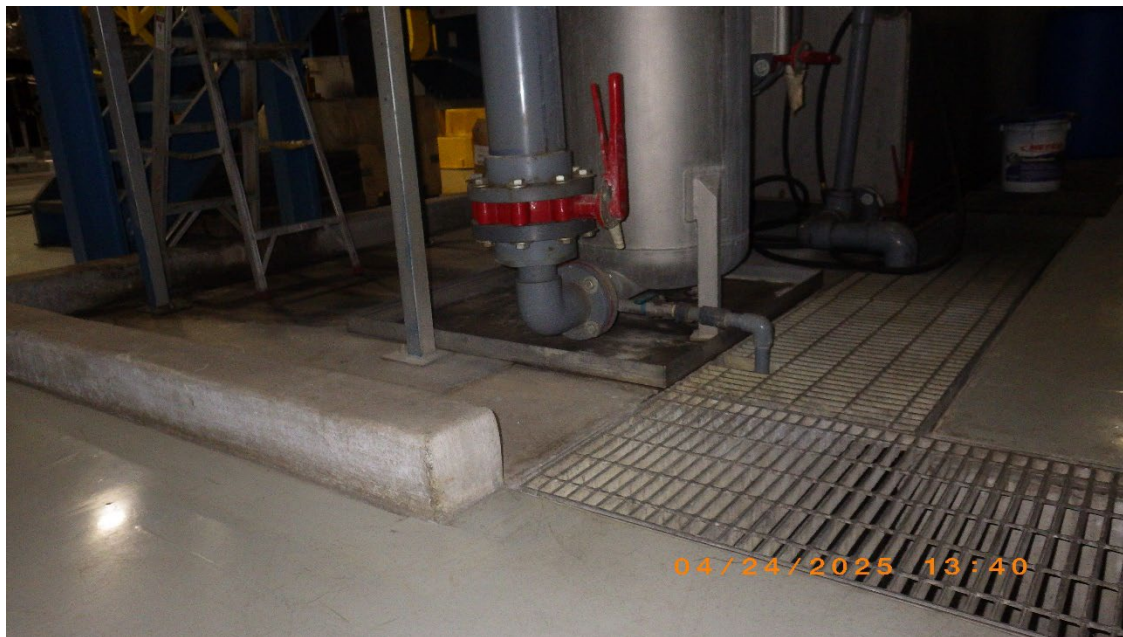
3: RIMG0291

Description: Cement secondary containment – internal trench located underneath the Paint Line Rinse Series.

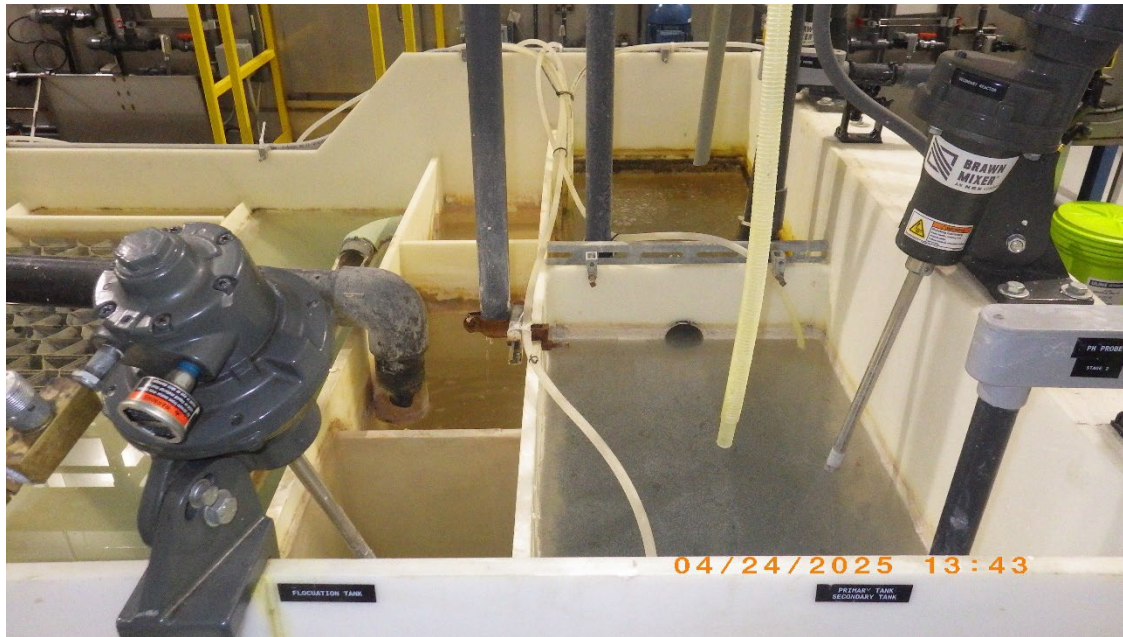
4: RIMG0292

Description: Overview of Onsite Waste Treatment Area with Primary Clarifier 1 and 2 on right side (Stage 1 in back right corner, Stage 2 in front right corner, Stage 3 flocculation on left side).

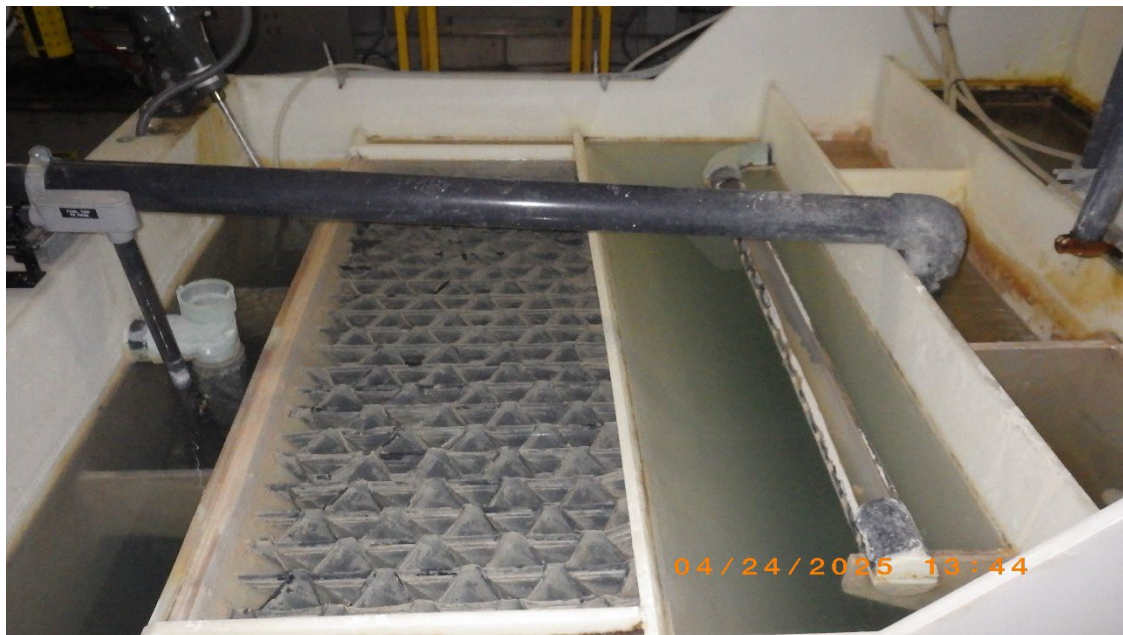
5: RIMG0293

Description: Oneiste Waste Treatment Area following Stage 3 flocculation. Clarifier and final pH adjustment.

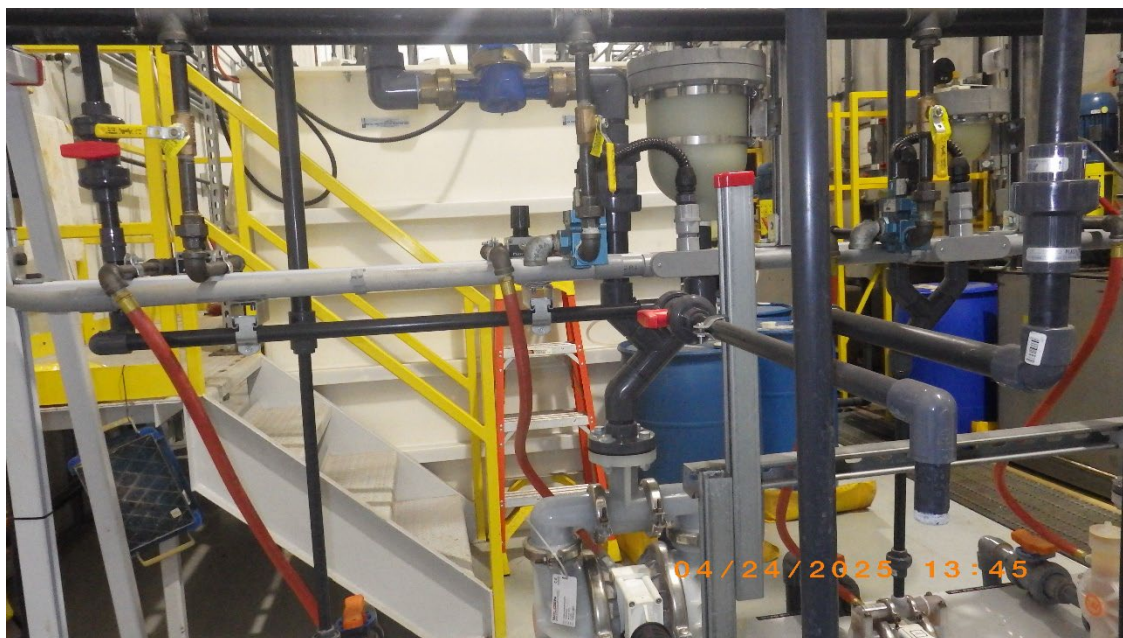
6: RIMG0294

Description: Sampling location from Onsite Waste Treatment Area before discharge is pumped to the lift station and sanitary sewer line. Blue flowmeter of effluent in background.

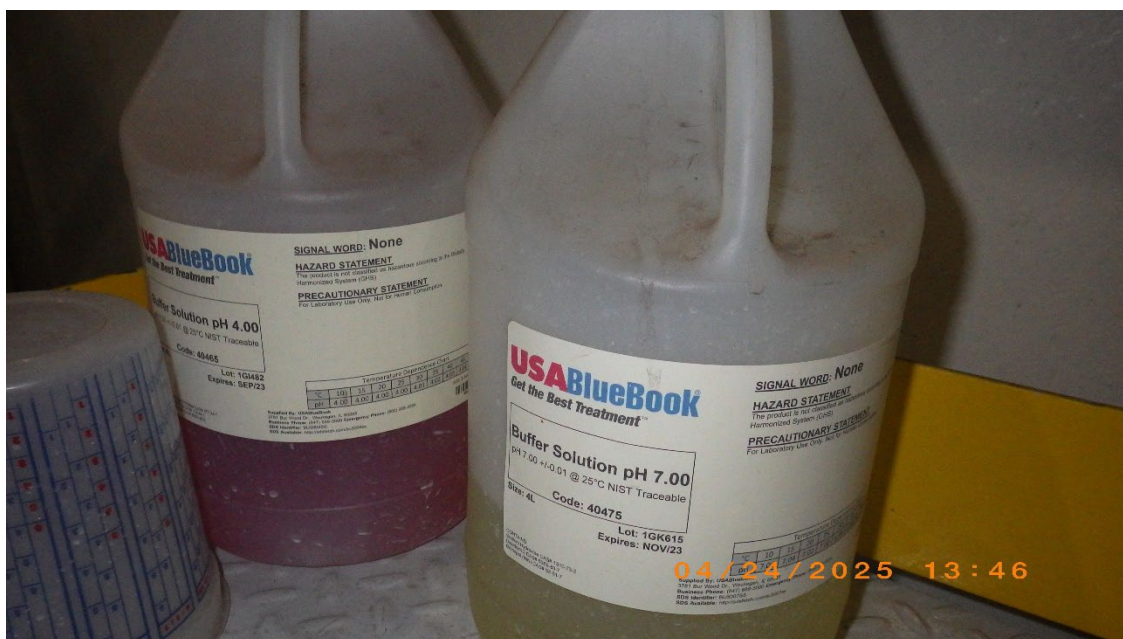
7: RIMG0295

- During the site walk through, the pH buffers located near the Onsite Waste Treatment Area indicated expiration dates of September 2023 (pH 4.0 buffer) and November 2023 (pH 7.0 buffer).

- During the Closing Conference, Tuf-Tile staff told EPA the pH buffers stored near the Onsite Waste Treatment area are not used regularly, but only used as backup if needed. Typically, Tuf-Tile uses pH paper for analyzing pH levels.

Description: pH buffers near Onsite Waste Treatment Area with expiration dates in September 2023 and November 2023.

- Even though the buffers are only used as backup, Tuf-Tile staff told EPA the replacement pH buffers had already been ordered at the time of the inspection.

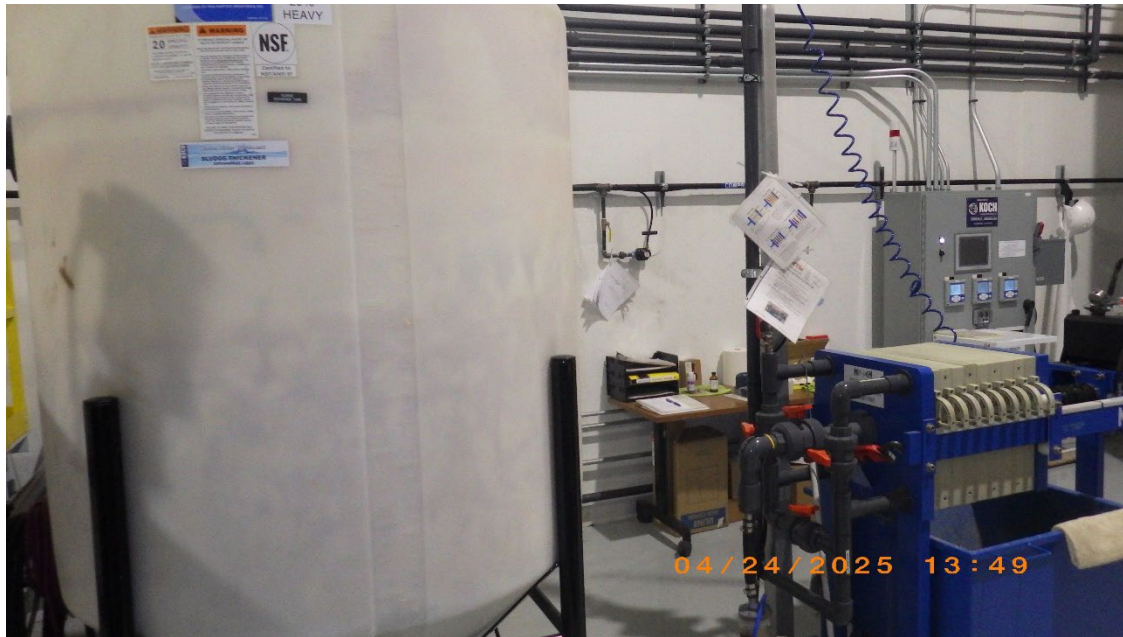
8: RIMG0296

Description: Sludge holding tank on left side, with sludge drying unit on right side. Process occurs after waste treatment.

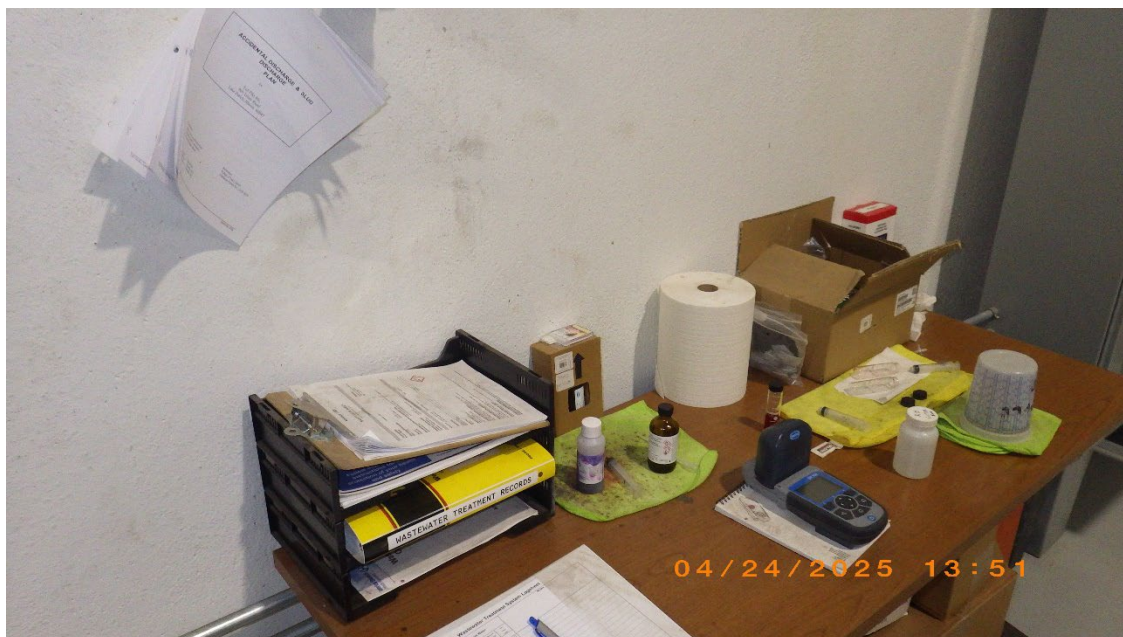
9: RIMG0297

- At the time of the inspection, Tuf-Tile kept an Accidental/Slug Discharge Plan near the Onsite Waste Treatment System. Tuf-Tile told EPA this plan is signed and reviewed every month. (Photo 9).

- At the time of the inspection, Tuf-Tile kept Safety Data Sheets (SDSs) near the Onsite Waste Treatment System. (Photo 9).
- All chemicals for waste treatment are kept on yellow lining.

Description: Record table with ~6 years of records and log sheets, with Slug Discharge Plan hanging on wall.
