## OECA – Air Enforcement Division INSPECTION REPORT

| Company Name: | <b>Blanchard Refining (Marathon)</b> | |
| Facility Name: | <b>Galveston Bay Refinery</b> | |

# CAA Inspection Report Photo Log Marathon – Blanchard Refining Galveston Bay Refinery

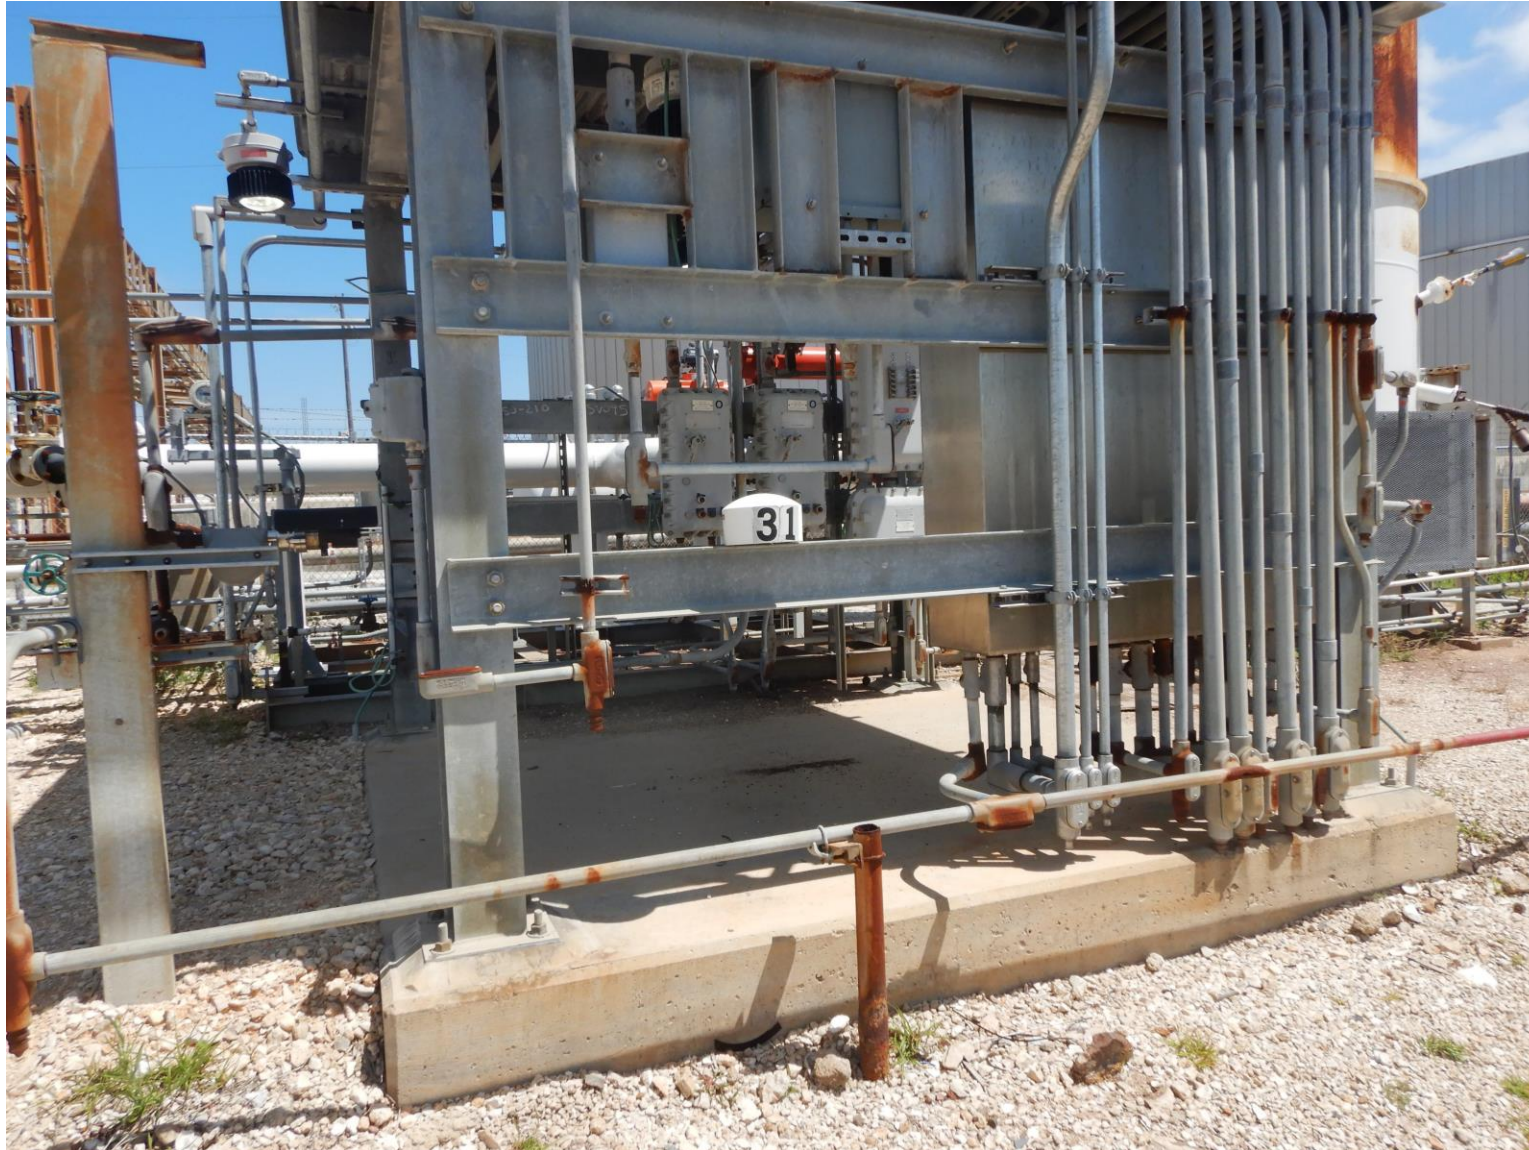
Photo 1154: Shelter 31 improper placement - 5/1/23 11:51 DSCN1154.jpg

While deploying EPA-1, I observed Shelter #31 and noticed the passive monitor was approximately 2-3 ft off the ground and was resting on a bar that partially blocked the inlet to the passive sampler hood. (Photo 1154) **[AOC 1]** After identification, facility staff moved Shelter #31 to a higher location, without obstruction to the passive sampler, and secured the monitor with zip ties.

I observed Shelter #31 to be approximately 2-3 feet off the ground and partially obstructed by a beam. Method 325 section 8.5.5 instructs to “Secure passive samplers so the bottom of the diffusive sampling cap is 1.5 to 3 meters (4.9 to 9.8 feet) above ground using a pole or other secure structure at each sampling location.” The facility corrected the placement of Shelter #31 during the inspection.

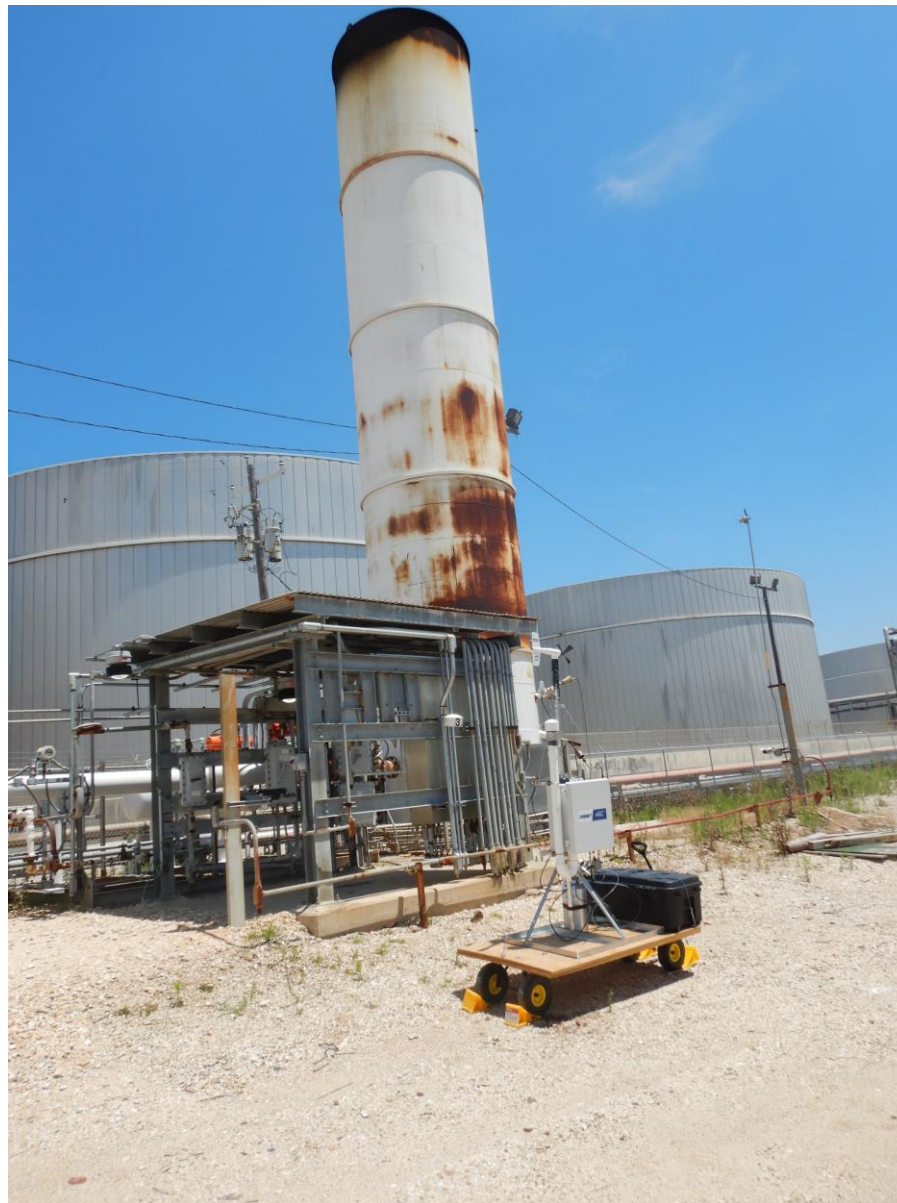
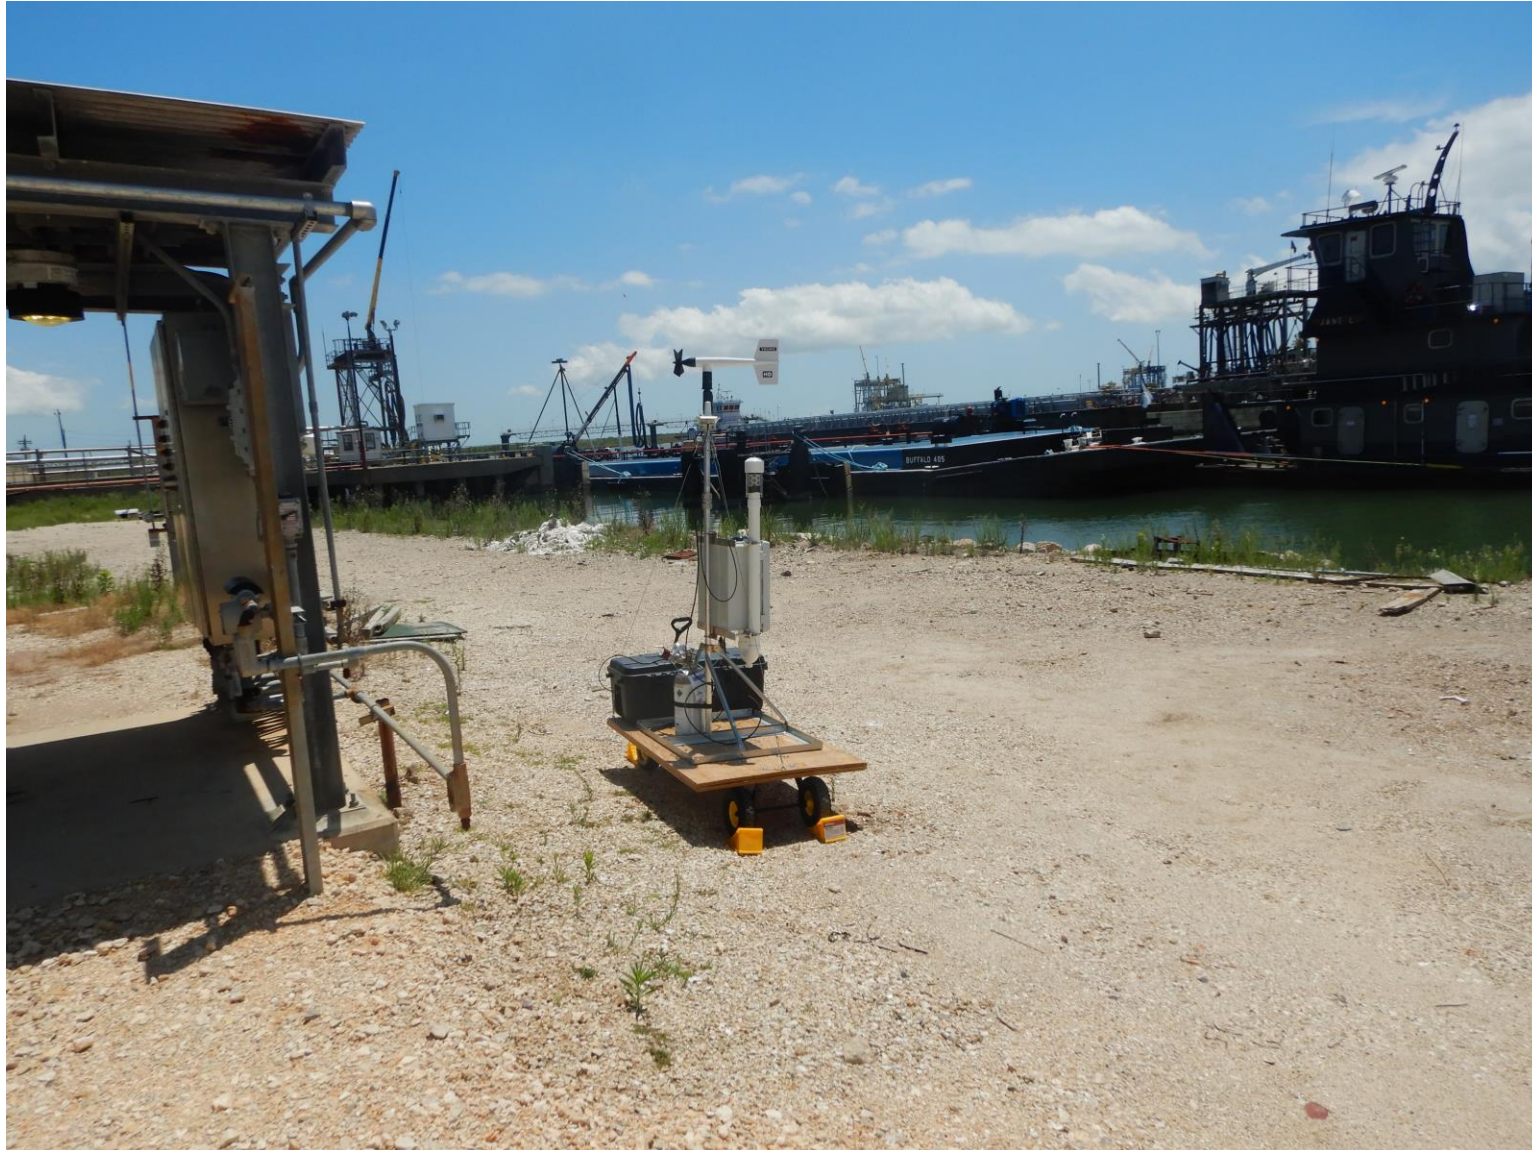
At approximately 12:00 on May 1, 2023, we arrived at Dock 18 and set up the eGC EPA-1 near Shelter #31 and the thermal oxidizer (“TO”) for Dock 18. (Photos 1155 and 1156. See Site EPA 1A in the eGC report.) The wind was from the South/Southwest; therefore EPA-1 was downwind of Docks 32/33/34. At 12:30, Tommy Featherly, Dock Foreman, informed inspectors that Dock 32 was almost done loading a form of diesel known as distillate intermediate blend (“DIB”) stock. He also said that Dock 33 was currently loading heavy virgin naptha with about 14 hours left, and that Dock 34 was not currently loading.

Photo 1155: EPA 1A Location near Dock 18 Thermal Oxidizer facing NE  
5/1/23 12:37 DSCN1155.jpg

Photo 1156: EPA 1A Location facing SE - 5/1/23 12:38 DSCN1156

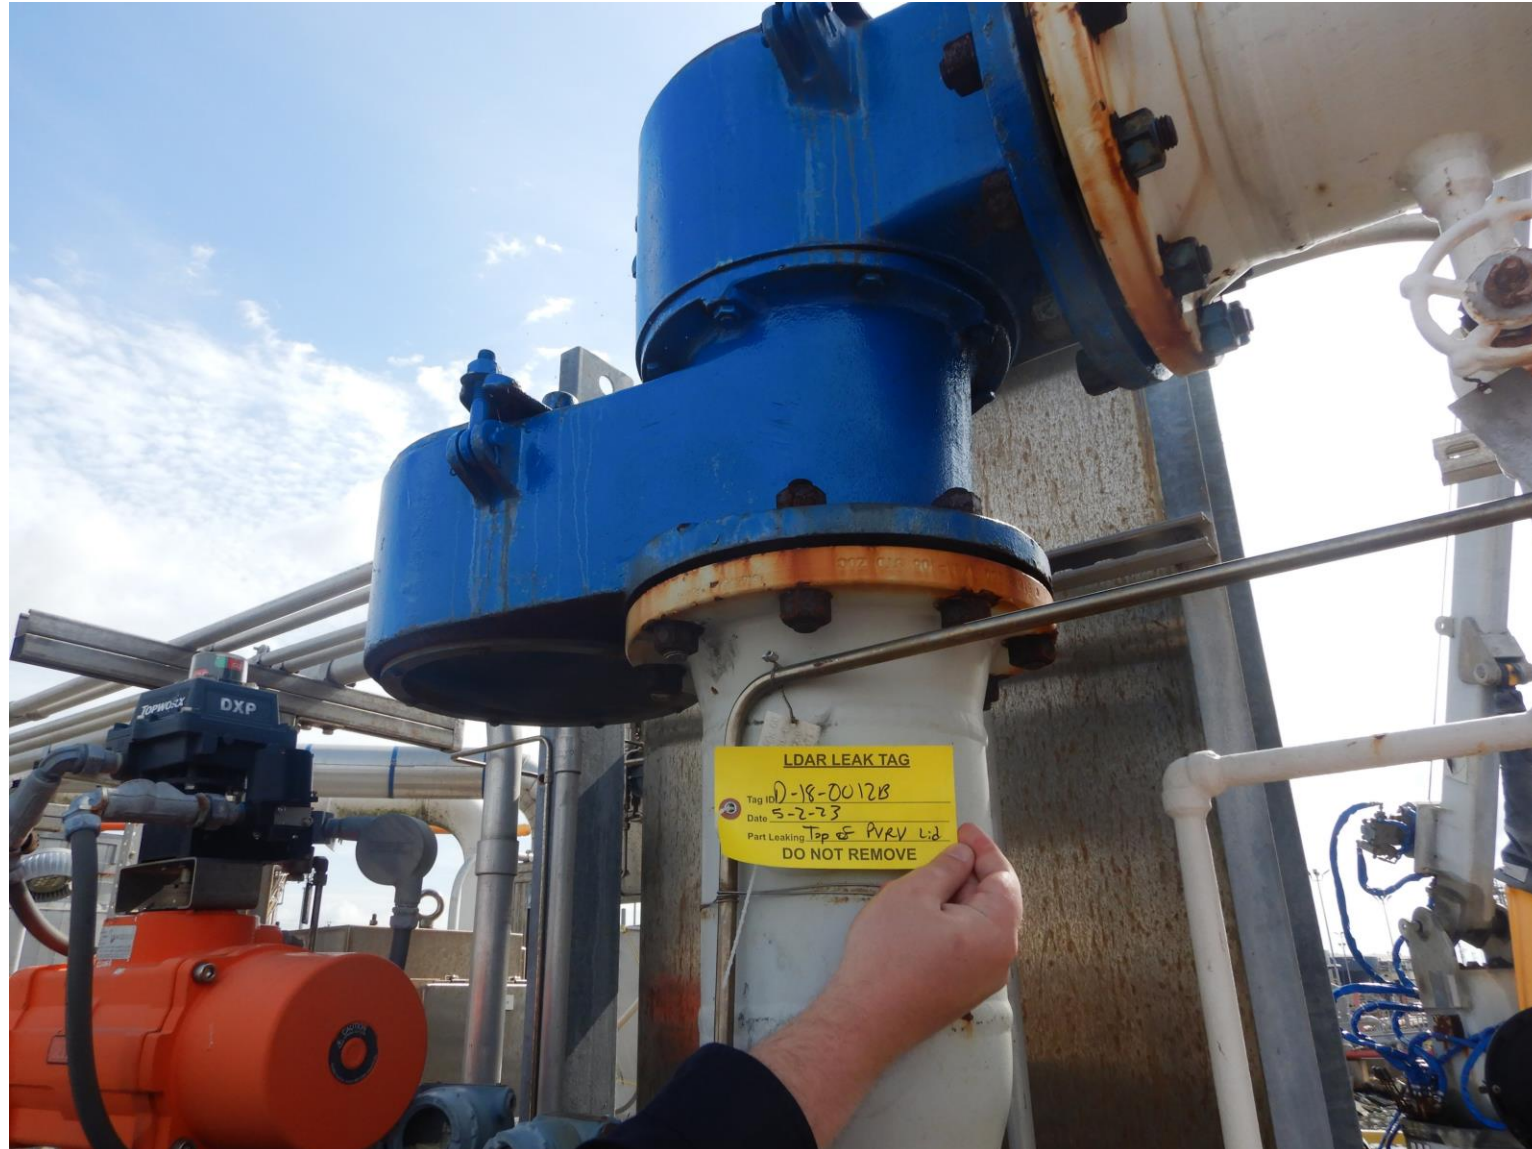
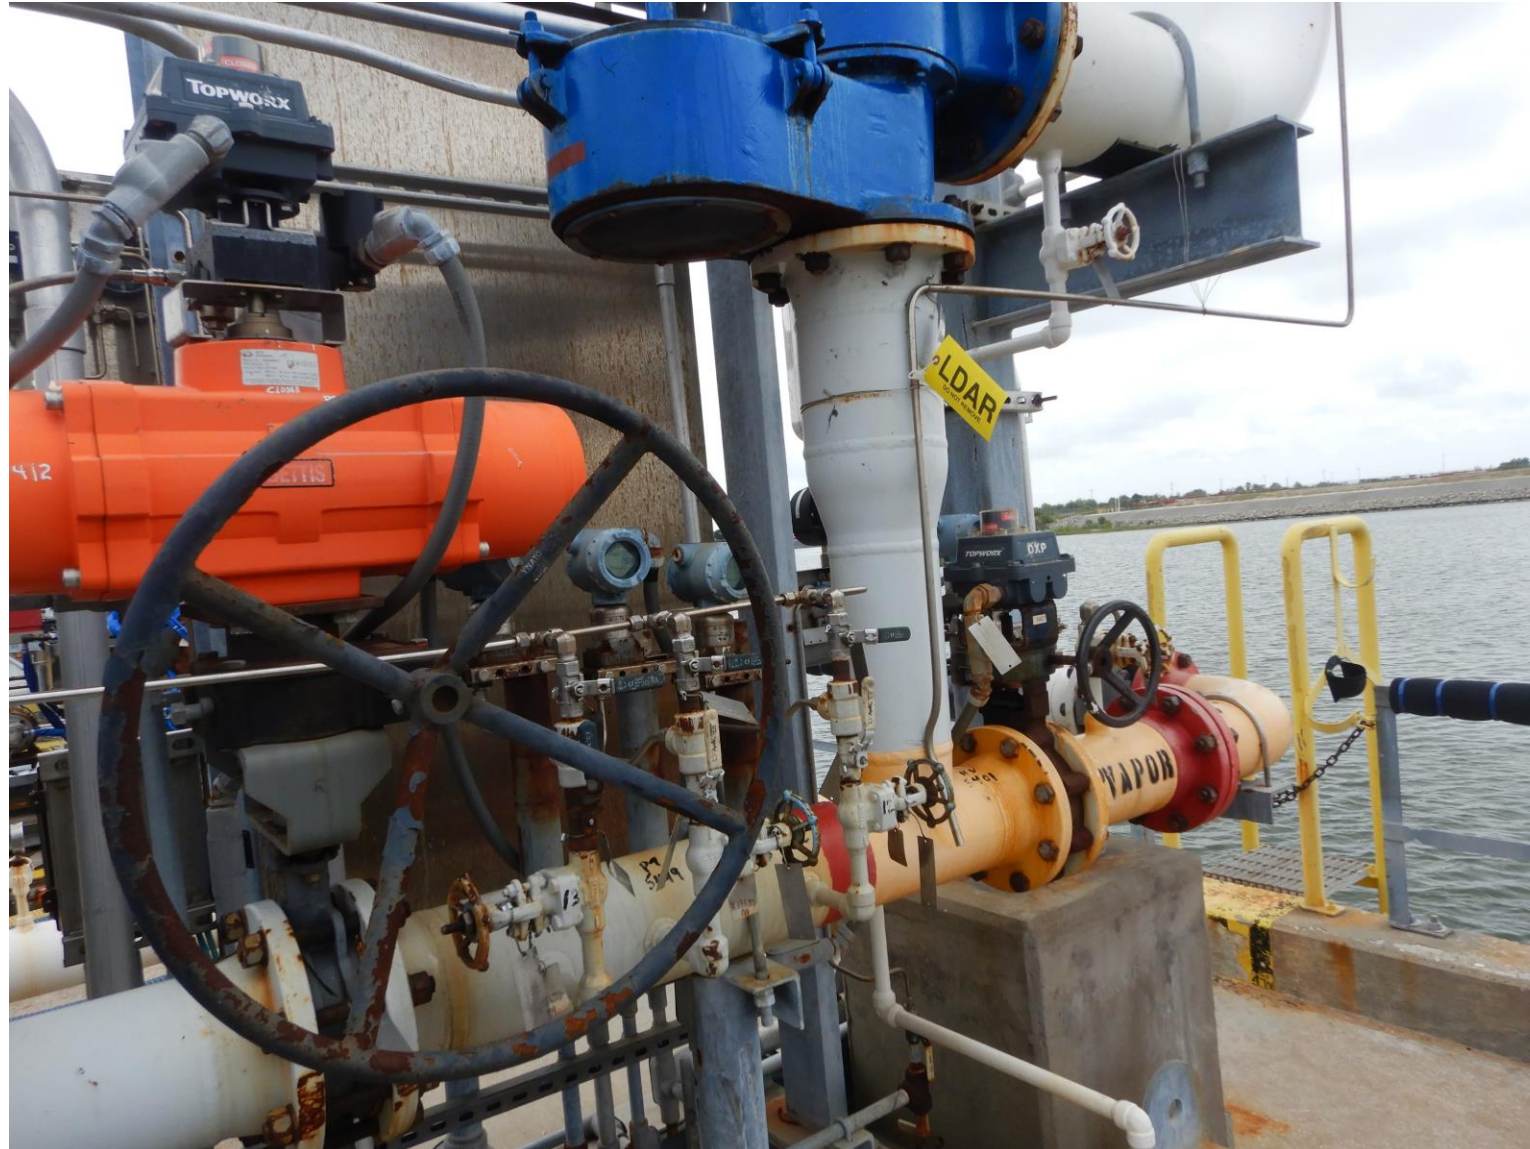
Donald Borsellino, a docks operator, told me that when barges arrive at Dock 54E, they connect to a vapor line and sometimes depressurize through the vapor line to the thermal oxidizer. If the vapor line pressure on the barge side is over 18-19" WC (0.68 psi), the dock operators use a manual valve to open the line instead of the automatic valve. They set the automatic valve to 30% open and slowly open the manual valve, which takes from 15 minutes to an hour. When the barge-side pressure gauge gets below 18-19" WC, they switch to "automatic mode" where the automatic valve controls pressure. I observed the pressure relief valve ("PRV") for Dock 54E and its LDAR tag. (Photos 1158 and 1166)

Mr. Borsellino said that they manually open the vapor line to prevent the PRV from popping from high pressures, though he added that the automatic valve is set to activate before the PRV pops. He said that they log the times when they start depressurizing the barge, and they record the pressure readings on the barge side and vapor line side during depressurizing. He said a high-pressure reading would trigger the automatic valve to shut down which would result in venting to the PRV, and the event would be recorded in the facility electronic logs.

Photo 1158: LDAR Tag D-18-0012B on the Dock 54 PRV  
5/2/23 9:47 DSCN1158.jpg

Photo 1166: Manual valve and PVRV for Dock 54 vapor line  
5/4/23 12:15 DSCN1166.jpg

The eGC EPA-2 detected benzene readings well above the action level before and after the loading of a barge with benzene at Dock 54E on May 1 to May 2, 2023. The highest concentration detected was 163 ppb at 1:36 AM on May 1, 2023, which was after the barge had arrived at Dock 54 but before transfer started. These detections indicate that emissions from barges docked at Dock 54 are contributing to high readings at Shelter #35. We recommend a review of procedures for barges sitting in Dock 54, both before and after attaching the vapor lines. We also recommend a review of the procedure for manually opening the vapor line and more record-keeping and safeguards to ensure the PRV does not open and release benzene emissions.

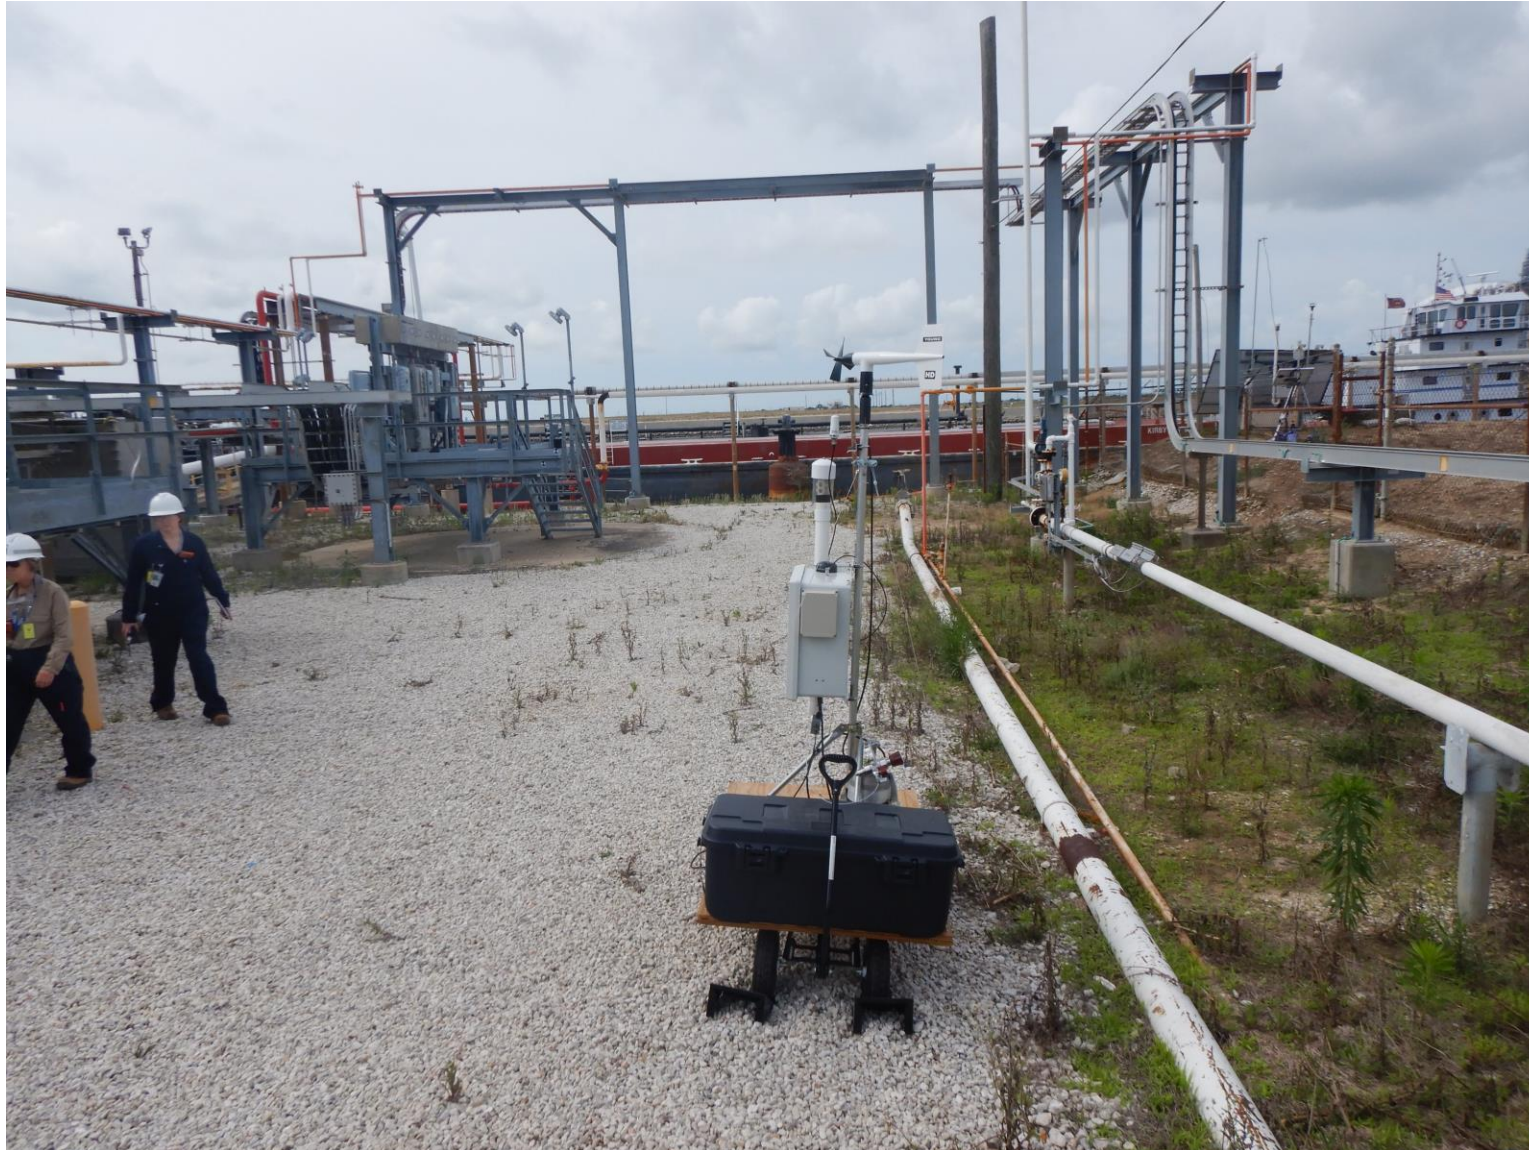
At approximately 15:45 on May 1, 2023, we set up eGC EPA-2 north of Dock 54, west of the thermal oxidizer for Dock 54 and near Shelter #35. (Photos 1157 and 1159) Refer to Site Code EPA 2A in the eGC report. EPA-2 remained in this location until the end of the inspection on May 4, 2023.

Photo 1157:EPA 2A Location near Dock 54 thermal oxidizer facing N  
5/2/23 9:33 DSCN1157.jpg

Photo 1159: EPA 2A Location near Dock 54 facing S - 5/2/23 10:10 DSCN1159

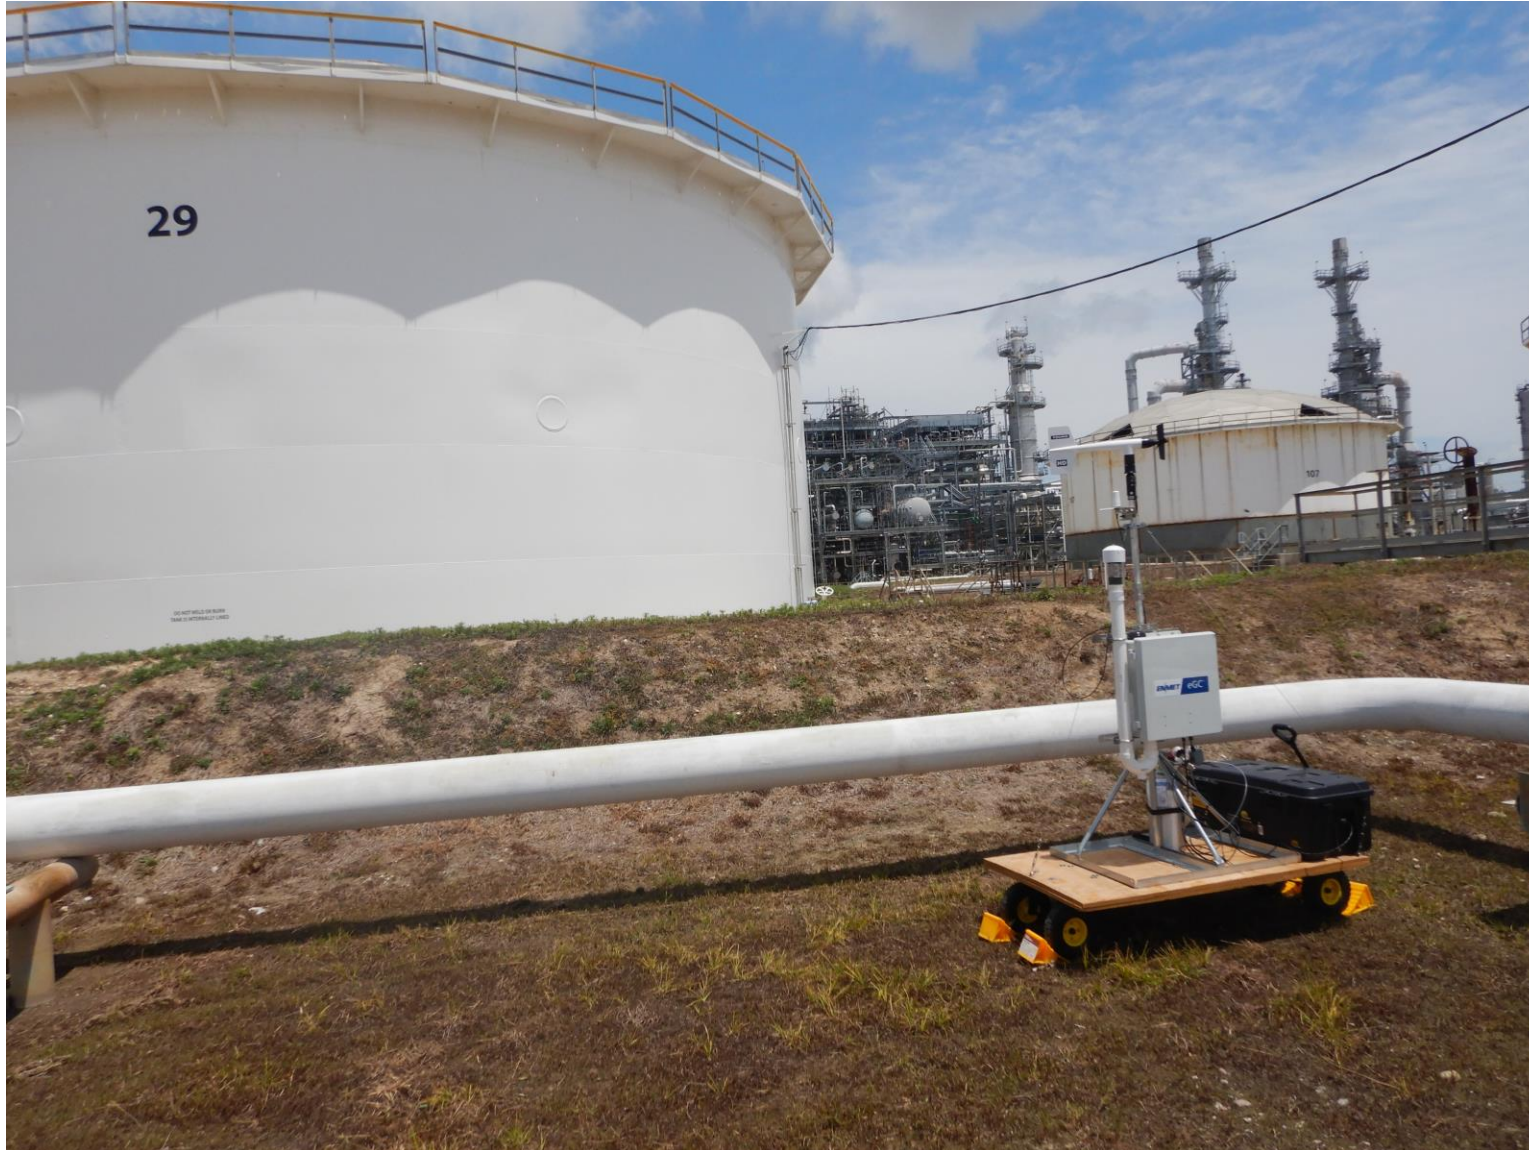
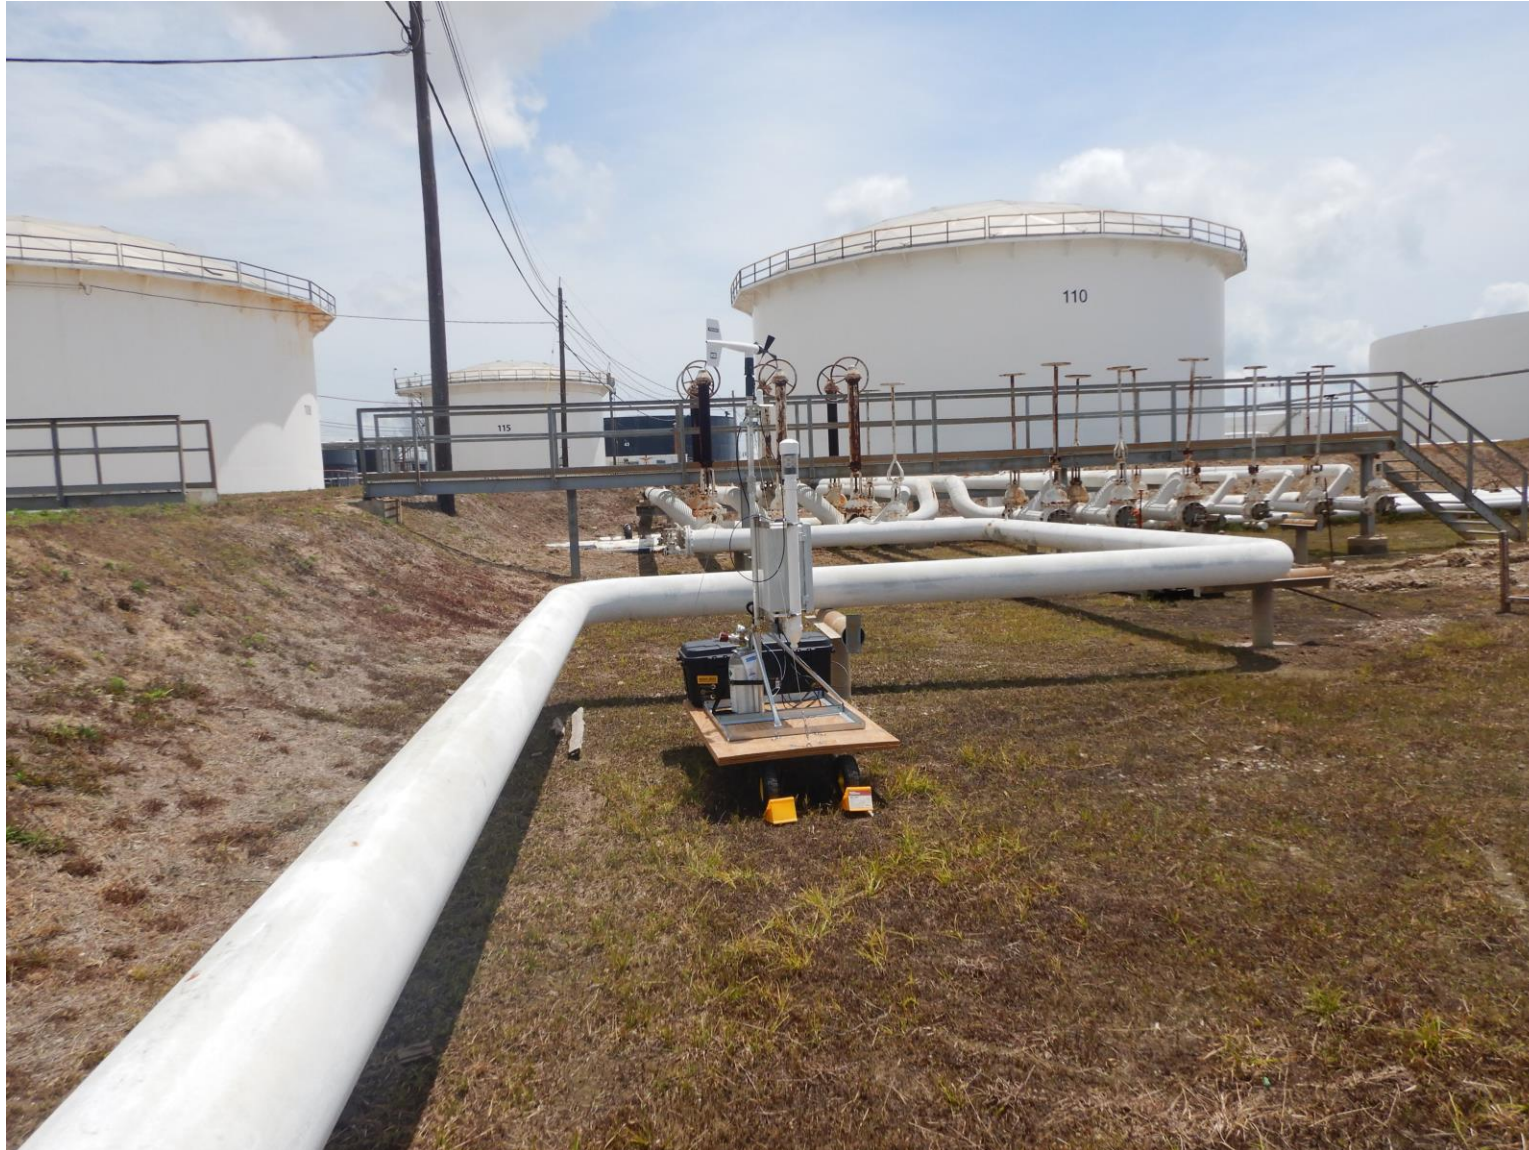
At 12:30 on May 2, 2023, we went to the ARU. We set up eGC EPA-1 at Laydown Yard 9 in the NE corner. This location was south of Tank 29, west of Tanks 110, 114, 115, 116 and the benzene cargo pumps F-231 and F-232, and north of tank 90. (Photos 1161 and 1162. See Site EPA 1B in the eGC report.) The eGC remained in this location until the end of the inspection on May 4, 2023.

Photo 1161: EPA 1B location near Tank 29, facing N  
5/2/23 12:37 DSCN1161.jpg

Photo 1162: EPA 1B Location facing E - 5/2/23 12:37 DSCN1162.jpg

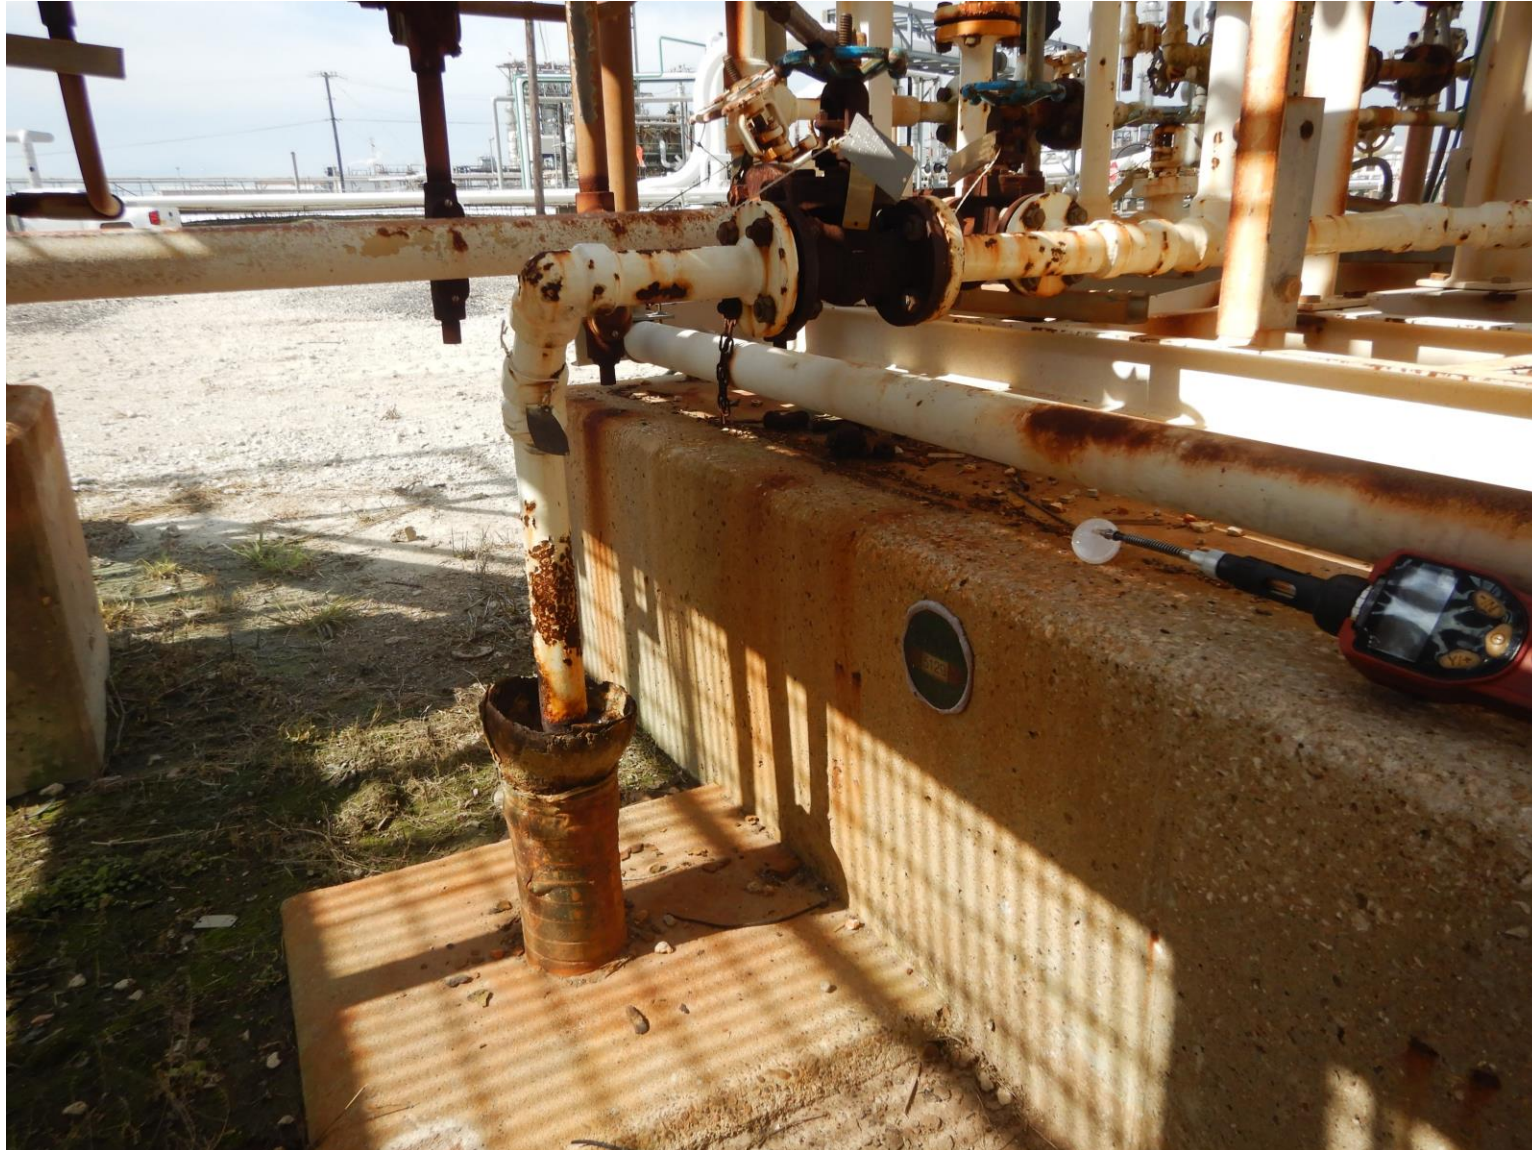
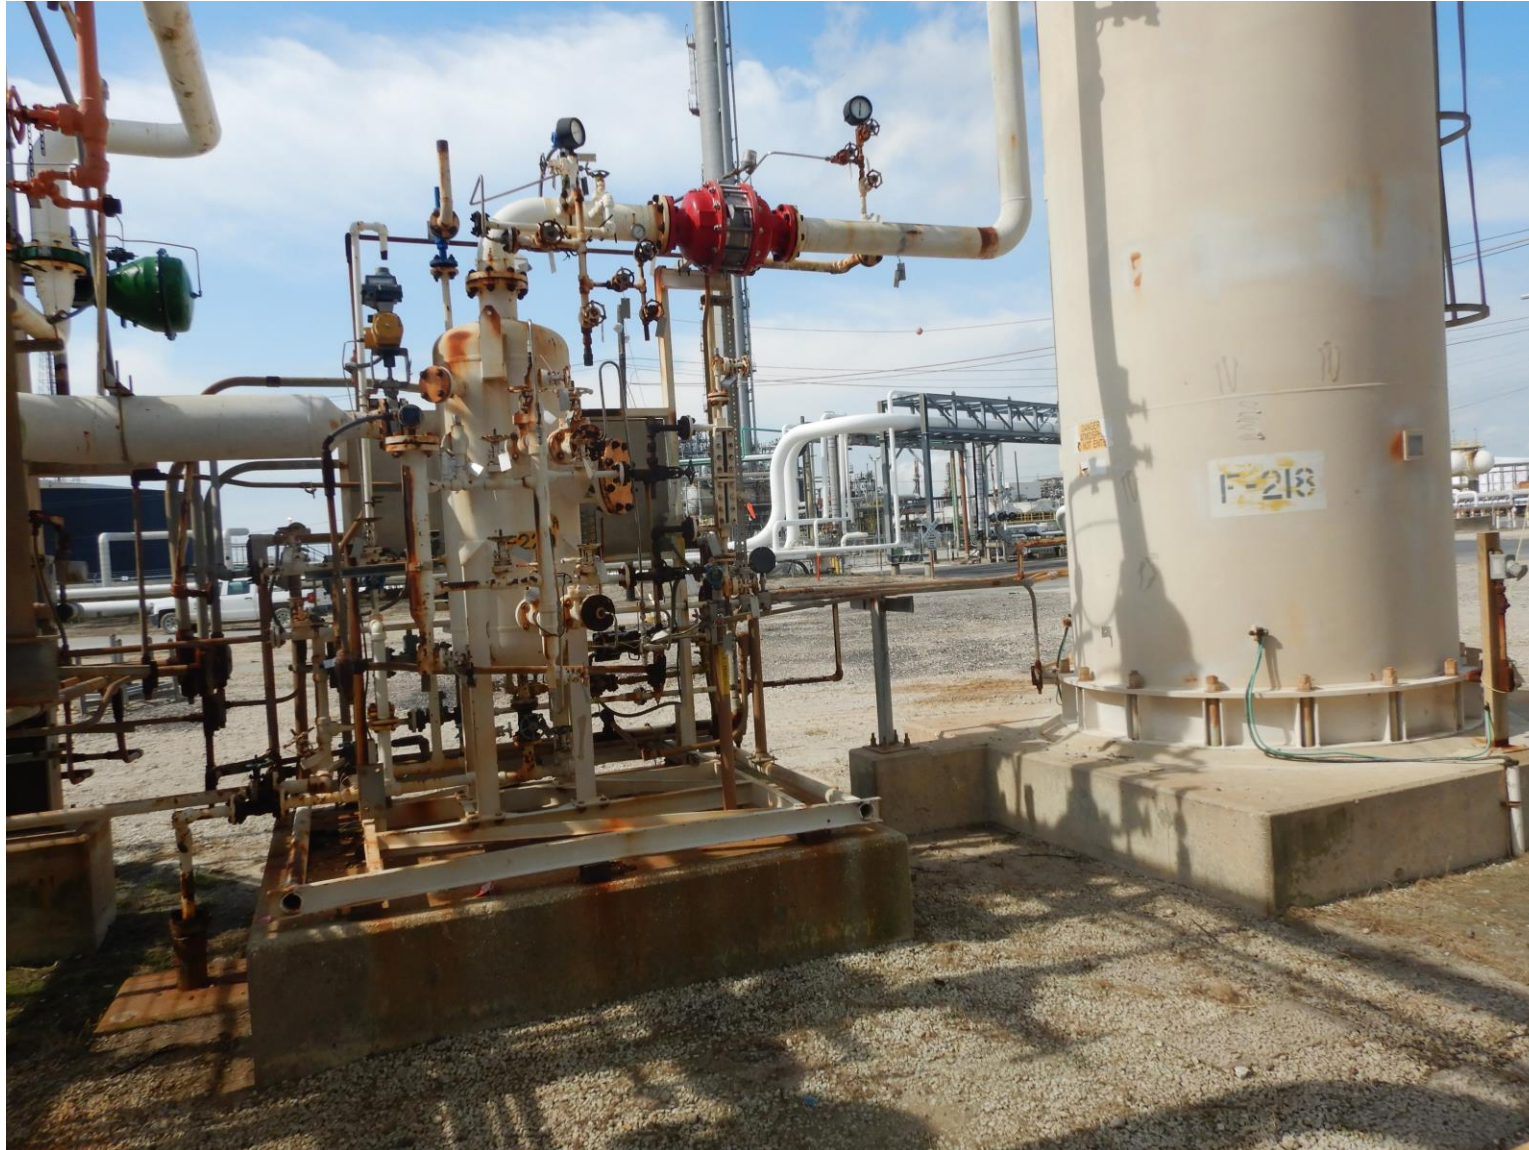
The WWTP has a seal pot F-220 on the stream leading to the thermal oxidizer. The F-220 seal pot has a drain underneath. I measured emissions from the drain with the UltraRae handheld benzene monitor and detected up to 30 ppm benzene. We also detected 127 ppm VOCs with a handheld Neo PID monitor. The facility detected up to 40 ppm benzene with their monitor. The drain had tag #5129 and

was covered under the facility's BWON program. I took photos 1163 and 1164 of the WWTP thermal oxidizer seal pot. **[AOC 3]**

We identified elevated benzene emissions from the F-220 seal pot drain. The TCEQ inspection in March 2022 had identified the seal pot drain as a source of VOCs. This benzene plume may have intermittently been affecting the benzene concentrations at the fenceline. The repairs made to the weirs inside the seal pot appear to have been insufficient, and the leak from the seal pot drain seems to be a reoccurring problem. We recommended finding a permanent solution for the seal pot drain emissions and including the corrective action in the facility’s corrective action plan submittals.

Photo 1163: WWTP F-220 seal pot drain  
5/3/23 10:01 DSCN1163.jpg

Photo 1164: WWTP thermal oxidizer and F-220 seal pot (zoomed out)  
5/3/23 10:07 DSCN1164.jpg

Mr. Murphy said that the facility was considering replacing the seal pot F-220 with two flame arrestors. Mr. Darcey said that under the BWON program requirements, they do a quarterly visual inspection of the seal pot drain to verify the presence of a water seal.

Mr. Darcey told me that the project to replace the seal pot on the WWTP had not been fully implemented as of May 9, 2024. He said that the project turned out to be more complex than originally contemplated following a hazard analysis. He provided records showing that the seal pot drain (tag 5129) had passed the quarterly visual inspections during the past year and showed minimal VOC concentration from a method 21 screening on April 18, 2024.

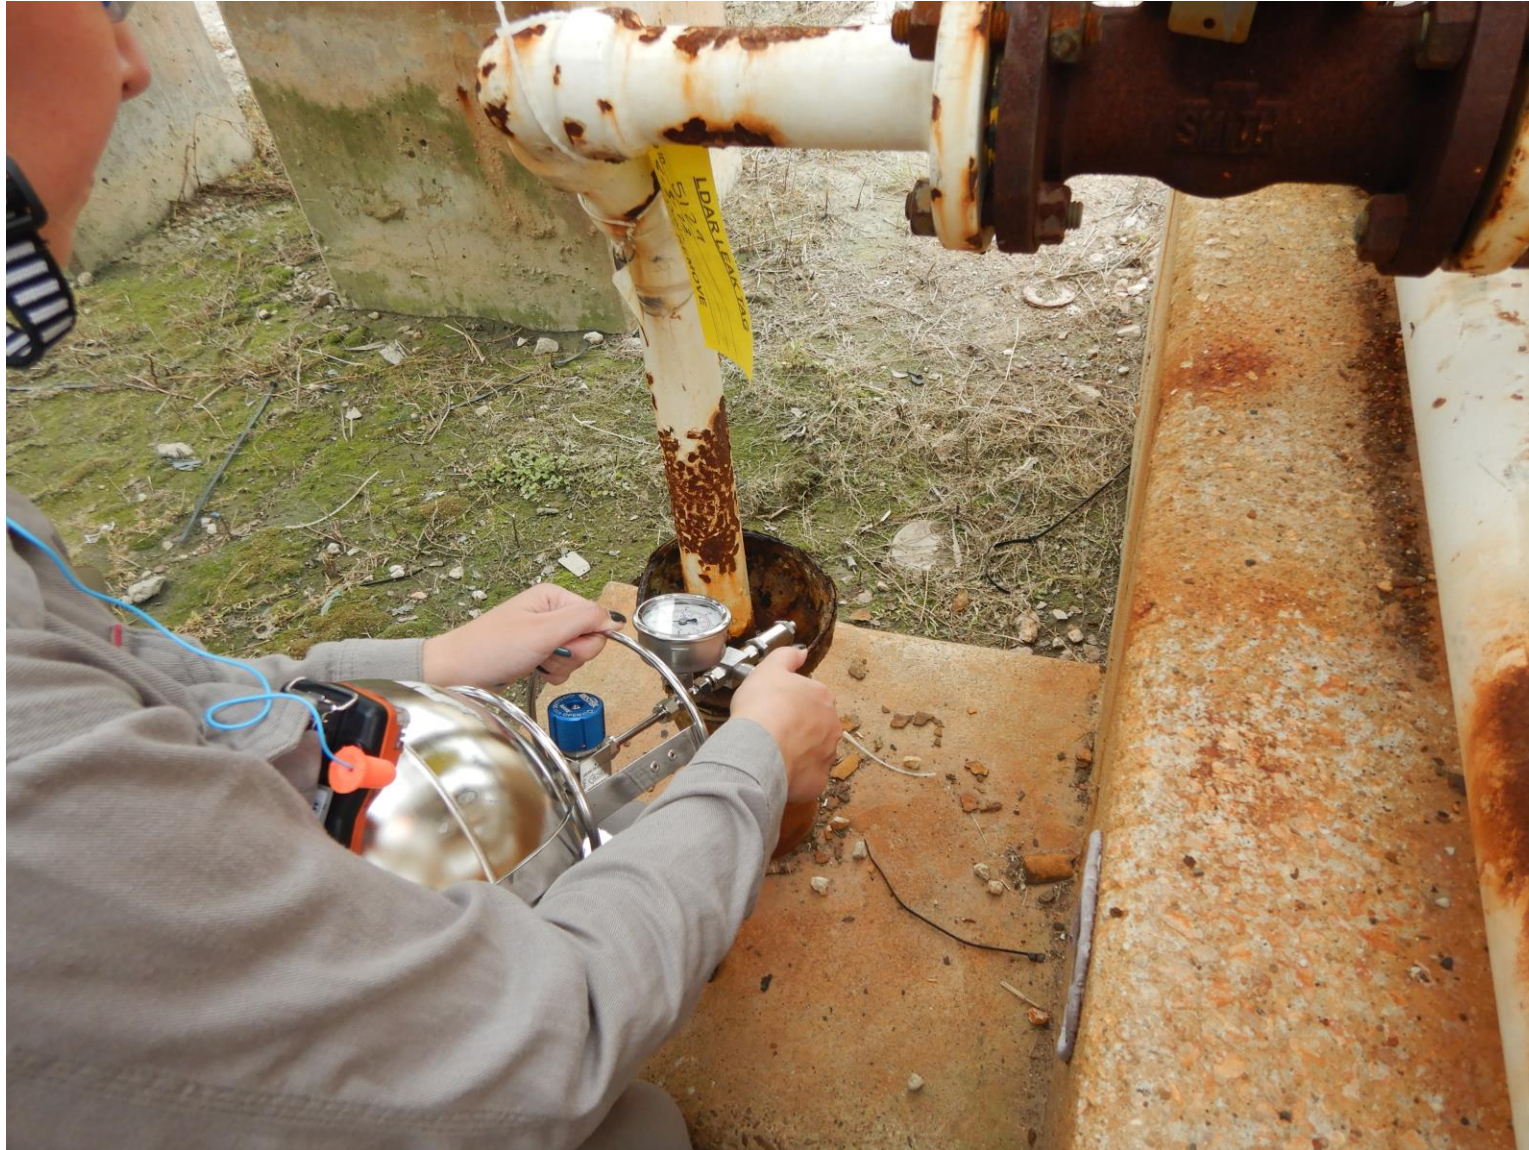
Photo 1165: Summa cannister collection of F-220 seal pot drain - 5/4/23 10:01 DSCN1165.jpg

The next day on May 4, 2023, we returned to the seal pot F-220 drain. The seal pot drain now had an LDAR leak tag, with tag ID 5129 and date 5/3/23. We took a summa cannister #N4104 of the environmental facility (WWTP) thermal oxidizer seal pot drain from 10:02:00 to 10:02:18. The sample was an 18 second grab sample taken at the surface of the seal pot drain, and corresponding readings of 25 ppm benzene and 300 ppm VOCs were observed with handheld monitors at the time of sampling. The summa cannister results showed 10.5 ppm benzene. See Appendix 7 for the full TO-15 results, with Lab Number 305923-01 corresponding to summa cannister #N4104.
