## **RCRA Inspection Report**

AkzoNobel Specialty Plastics EPA ID# SCD000608331  
1872 Highway 9 Bypass West  
Lancaster, South Carolina 29720

January 13, 2022

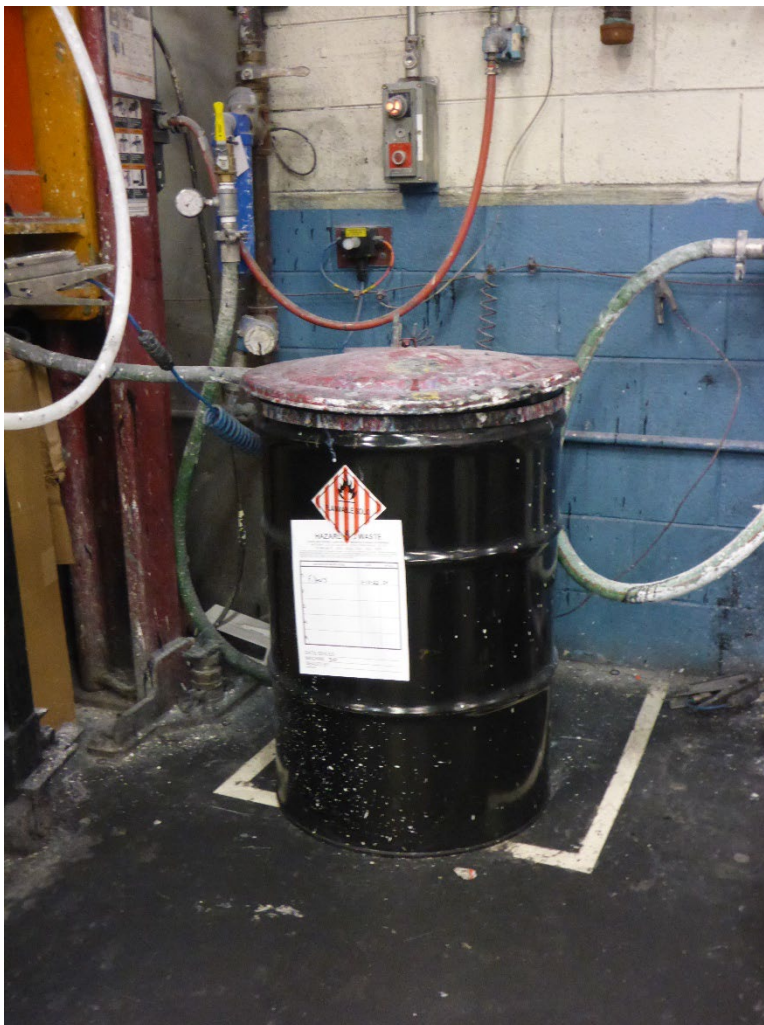
The inspectors observed three SAAs for accumulating Stream G hazardous waste solids in the Mix Room: one near the CMX-200 Tank Washer (Photo 1), one in the far corner of the room (Photo 2), and one in the middle of the room (Photo 3). One 55-gallon drum with a flip-top lid was observed in each SAA. The lid on the container near the middle of the room was damaged and left a partial gap between the lid and the top of the drum. The container in the CMX-200 Tank Washer SAA was labeled for accumulating hazardous waste solid filters; the container in the corner SAA was labeled for accumulating hazardous waste solid chips; and the container in the middle SAA was labeled for accumulating hazardous waste solids. All of the containers were marked with a flammable solid DOT hazard placard, but none were marked with an indication that the contents are toxic.

**Photo 1:** One of three SAAs in the Mix Room for accumulating Stream G hazardous waste solids. This SAA is located next to the CMX-200 Tank Washer. The 55-gallon drum in this SAA is labeled hazardous waste solid filters and it is marked with a flammable solids DOT hazard placard. It is not marked to indicate the contents are toxic.

On 01/28/2022, Mr. LaBarge sent a letter to SCDHEC and the EPA in which he stated that all damaged lids have been discarded and replaced with a new lid and provided a photograph documenting an example of the new lids.

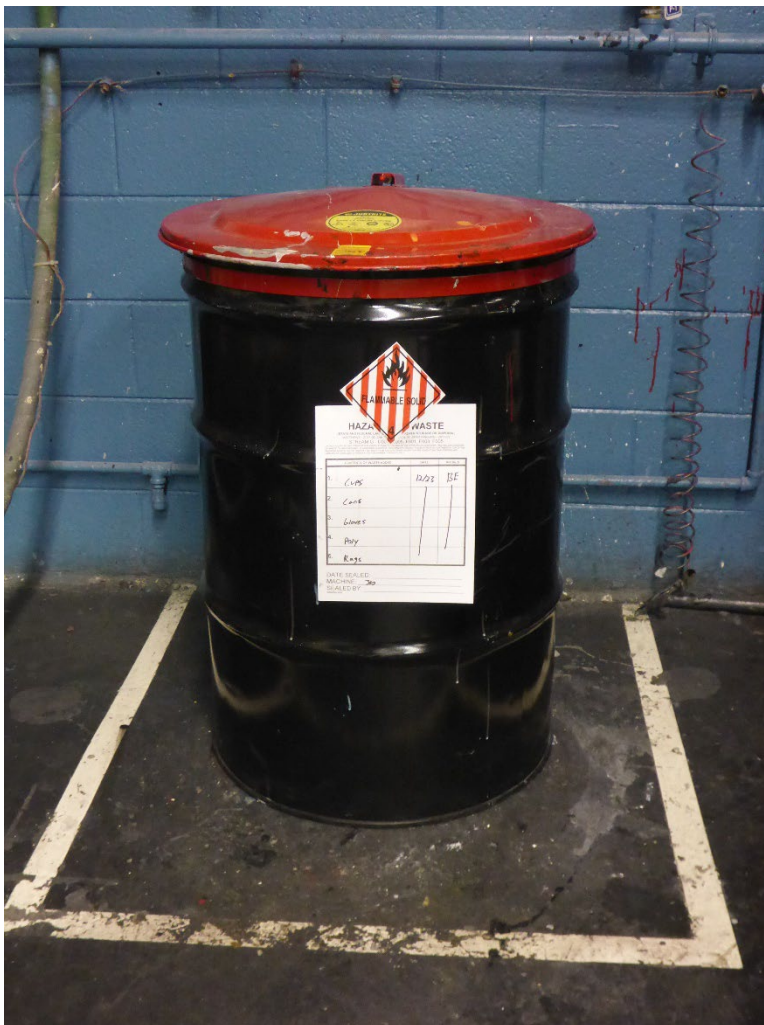
**Photo 2:** One of three SAAs in the Mix Room for accumulating Stream G hazardous waste solids. This SAA is located in the far corner of the room. The 55-gallon drum in this SAA is labeled hazardous waste solid chips and it is marked with a flammable solids DOT hazard placard. It is not marked to indicate the contents are toxic.

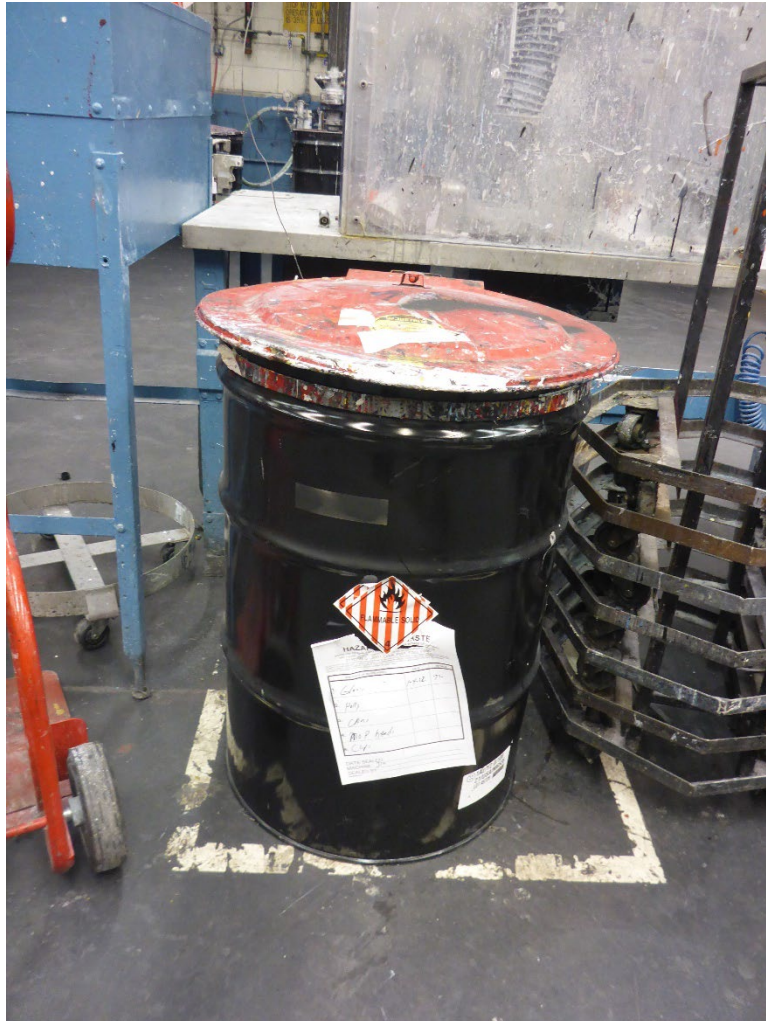
**Pursuant to 25 S.C. Code Ann. Regs. 61-79.262.15(a)(4) [40 C.F.R. § 262.15(a)(4)], which is a condition of the SAA Permit Exemption, a generator is required to keep containers of hazardous waste closed at all times during accumulation, except when adding, removing, or consolidating waste; or when temporary venting of a container is necessary for the proper operation of equipment, or to prevent dangerous situations, such as build-up of extreme pressure.**

**Photo 3:** One of three SAAs in the Mix Room for accumulating Stream G hazardous waste solids. This SAA is located in the middle of the room. The 55-gallon drum in this SAA is labeled hazardous waste solids and it is marked with a flammable solids DOT hazard placard. It is not marked to indicate the contents are toxic. The container lid does not make complete contact with the top of the container.

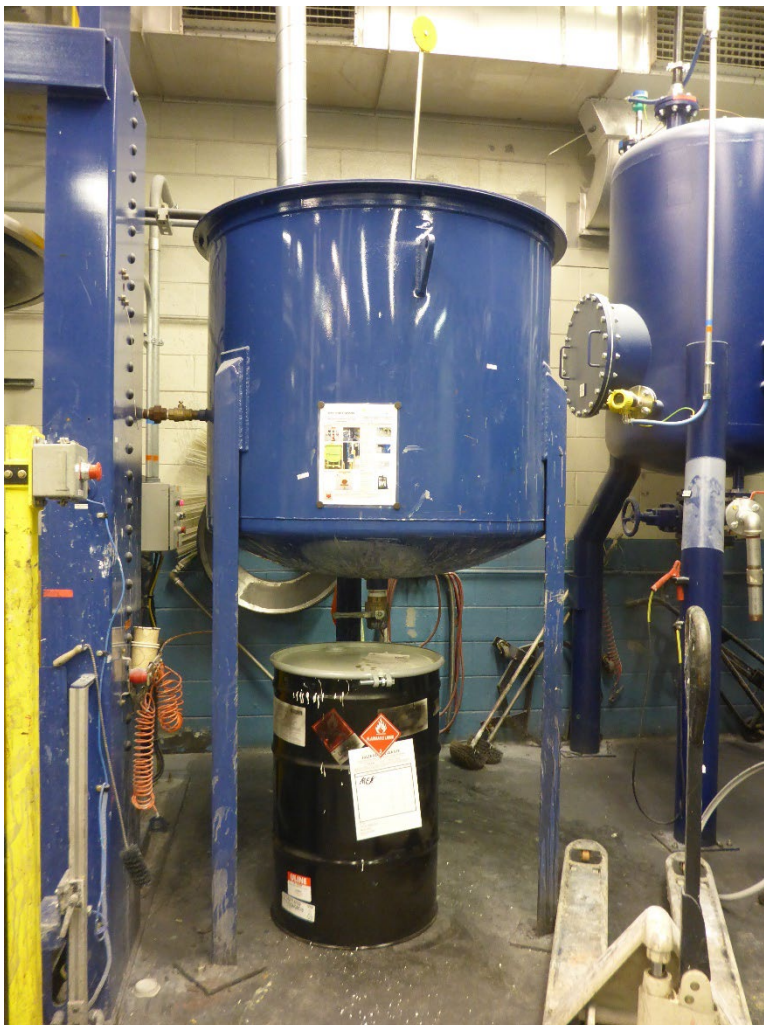
The facility manages another SAA for accumulating Stream A hazardous waste MEK near the CMS-2000 Tank Washer in the Mix Room (Photo 4). Facility personnel explained that MEK is used in the CMX-200 Tank Washer to clean green vats for reuse on-site. All spent solvents leaving the CMX-200 Tank Washer are accumulated in the associated rinse tank, where they are stored and then recirculated through the system for use during the initial vat wash cycle(s). The vat's final rinse is done using virgin MEK solvent. When the rinse tank fills, spent solvents are

drained from the tank into a 55-gallon drum in this SAA. The inspectors observed one 55-gallon drum in this SAA. The drum was closed and labeled hazardous waste Stream A MEK. It was also marked with a flammable liquid DOT hazard placard, but it was not marked with an indication that the contents are toxic.

**Pursuant to 25 S.C. Code Ann. Regs. 61-79.262.15(a)(5)(ii) [40 C.F.R. § 262.15(a)(5)(ii)], which is a condition of the SAA Permit Exemption, a generator is required to mark or label its containers with an indication of the hazards of the contents.**

**Photo 4:** An elevated blue rinse tank used with the CMX-200 Tank Washer and one 55-gallon drum in the CMX-200 Tank Washer SAA in the Mix Room. The drum was closed and labeled hazardous waste Stream A MEK, and it was marked with flammable liquid DOT hazard placard. It is not marked to indicate the contents are toxic.

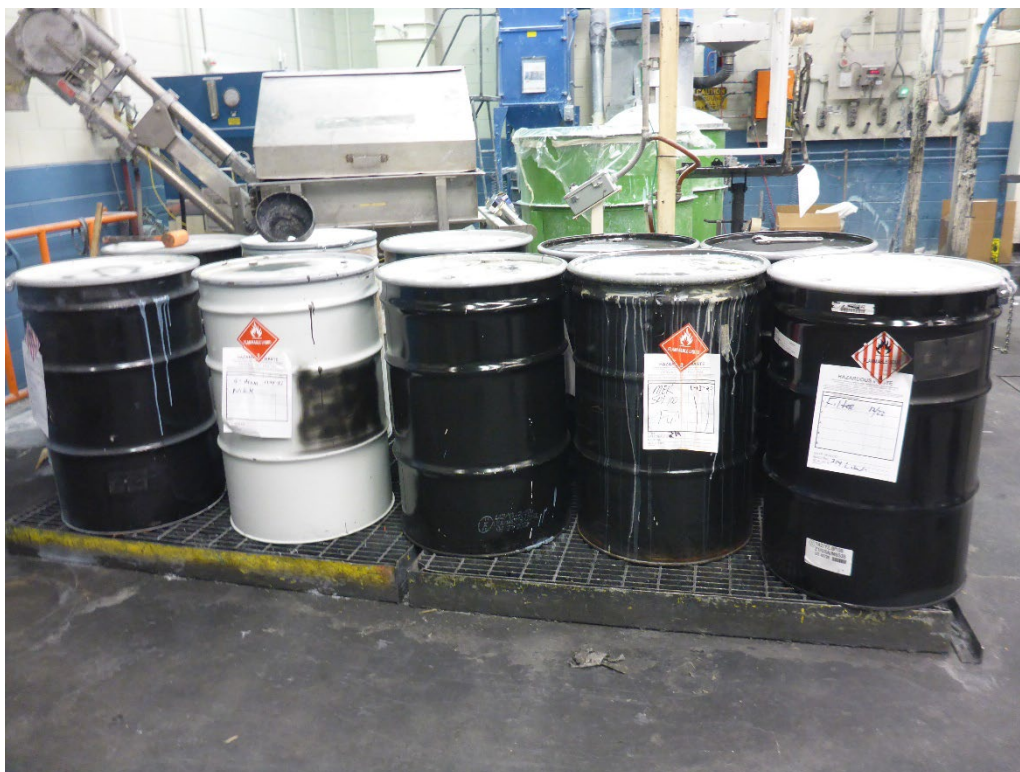
In addition to the containers observed in the SAAs noted above, the inspectors also observed approximately ten 55-gallon drums of hazardous waste on portable secondary containment pallets lined up near the Distillation Unit (Photos 5 and 6) and six 55-gallon drums of hazardous waste on portable secondary containment pallets near the middle of the room (Photos 7, 8, and 9).

**Photo 5:** Ten 55-gallon drums of hazardous waste observed on portable secondary containment pallets in the Mix Room near the Distillation Unit. None of the containers were marked to indicate the contents are toxic.

On 01/28/2022, Mr. LaBarge sent a letter to SCDHEC and the EPA in which he stated that the facility has reclassified the Mix Room as a hazardous waste CAA.

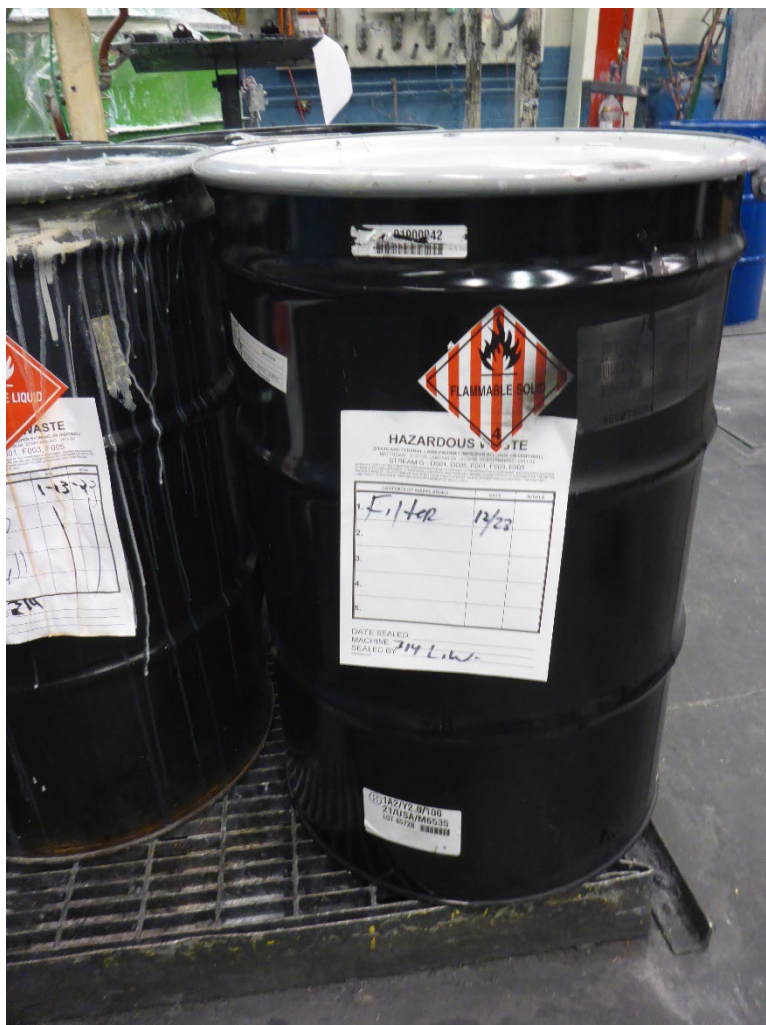
**Photo 6:** Closer view of two of the ten 55-gallon drums of hazardous waste observed on portable secondary containment pallets in the Mix Room near the Distillation Unit shown in Photo 5. It is not marked to indicate the contents are toxic.

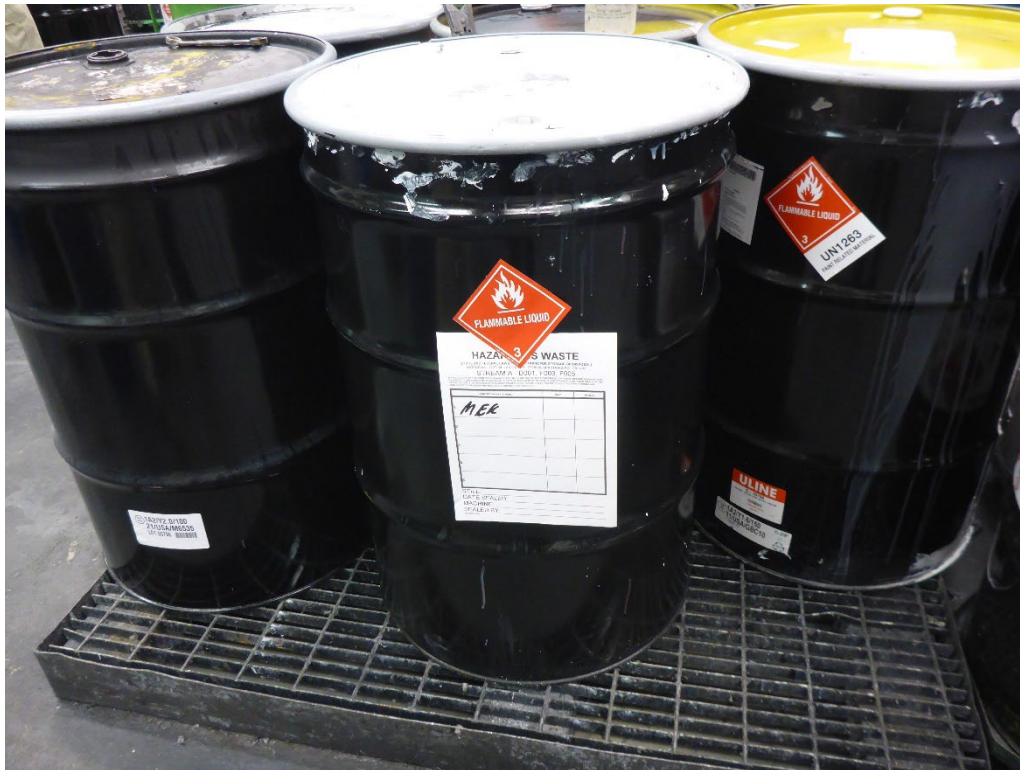
Facility personnel stated that six additional 55-gallon drums, located on another set of portable secondary containment pallets, contained hazardous waste. One of these drums was labeled hazardous waste and marked with a flammable liquid DOT hazard placard (Photo 7). Another was not labeled as hazardous waste but was marked with a flammable liquid DOT hazard placard (Photo 7). Three of these drums were not labeled as hazardous waste or marked with an indication of the hazards of their contents (Photos 7 and 8). The final drum was not labeled as hazardous waste, but it was marked with an NFPA fire diamond (Photo 9). However, the ink had run on this label, causing the values marked on the NFPA fire diamond to be illegible. None of these containers were marked with an indication that the contents are toxic.

**Photo 7:** Three of six 55-gallon drums of hazardous waste observed on portable secondary containment pallets in the Mix Room near the center of the room. The drum on the left was not labeled as hazardous waste or marked with an indication of the hazards of its contents. The drum in the center was labeled as hazardous waste and marked with a flammable liquid DOT hazard placard. The drum on the right was not labeled as hazardous waste, but it was marked with a flammable liquid DOT hazard placard. None of the hazardous waste containers were marked to indicate their contents are toxic.

On 01/28/2022, Mr. LaBarge sent a letter to SCDHEC and the EPA in which he stated that the Mix Room has been reclassified as a hazardous waste CAA, and that containers in the Mix Room have been labeled as hazardous waste and with an indication that the contents are flammable.

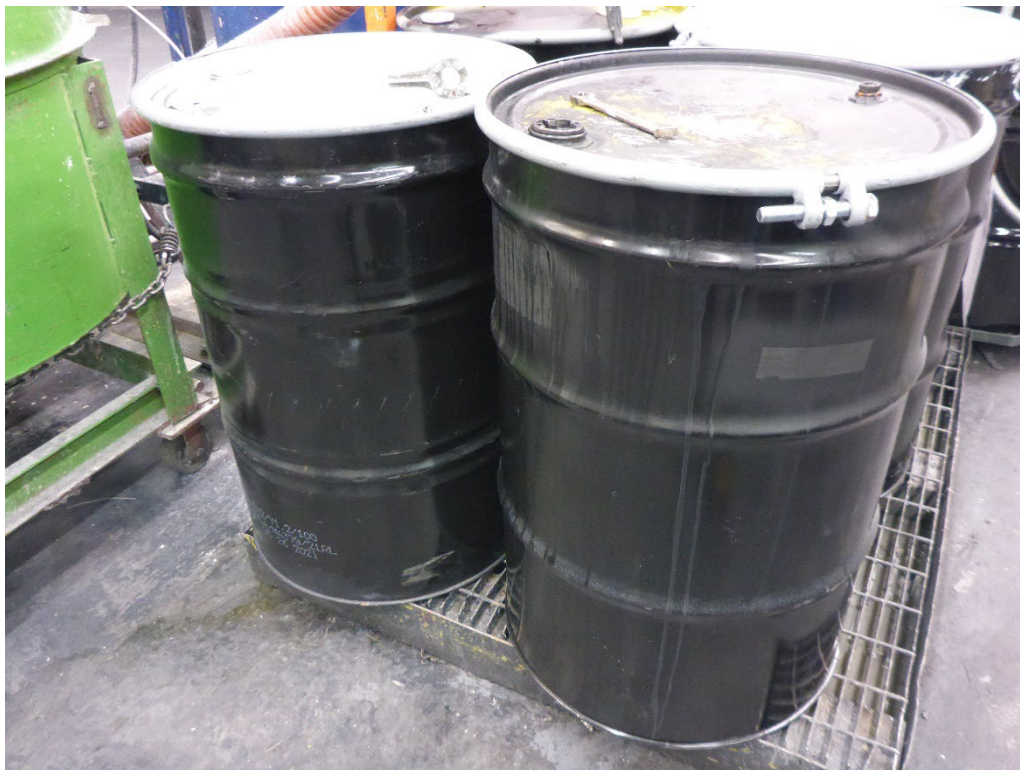
**Photo 8:** Two of six 55-gallon drums of hazardous waste observed on portable secondary containment pallets in the Mix Room near the center of the room. The drums were not labeled as hazardous waste, marked with an indication of the hazards of its contents, or marked with an accumulation start date.

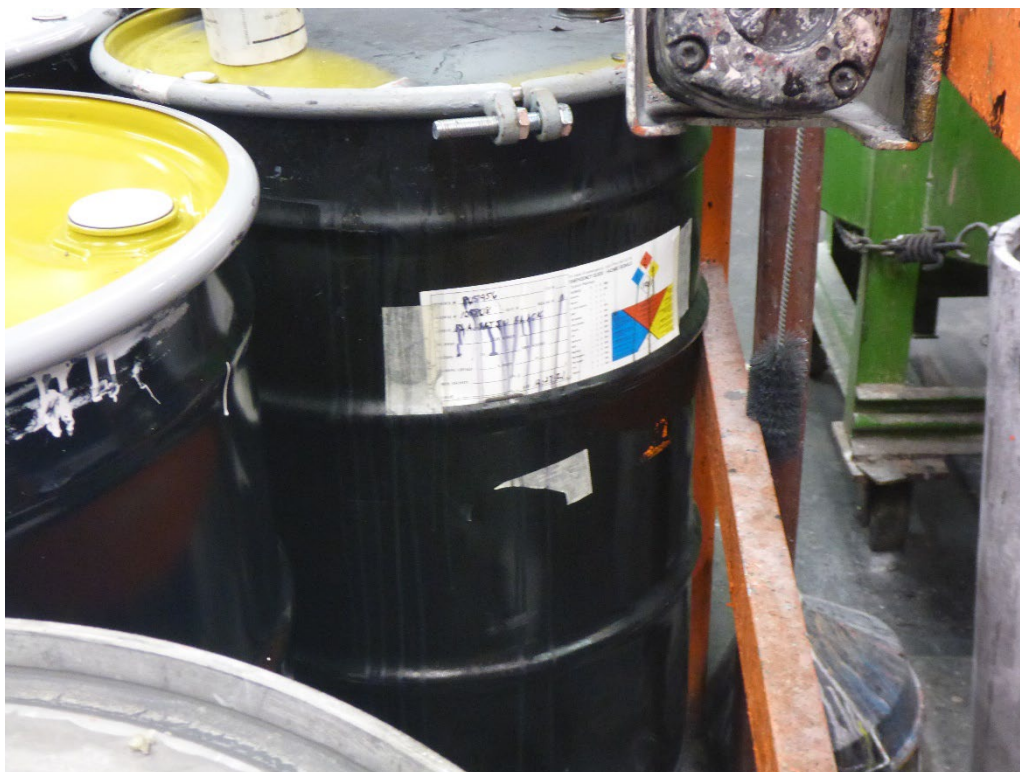
**Photo 9:** One of six 55-gallon drums of hazardous waste observed on portable secondary containment pallets in the Mix Room near the center of the room. The drum was not labeled as hazardous waste. The ink on the label had run, causing the values marked on the NFPA fire diamond to be illegible.

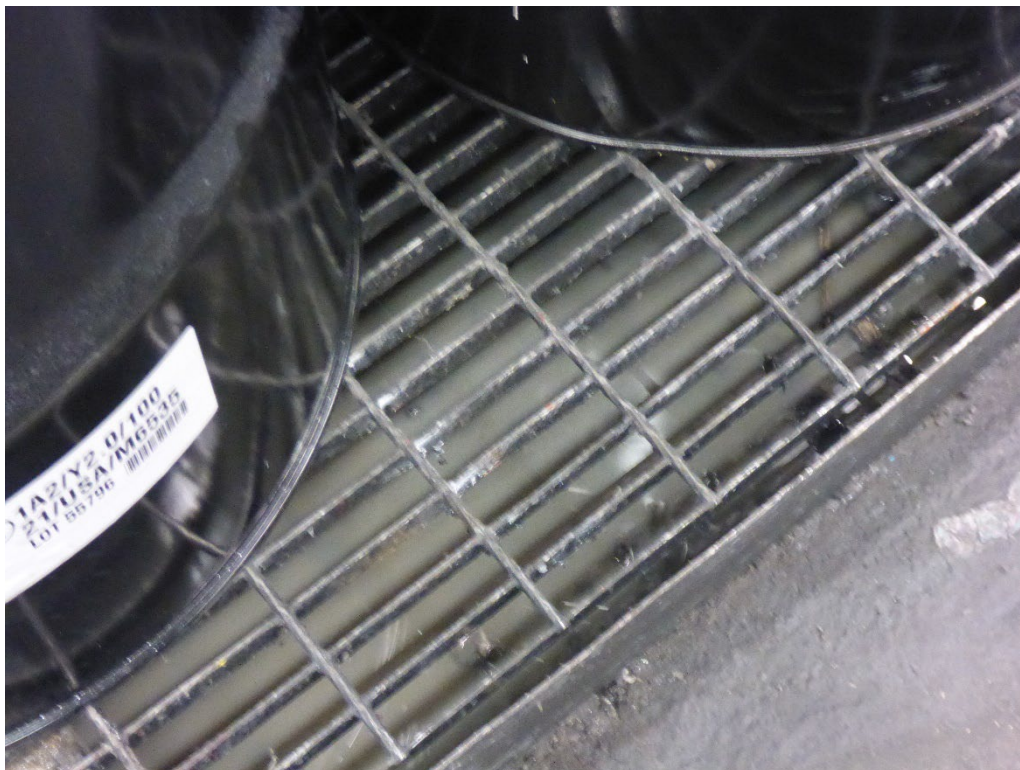
In addition, the inspectors observed hazardous waste liquid inside the portable secondary containment pallet (Photo 10). As a result, the secondary containment pallet appeared to be a container holding hazardous waste at the time of the inspection, and that container was neither closed nor labeled. Personnel stated that this material will be mopped up with rags when the drums are sent off-site for disposal.

**Photo 10:** Hazardous waste liquid observed in the portable secondary containment unit beneath six 55-gallon drums of hazardous waste in the middle of the Mix Room. This secondary containment pallet appeared to be a container holding hazardous waste at the time of the inspection, and that container was neither closed nor labeled.

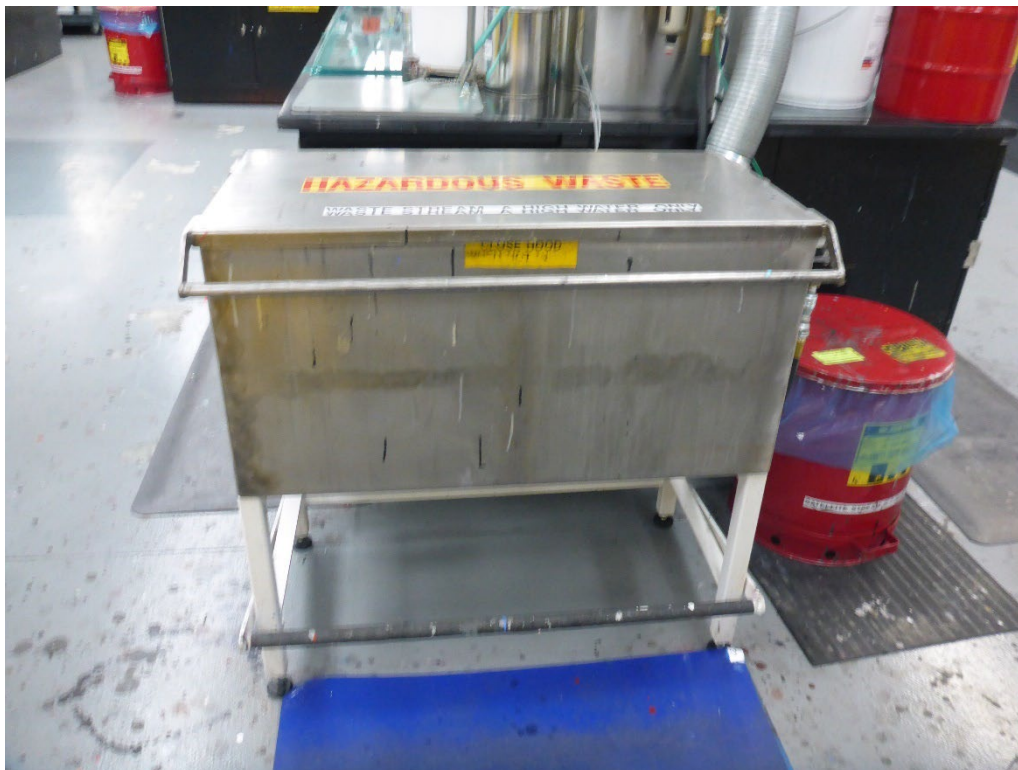
Liquid Laboratory SAAs: AkzoNobel manages one SAA in the Liquid Laboratory for accumulating hazardous waste Stream A High Water that is generated as excess sample material. The inspectors observed one basin container in this SAA (Photo 11). The container was located at the end of a laboratory bench, and it was equipped with a step-activated lid. Emissions from the solvent waste are captured by an air handling system that is connected to the basin lid. The basin was labeled “hazardous waste,” but it was not marked with an indication of the hazards of its contents.

When the lid of the basin was opened, the inspectors observed one 5-gallon bucket inside the basin. The bucket contained excess sampling material, which is managed as hazardous waste Stream A High Water. Personnel explained that a lid is crimped onto the bucket when it becomes full, so that the bucket may be carried to the Mix Room and its contents may be emptied into another 55-gallon drum in the Mix Room. This practice is referred to as “satellite-to-satellite transfer,” and was discussed in the Mix Room Section of this report.

**Photo 11:** SAA for accumulating hazardous waste Stream A High Water in Liquid Laboratory. The basin is labeled as hazardous waste, but it is not marked with an indication of the hazards of its contents. One 5-gallon bucket of hazardous waste was observed inside the basin, which is connected to the air handling system.

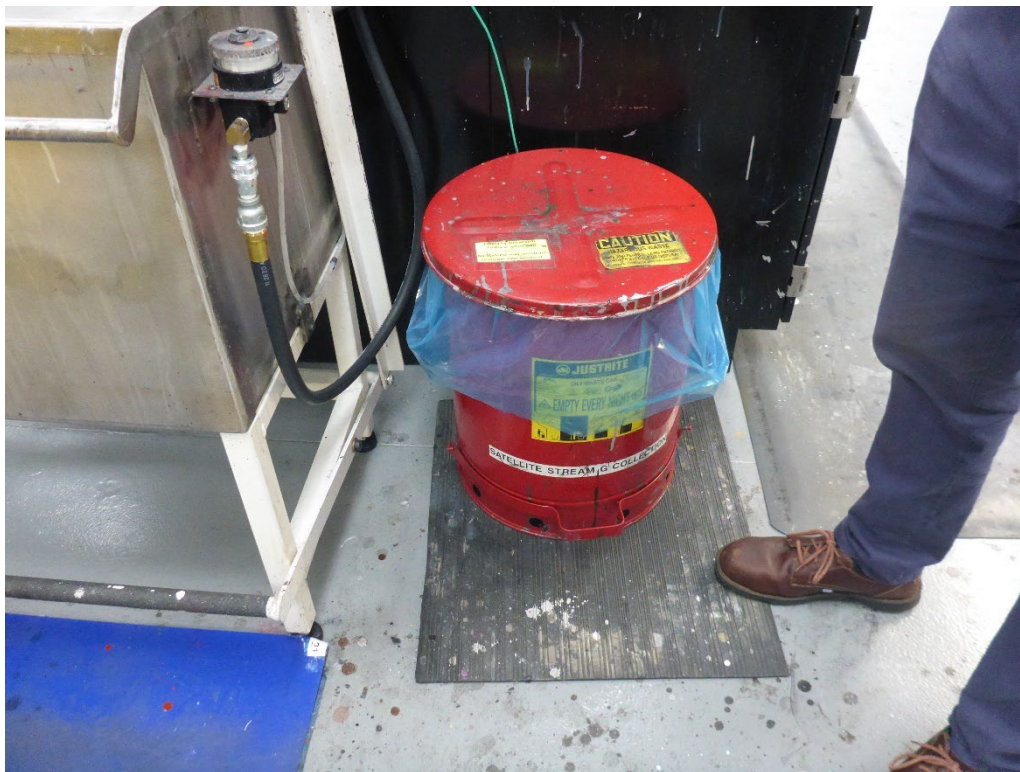
AkzoNobel manages a second SAA in the Liquid Laboratory for accumulating hazardous waste Stream G that is generated as used rags, wipes, cups, and solids contaminated with solvents. The inspectors observed six 14-gallon step-to-open flammable cans in this SAA (Photo 12). Each of these cans was labeled as “Stream G hazardous waste solids,” but none were marked with an indication of the hazardous of its contents. In addition, the original “oily rags” and “empty every night” labels, which did not apply to the containers, were still visible.

**Photo 12:** One of six 14-gallon step-to-open flammable cans in the Liquid Laboratory SAA for accumulating Stream G hazardous waste solids. The container is labeled “Stream G hazardous waste solids,” but it is not marked with an indication of the hazards of its contents. In addition, the original “oily rags” and “empty every night” labels are still visible on the container.

On 01/28/2022, Mr. LaBarge sent a letter to SCDHEC and EPA in which he stated that the facility has labeled each can of Stream G hazardous waste solids as hazardous waste

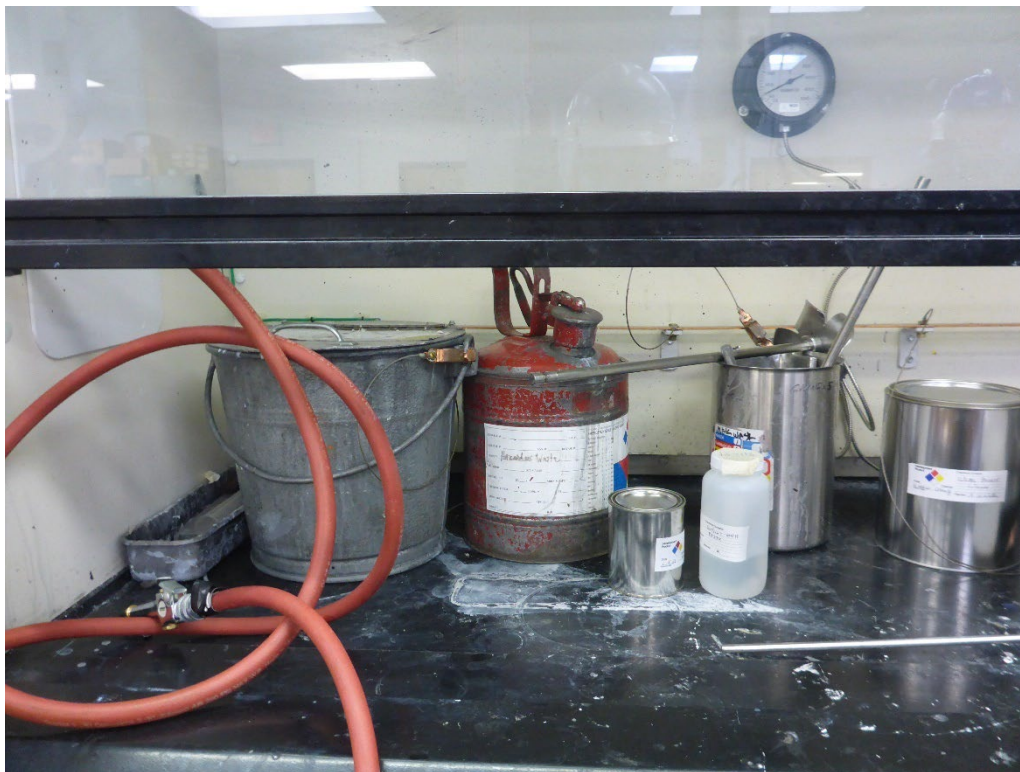
Film Laboratory SAAs: AkzoNobel manages one SAA in the Film Laboratory for accumulating Stream A hazardous waste liquids. The inspectors observed one 2-gallon container in this SAA (Photo 13). The container was located under a laboratory hood. It was labeled as hazardous waste and marked with a National Fire Protection Association (NFPA) fire diamond. However, the numbers marked on the fire diamond had smudged off and were no longer legible.

**Photo 13:** One of red 2-gallon container in the Film Laboratory SAA for accumulating Stream A hazardous waste liquids. The container is labeled hazardous waste, and it is marked with an NFPA fire diamond. However, the numbers marked on the fire diamond had smudged off and were no longer legible.

On 01/28/2022, Mr. LaBarge sent a letter to SCDHEC and the EPA in which he stated that the facility has labeled each can of Stream G hazardous waste solids as hazardous waste and flammable solids and has covered all oily waste labels so that they are no longer visible.

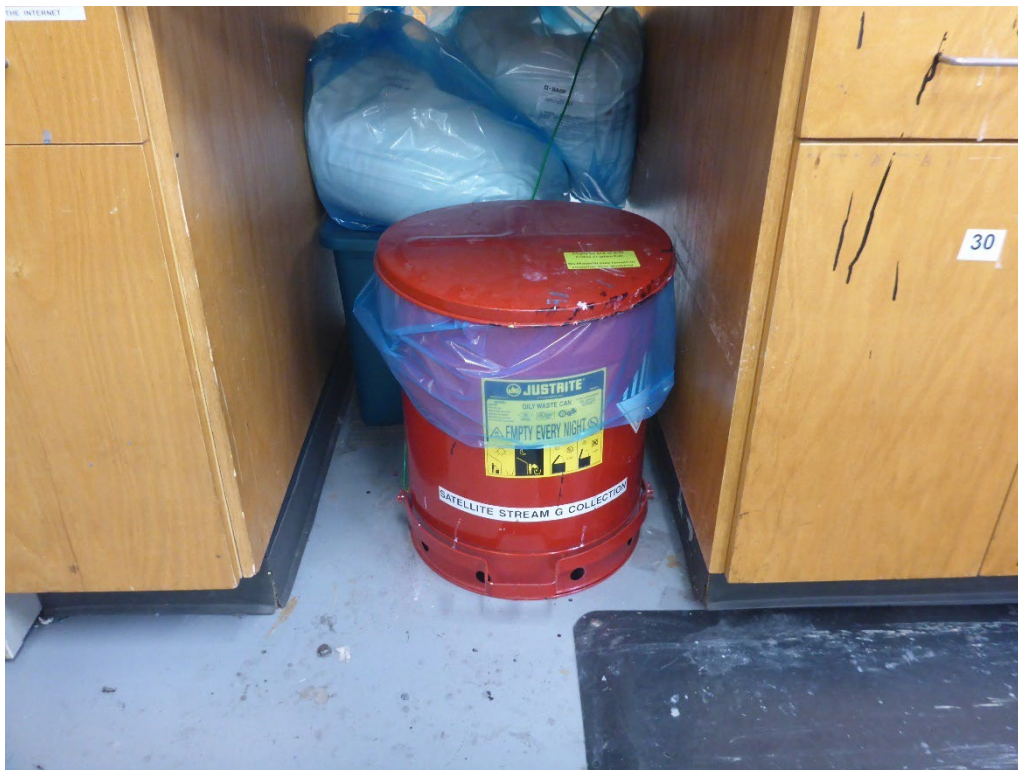
The facility manages a second SAA in the Film Laboratory for accumulating Stream G that is generated as used rags, wipes, cups, and solids contaminated with solvents. The inspectors observed four 14-gallon step-to-open flammable cans in this SAA (Photo 14). The cans were not labeled as hazardous waste or marked with an indication of the hazardous of their contents.

**Photo 14:** One of four 14-gallon step-to-open flammable cans in the Film Laboratory SAA for accumulating Stream G hazardous waste solids. The container was not labeled “hazardous waste” or marked with an indication of the hazards of its contents. In addition, the original “oily rags” and “empty every night” labels are still visible on the container.

On 01/28/2022, Mr. LaBarge sent a letter to SCDHEC and the EPA in which he stated that the facility has labeled each can of Stream G hazardous waste solids as hazardous waste and flammable solids and has covered all oily waste labels so that they are no

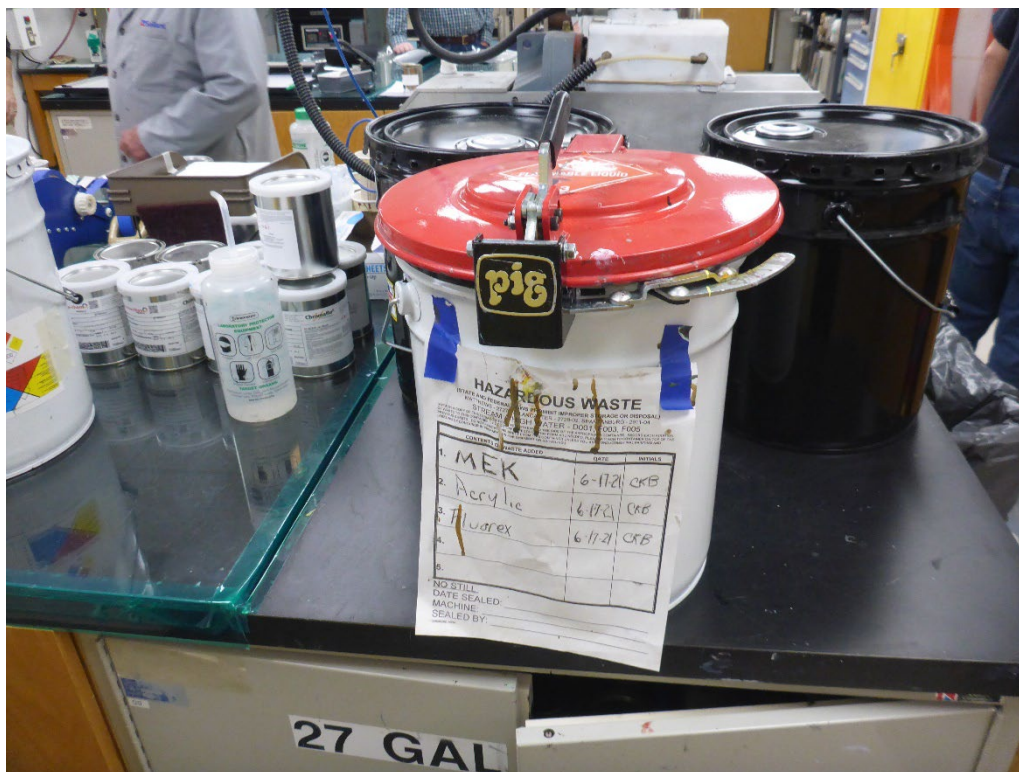
Color Laboratory SAAs: AkzoNobel manages one SAA in the Color Laboratory for accumulating Stream A High Water hazardous waste liquids. The inspectors observed one 5-gallon container in this SAA (Photo 15). The container was located on a laboratory bench. It was labeled as hazardous waste MEK acrylic fluorex and marked with an NFPA fire diamond.

**Photo 15:** One 5-gallon container in the Color Laboratory SAA for accumulating Stream A High Water hazardous waste liquids. The container is labeled hazardous waste, and the hazards of the contents of the container are indicated using an NFPA fire diamond.

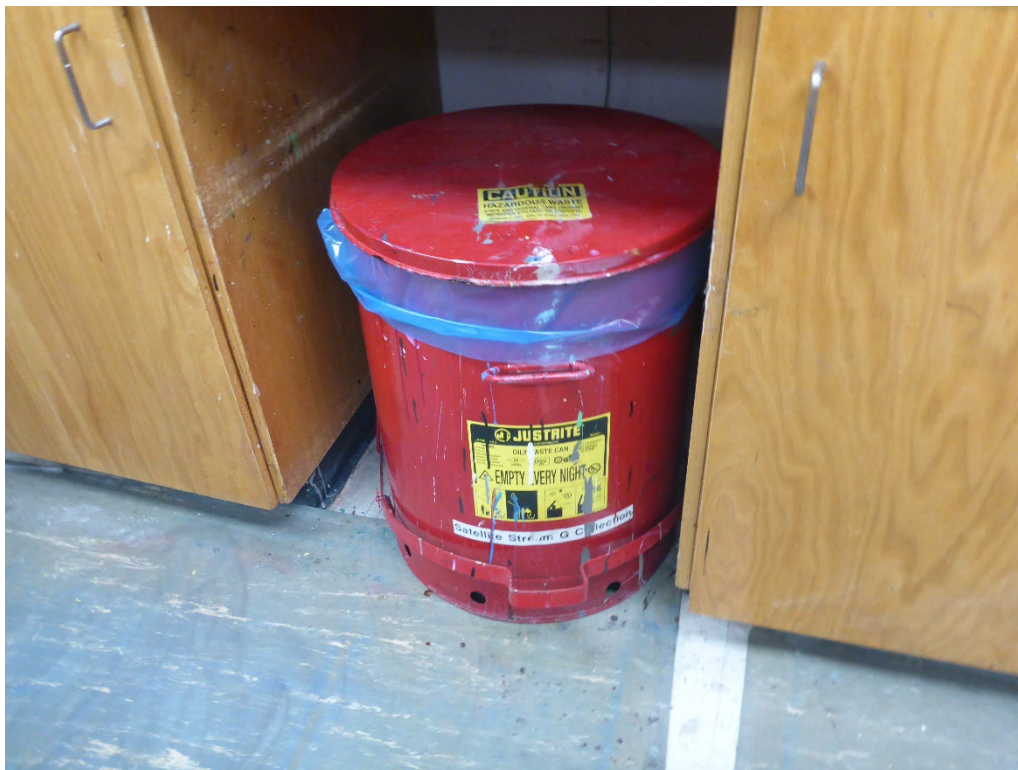
The facility manages a second SAA in the Color Laboratory for accumulating Stream G that is generated as used rags, wipes, cups, and solids contaminated with solvents. The inspectors observed two 14-gallon step-to-open flammable cans in this SAA (Photo 16). The cans were not labeled as hazardous waste or marked with an indication of the hazardous of their contents.

**Photo 16:** One of two 14-gallon step-to-open flammable cans in the Color Laboratory SAA for accumulating Stream G hazardous waste solids. The container is not labeled hazardous waste, and it is not marked with an indication of the hazards of its contents. In addition, the original “oily rags” and “empty every night” labels are still visible on the container.

On 01/28/2022, Mr. LaBarge sent a letter to SCDHEC and the EPA in which he stated that the facility has labeled each can of Stream G hazardous waste solids as hazardous waste and flammable solids and has covered all oily waste labels so that they are no longer visible.

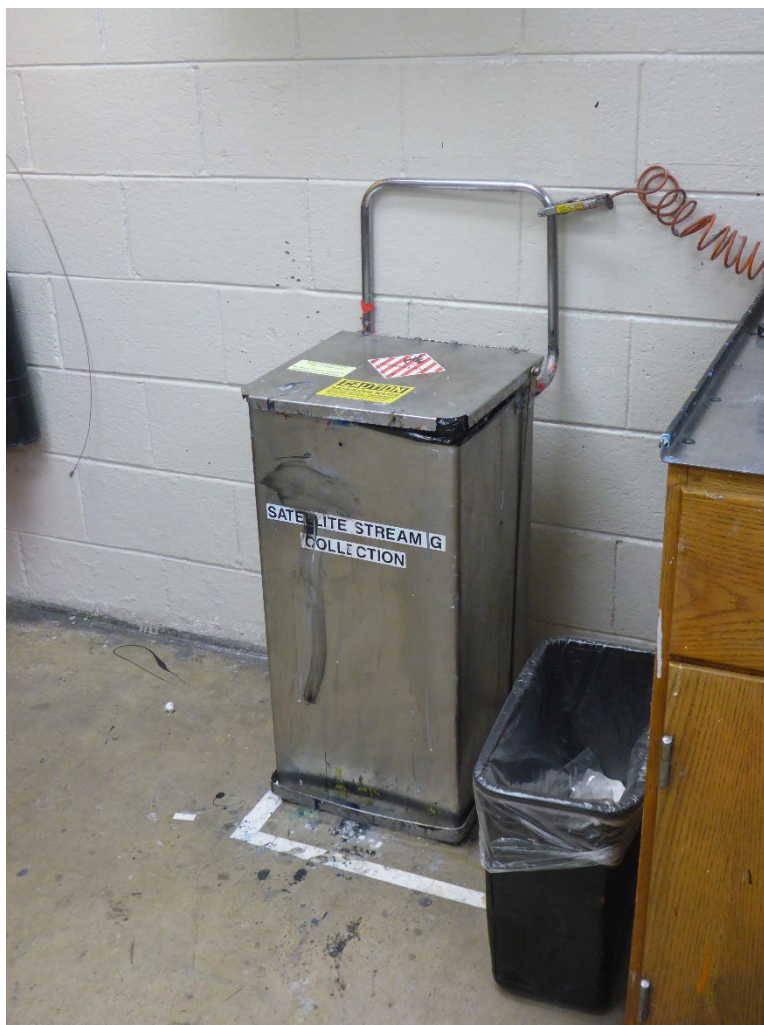
**Photo 17:** One 30-gallon step-to-open can in the Mix Room Laboratory SAA for accumulating Stream G hazardous waste solids. The container is labeled hazardous waste, and it is marked with a flammable solids DOT hazard placard. It is not marked to indicate the contents are toxic.

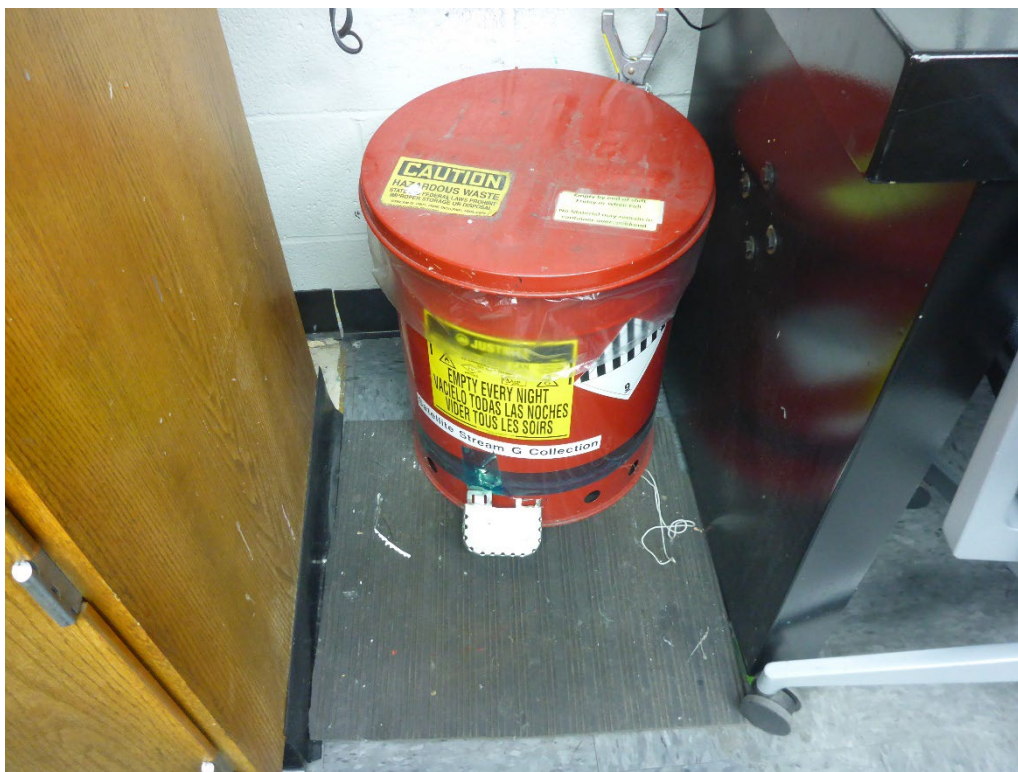
**Photo 18:** One 14-gallon step-to-open flammable can in the In-Process Laboratory SAA for accumulating Stream G hazardous waste solids. The container is labeled hazardous waste, but it is not marked with an indication of the hazards of its contents. In addition, the original “oily rags” and “empty every night” labels are still visible on the container.

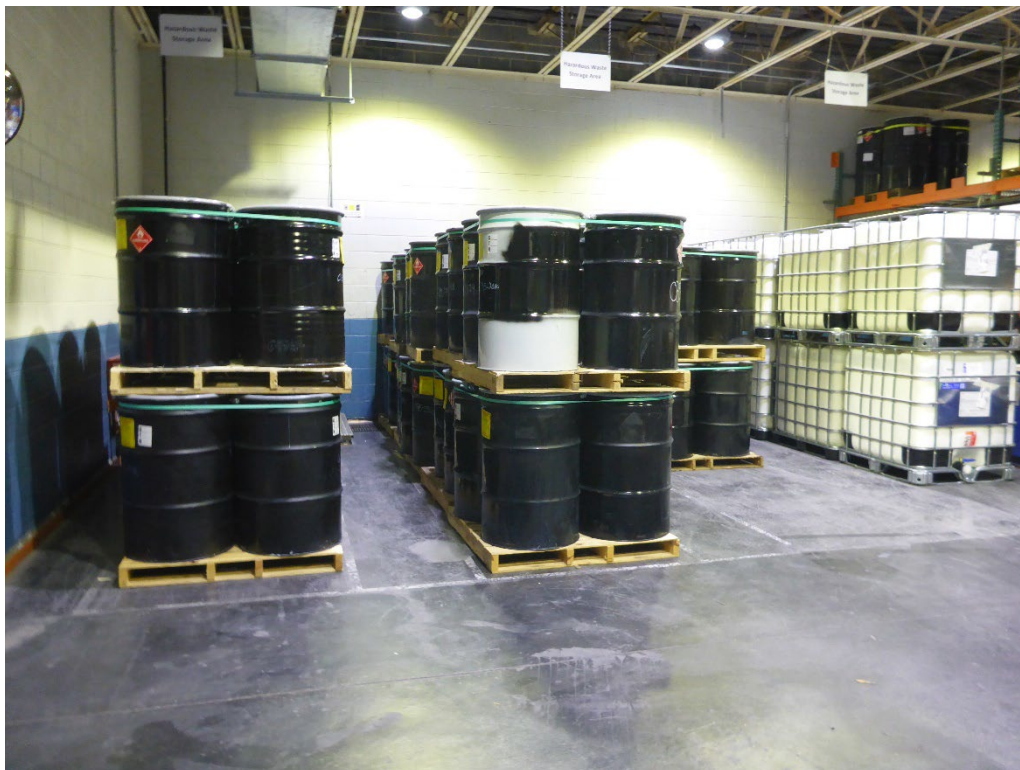
**Photo 19:** CAA located in Drum Storage Area 2. The floor has been painted to define individual rows for storing pallets of hazardous waste containers. The inspectors observed approximately one-hundred 55-gallon drums of hazardous waste arranged in three rows of wooden pallets.

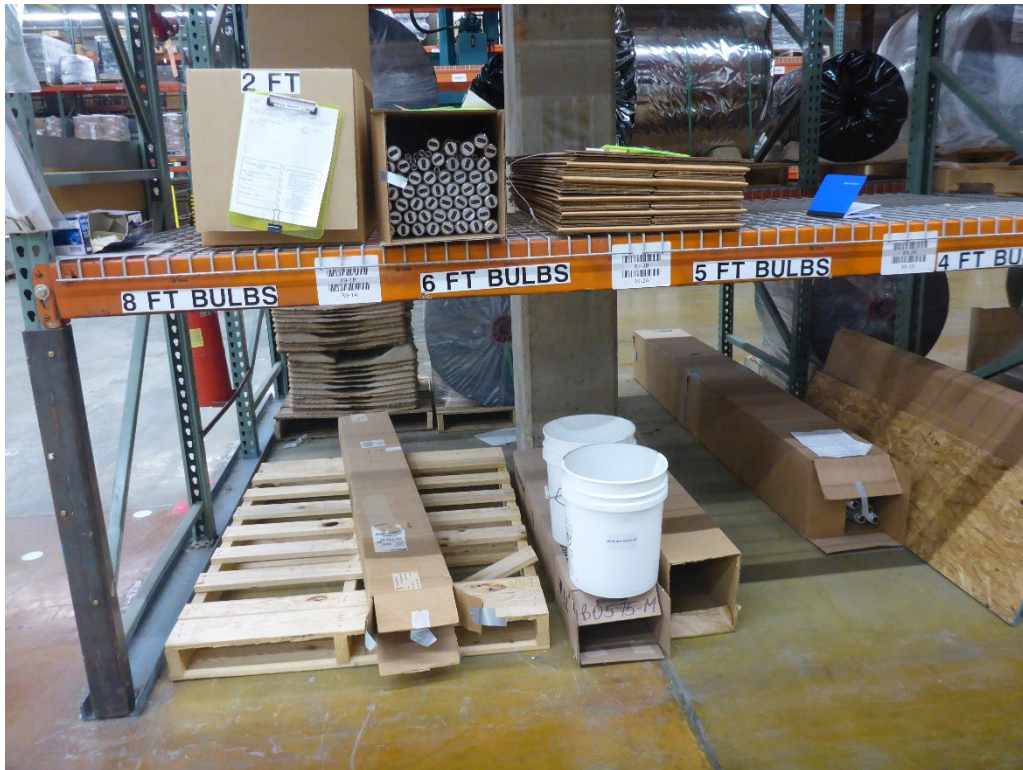
**Photo 20:** One box of 2-foot universal waste lamps, one box of 4-foot universal waste lamps, one box of 6-foot universal waste lamps and one box of 8-foot universal waste lamps in the Warehouse. All of the boxes were open. The boxes of 6-foot and 8-foot lamps were labeled as universal waste lamps, but no labels were affixed to the boxes of 2-foot and 4-foot lamps. Instead, these labels were located on a clipboard that had been placed on top of each container. The oldest universal waste label was dated 11/04/2021.
