# NPDES Compliance Inspection Report

## **LKQ KC Truck Parts Spokane Facility**

**Permit # WAU000658**

**Inspection Date: 11/17/2020**

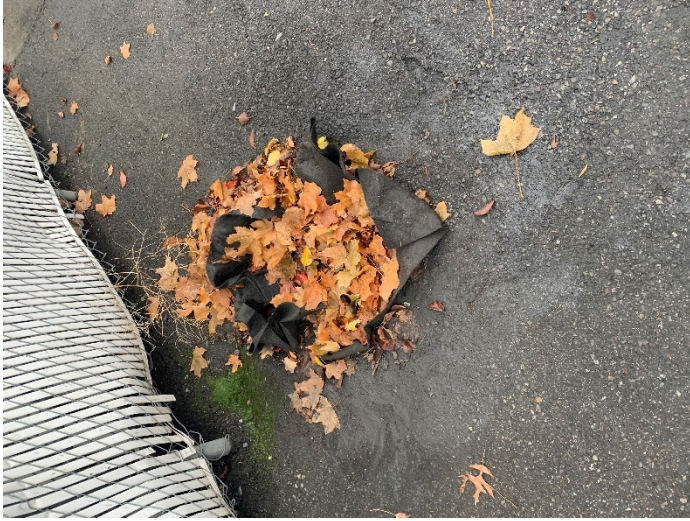
Photo #:01

Description: This is a photo of one of the storm drains that leads to a dry well. The storm drain sock prevented the leaves from entering the dry well.

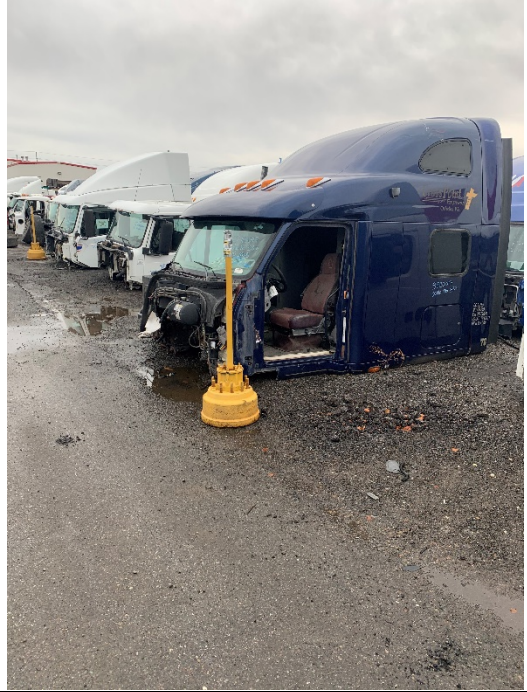
Photo #:02

Description: Southernmost part of the facility. These trucks have had all the fluids and mechanical parts removed from them.
