**Region 6 - Enforcement & Compliance Assurance Division**  
**INSPECTION REPORT**

| Company Name: | <b>Pojoaque Terraces Mobile Home Park</b> | | |
| Facility Name: | <b>Pojoaque Terraces MHP</b> | | |
| Identification/Permit Number: | NM0028436 | | |

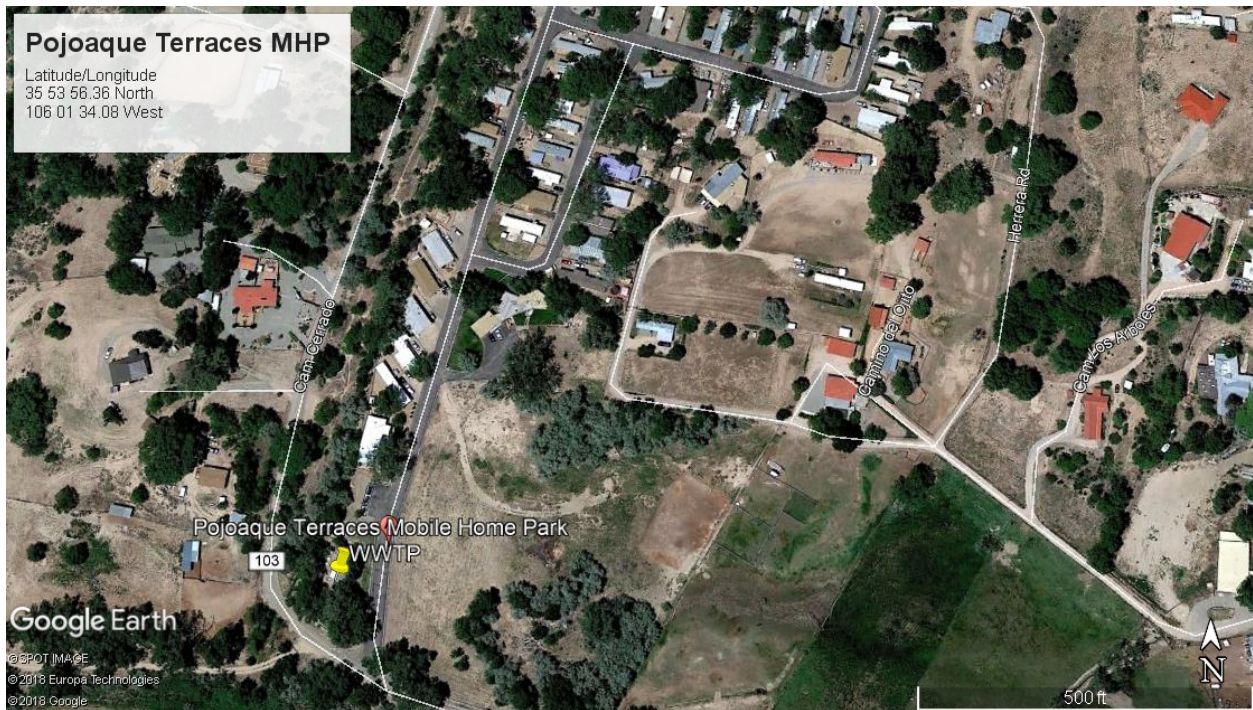
**Aerial Image #1:** Overall view of the Pojoaque terraces MHP Wastewater Treatment Plant. Aerial from Google Earth maps.
