## **RCRA Inspection Report**

Piedmont Chemical Industries I, LLC  
331 Burton Avenue  
High Point, North Carolina 27261

December 01, 2022

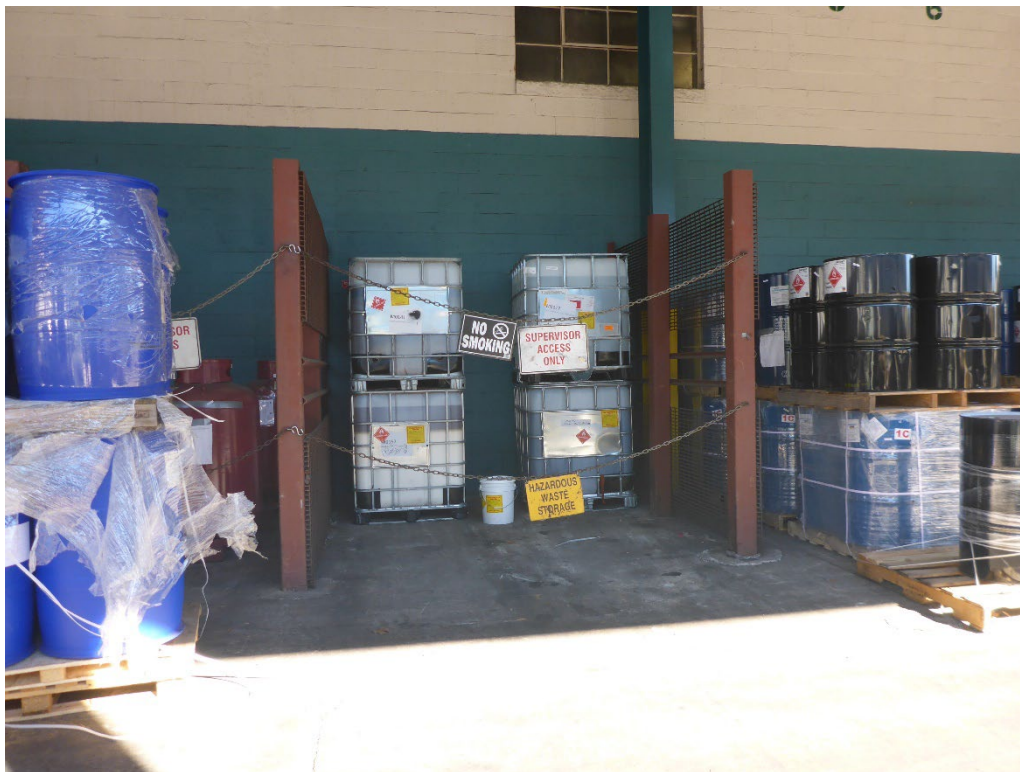
Next, the inspection participants toured the hazardous waste CAA, which is located in the “P-Shed,” a covered concrete pad along the outside wall of the warehouse. The CAA is located in one of several bays which are separated by metal screens in the P-Shed. The inspectors observed signs reading “supervisor access only” and “hazardous waste storage” hanging on metal chains across the opening to the designated CAA bay. Personnel attached a “no smoking” sign to the upper chain during the inspection (Photo 1).

**Photo 1:** Hazardous waste central accumulation area (CAA) after employees attached a “no smoking” sign to the upper chain.

**Pursuant to 15A NCAC 13A .0107 [40 C.F.R. § 262.17(a)(1)(vi)(B)], which is a condition of the LQG Permit Exemption, if hazardous waste is placed in containers, “No Smoking” signs must be conspicuously placed wherever there is a hazard from ignitable or reactive waste.**

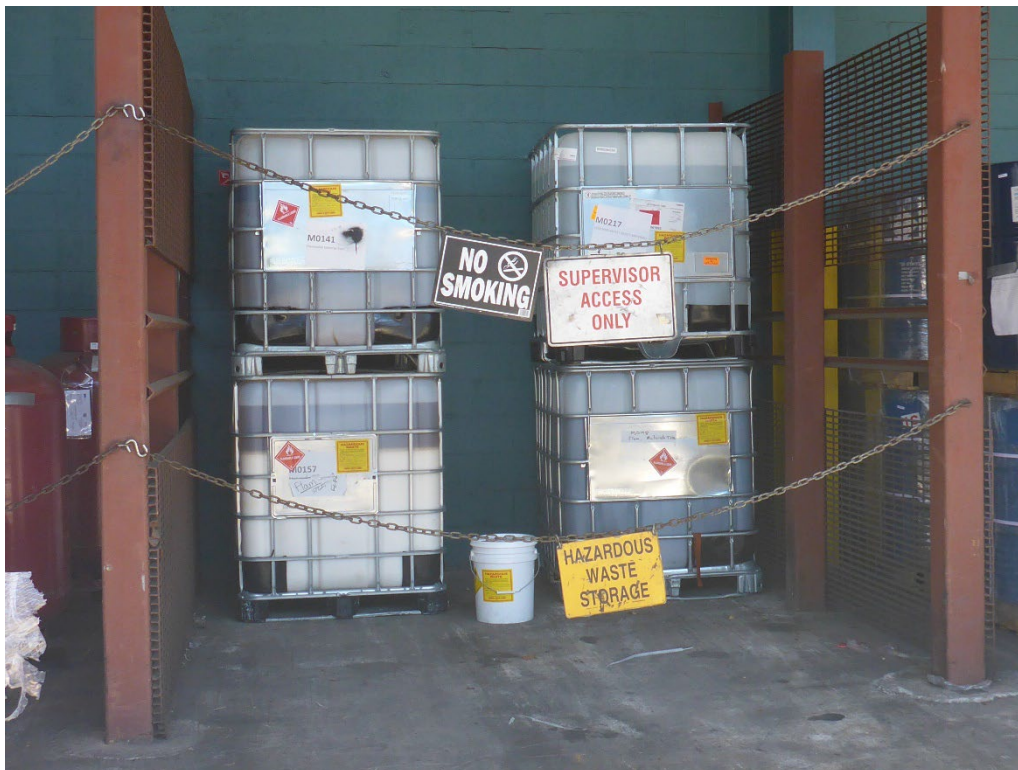
The inspectors observed four 275-gallon totes and one 5-gallon bucket of hazardous waste in the CAA during the inspection (Photo 2). Michael Chestnut stated that one tote contained hazardous waste generated from a “bad” production batch and that the other three totes contained hazardous waste samples from the Quality Control laboratory or otherwise off the process lines. The tote of off-spec product was labeled hazardous waste flammable liquid (vinyl trimethoxysilane) with the EPA Hazardous Waste Number D001, and it was marked with an accumulation start date of November 22, 2022. Each of the three totes of hazardous waste samples was labeled hazardous waste flammable liquid (isopropanol, butanol), identified with the EPA Hazardous Waste Number D001, and classified with a flammable liquid DOT hazard placard. Two of these totes

were marked with an accumulation start date of November 3, 2022, and the third was marked with an accumulation start date of November 22, 2022. The 5-gallon bucket was labeled hazardous waste sodium nitrate, identified with the EPA Hazardous Waste Number D001, classified with an oxidizer DOT hazard placard, and marked with an accumulation start date of November 17, 2022.

**Photo 2:** Four 275-gallon totes and one 5-gallon bucket in the CAA.

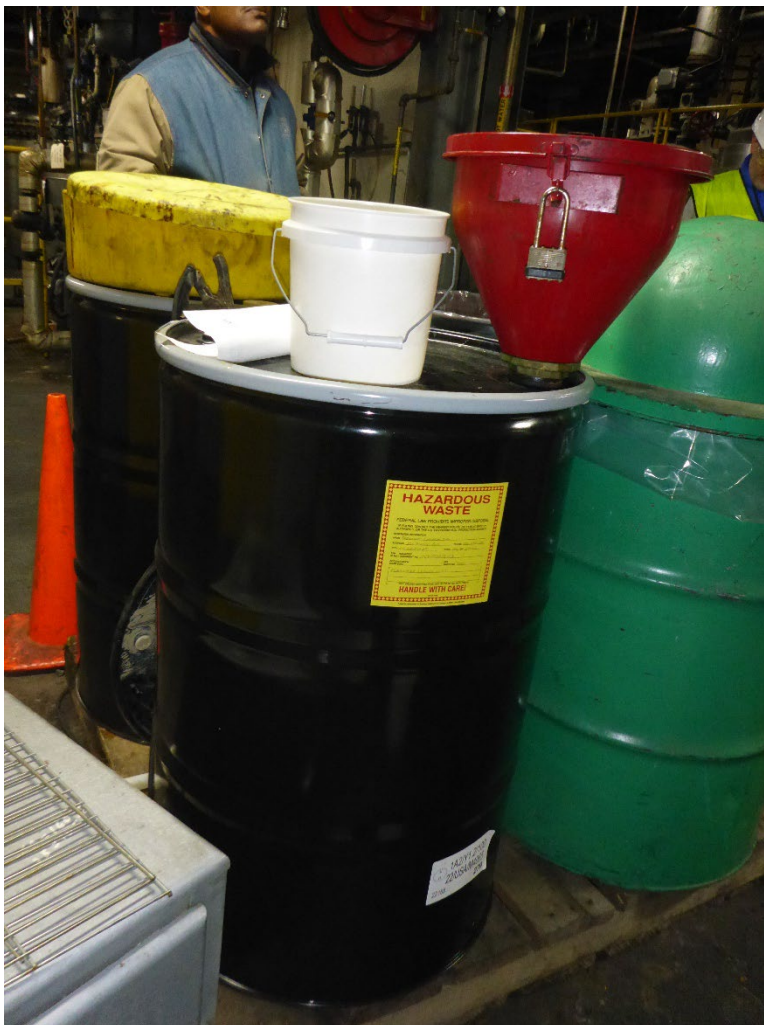
The 55-gallon drum in the QC Laboratory SAA was observed on a wooden pallet just outside the laboratory door (Photo 3). The drum was labeled as hazardous waste flammable liquids, identified with the EPA Hazardous Waste Number D001, and secured with a locked funnel lid. Two more 55-gallon drums, labeled “lab waste nonregulated liquid” and “lab waste nonregulated solids” were also observed on this wooden pallet. The drum labeled lab waste nonregulated solids did not have a lid, and the inspectors observed used PPE and glass bottles inside the open container. According to facility personnel, the standard operating procedure for the laboratory is to pour liquids from the smaller containers into either the hazardous waste container or the lab waste nonregulated liquid container, and then place the empty containers into the lab waste nonregulated solids container. Some of the small containers observed in the open lab waste nonregulated solids container were not empty, and it was unclear if the material inside the small containers was hazardous waste.

Just outside the laboratory door, the drum labeled lab waste nonregulated solids did not have a lid, and the inspectors observed used PPE and glass bottles inside the open container. Some of the small containers were not empty, and it was unclear if the material inside the small containers was hazardous waste.

**Photo 3:** 55-gallon drum in the laboratory SAA.

**Pursuant to 15A NCAC 13A .0107(a) [40 C.F.R. § 262.11], a person who generates a solid waste, as defined in 15A NCAC 13A .0106 [40 C.F.R. § 261.2], must use the steps articulated in 15A NCAC 13A .0107(a) [40 C.F.R. § 262.11] to make an accurate determination as to whether that waste is a hazardous waste in order to ensure wastes are properly managed according to applicable RCRA regulations.**

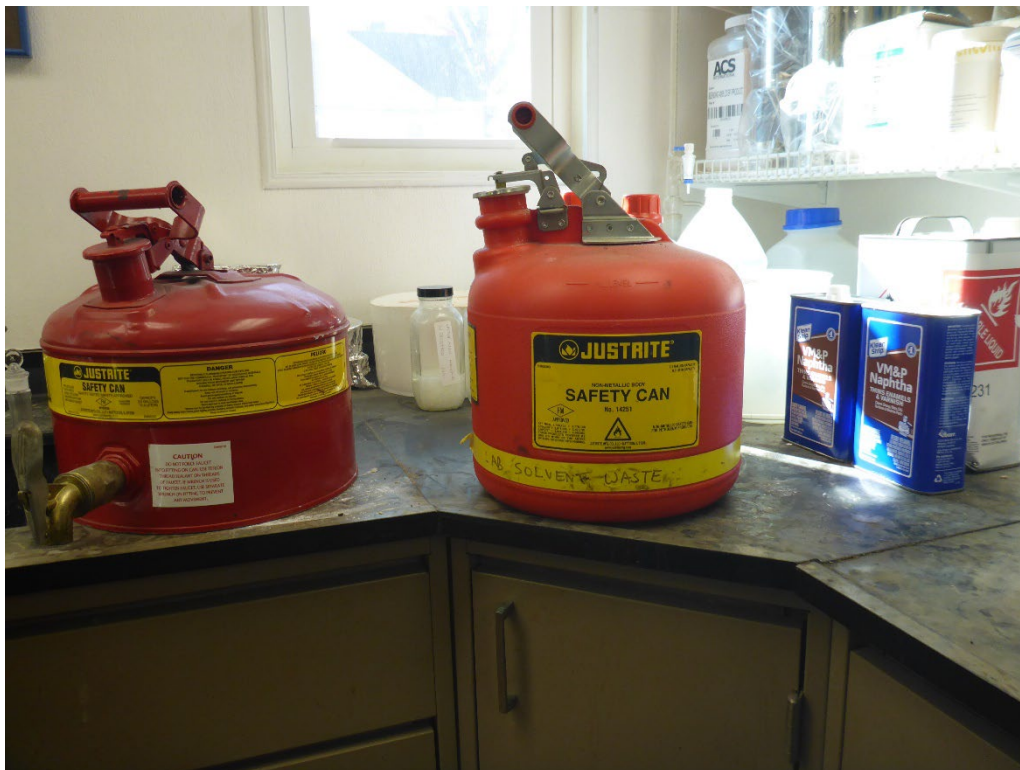
The 2-gallon and 2.5-gallon flammable safety cans in the QC Laboratory SAA were observed on laboratory benches inside the laboratory (Photo 4). Each container was closed and marked to indicate that its contents are flammable, but neither was labeled with the words “hazardous waste.”

The 2-gallon and 2.5-gallon flammable safety cans in the QC Laboratory SAA were closed and marked to indicate that its contents are flammable, but neither was labeled with the words “hazardous waste.”

**Photo 4:** 2.5-gallon flammable safety can in the laboratory SAA, which was not labeled with the words “hazardous waste.”

**Pursuant to 15A NCAC 13A .0107(a) [40 C.F.R. § 262.15(a)(5)(i)], which is a condition of the SAA Permit Exemption, a generator is required to mark or label its containers with the words “Hazardous Waste.”**

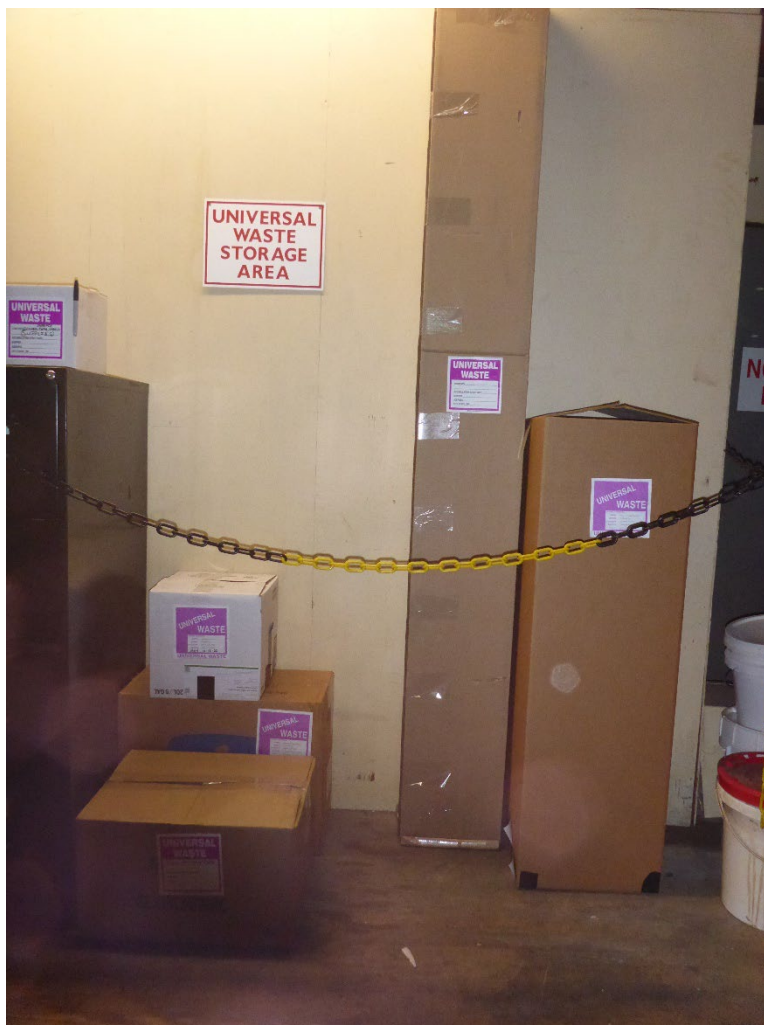
The inspectors observed one box of 4-foot fluorescent lamps, one box of 8-foot fluorescent lamps, three small boxes of universal waste lamps or emergency lights, two empty 5-gallon buckets for universal waste batteries, and one 5-gallon bucket of used alkaline batteries in the universal waste management area (Photo 5). All containers holding universal waste were closed, and the oldest container was dated June 3, 2022. Each box of lamps or lights was labeled as universal waste, but one or more of the boxes was labeled “universal waste bulbs” rather than “universal waste lamps.”

**Photo 5:** Containers of universal waste in the attic.
