## NPDES Inspection Report – Wastewater Treatment Facility

| Facility Location Information | |
|---|---|
| <b>Site/Facility Name &amp; Location:</b><br>Saint Stephens Indian Mission<br>33 Saint Stephens Road<br>Saint Stephens, Wyoming 82524<br>42.982286, -108.413124 | <b>Email Report to:</b><br>Jon Esquibel and Melissa Brown<br>Saint Stephens Indian Mission<br>melissa.brown@saintstephensmission.com |

## Inspection Narrative and Site Description

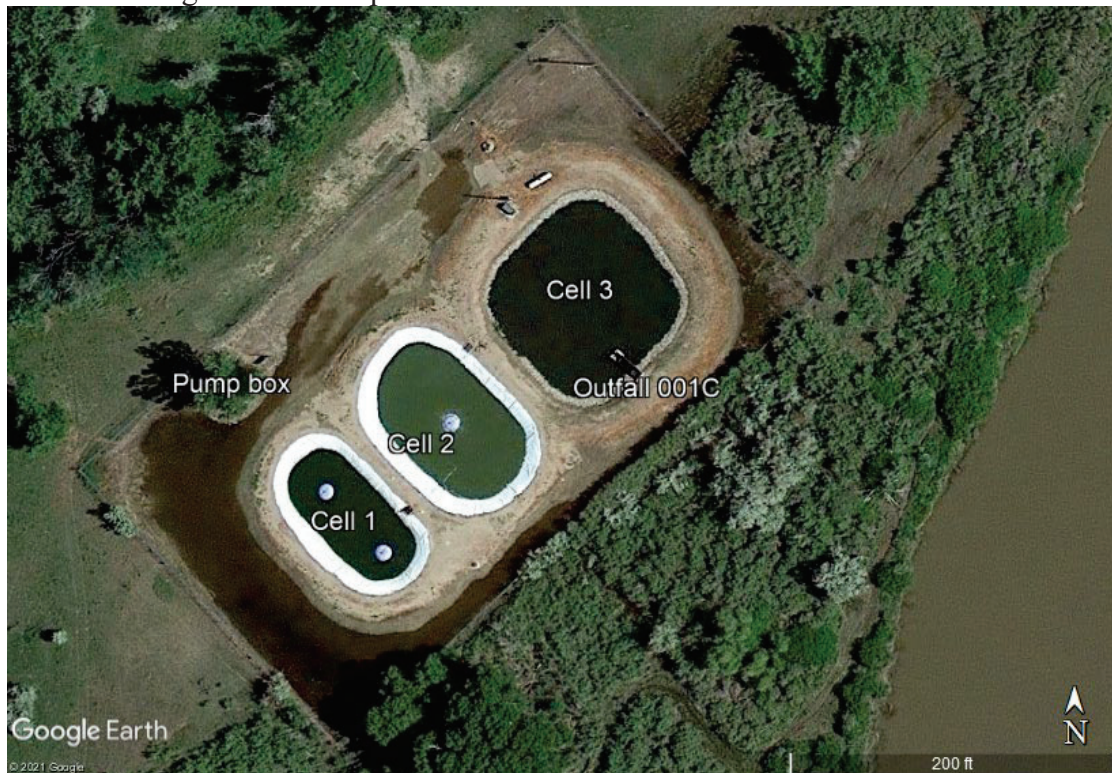
Saint Stephens is a three (3)-cell wastewater lagoon system and according to Mr. Esquibel all three cells were lined about 2 years ago (~2019). The influent from the Saint Stephens Church, five (5) homes, and church administrative building gravity flows to a manhole on the northwest corner of Cell 3 before flowing to the pump box/lift station and discharging into Cell 1. Influent from the Saint Stephens Indian School, including the cafeteria, gravity flows to the pump box/lift station, comingling with the wastestream from the northwest manhole, and flowing into Cell 1. Cell 1 is the primary cell and has two aerators. Wastewater flows through a valve box to Cell 2, and there is one aerator in Cell 2. Wastewater flows through a valve box to Cell 3 and Outfall 001C is located on the southeast side of Cell 3. Discharge through Outfall 001C flows via a buried pipe approximately 225 feet to the Mission Ditch – Little Wind River.

Below is an aerial image of Saint Stephens Indian Mission.
