**CWA COMPLIANCE EVALUATION INSPECTION REPORT  
U.S. ENVIRONMENTAL PROTECTION AGENCY, REGION 5**

**Facility:** J&G Storage  
West of the Intersection Wisconsin State Route 47 and Larch Road  
Parcel #10-706-01  
Lac du Flambeau, Wisconsin 54538

**Date of Inspection:** December 14-15, 2023

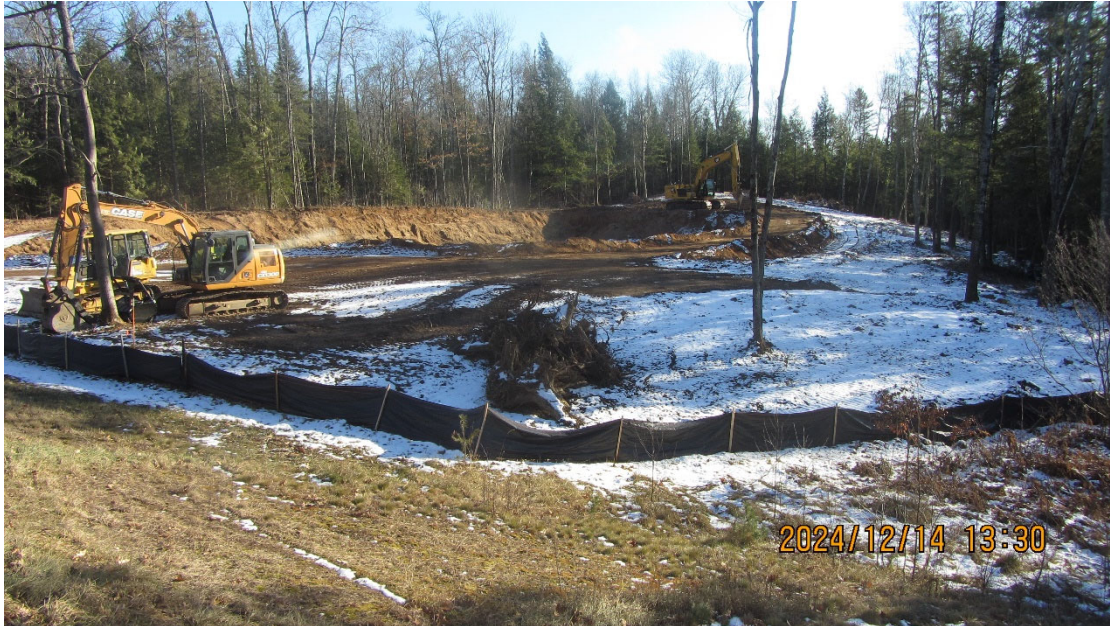
1. IMG\_0839

Description: J&G Storage Construction Site

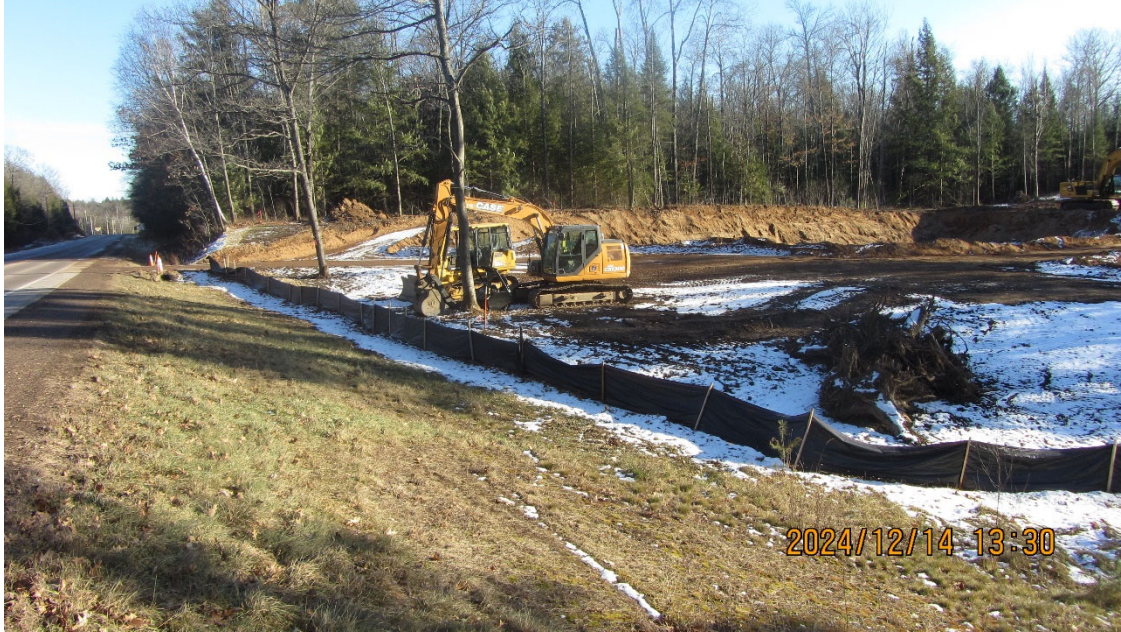
2. IMG\_0840

Description: J&G Storage Site - Entrance

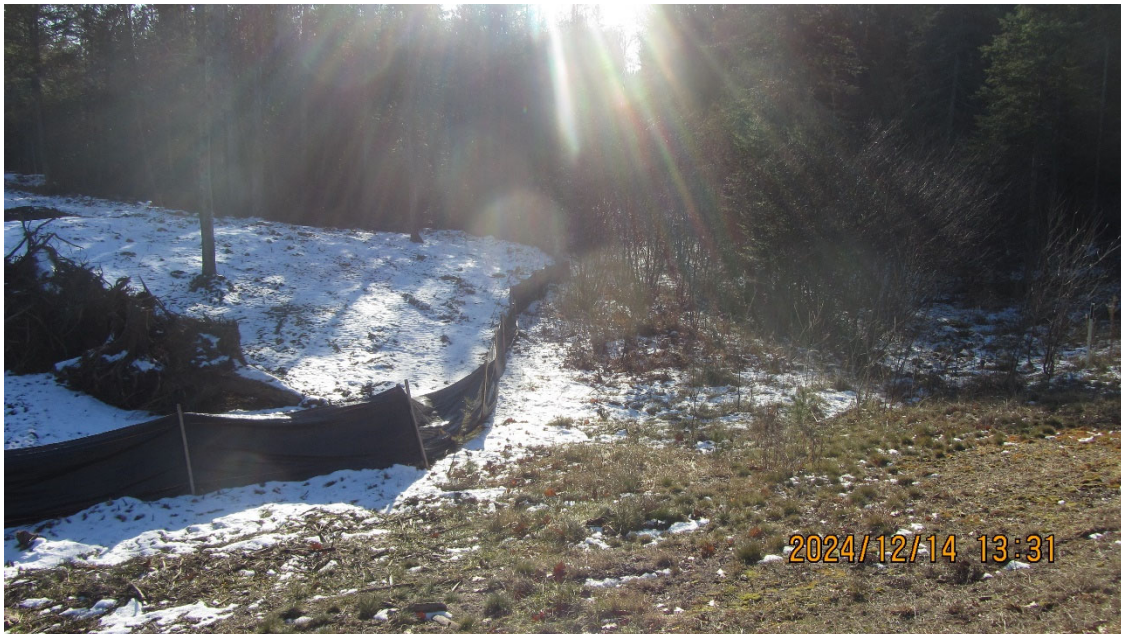
3. IMG\_0841

Description: J&G Storage Site – Northwest Corner

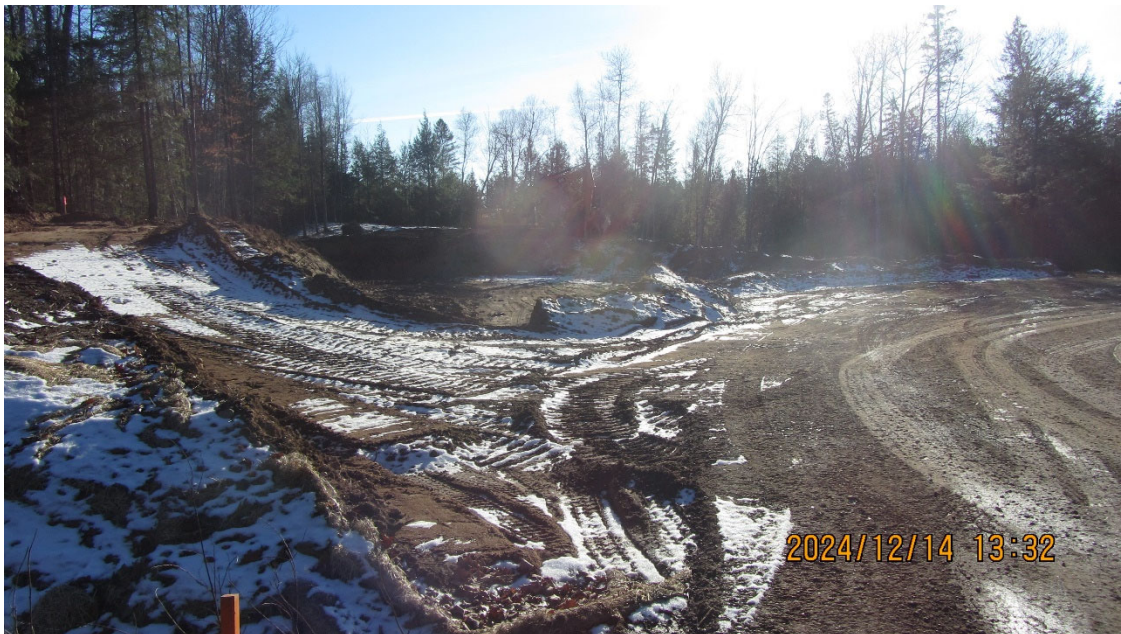
5. IMG\_0843

Description: J&G Storage Site

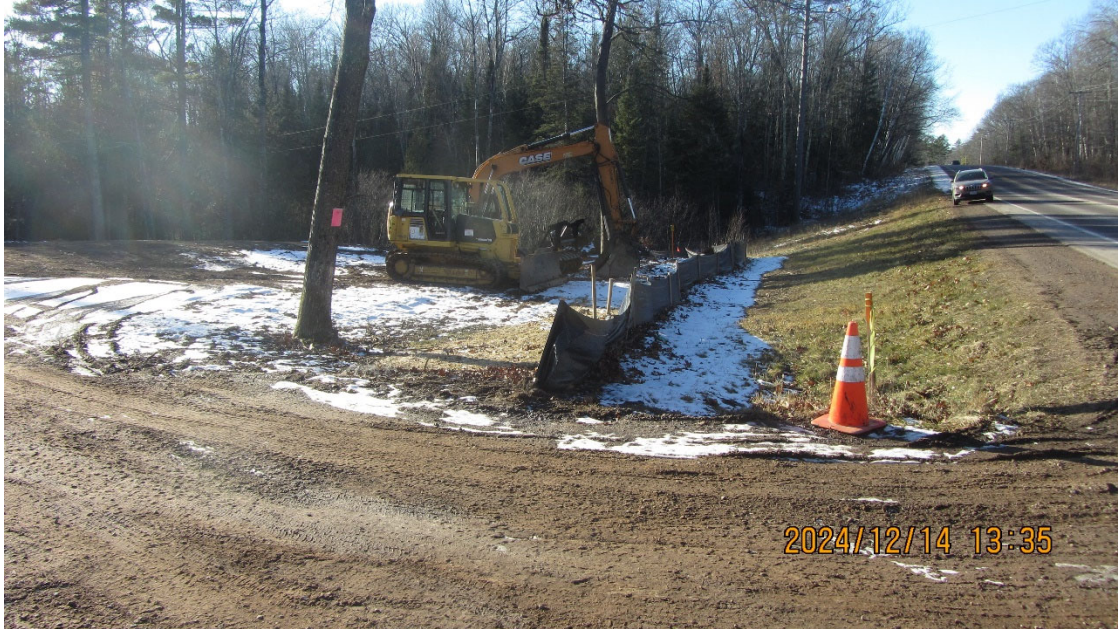
6: IMG\_0844

Description: J&G Storage Site – Entrance/North Side of Site

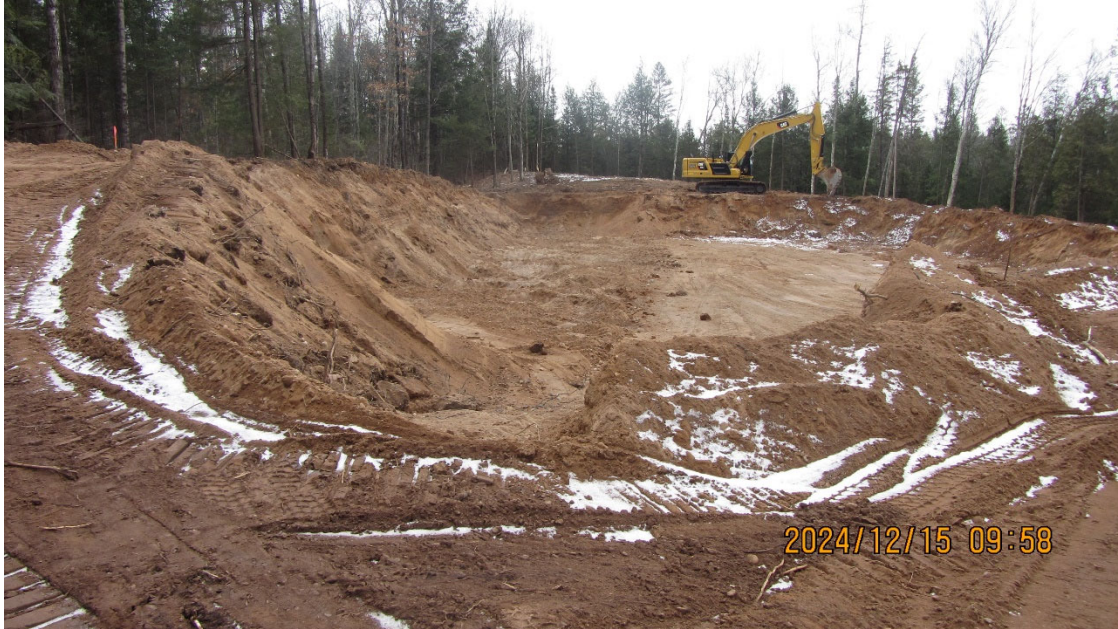
8. IMG\_0846

Description: J&G Storage–Excavated Area

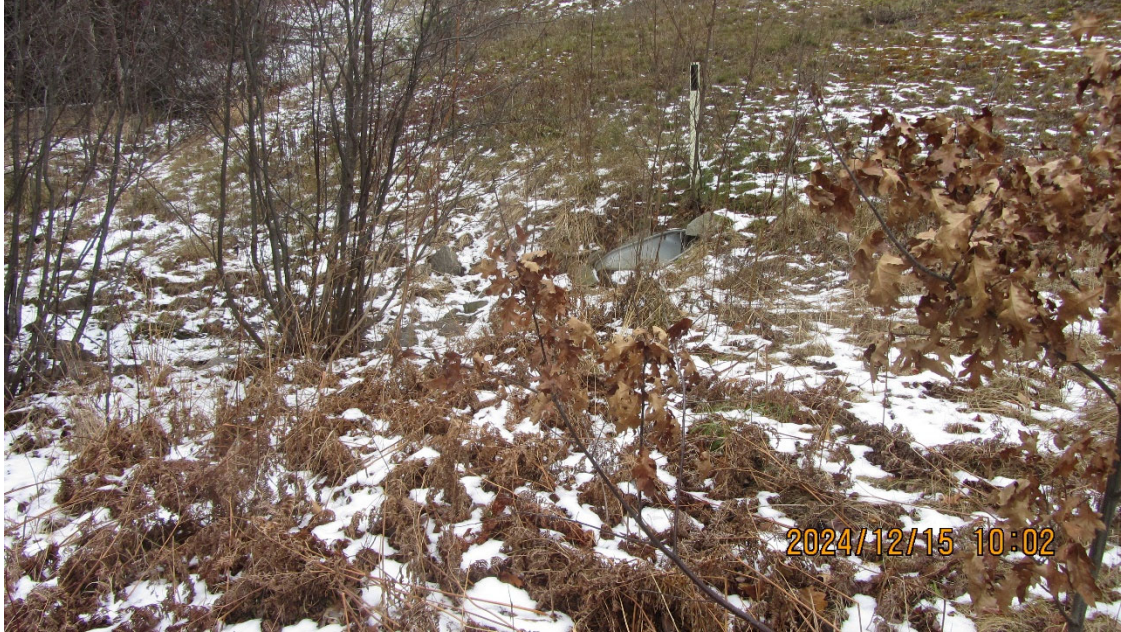
4. IMG\_0848

- EPA observed minimal sediment tracking from the site's entrance (Photograph 4 in Attachment A).
- Photograph 7 in Attachment A shows the upstream culvert and headwall for a small ditch that runs west of the site (referred to above in the Receiving Waters section of this report) and that would likely flow from north to south towards Fence Lake. At the time of this inspection, there was no water flowing through this culvert.

Description: Area West of J&G Storage Site – Note Culvert under Route 47

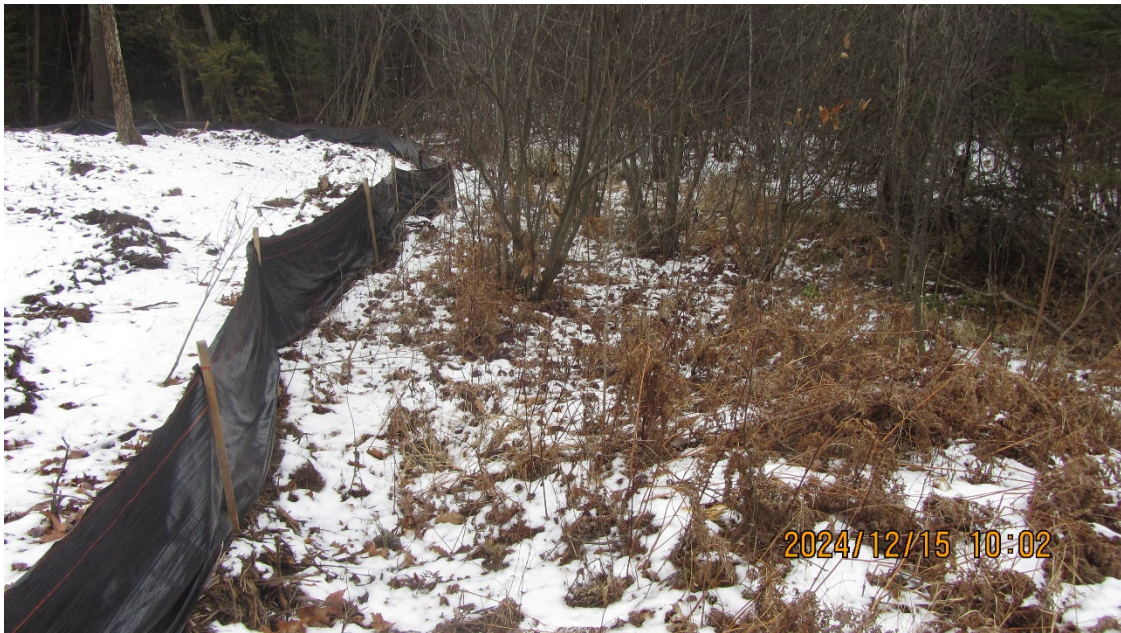
11. IMG\_0849

Description: Silt Fence on Northwest/West Sider of the J&G Storage Site

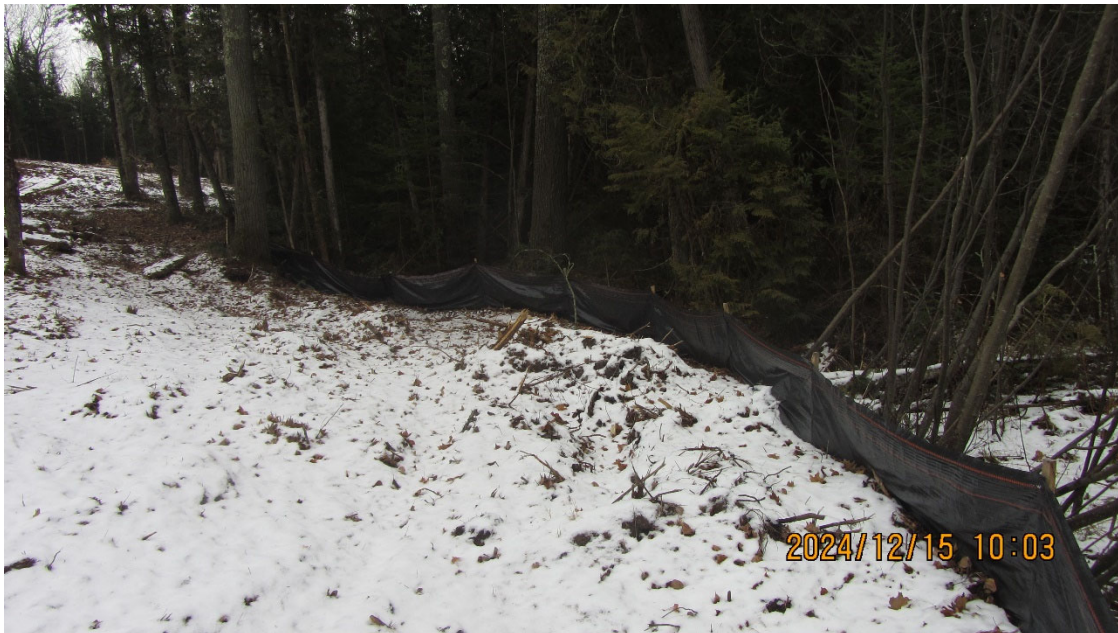
13. IMG\_0851

Description: Silt Fence on West Site of the J&G Storage Site

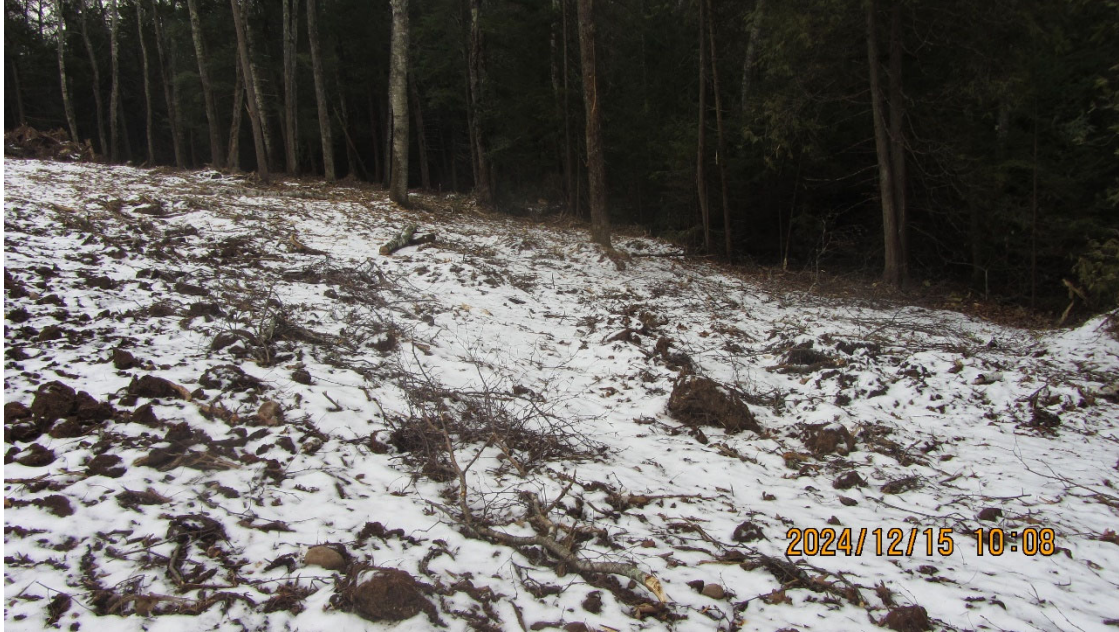
5. IMG\_0856

Description: Property Boundary on West Side of J&G Storage

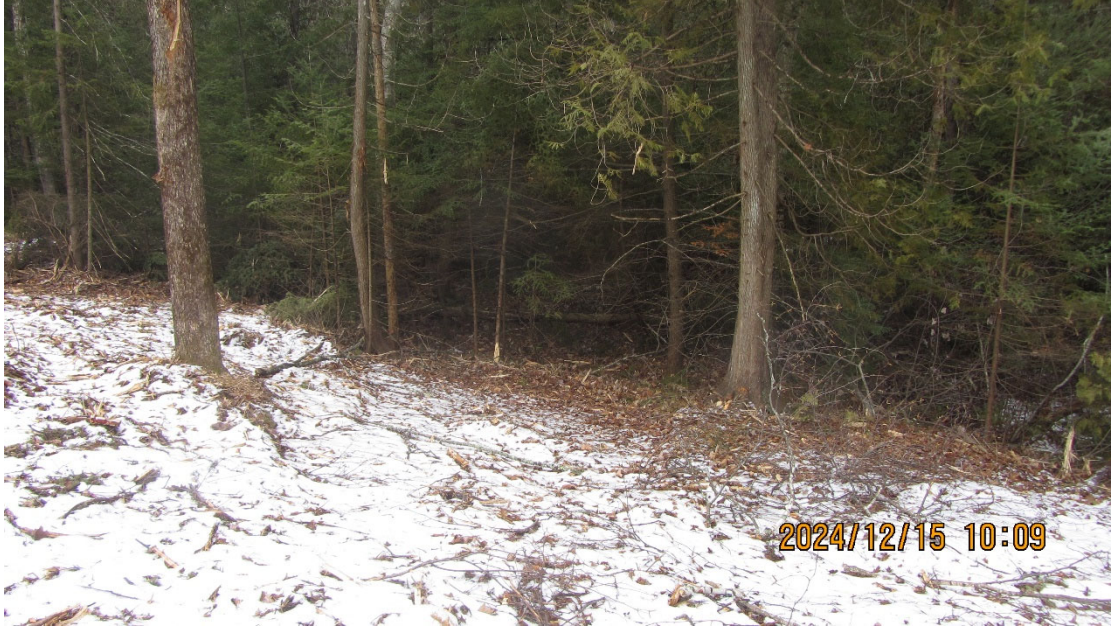
6 IMG\_0858

Description: Property Boundary on Southwest Side of J&G Storage Site

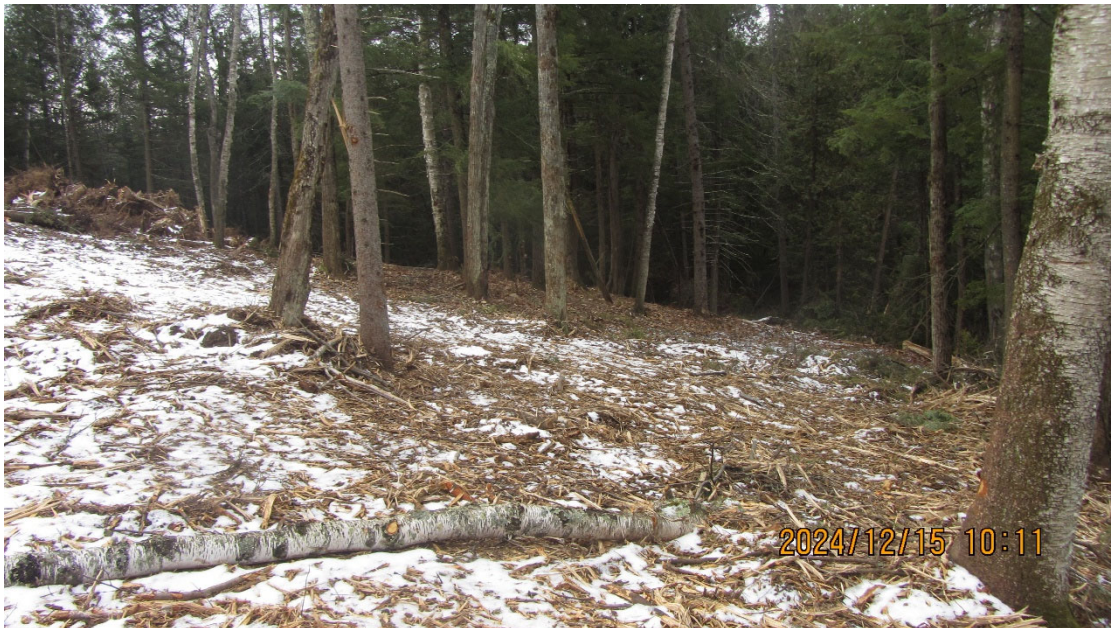
21. IMG\_0859

Description: Property Boundary on Southwest Side of J&G Storage Site

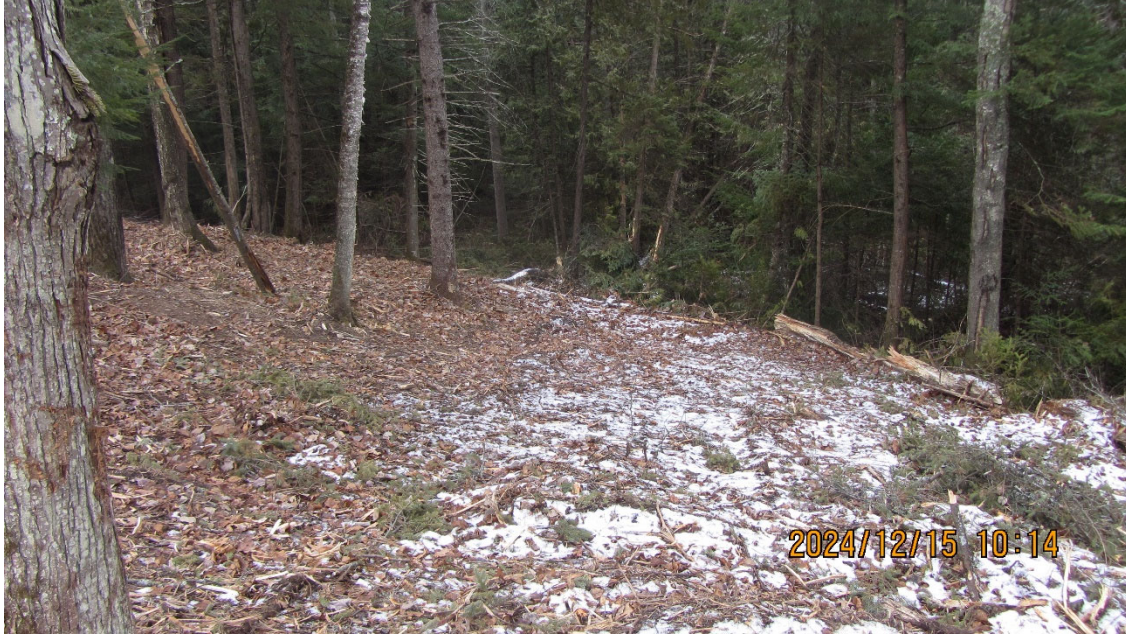
72. IMG\_0860

Description: Property Boundary on West Side of J&G Storage Site

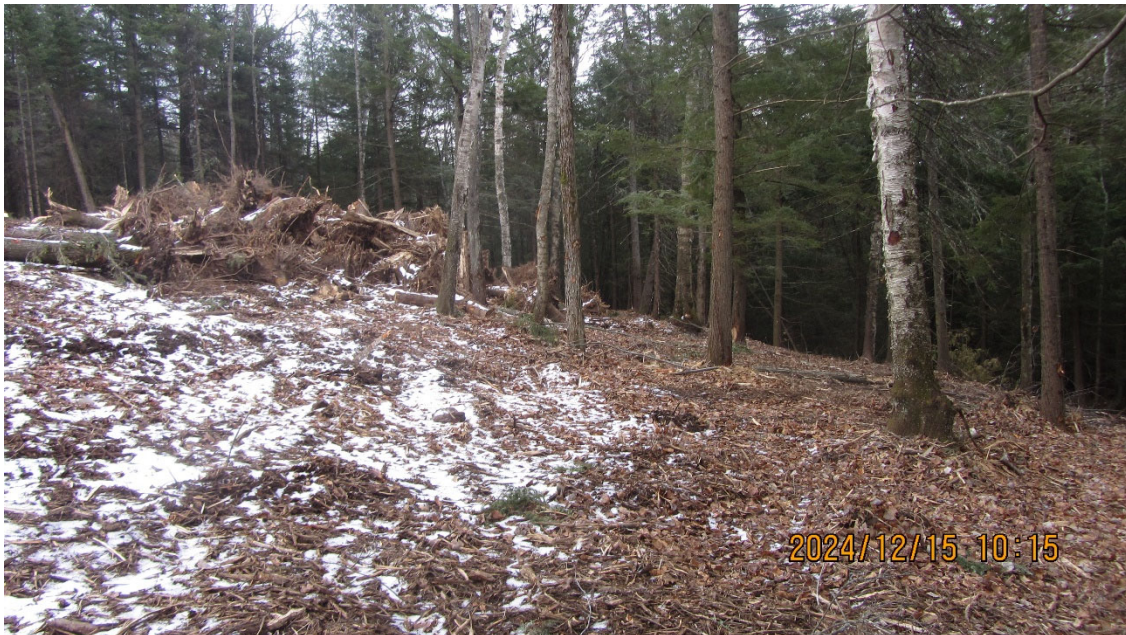
83: IMG\_0861

Description: South/Southwest Side of J&G Storage Site with Tree Stump Pile

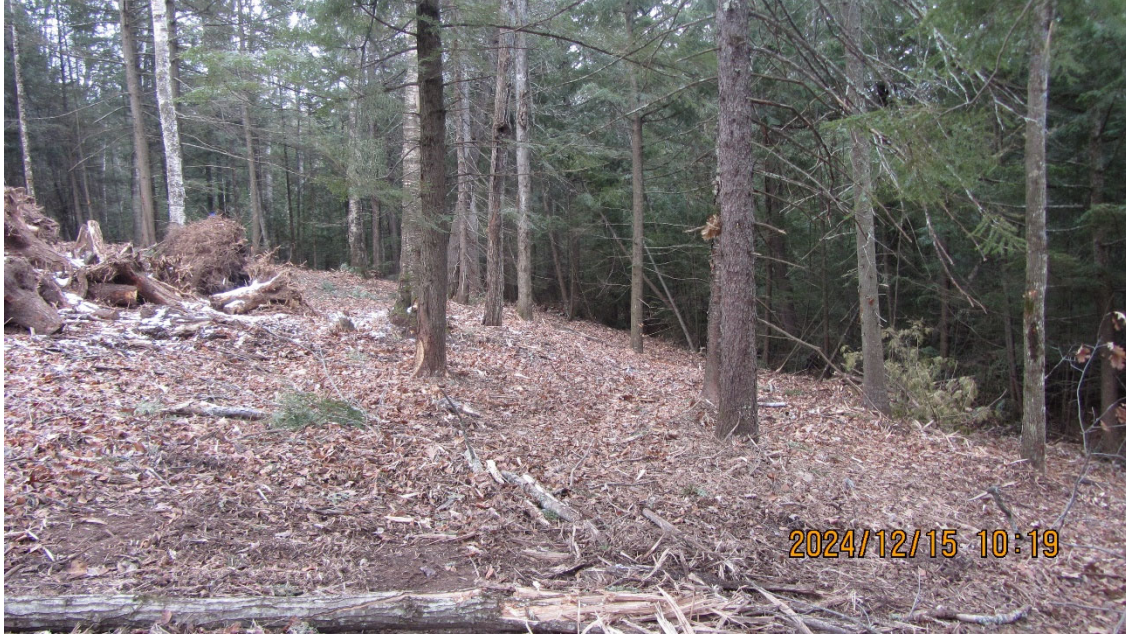
9: IMG\_0862

Description: South/Southwest Side of J&G Storage Site

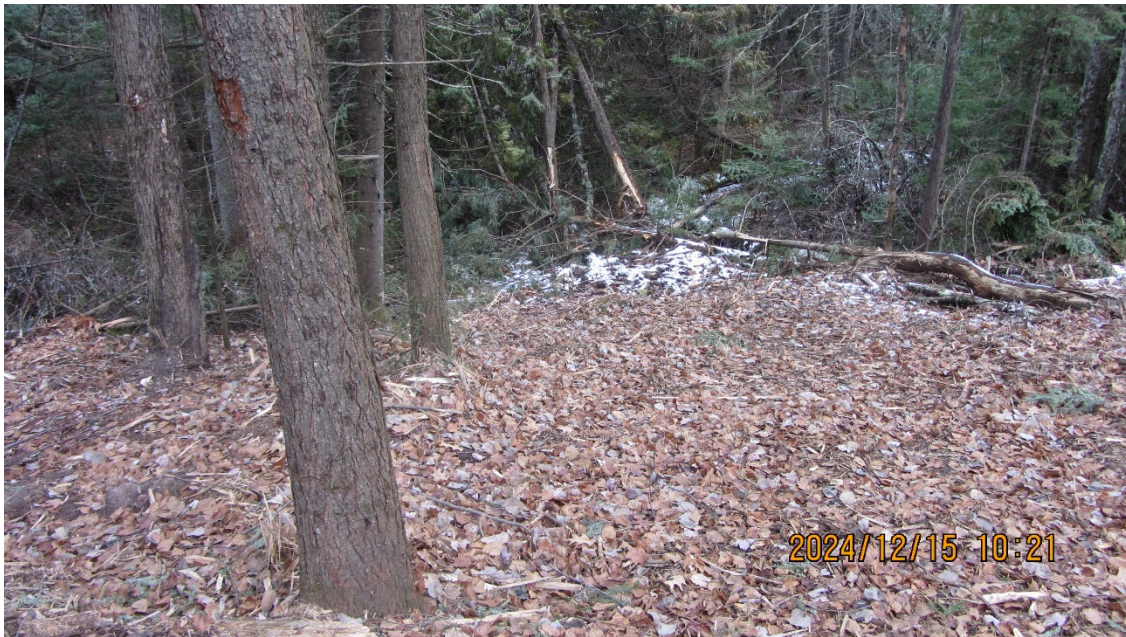
10: IMG\_0863

Description: West Side of J&G Storage Site

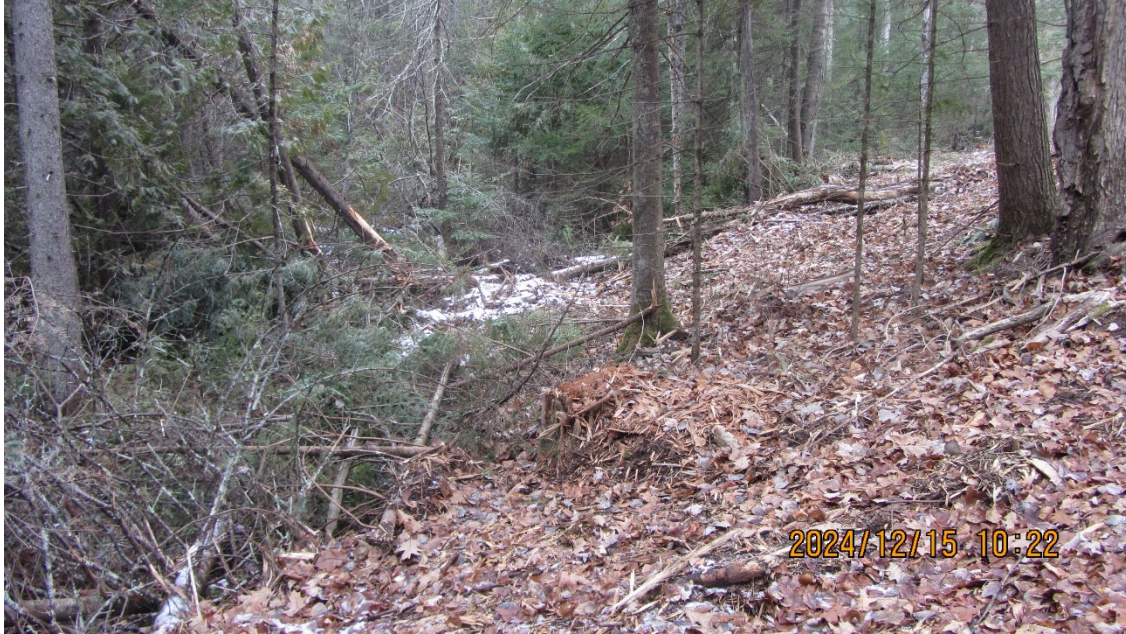
11: IMG\_0864

Description: West Side of J&G Storage Site

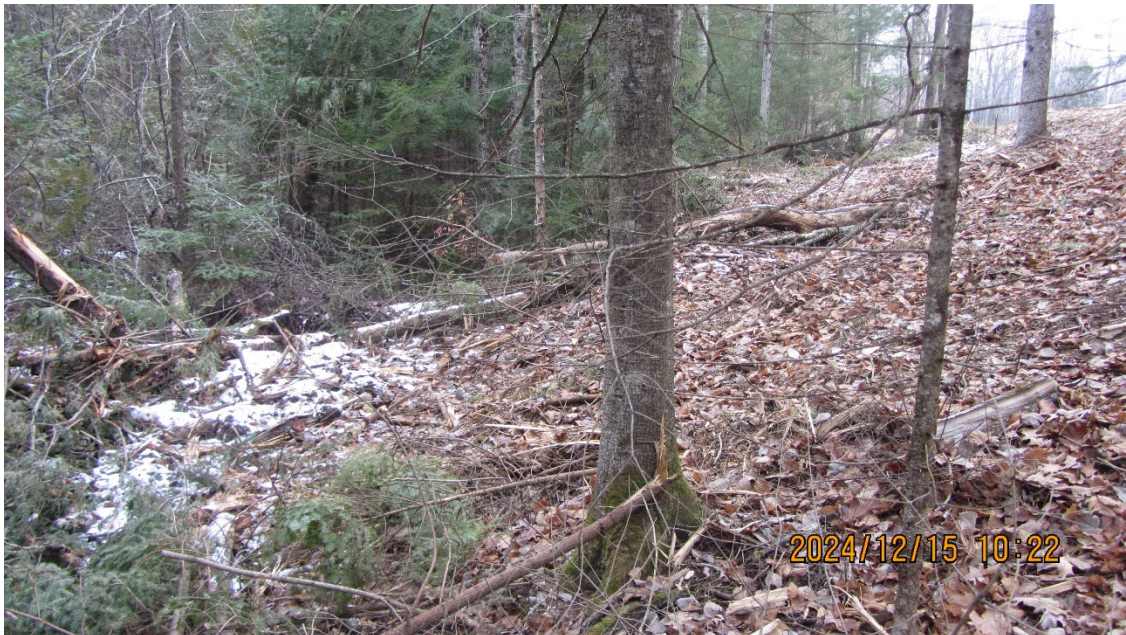
12 IMG\_0865

Description: West Side of J&G Storage Site

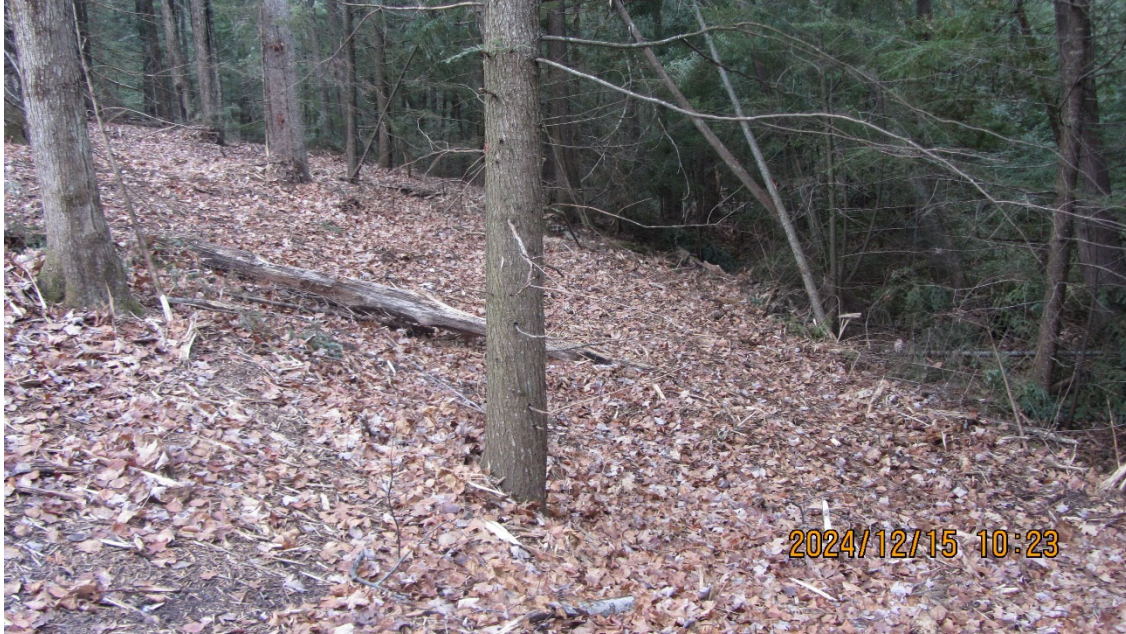
28. IMG\_0866

Description: Southwest Side of J&G Storage Site

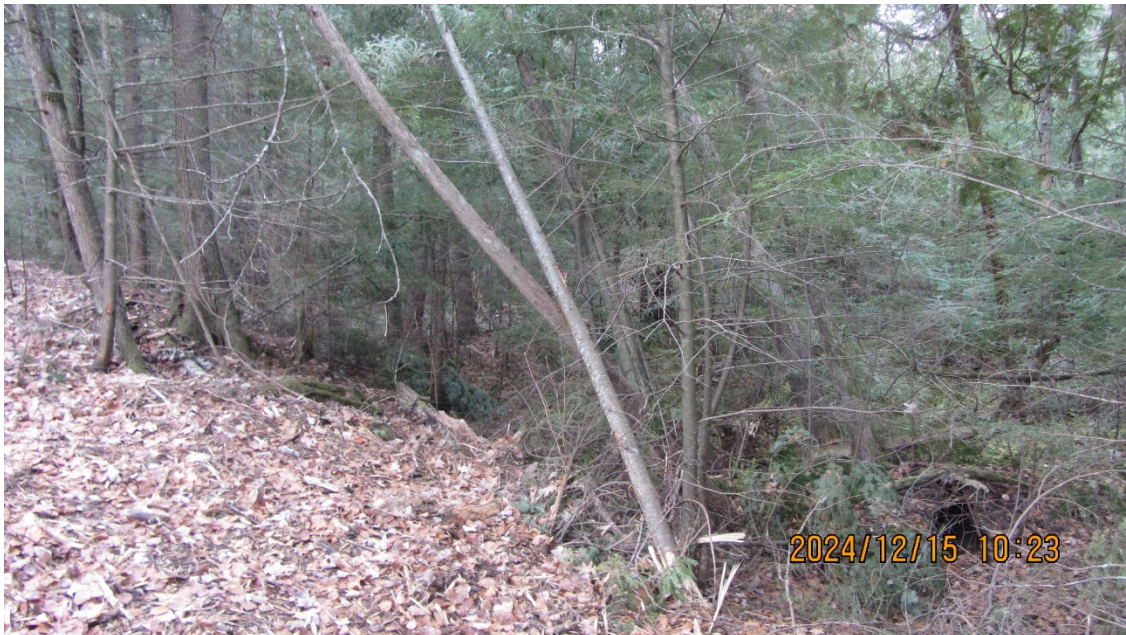
13 IMG\_0867

Description: Southwest Side of J&G Storage Site

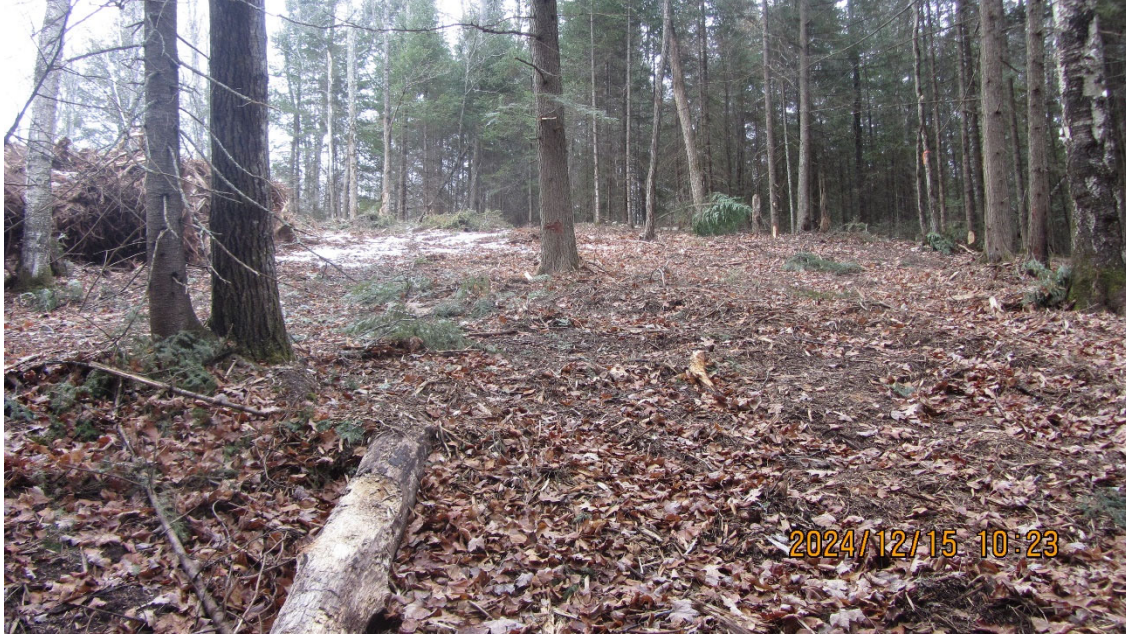
30. IMG\_0868

Description: South Portion of J&G Storage Site

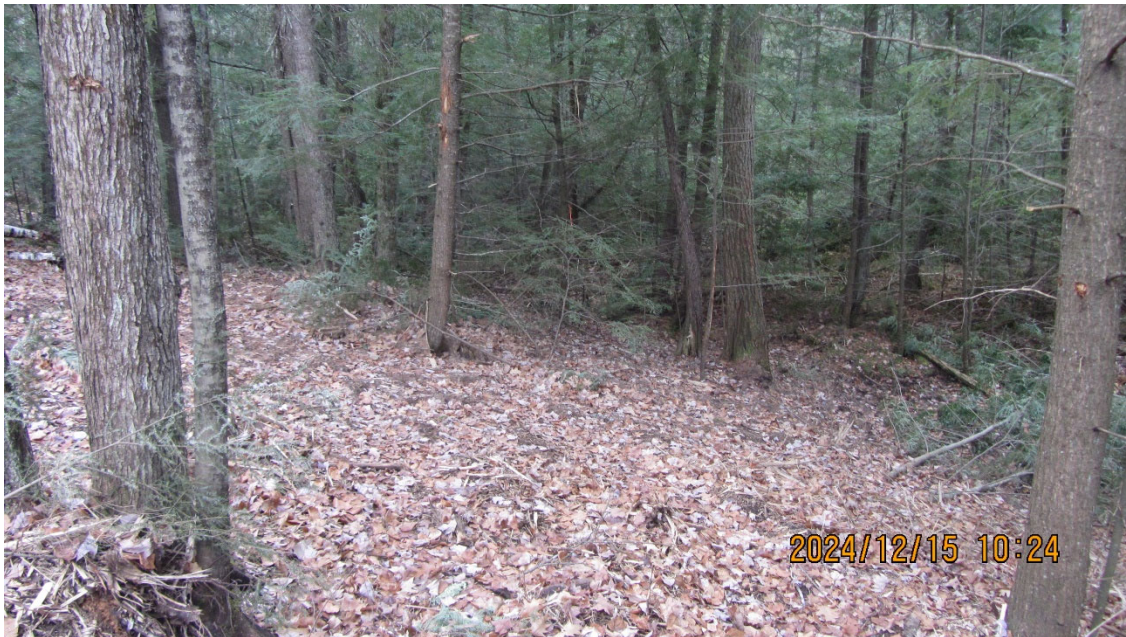
31. IMG\_0869

Description: Southwest Side of J&G Storage Site

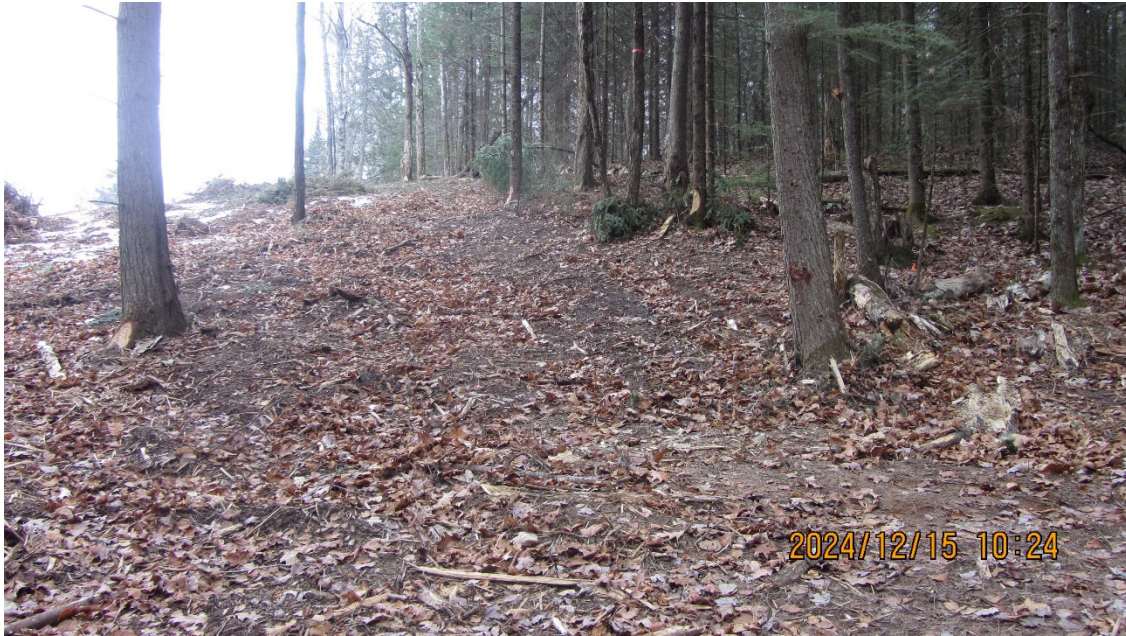
32. IMG\_0870

Description: South Side of J&G Storage Site

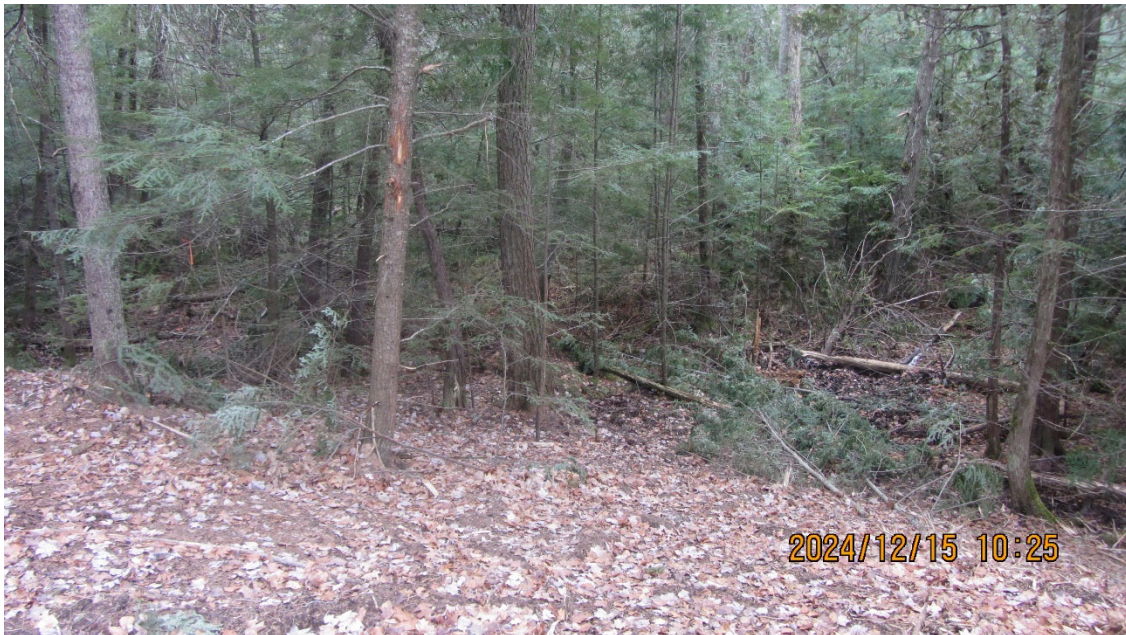
14. IMG\_0871

Description: Southwest Side of J&G Storage Site

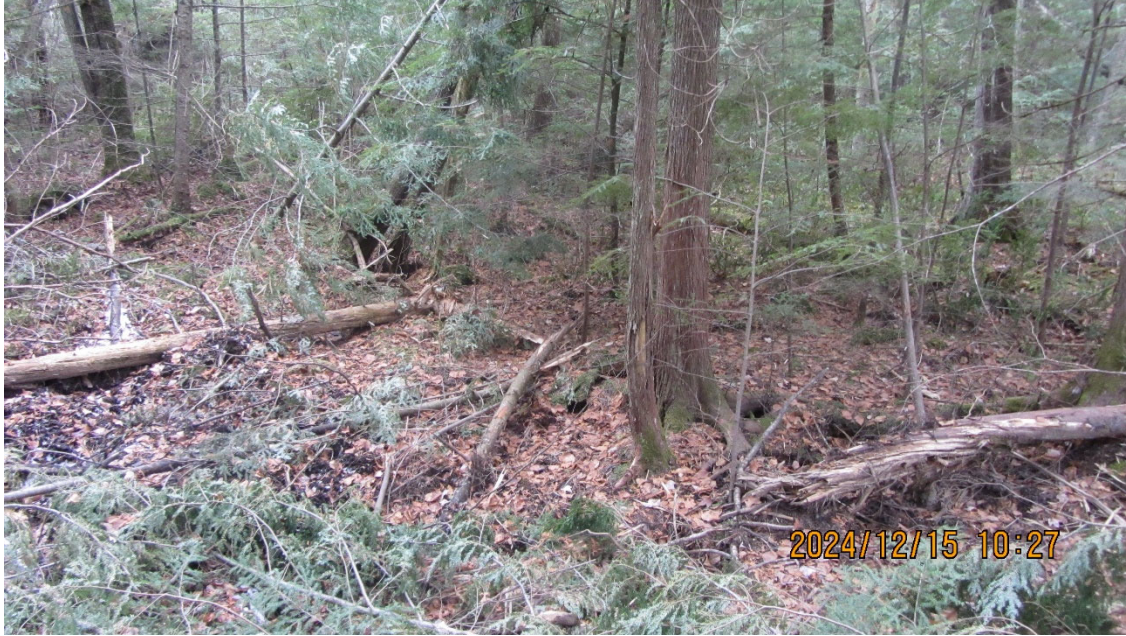
34. IMG\_0872

Description: Southwest Side of J&G Storage Site – Looking Into Forested Area

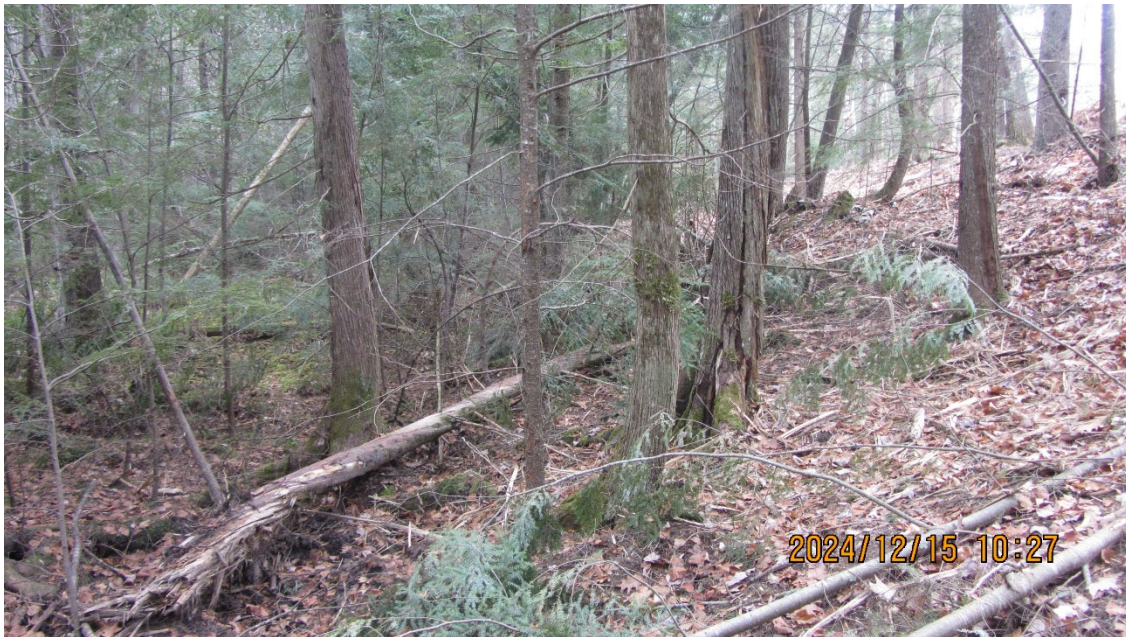
35. IMG\_0873

Description: West Side of J&G Storage Site

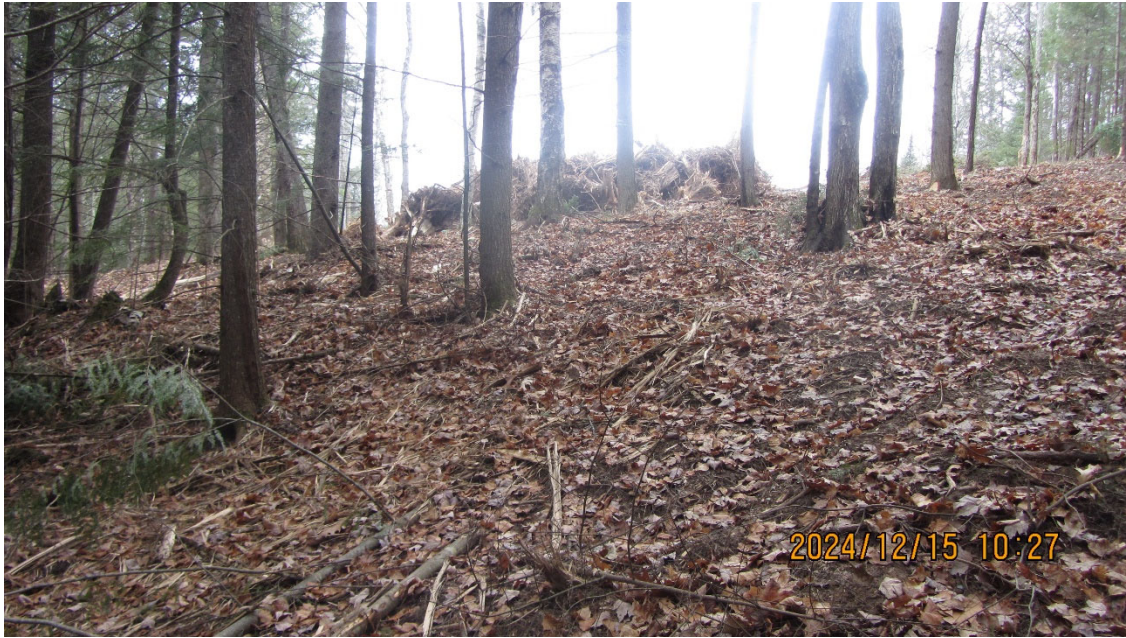
36. IMG\_0874

Description: Tree Stump Pile on Southern Portion of J&G Storage Site

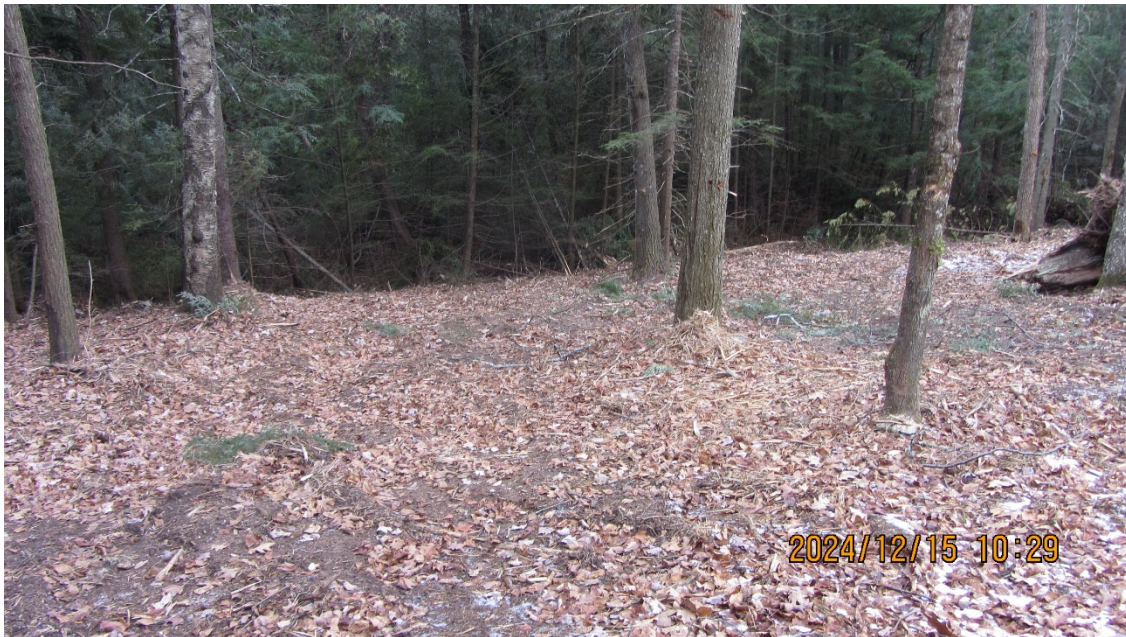
37. IMG\_0875

Description: Southwest Side of J&G Storage Site

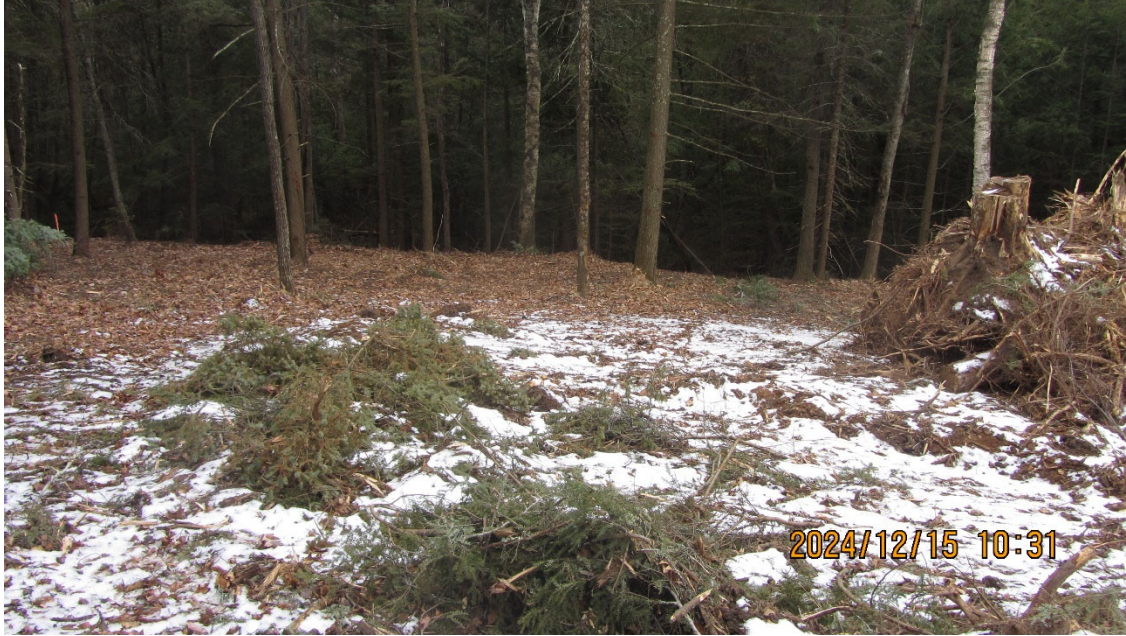
38. IMG\_0876

Description: South Side of J&G Storage Site

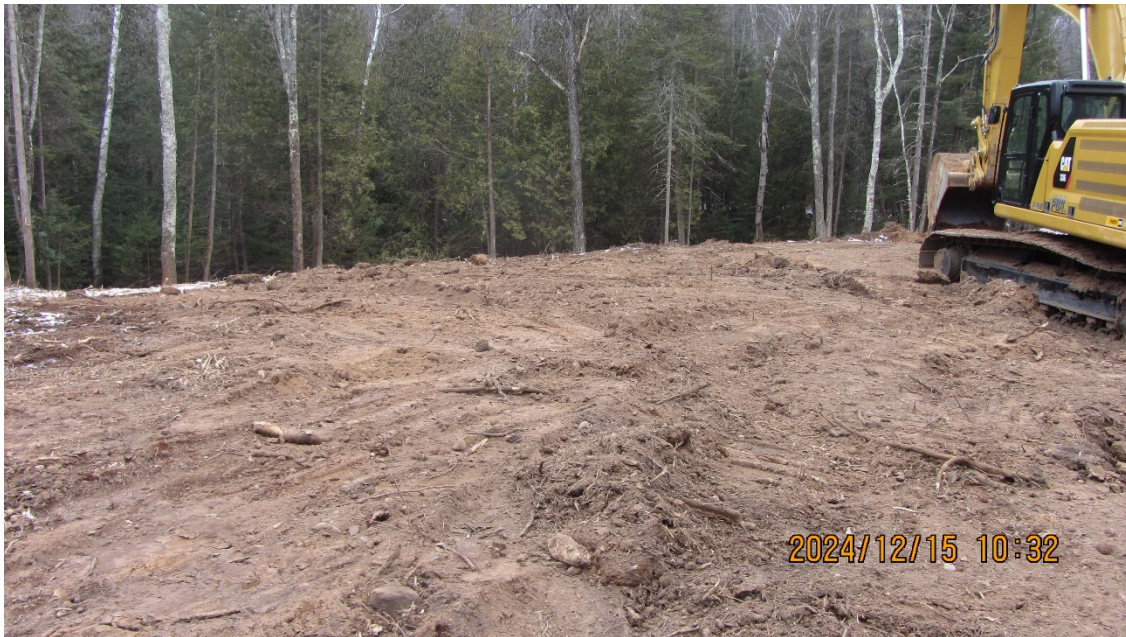
39. IMG\_0877

Description: Southern Portion of J&G Storage Site

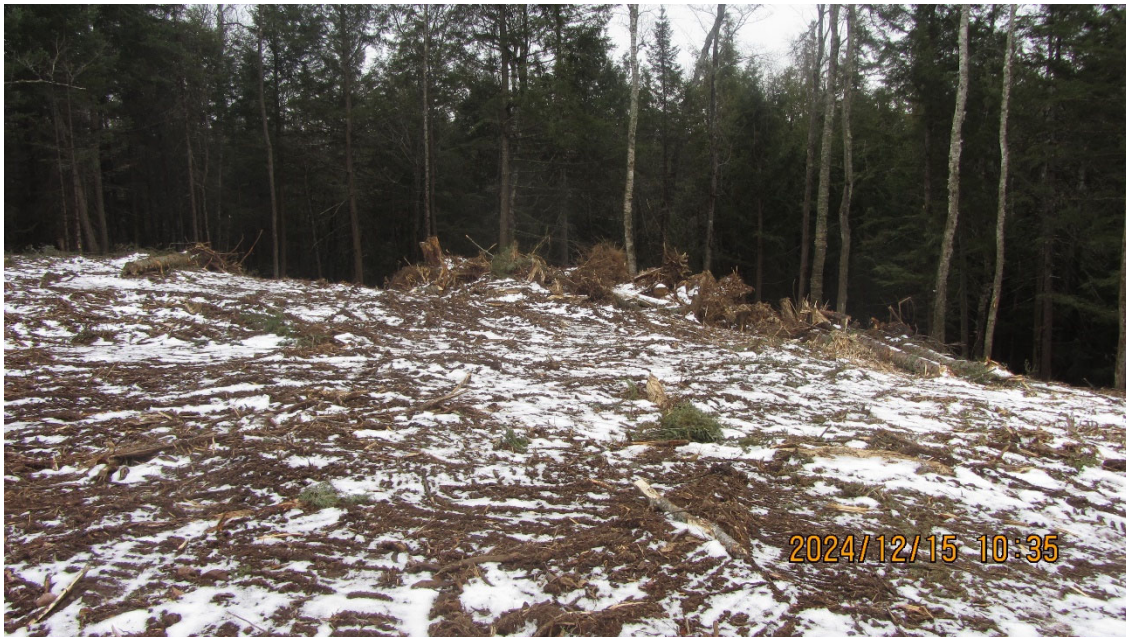
41. IMG\_0879

Description: South Side of J&G Storage Site and Tree Stump Pile
